Inspection Photos

1/31/2019

Operator: VERDAD RESOURCES LLC - 10651

Location ID: 425475

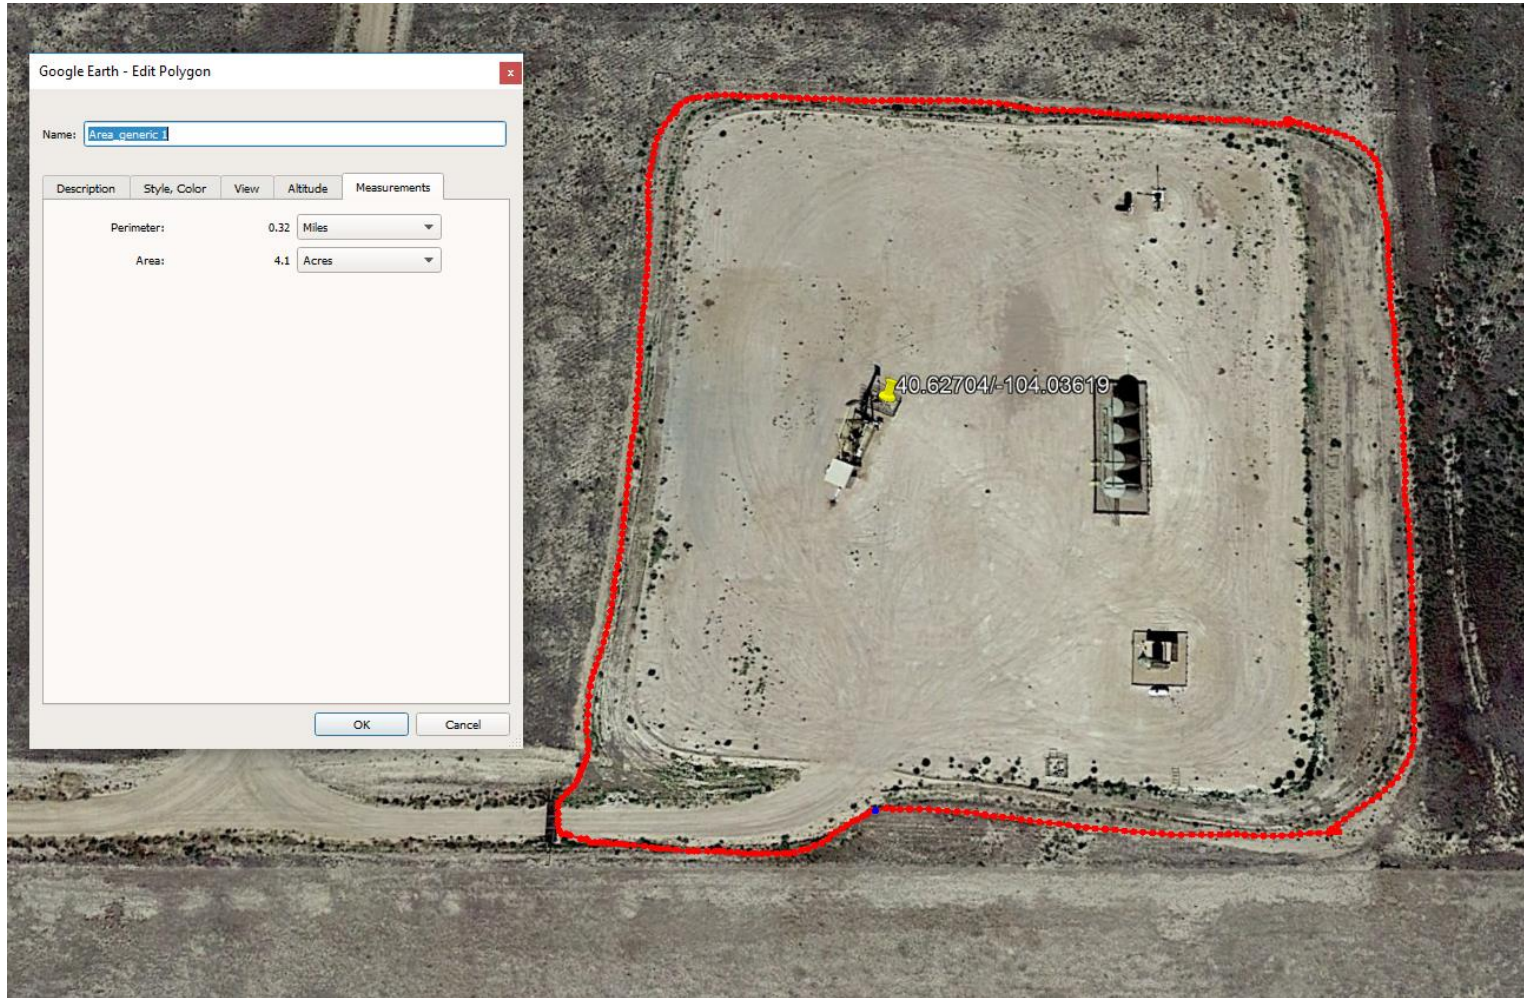
Photo 1: 2013 Google earth aerial imagery. Photo shows disturbance area for the location. A disturbance area of 4.1 acres was measured using a Trimble Juno 3B handheld device

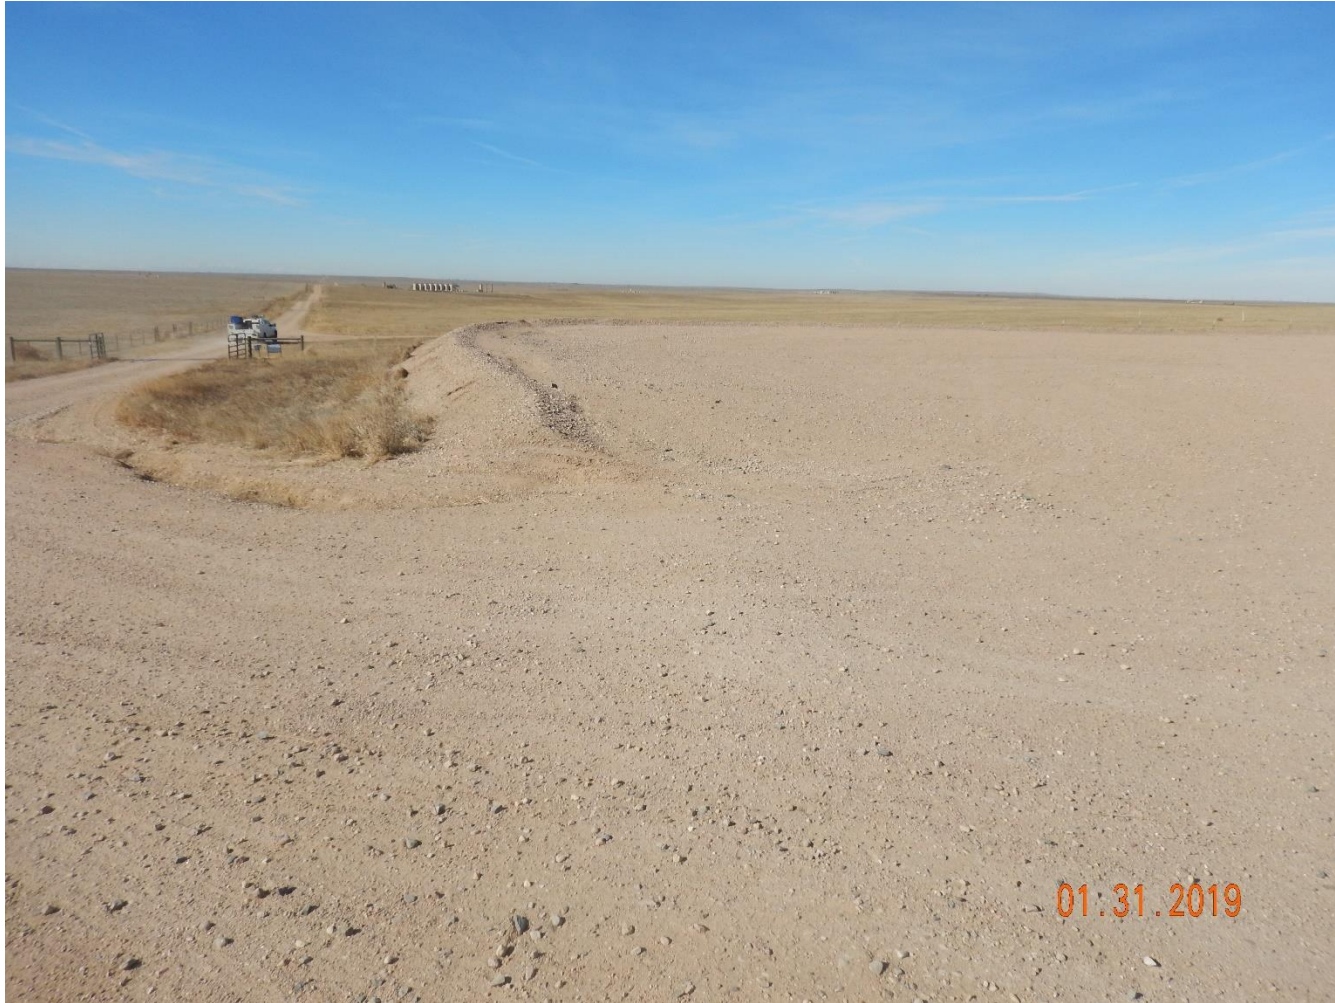
Photo 2: Photo taken from the south end of the location, facing east. Photos 2- 5 provide and overview of the location from west, northwest, northeast to east. Photos also show interim reclamation has not been conducted in accordance with COGCC rule 1003.

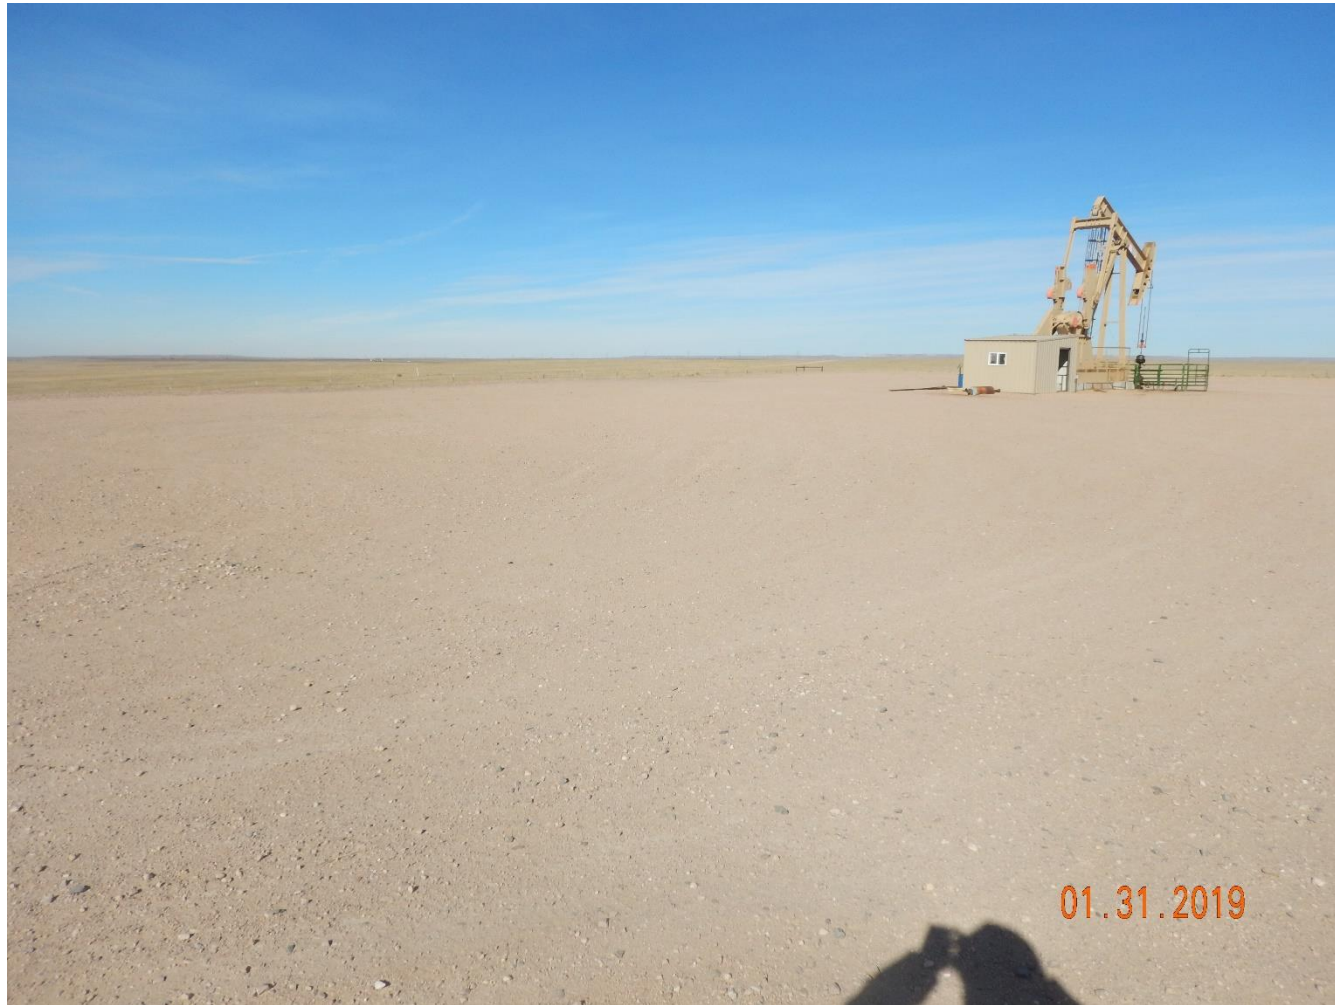
Photo 3: See comments under photo 2.

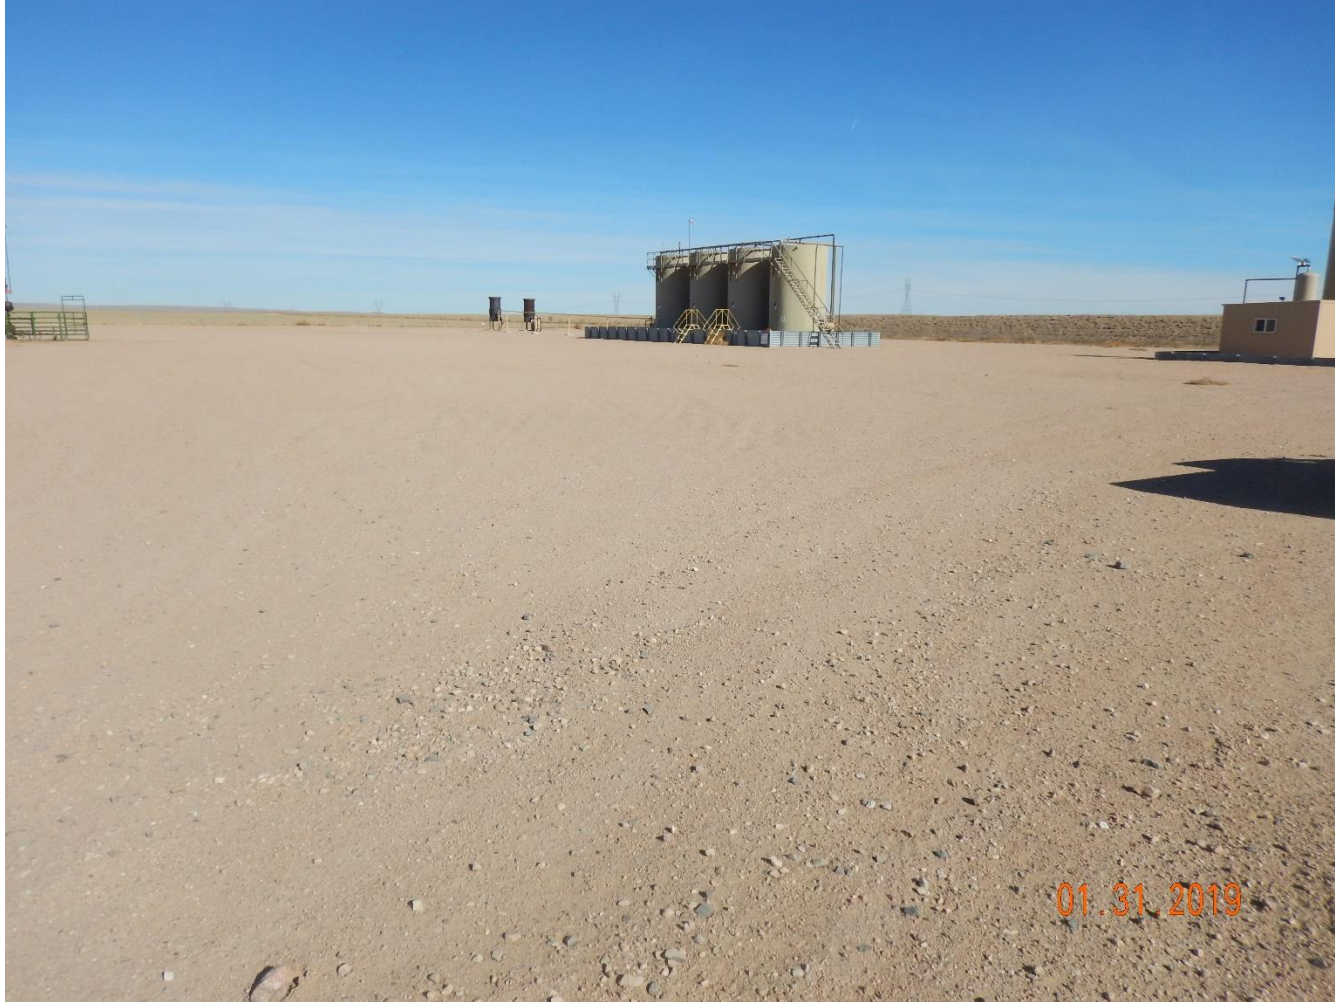
Photo 4: See comments under photo 2.

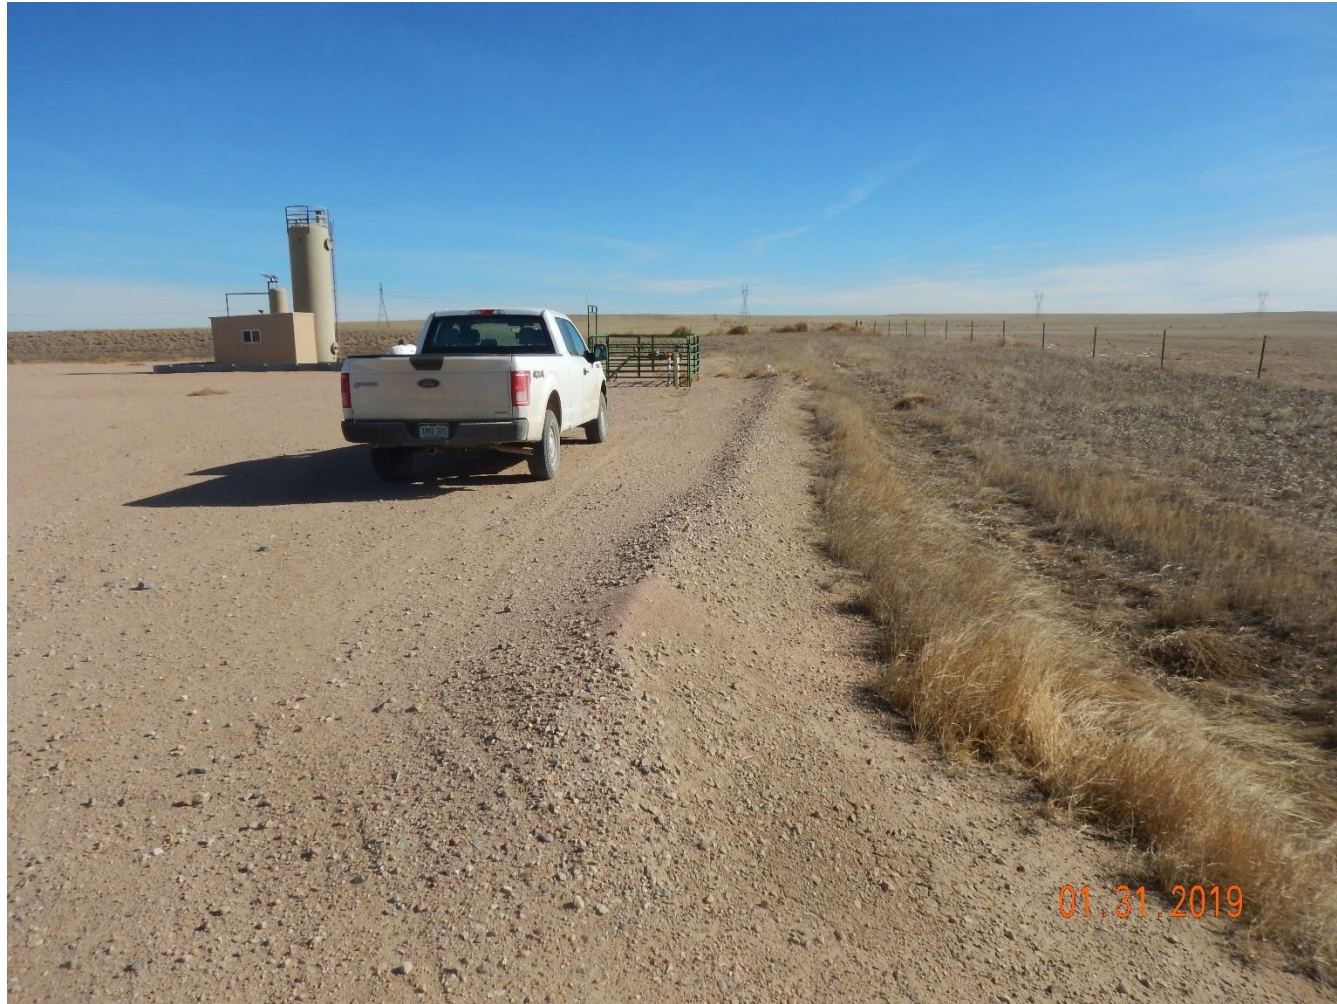
Photo 5: See comments under photo 2.

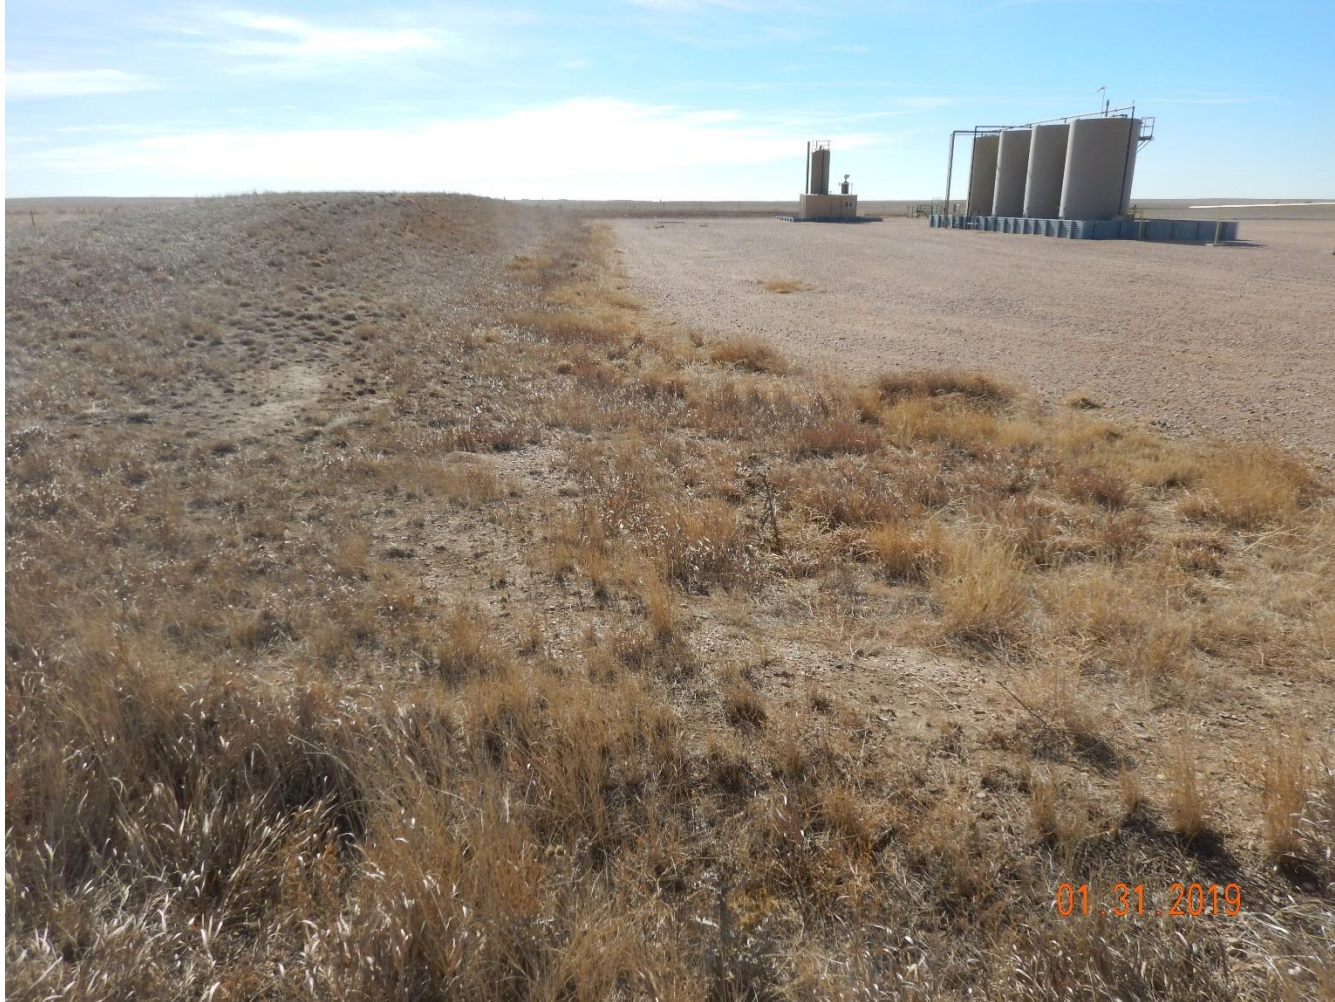
Photo 6: Photo taken from the northeast corner of the location, facing south. Photo shows interim reclamation has not been conducted in accordance with COGCC rule 1003

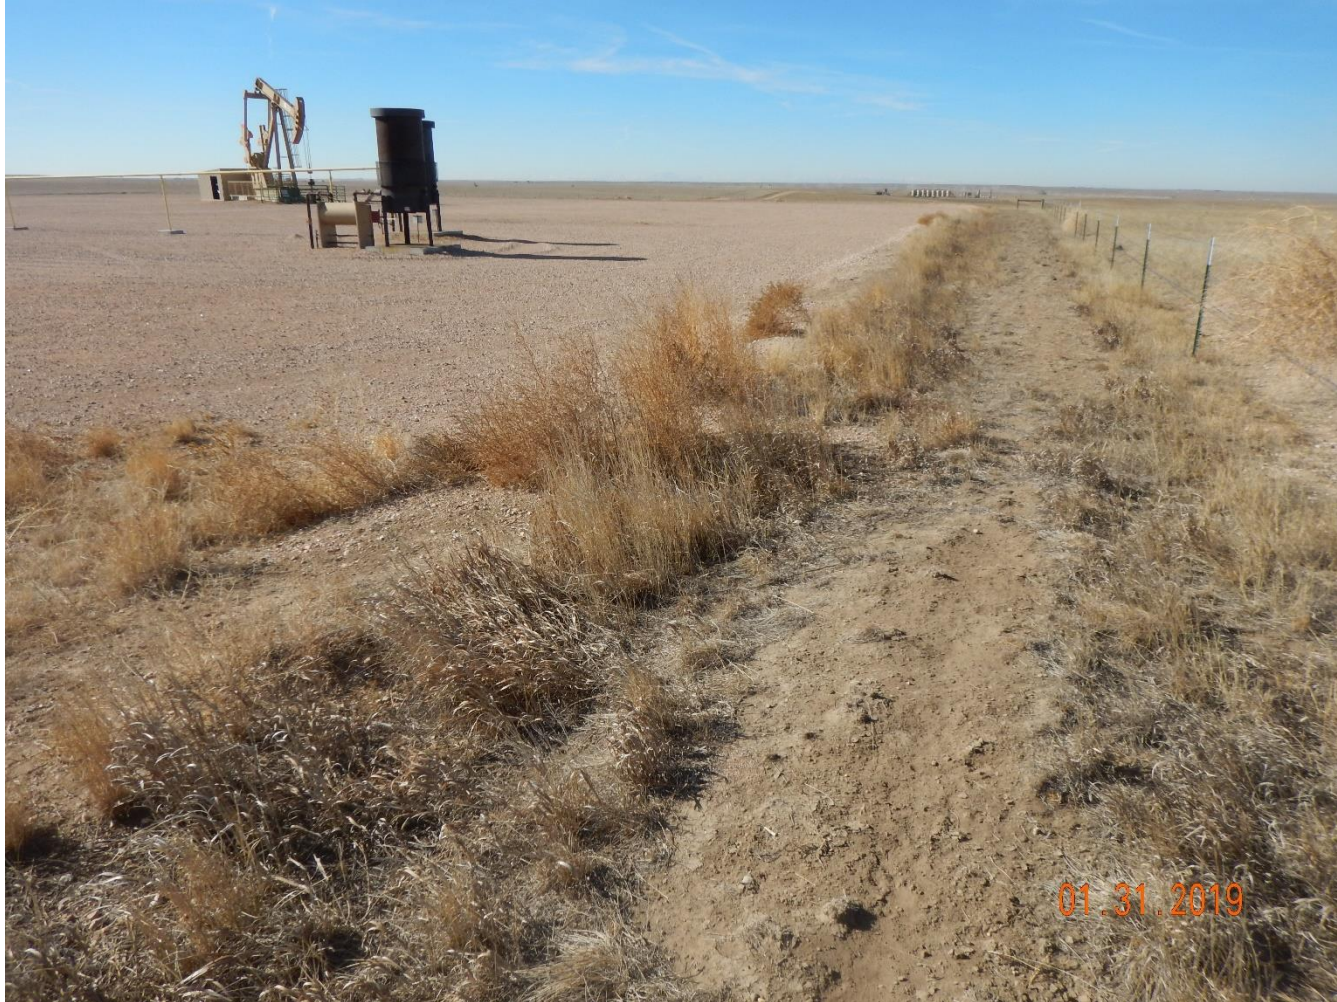
Photo 7: Photo taken from the northeast corner of the location, facing west. Photo shows interim reclamation has not been conducted in accordance with COGCC rule 1003

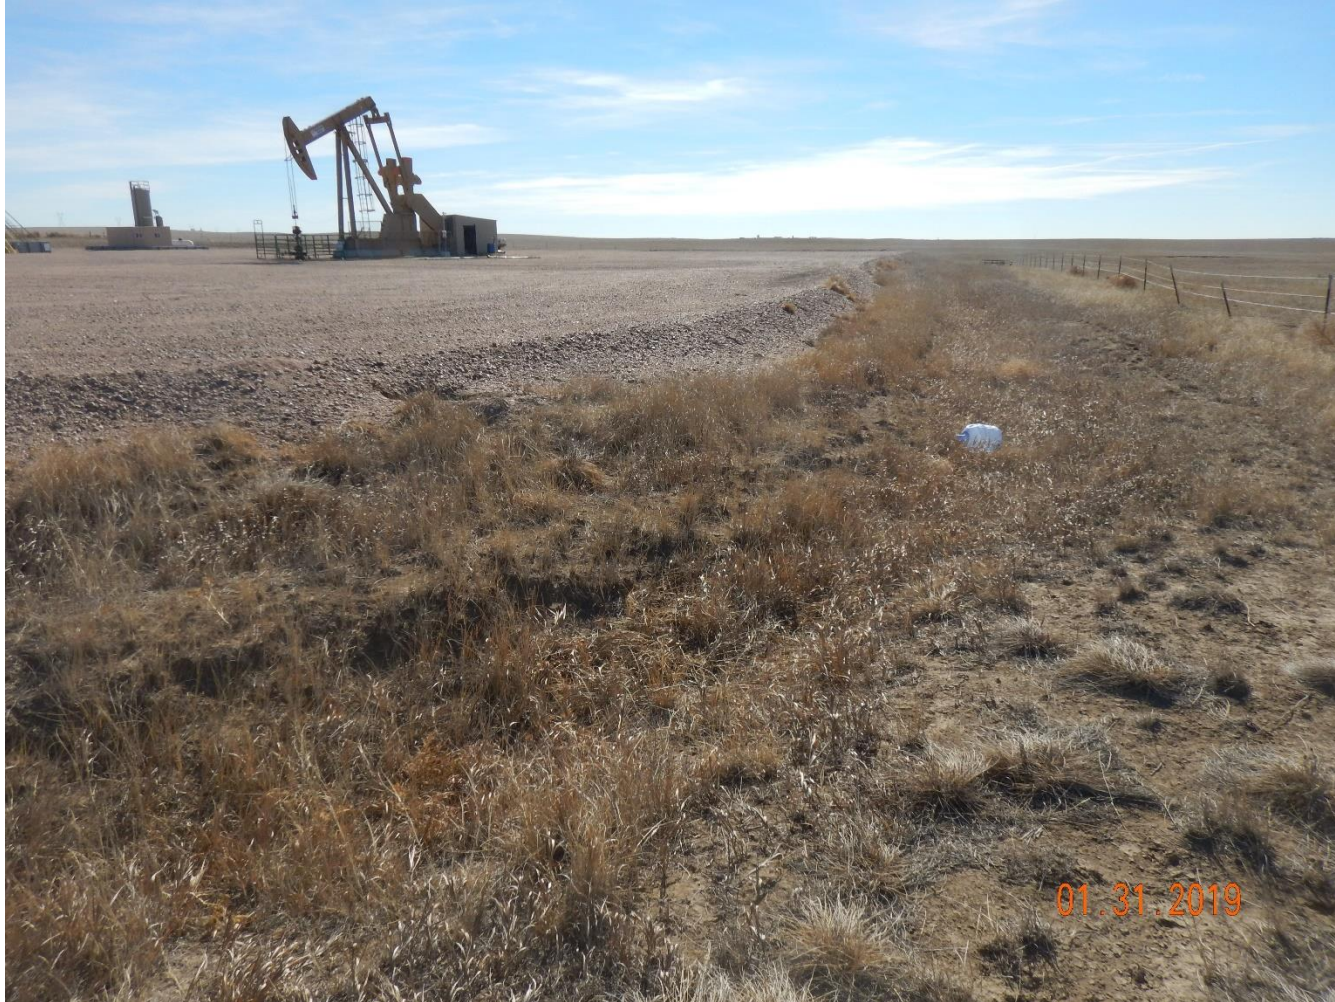
Photo 8: Photo taken from the northwest corner of the location, facing south. Photo shows interim reclamation has not been conducted in accordance with COGCC rule 1003

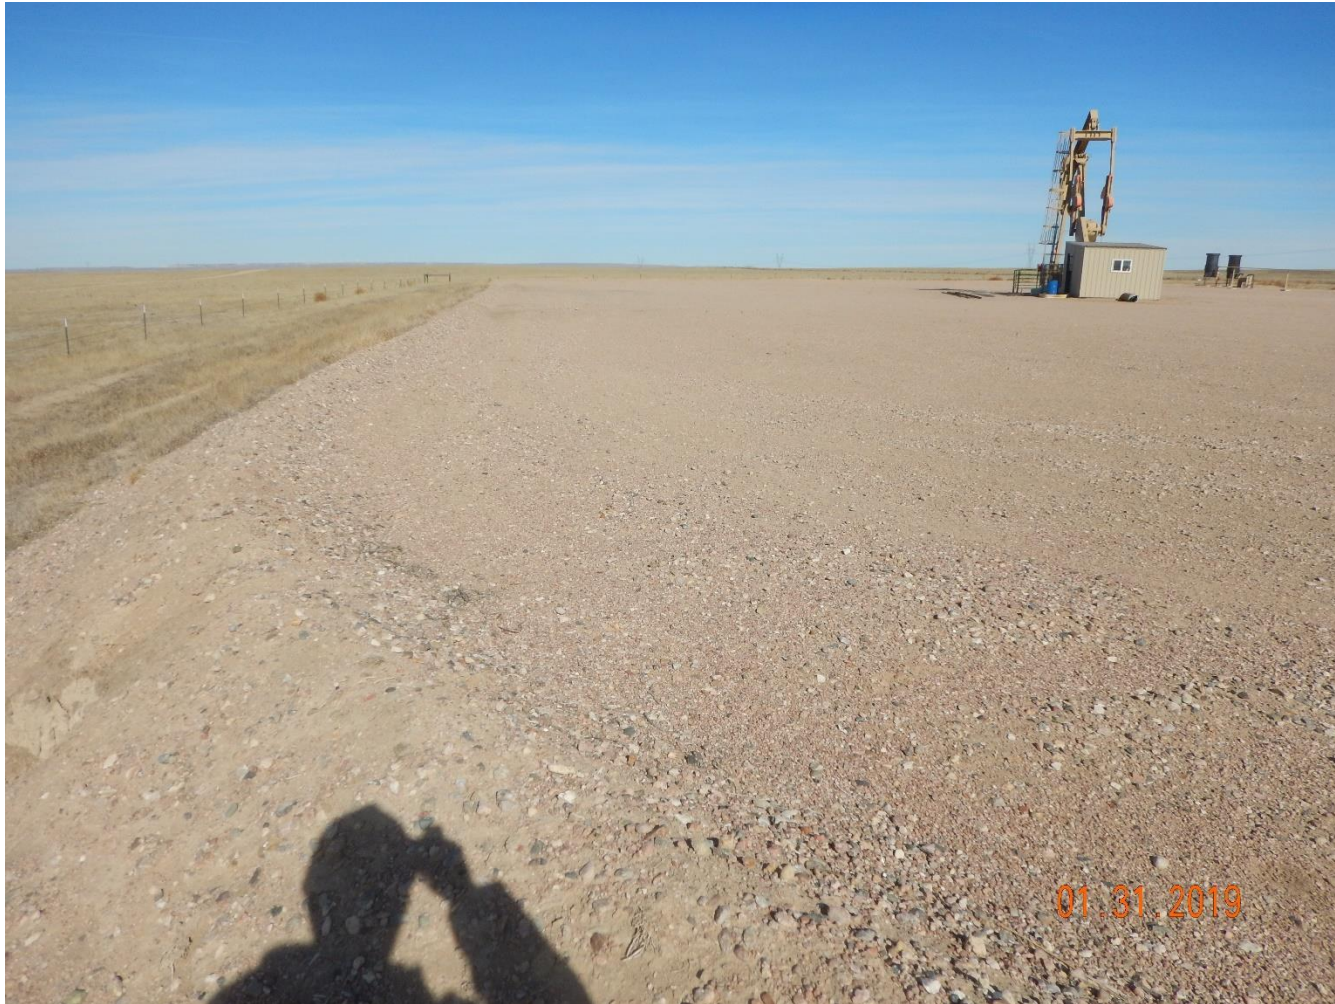
Photo 9: Photo taken from the southwest corner of the location, facing north. Photo shows interim reclamation has not been conducted in accordance with COGCC rule 1003

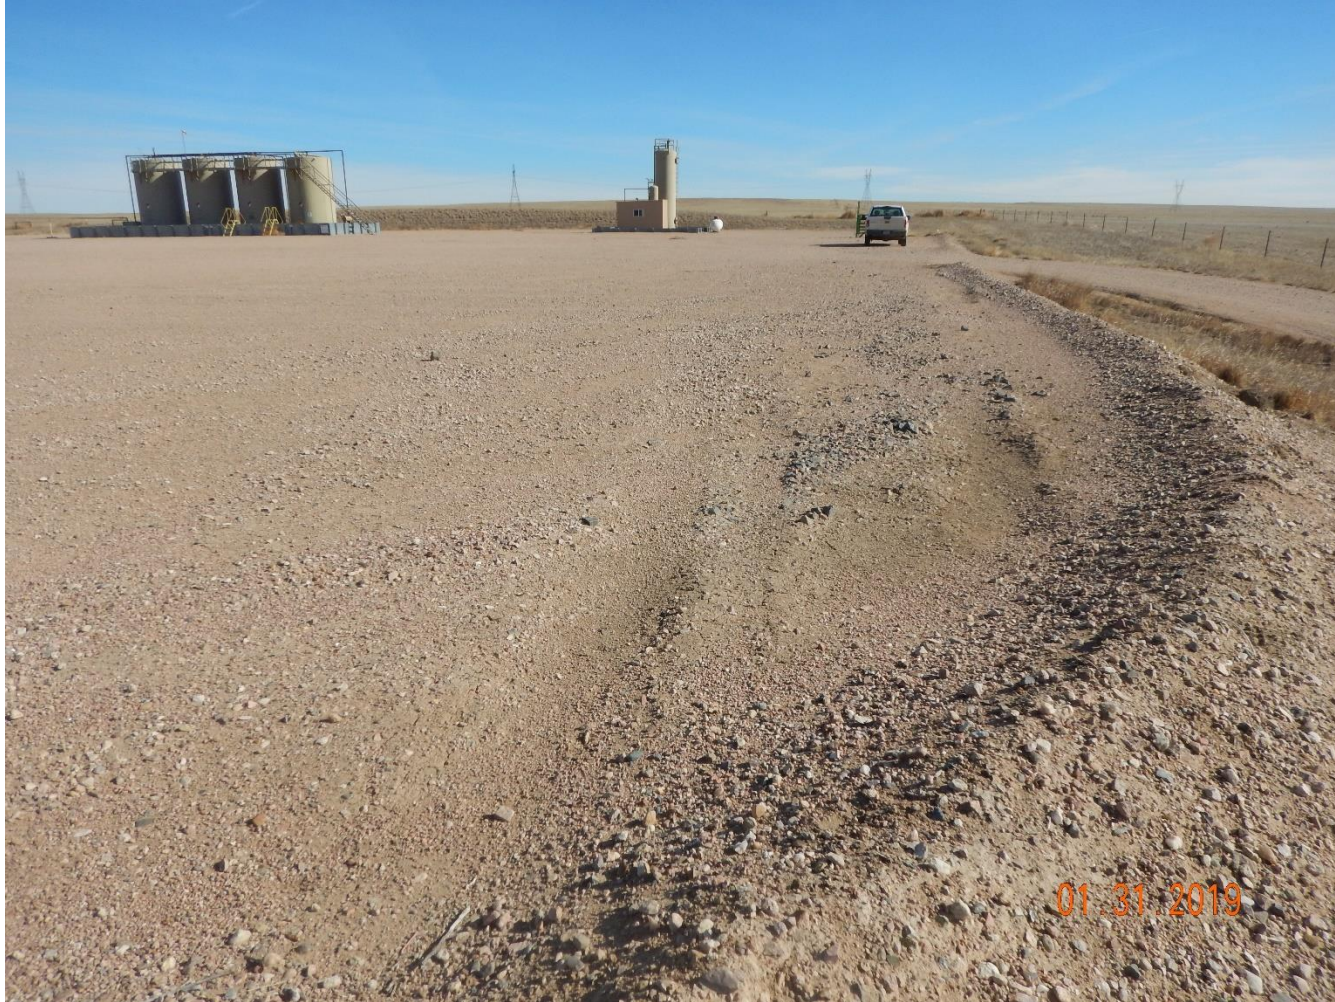
Photo 10: Photo taken from the southwest corner of the location, facing east. Photo shows interim reclamation has not been conducted in accordance with COGCC rule 1003

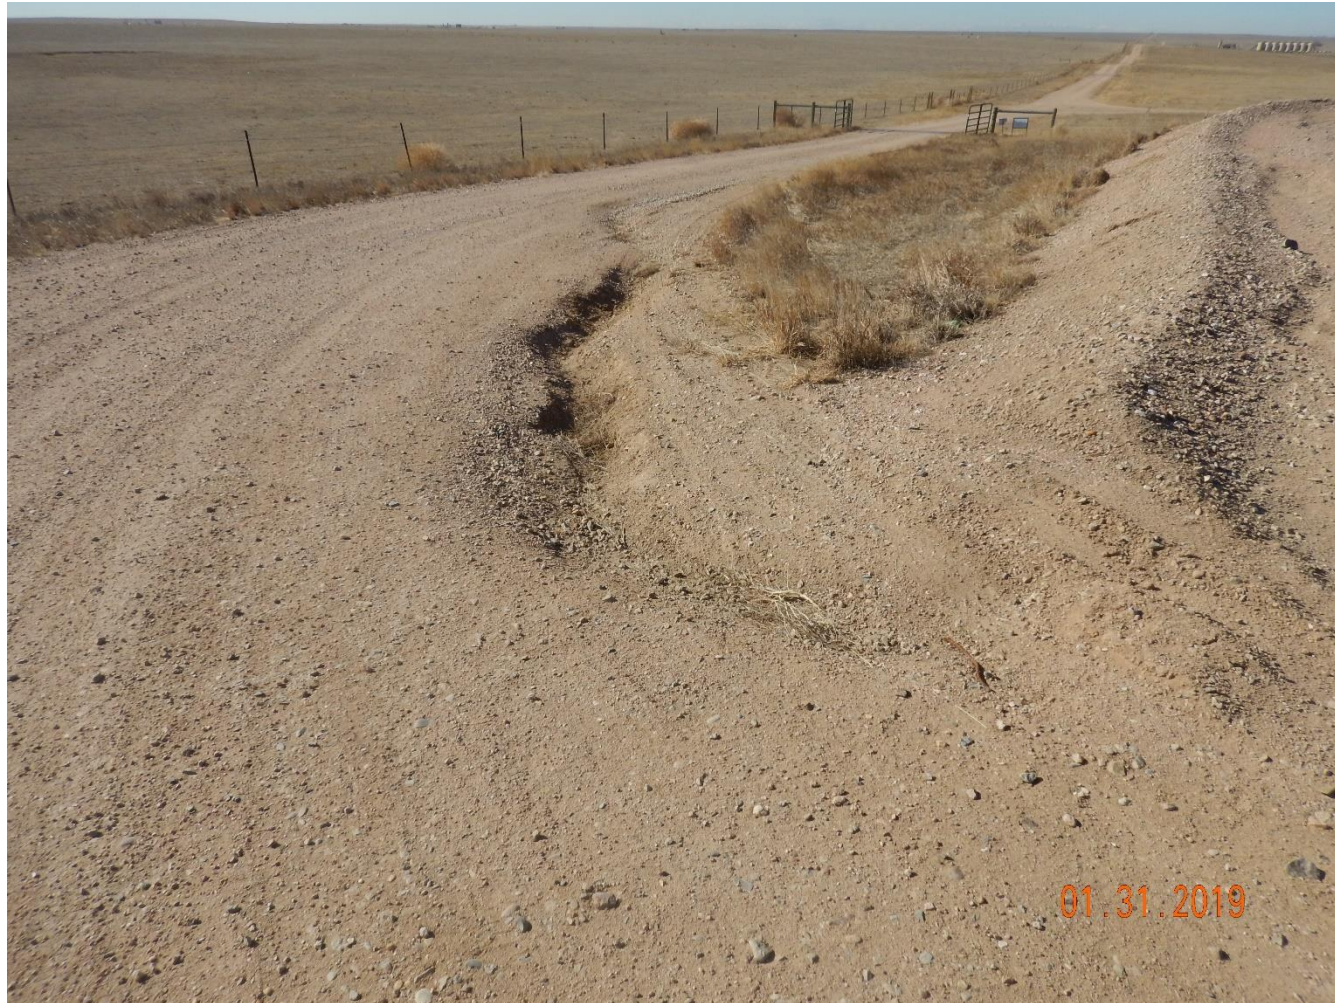
Photo 11: Photo taken from the access road on the south end of the location, facing southwest. Photo shows erosion degradation along access road due to stormwater runoff.
