D. C. DOZER SERVICE, LLC
1403 Fillmore
Sterling, CO 80751
(970) 580 - 0062
Troutman0231@msn.com

Location: Monahan Rex Family Trust – Atwood East Unit 5 - 1

Scope of work provided by Inspection Document 682503878:

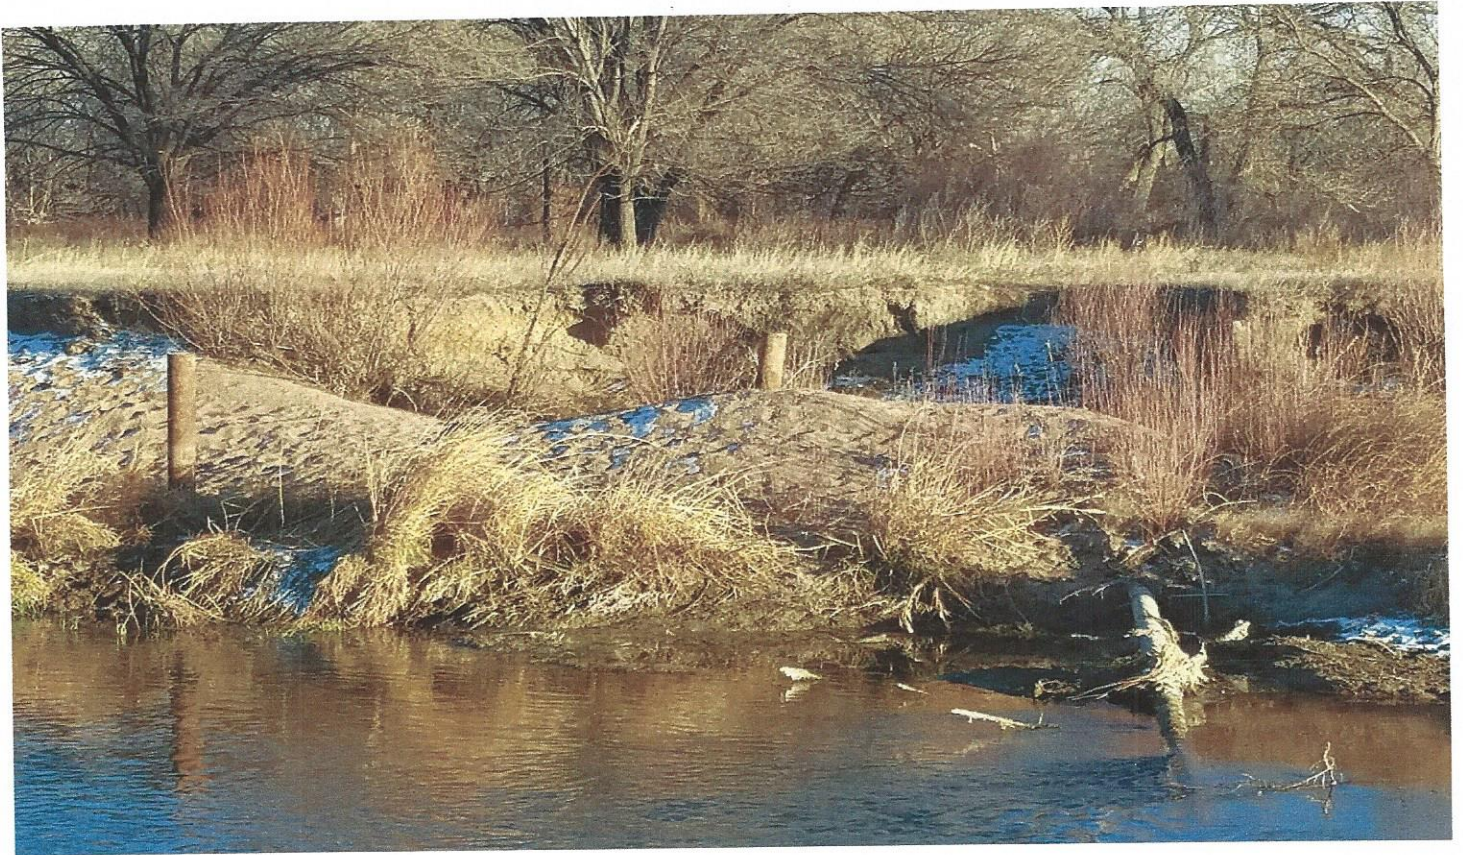
Three Risers Exposed Looking South

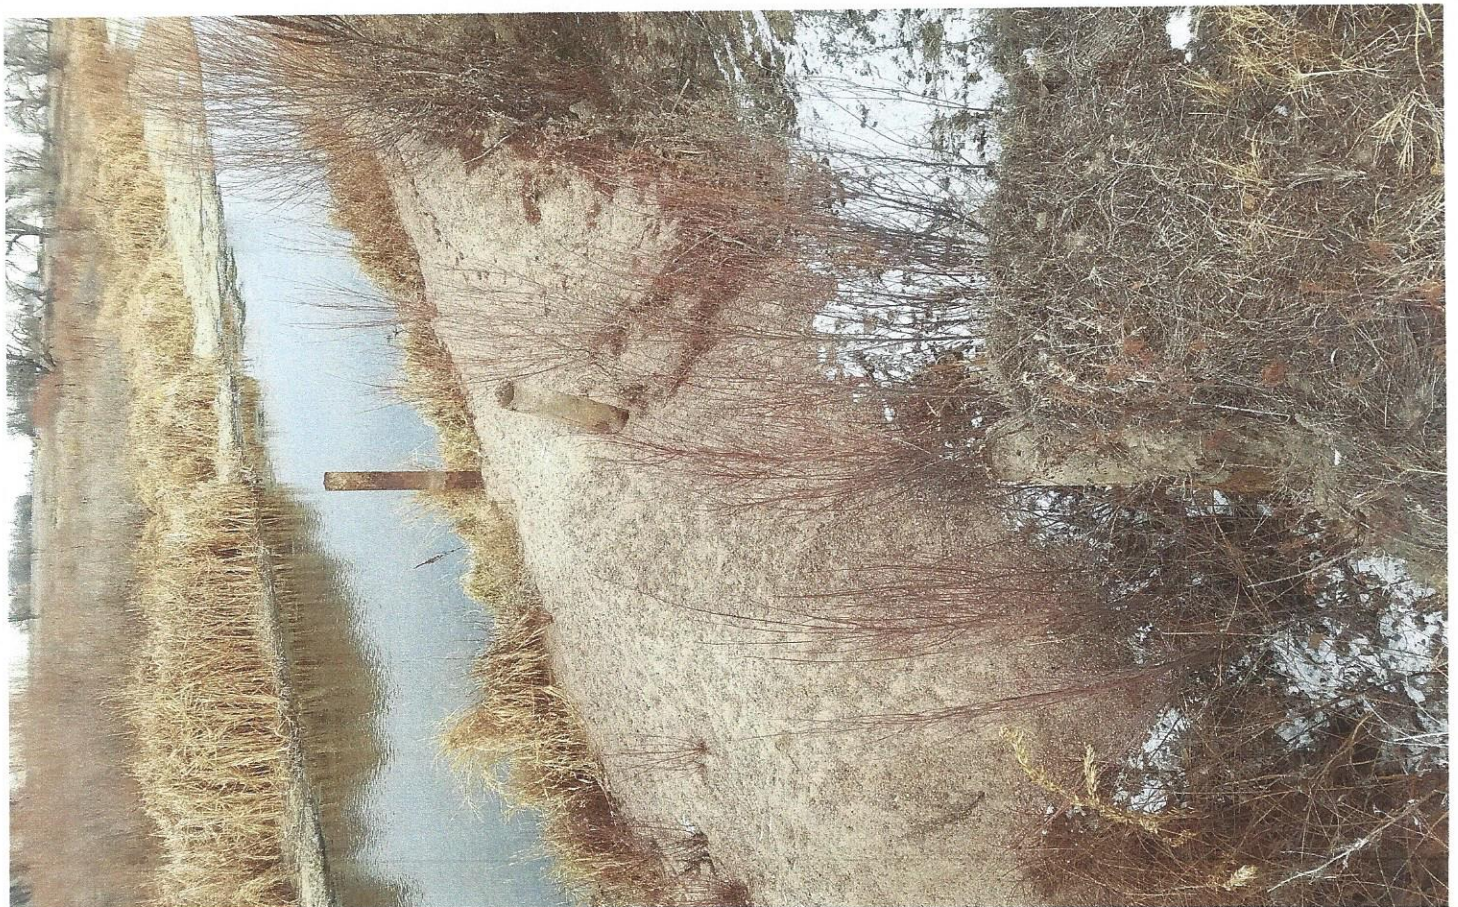
Three Risers Exposed Looking East

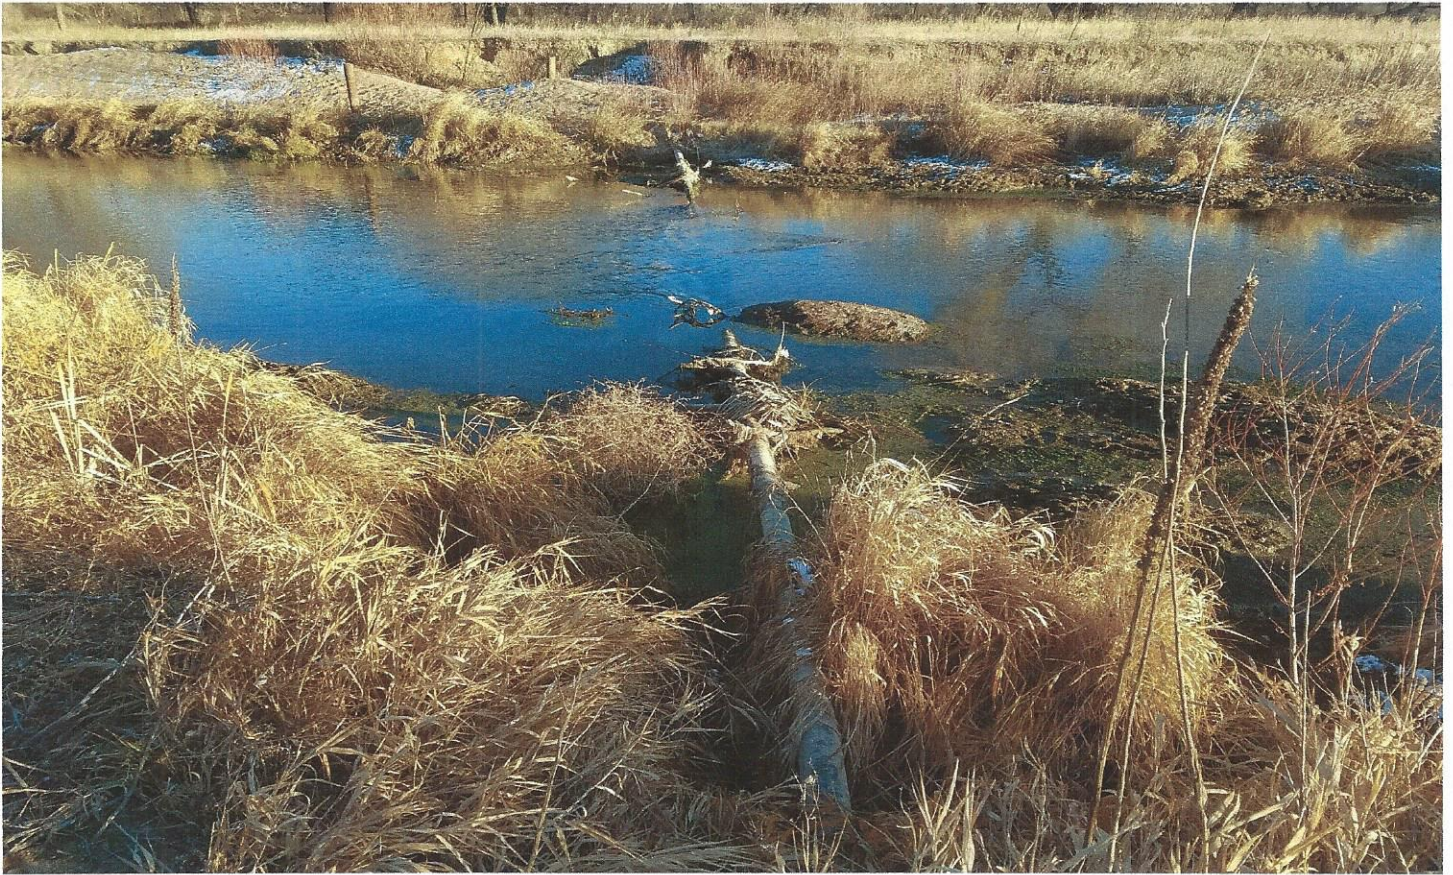
Flowline Exposed Looking South

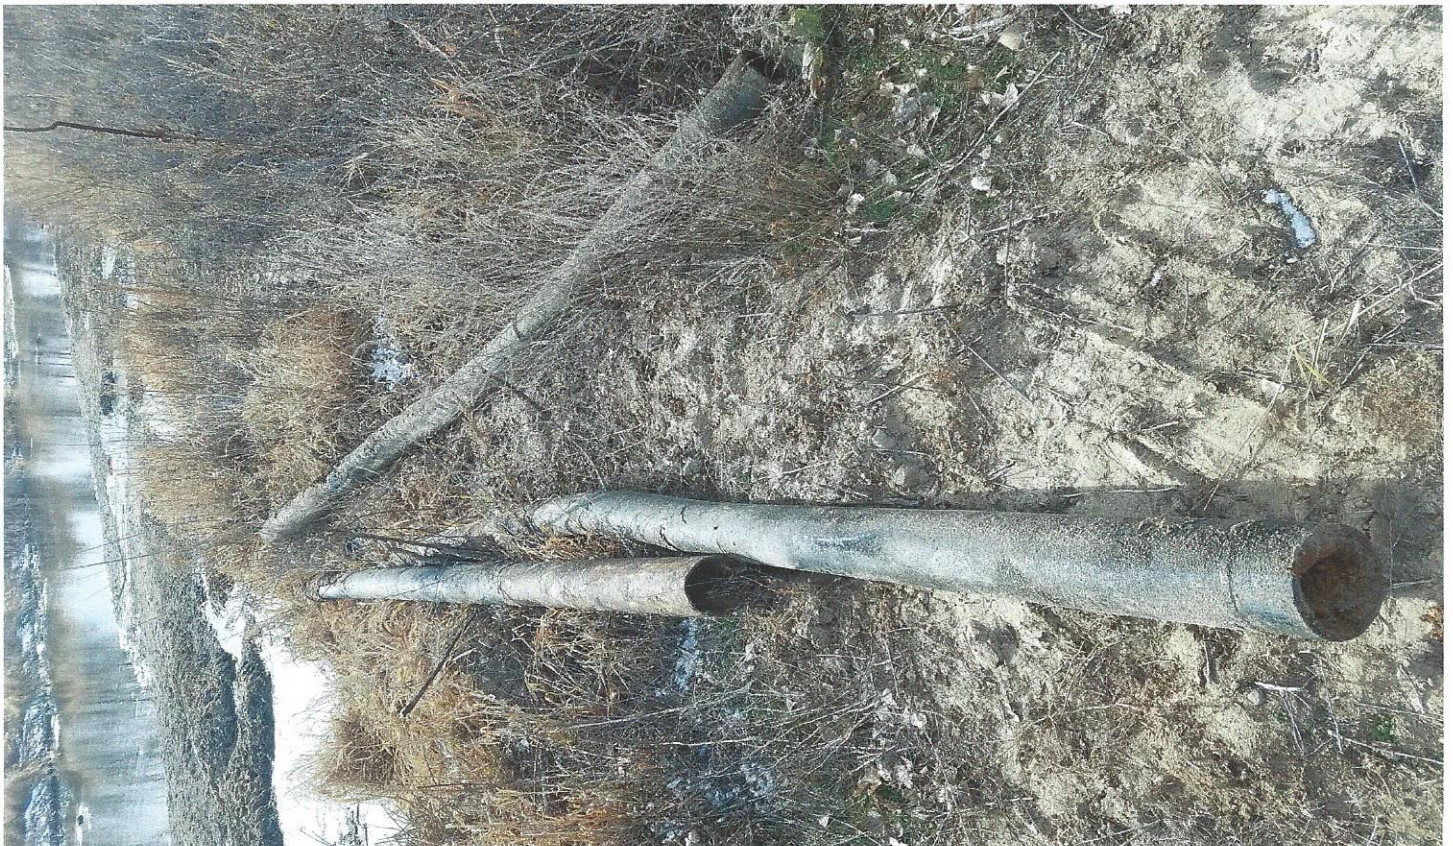
Three Risers Excavated

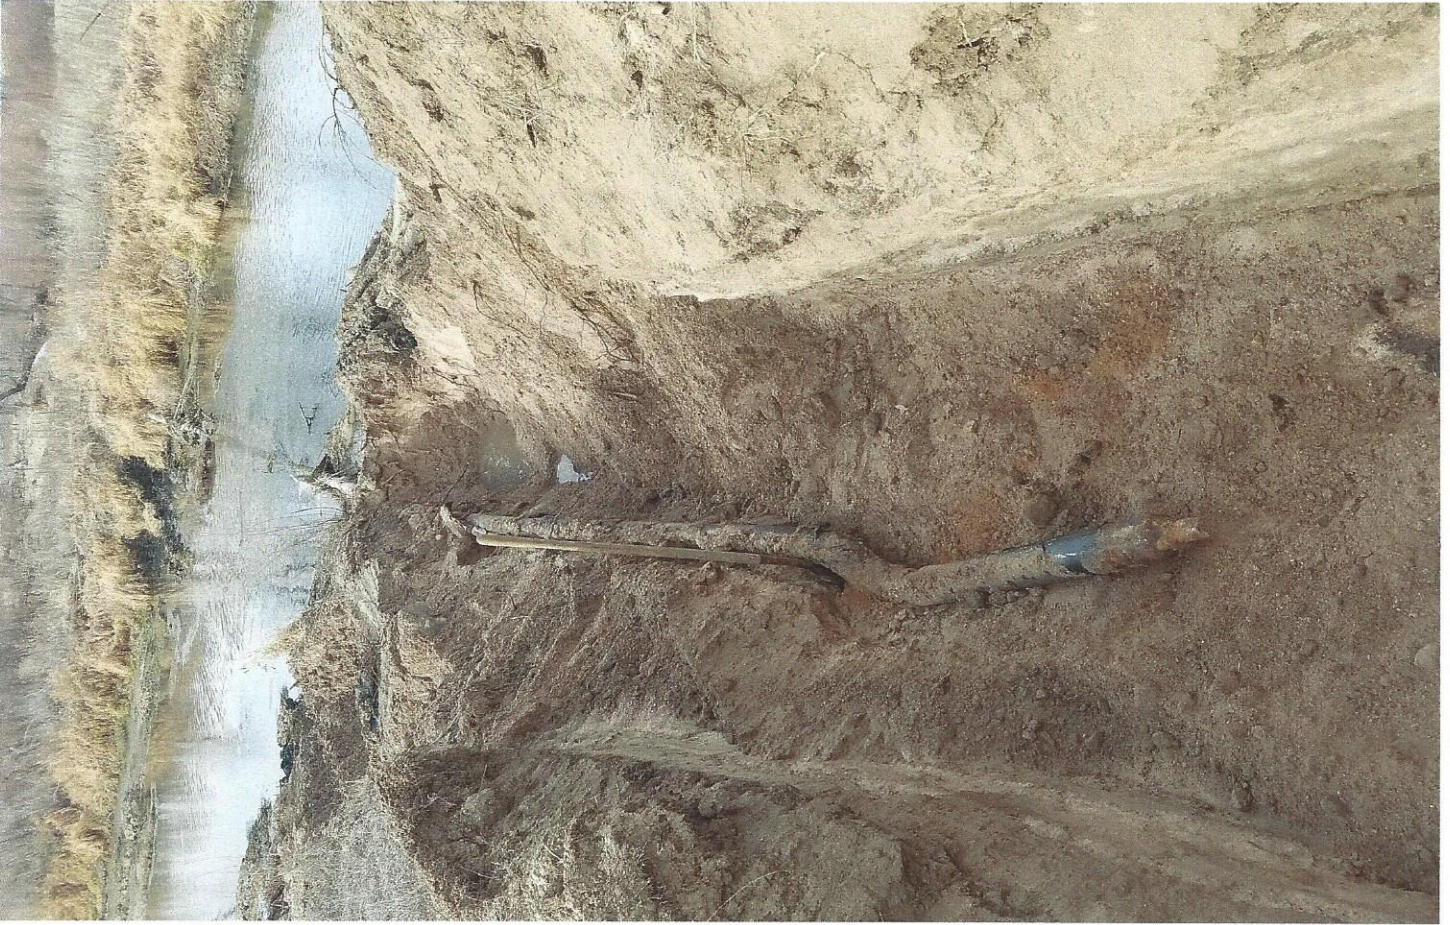
South Bank Excavated Flow line

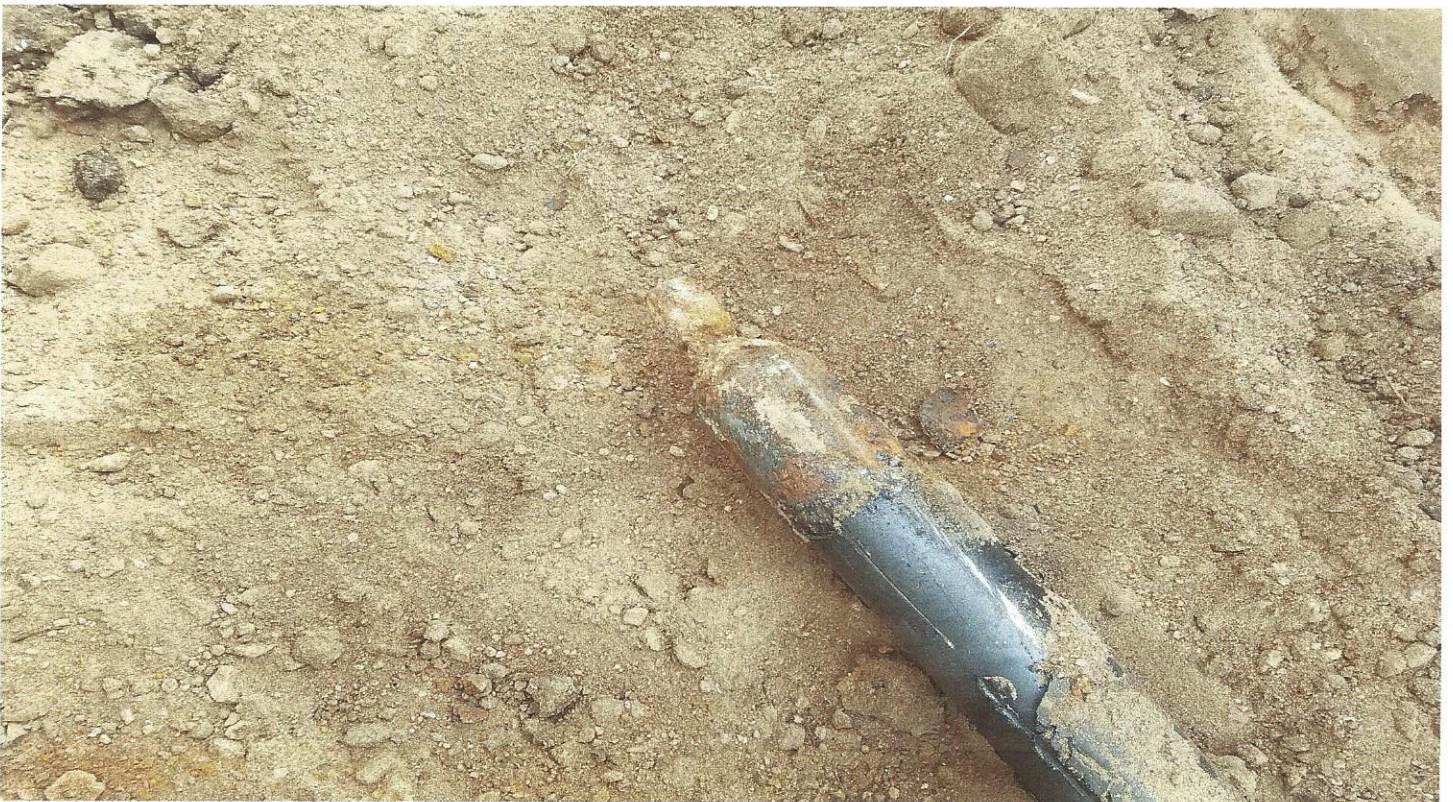
South End of Flowline Discovered Previously Capped

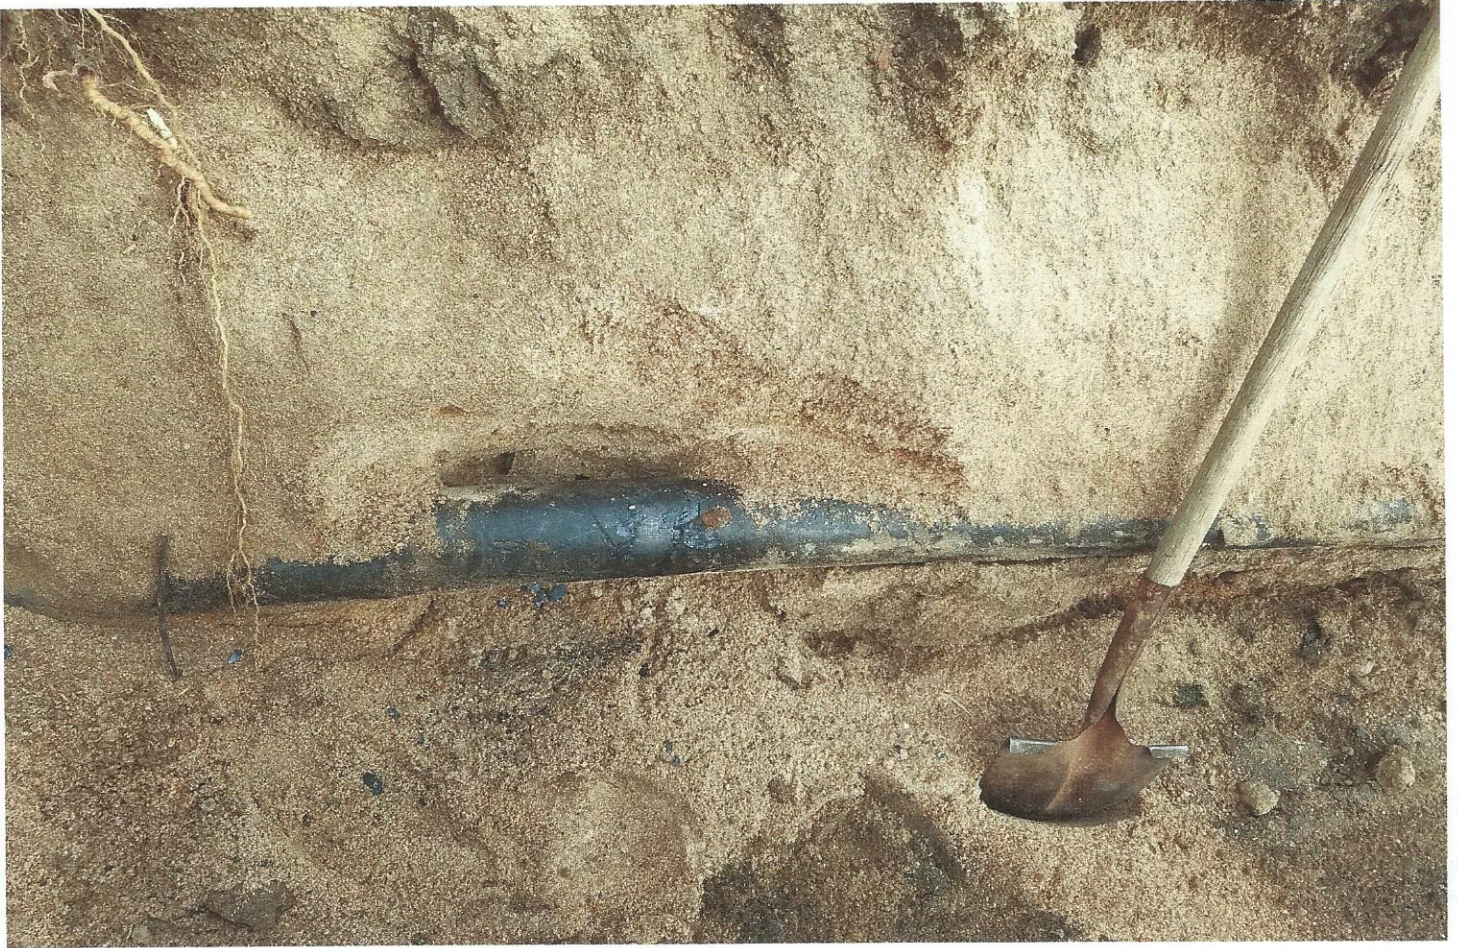
North End of Flowline Excavated Point of Cut

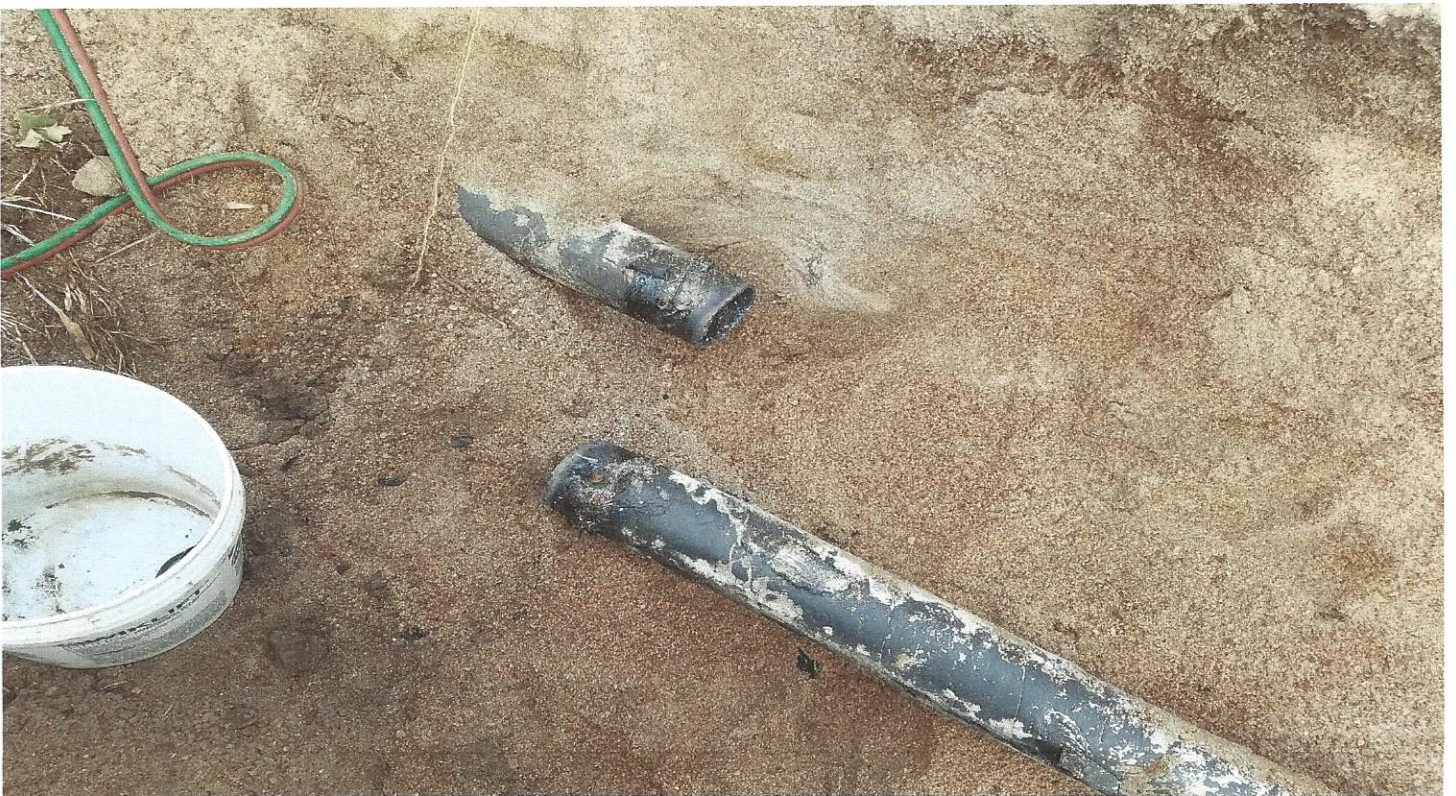
North End of Flowline Cut

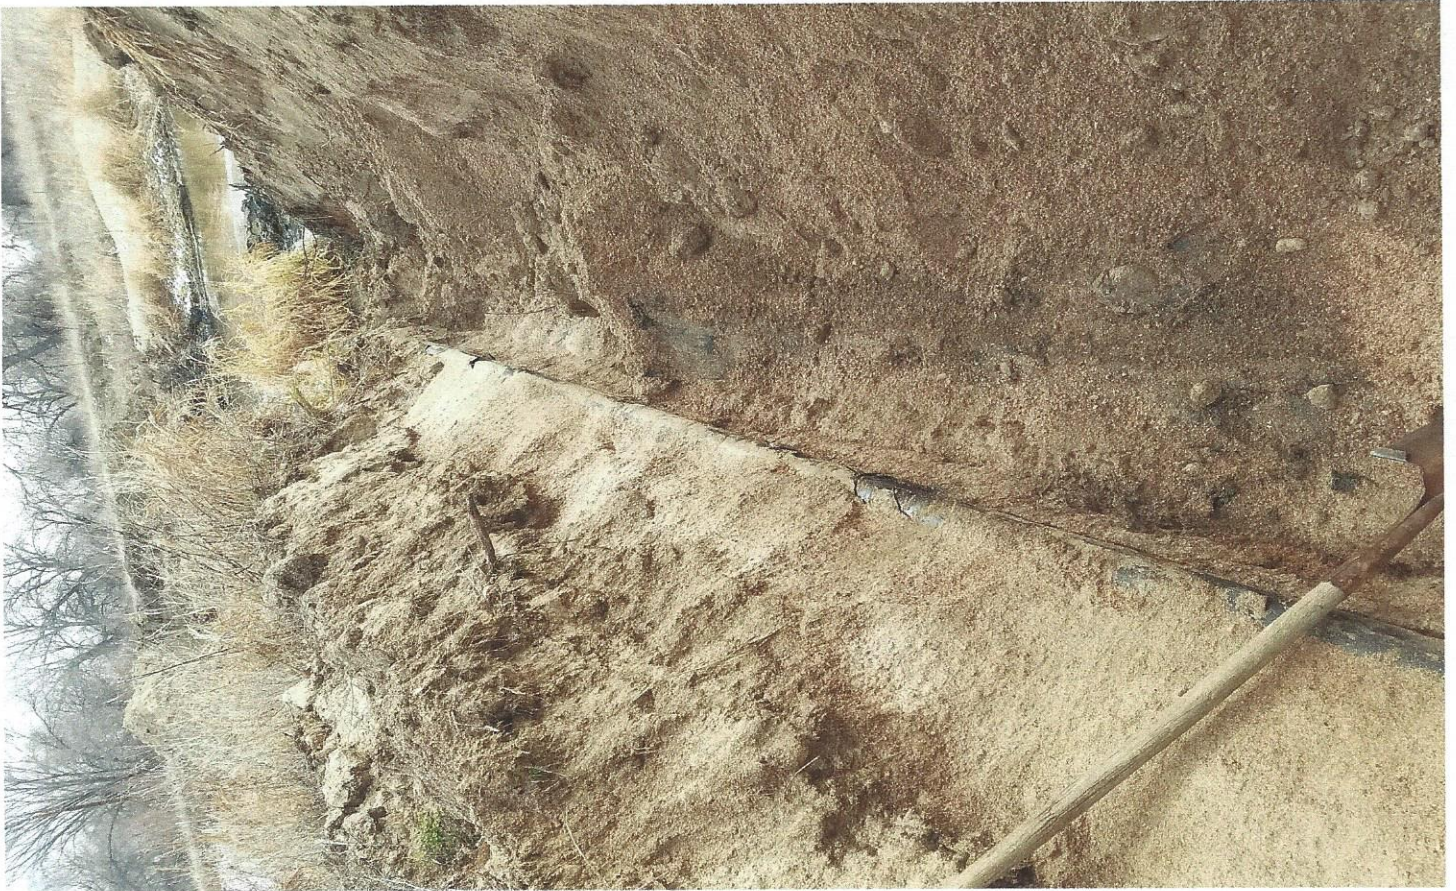
North End of Flowline Excavated

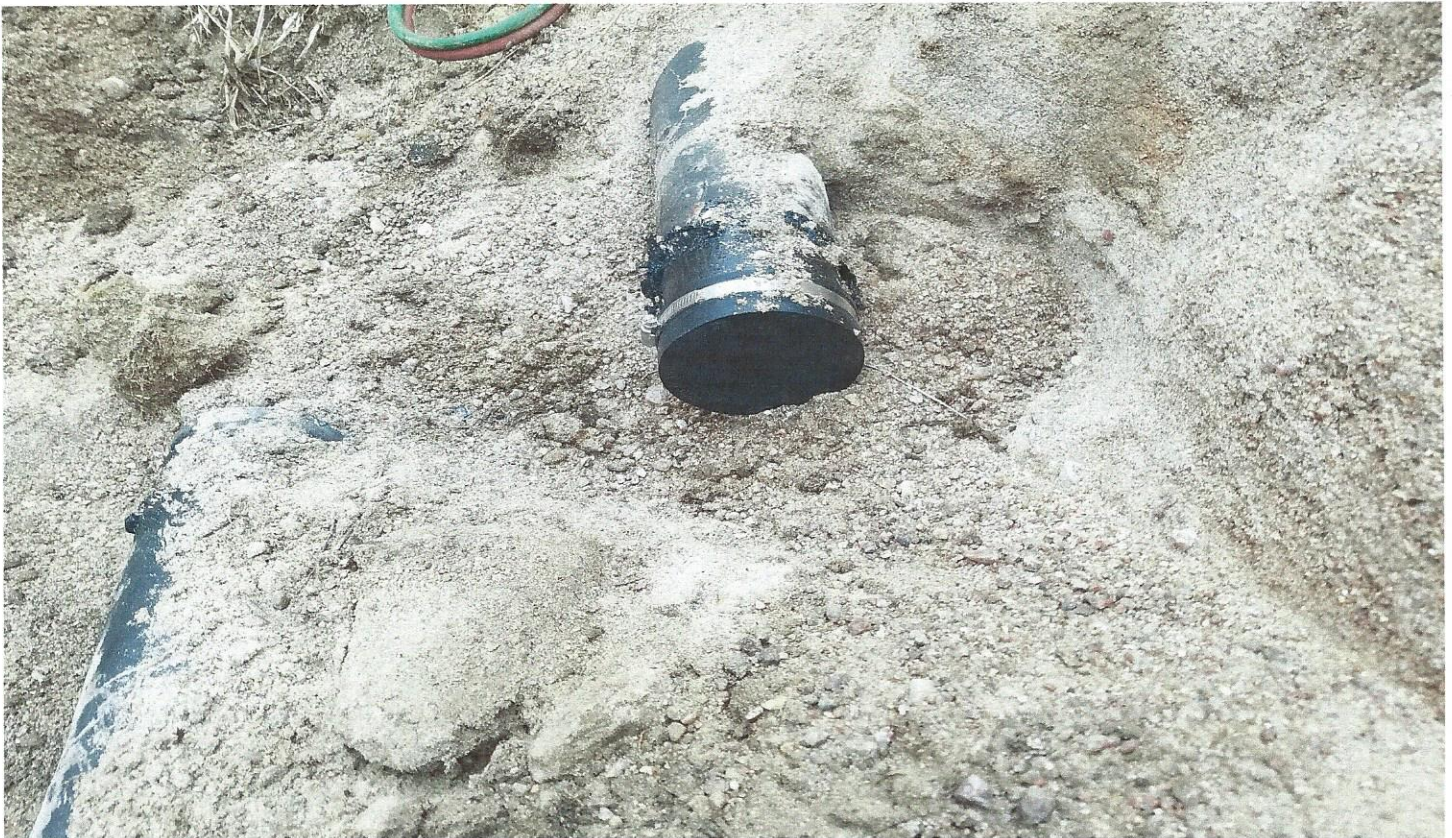
North End of Flowline Capped

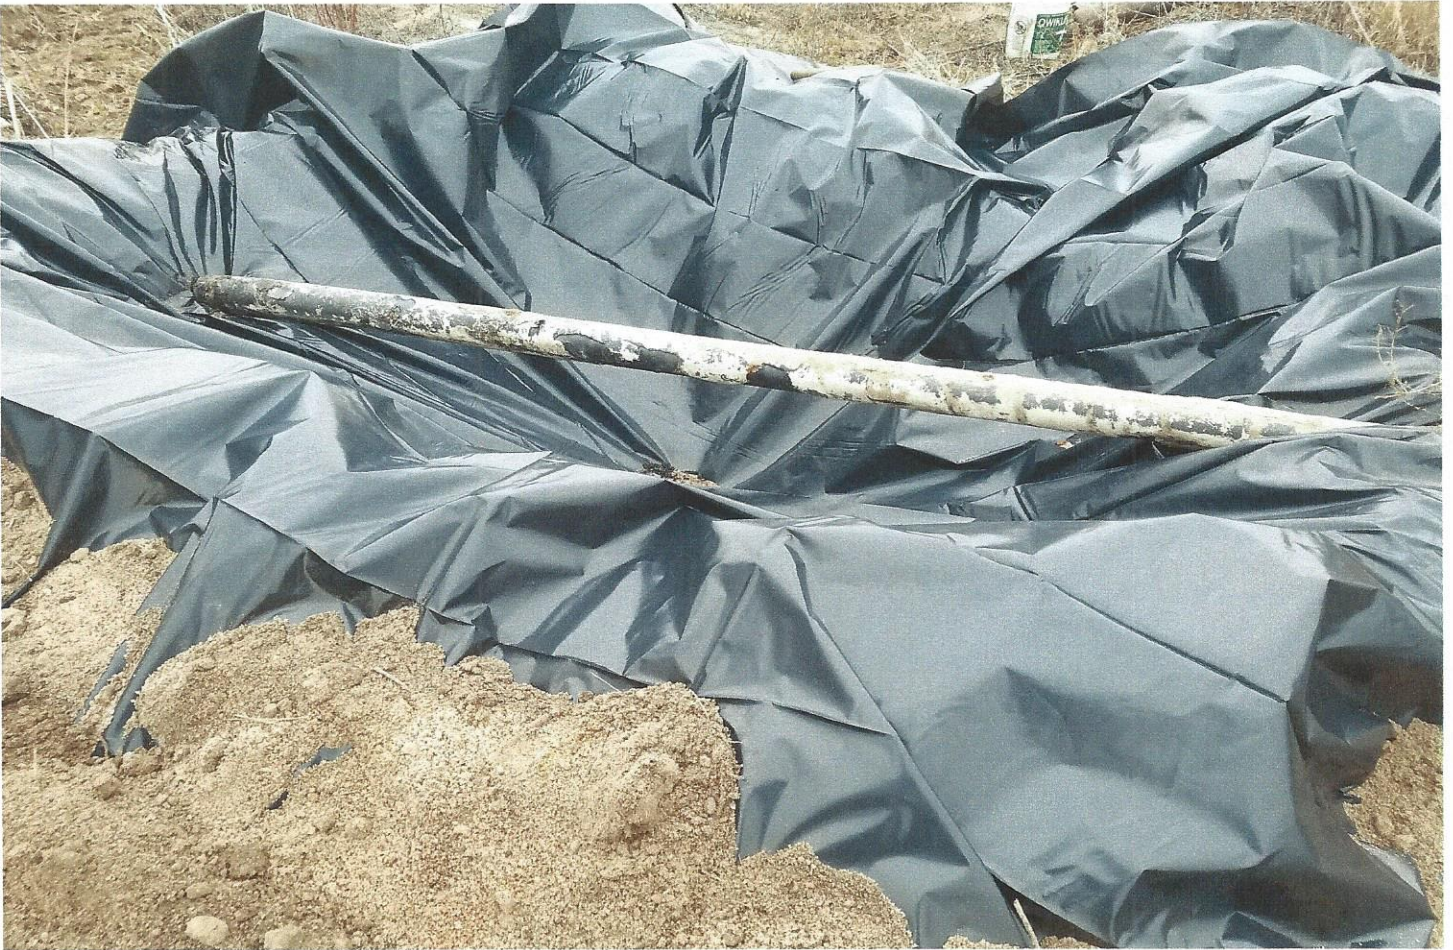
North End of Flow line placed in Lined Pit in order to catch any fluids in line

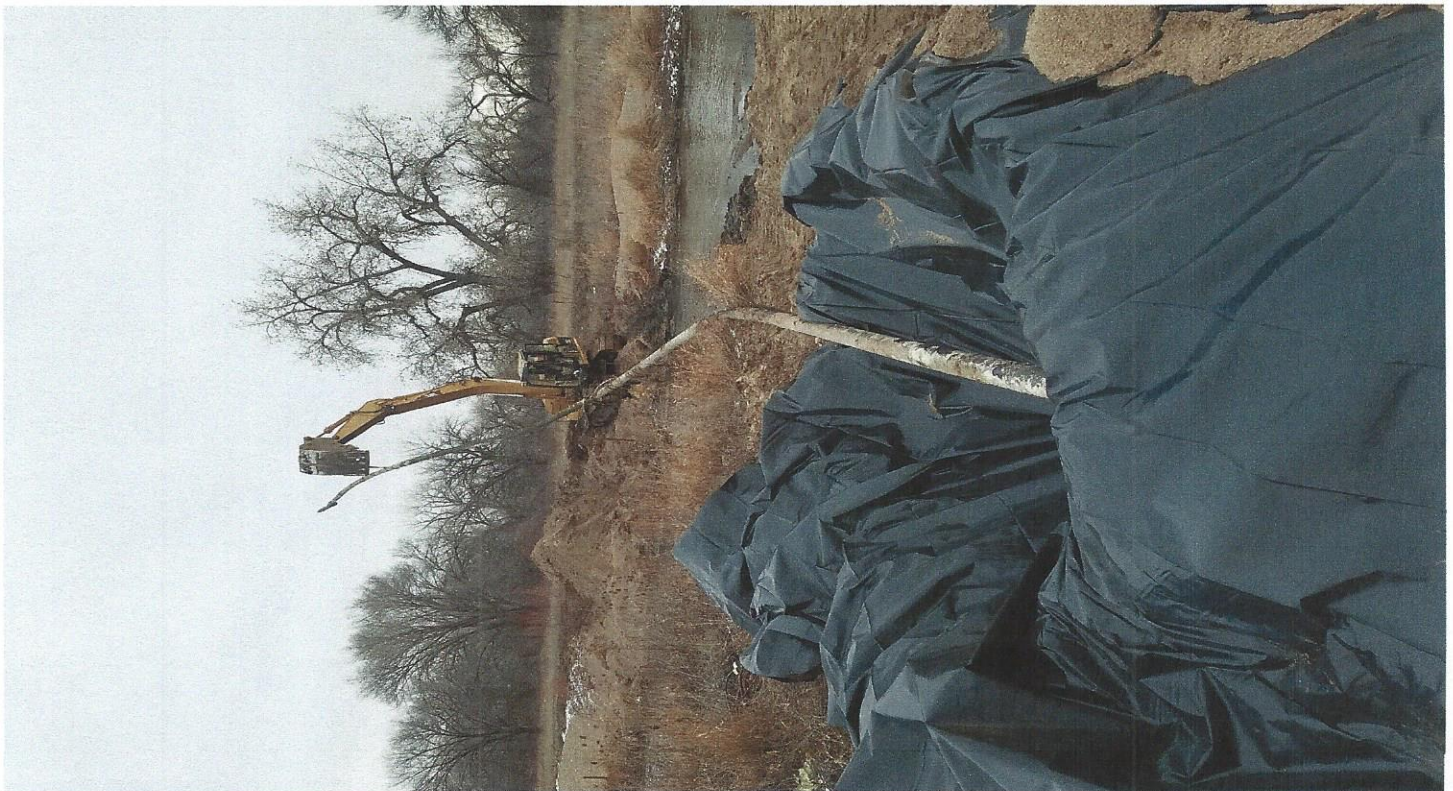
South End of Flowline raised to adequate height in order to purge line of fluids

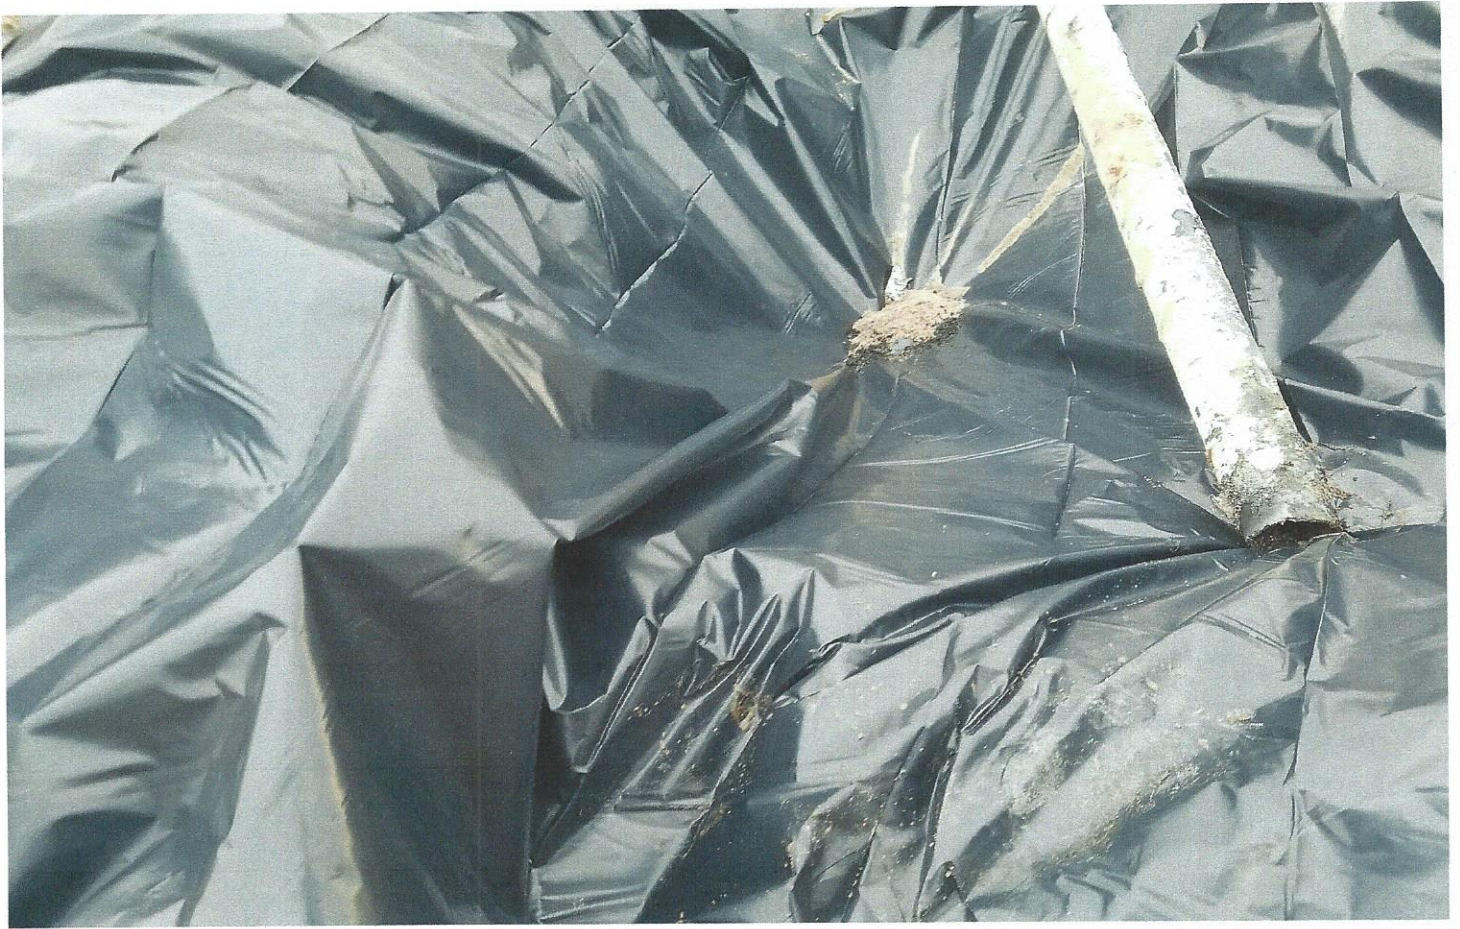
No Fluids produced, Flowline was dry

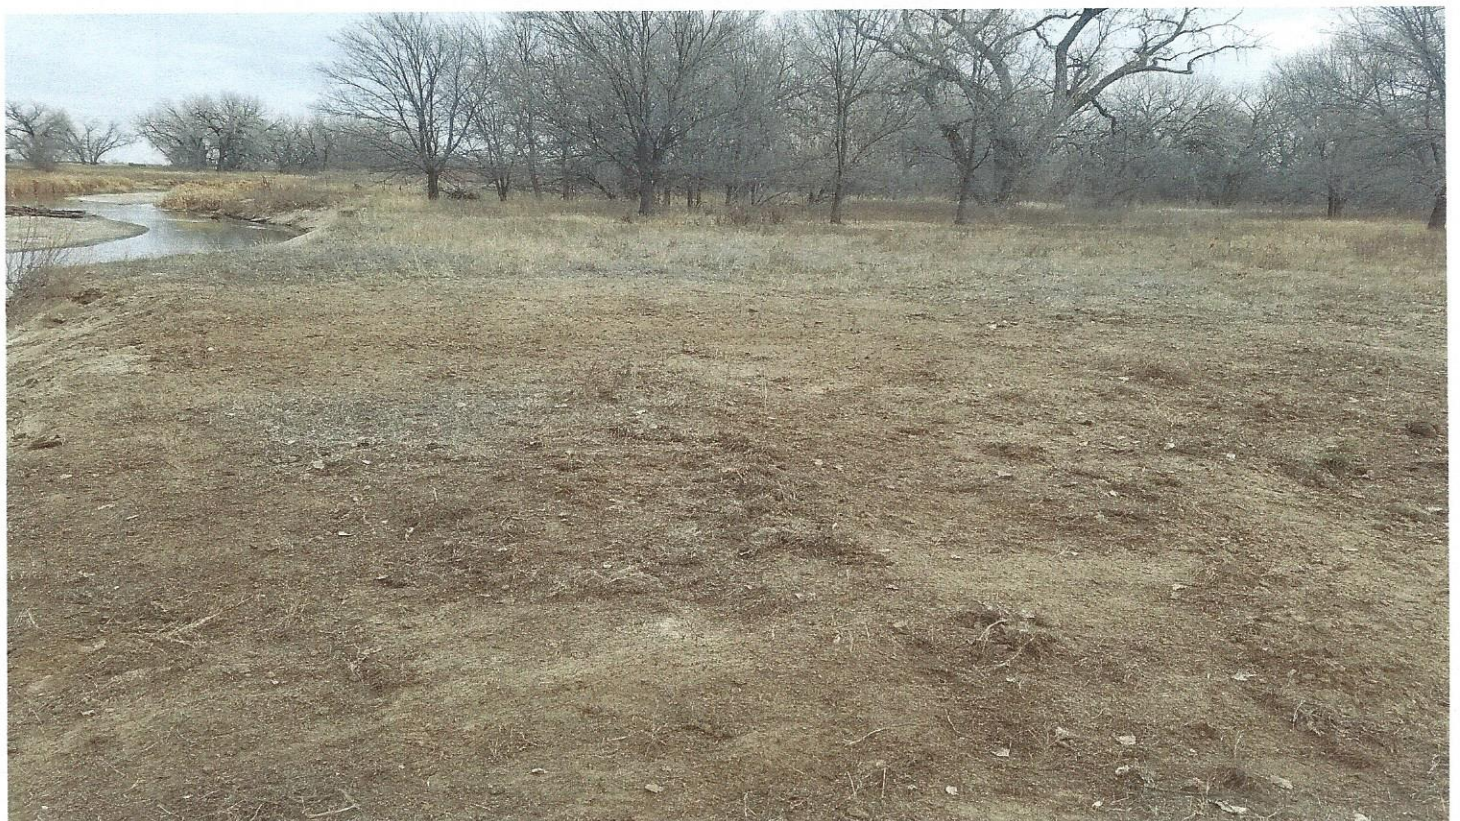
South Bank Reclaimed and Broadcast Seeded

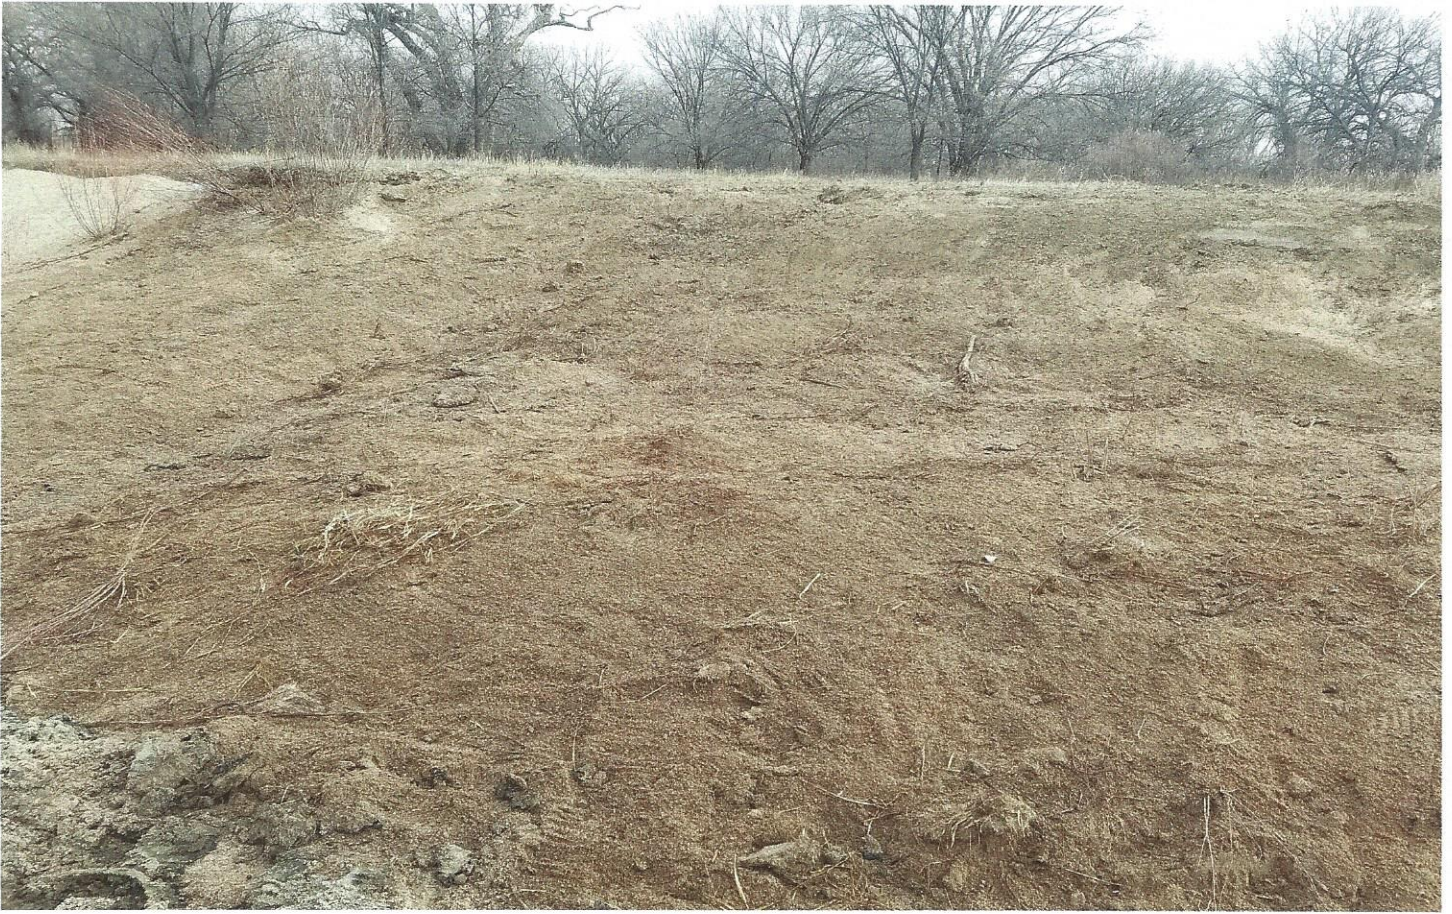
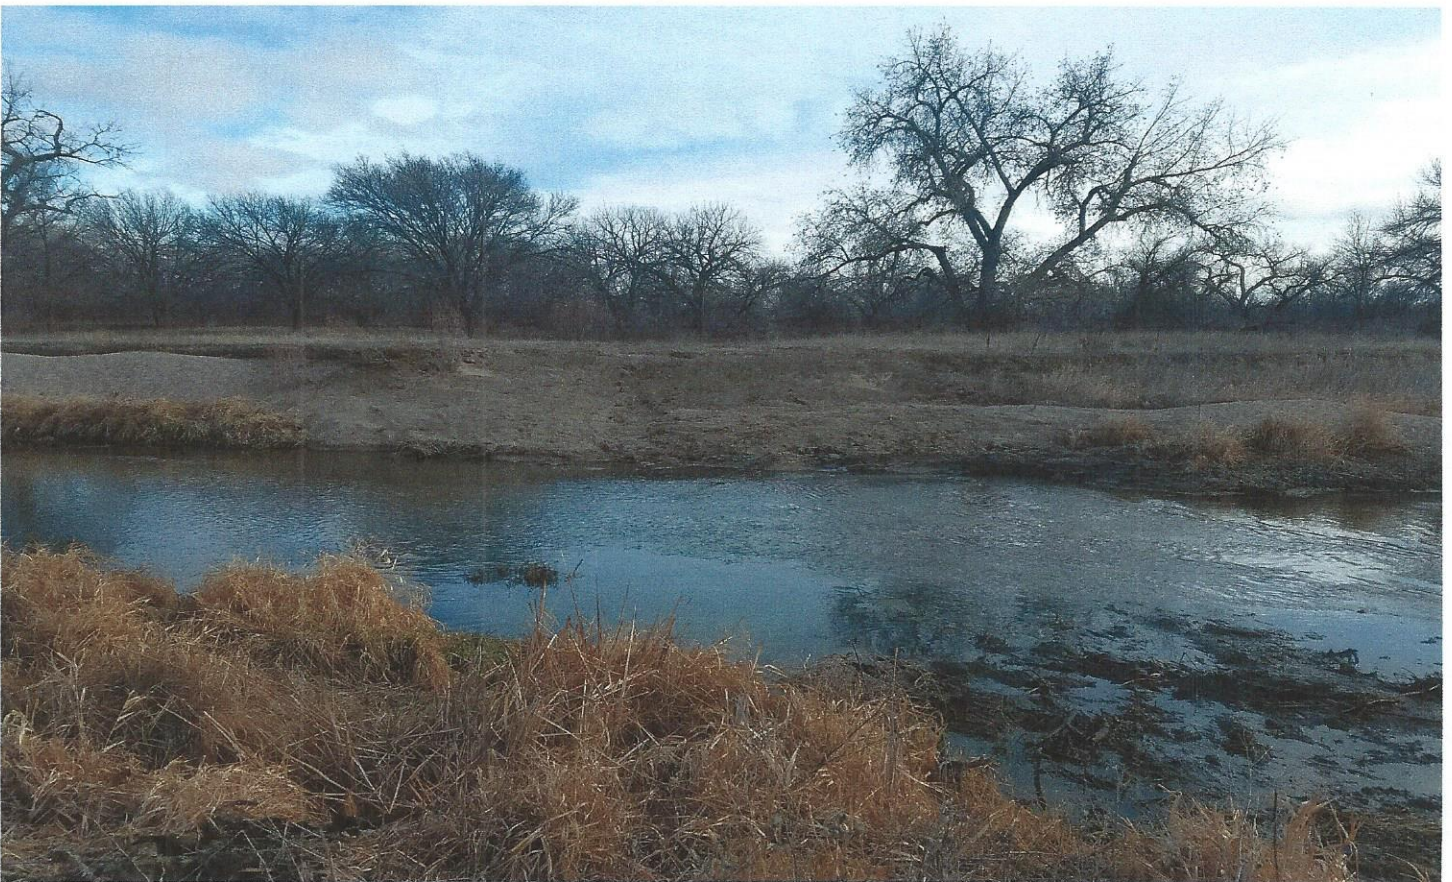
South Bank Reclaimed and Broadcast Seeded

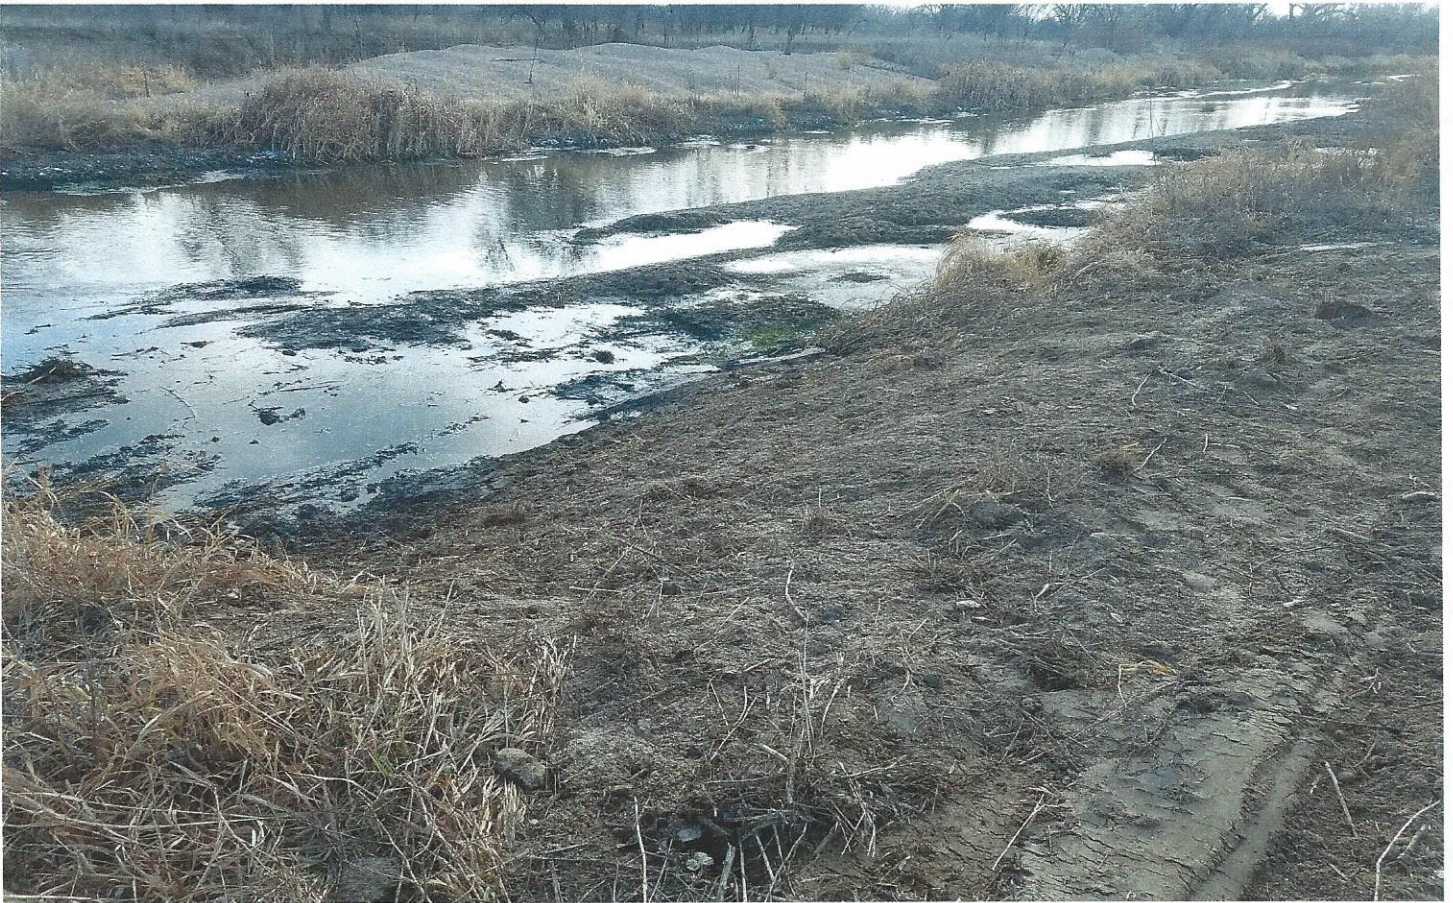
North Bank Reclaimed and Broadcast Seeded

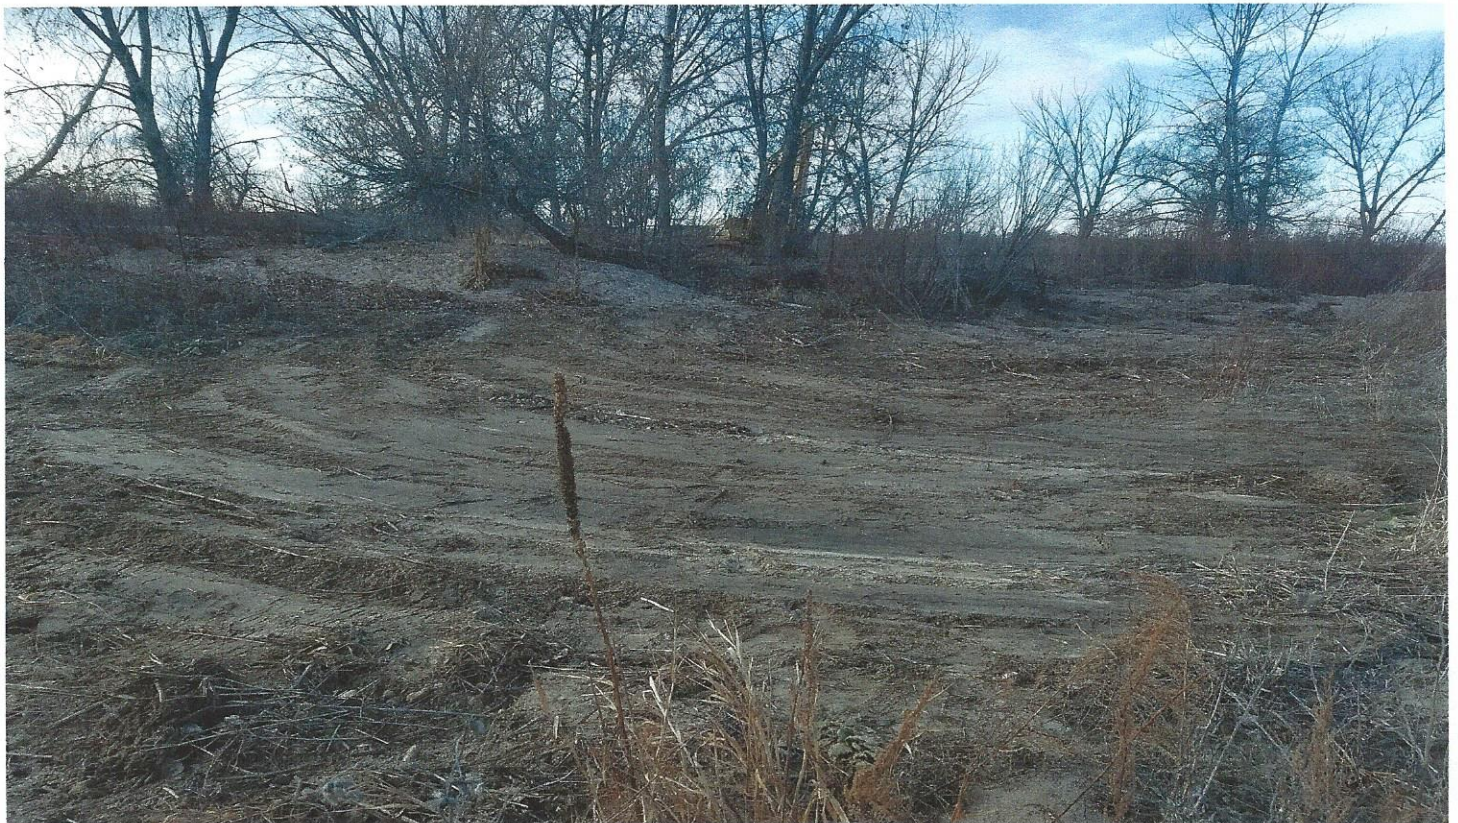
North Bank Reclaimed
