D. C. DOZER SERVICE, LLC
1403 Fillmore
Sterling, CO 80751
(970) 580 - 0062
Troutman0231@msn.com

Location: Monahan Rex Family Trust – Atwood East Unit 5 - 1

Scope of work provided by Inspection Document 682503878:

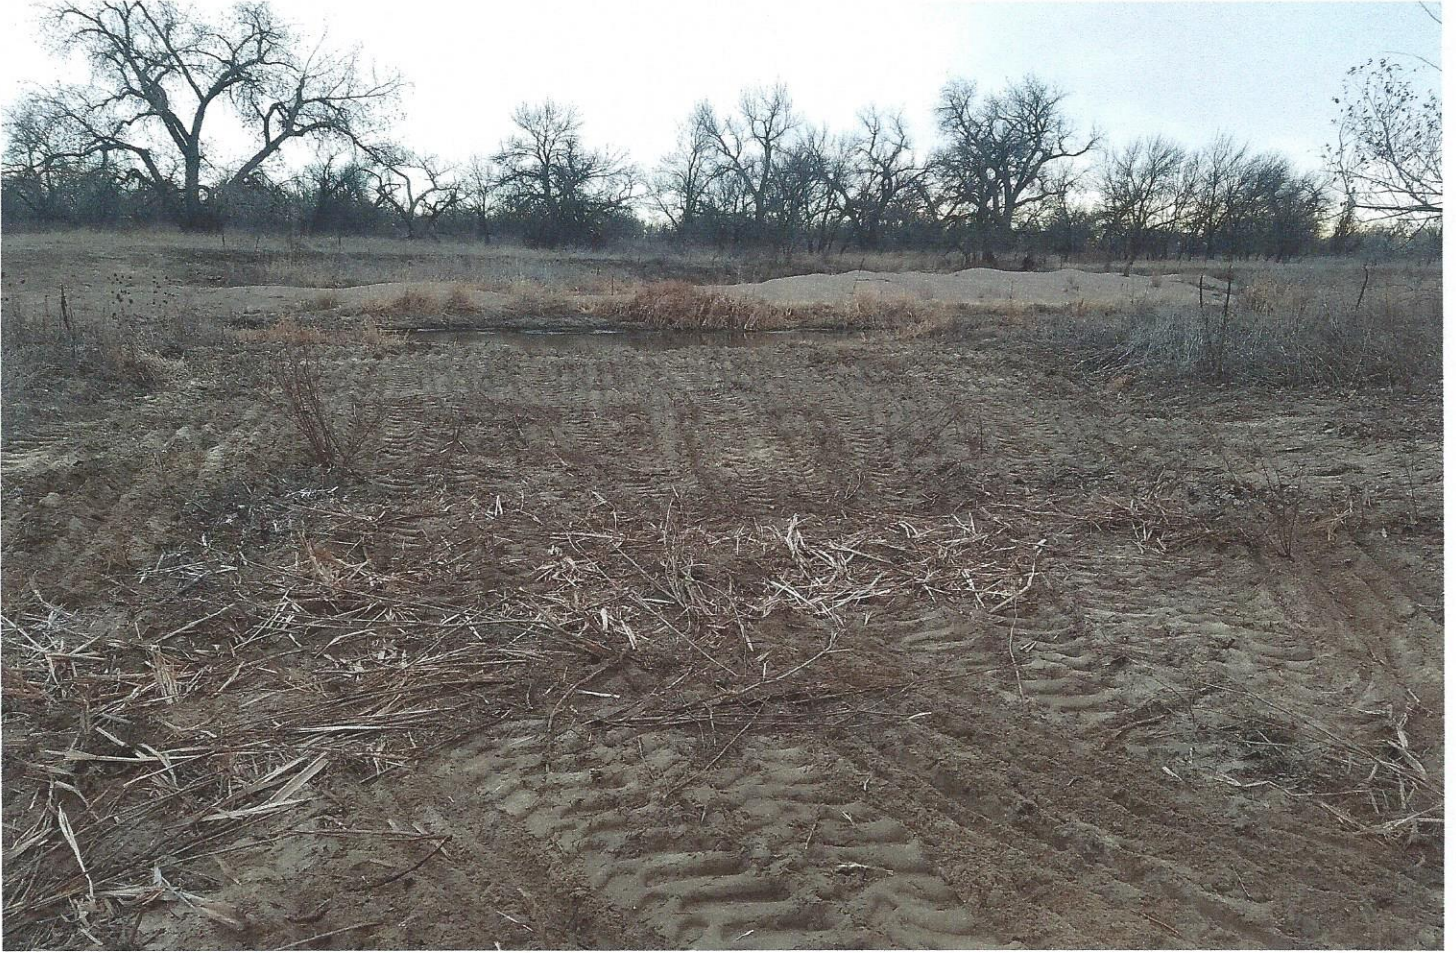
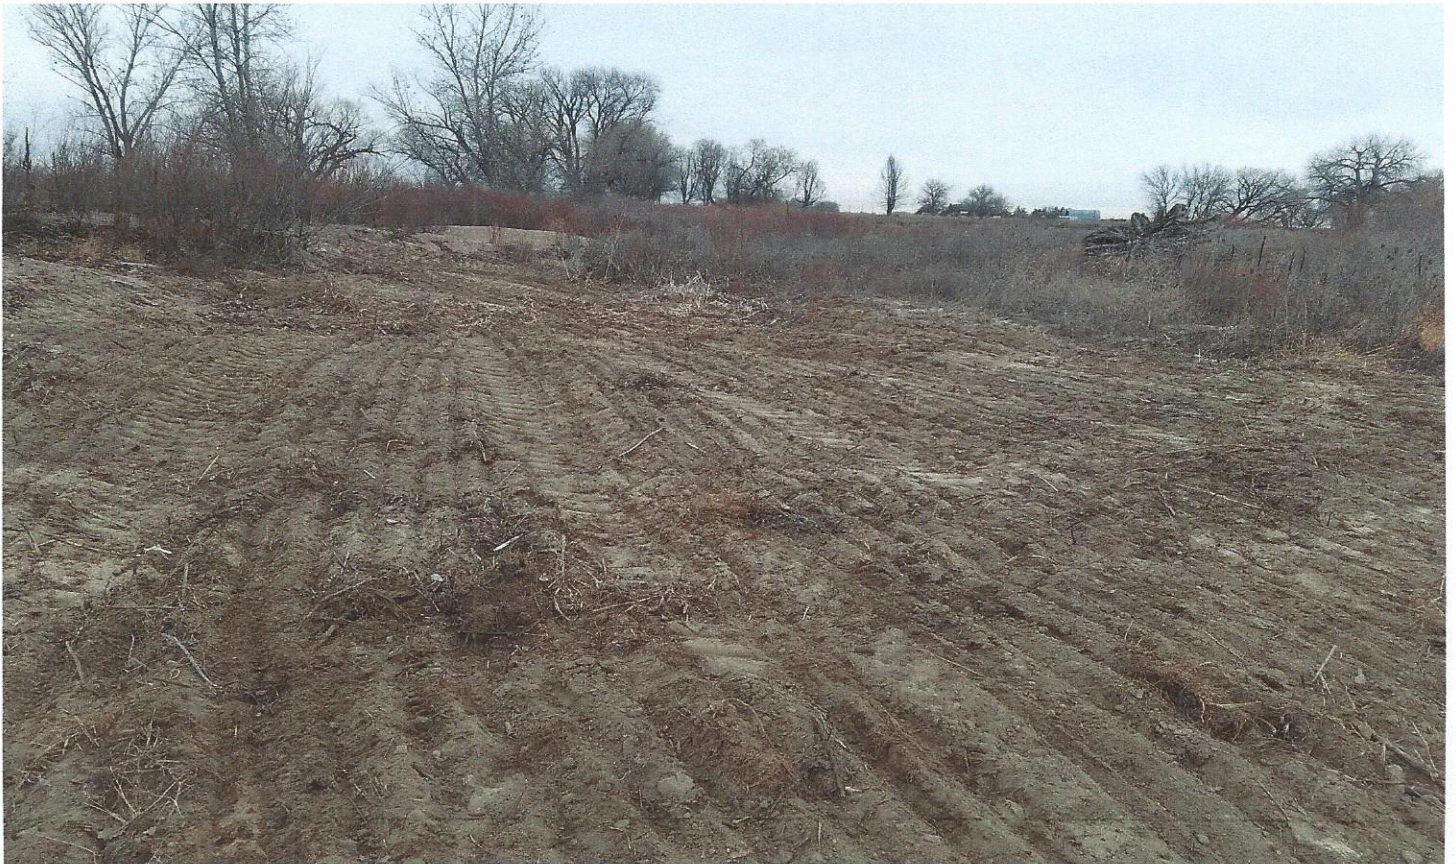
North Bank Reclamation Seeding
