**Inspection Photo (s)**  
**Clough 134**  
**API # 05-045-06270**  
**Inspection # 689303160**

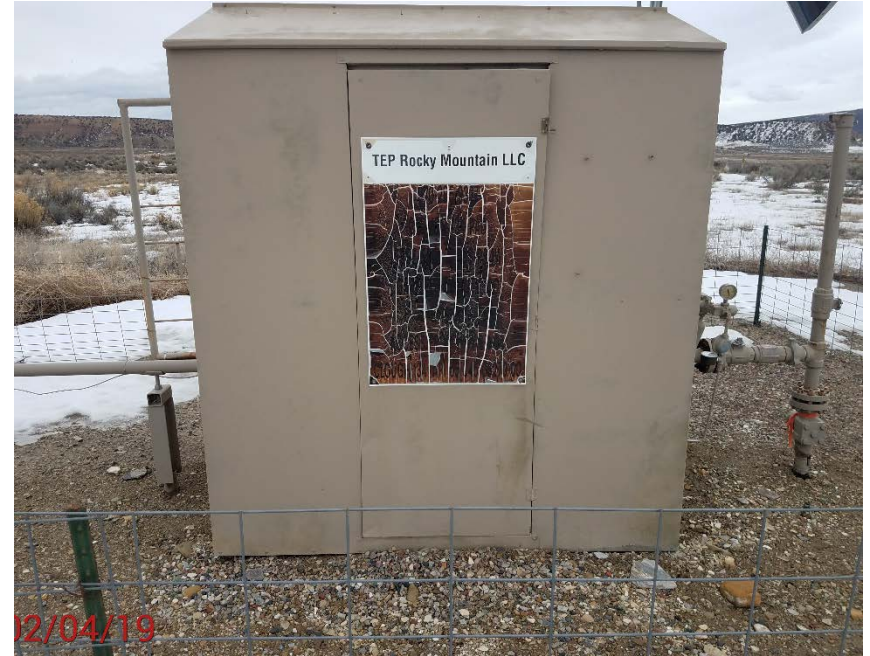
**Location Photo #2, non legible sign on meter run.**
