**RE: Corrective Action Response to Field Inspection Forms, COGCC Doc. Nos. 67490239; 674902482**

**February 7, 2019**

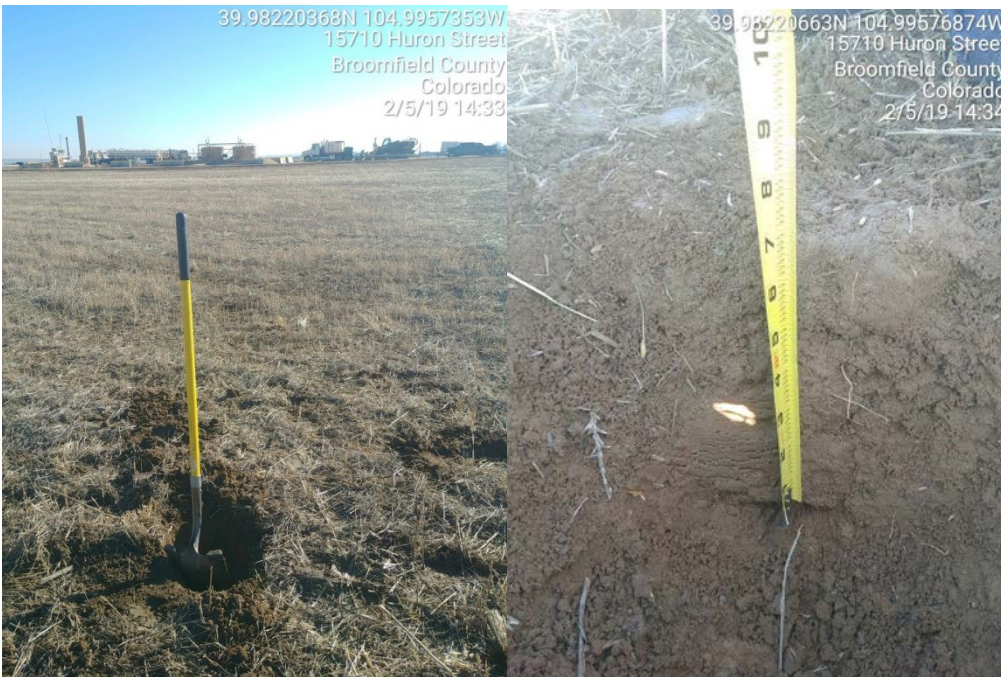
Test Hole #1: The left photo shows the hole is adjacent to the pad disturbance. The top approx. 2" were organic litter and clay. 2-7" was a brown clay layer with root structures present. The ruler is placed at the depth the density increased and the shovel was rejected without substantial effort.

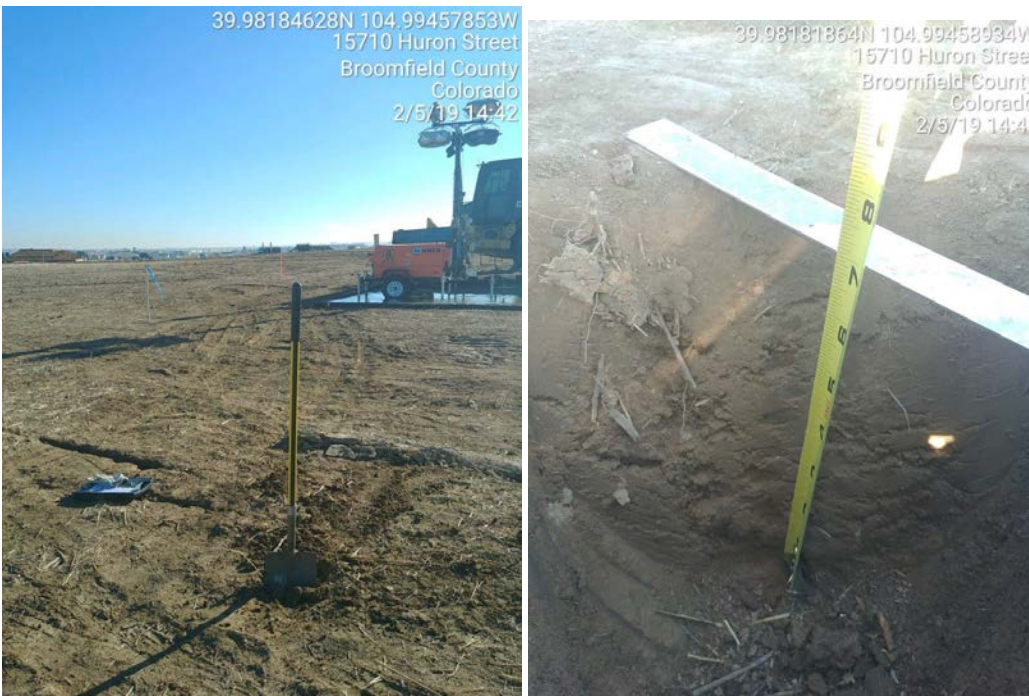
Test Hole #2: The left photo shows the hole is adjacent to the pad disturbance. The top approx. 2" were organic litter and clay. 2-7" was a brown clay layer with root structures present. The ruler is placed at the depth the density increased and the shovel was rejected without substantial effort.

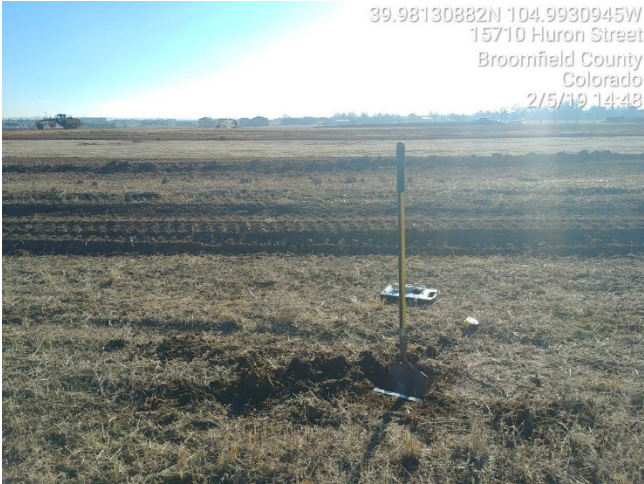
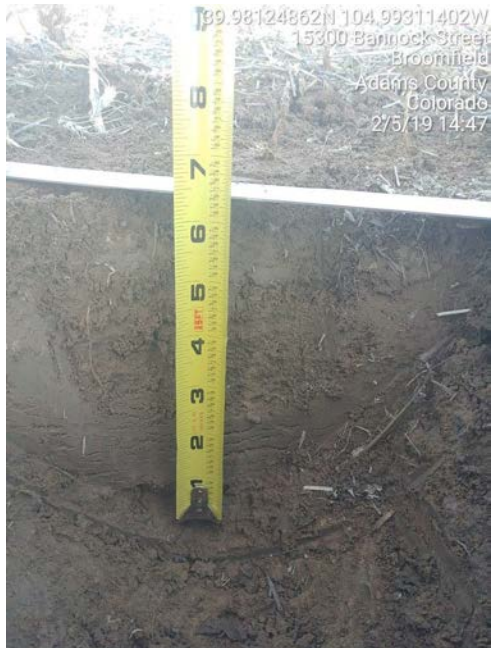
Test Hole #3: The left photo shows the hole is adjacent to the pad disturbance. The top approx. 2" were organic litter and clay. 2-6.5" was a brown clay layer with root structures present. The ruler is placed at the depth the density increased and the shovel was rejected without substantial effort.
