Inspection Photo (s)
Miller 43B
API # 05-045-17933
Inspection # 689303186

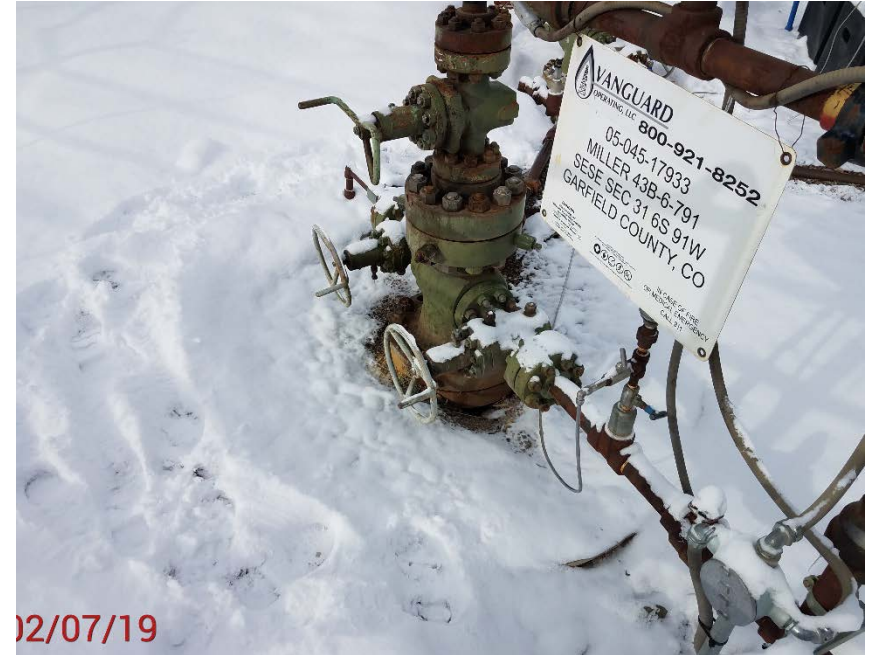
Location Photo #4, Dripping master valve.

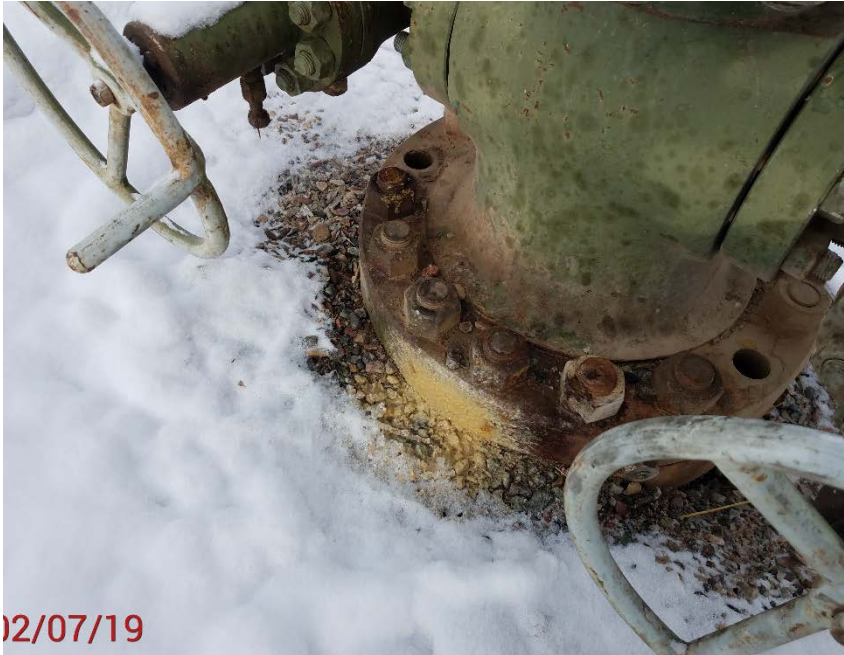
Location Photo #5, stained ground below master valve.

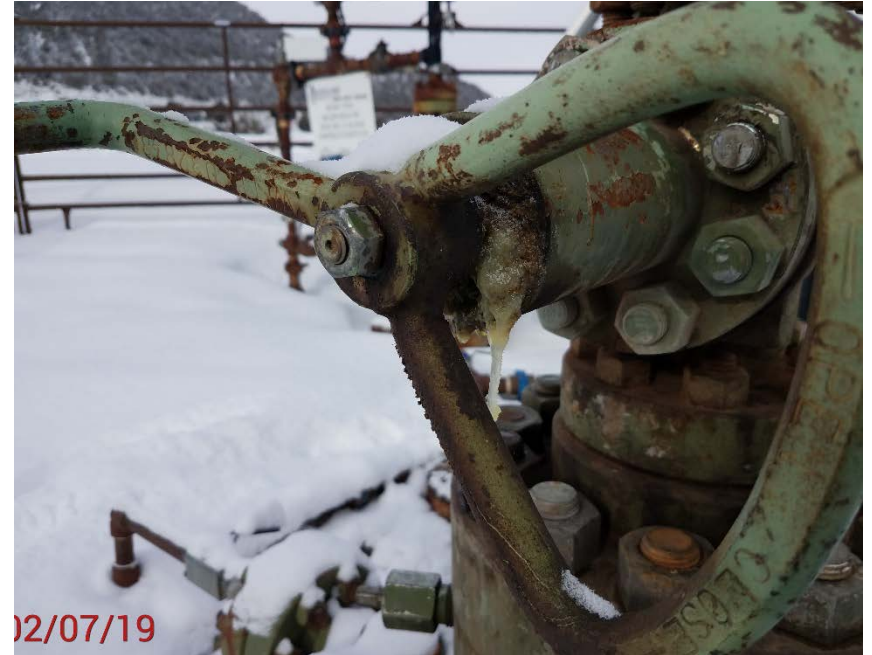
Location Photo #6, Leaking packing on master valve.

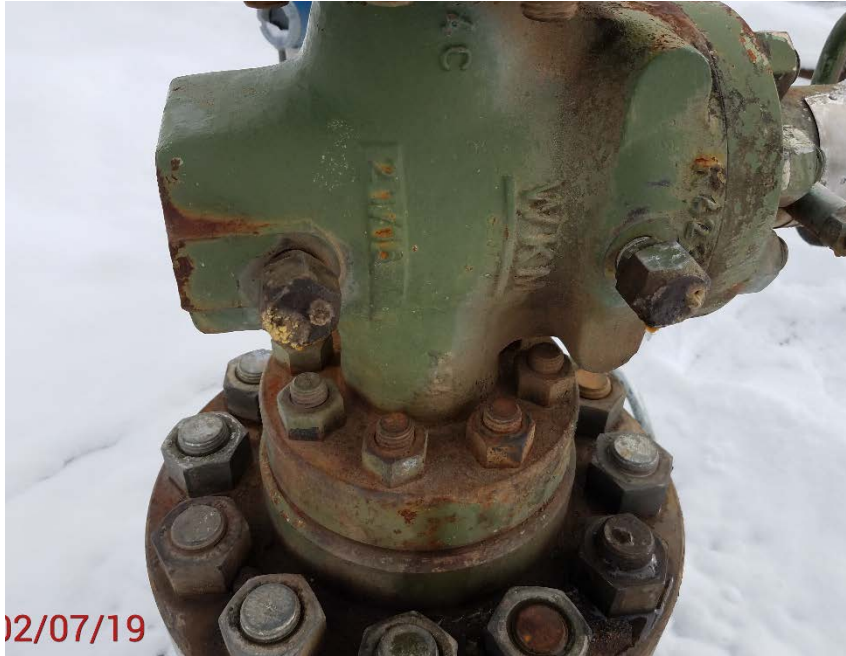
Location Photo #7, Mechanical condition of master valve.
