# *Inspection Photos*

*Loc#335879*

*Operator: Ursa*

*Inspection Number: 692400636*

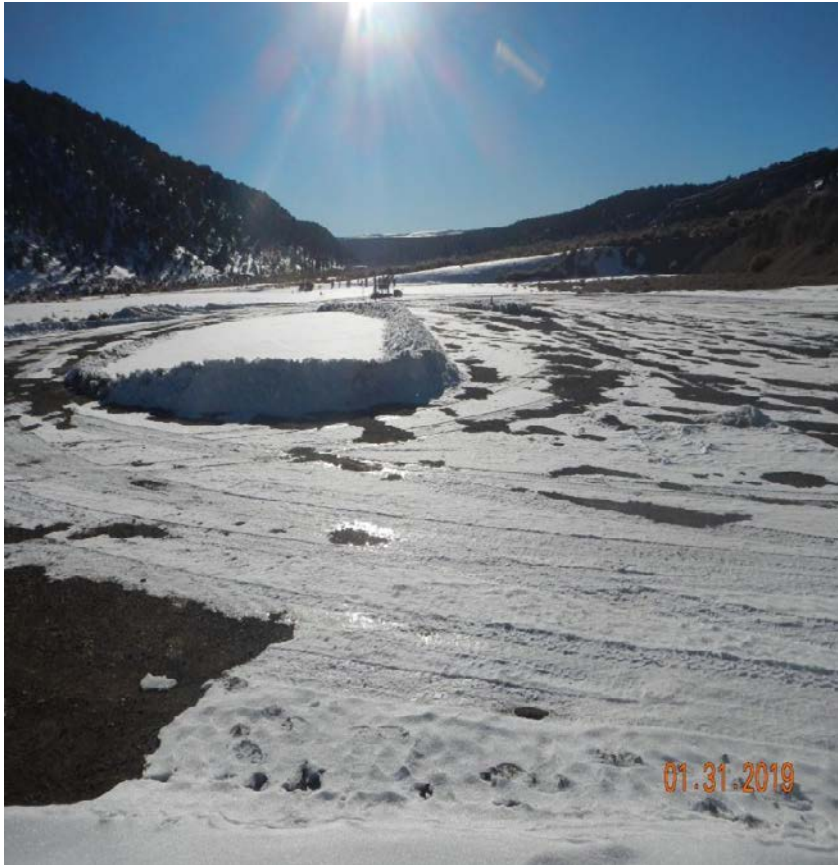
Photo#1:  
Overview of Location to Southwest.

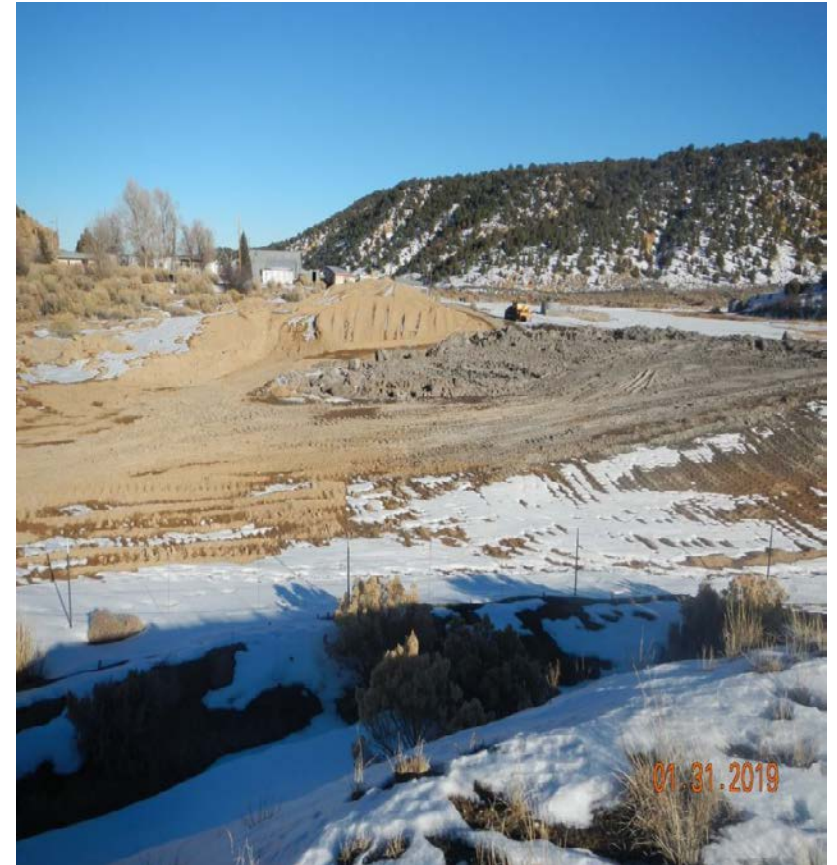
Photo#2:  
Overview of Cuttings area to Northeast.

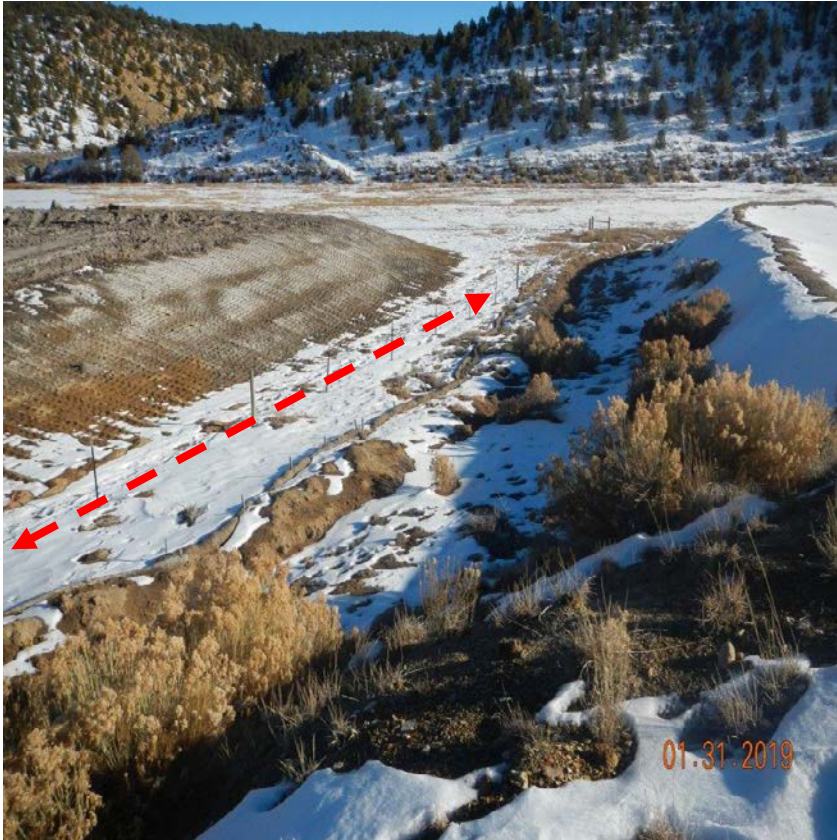
Photo#3:

Line indicates where BMP perimeter control is needed on West side, along fill slope of cuttings area.

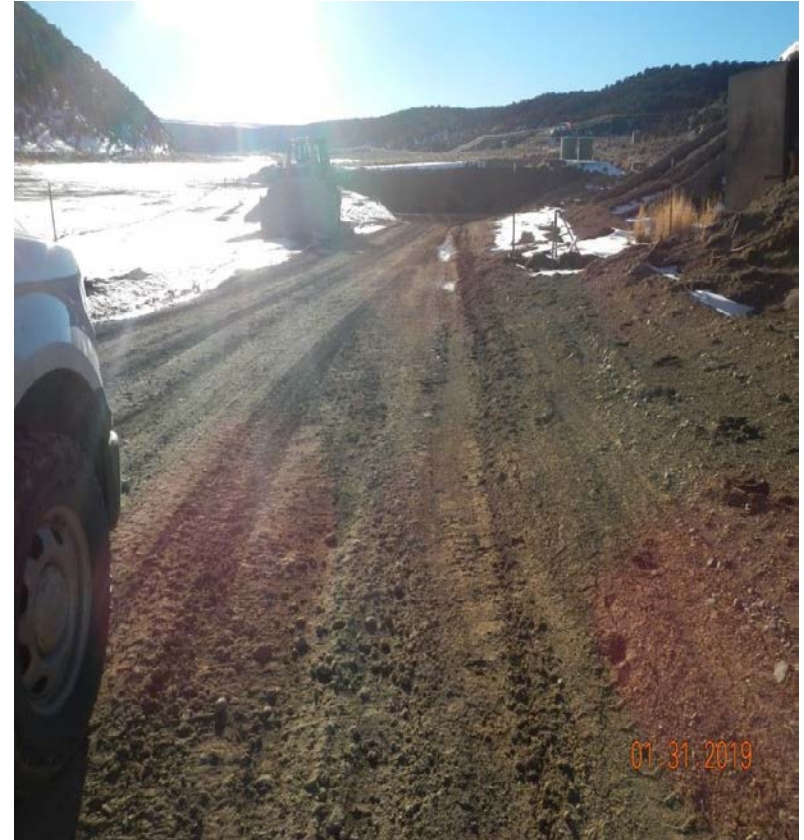
Photo#4:

Tracking pad not installed on Cuttings area entry road.

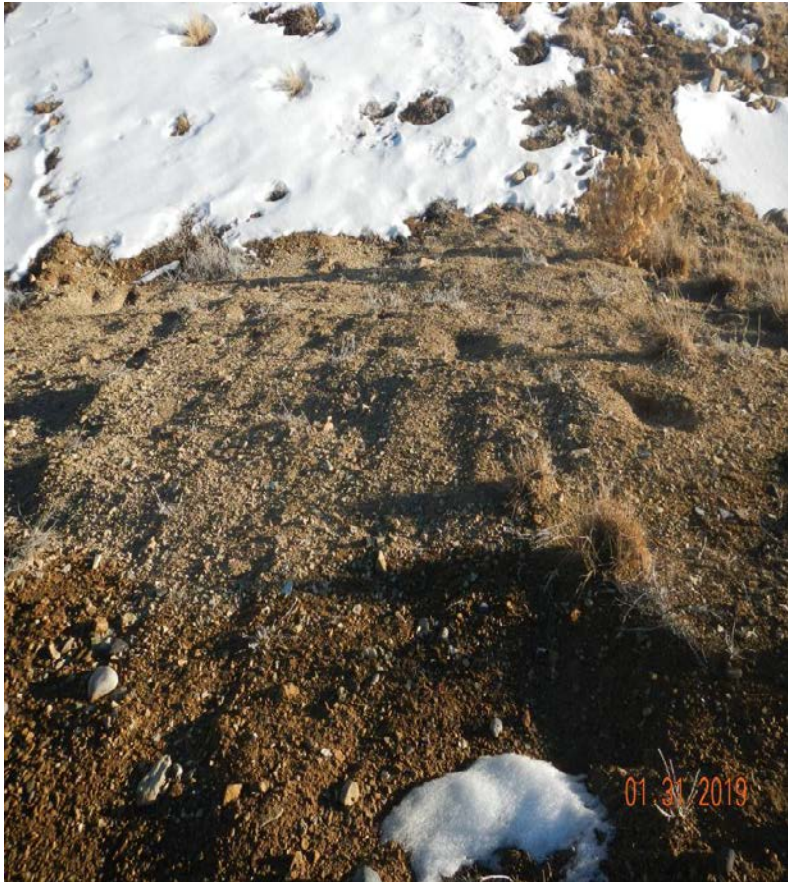
Photo#5:  
Vegetation establishment on slopes is largely unsuccessful.

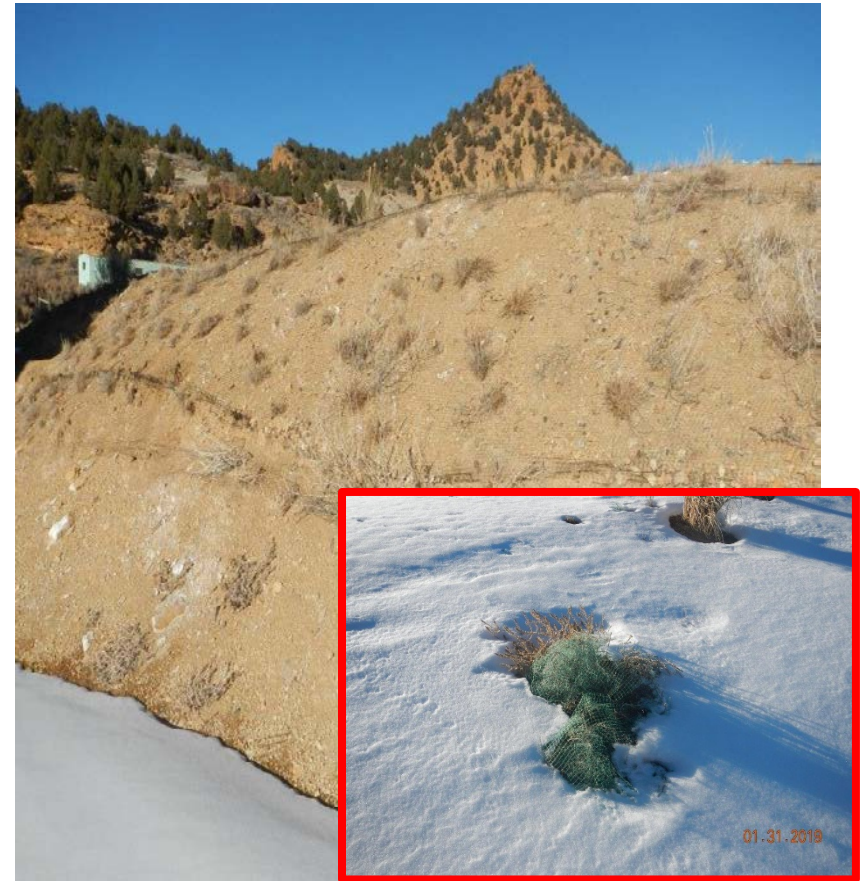
Photo#6:  
Vegetation establishment on slopes is largely unsuccessful. Insert of netting Debris

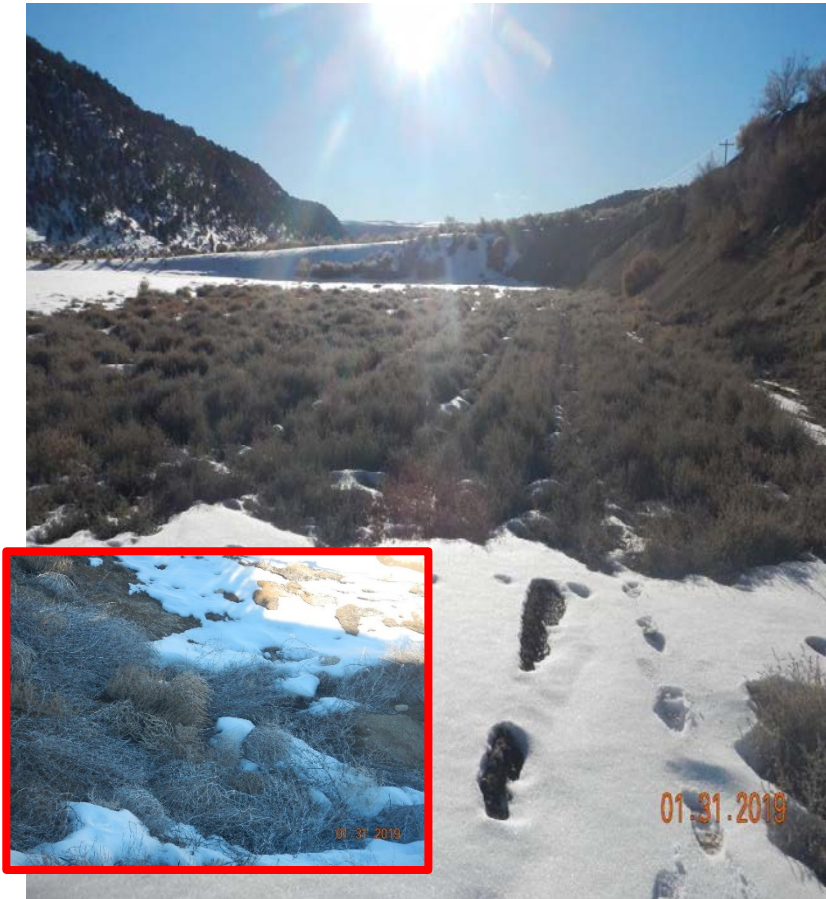
Photo#7:

Pit area has infestation of Russian Thistle. Insert is of Thistle that has become Debris.

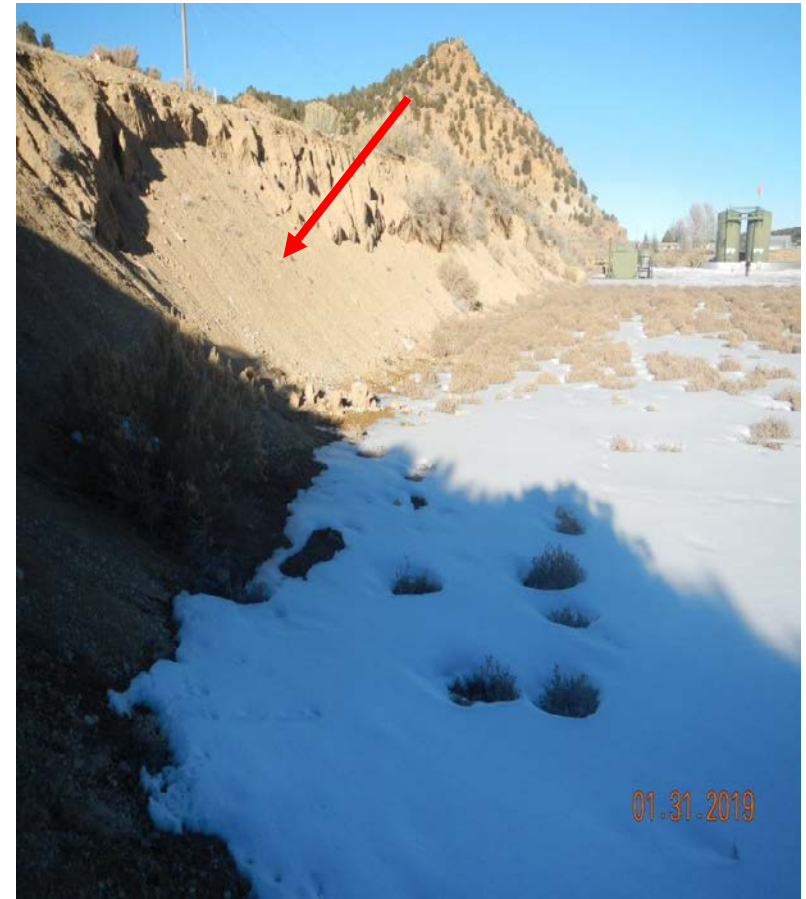
Photo#8:

Pit area has infestation of Russian Thistle. Arrow indicates unstable area of Cut Slope.
