Inspection Photos
Location Name: TADPOLE 21-12
API #: 05-071-06671
Insp. Doc. # 695100147

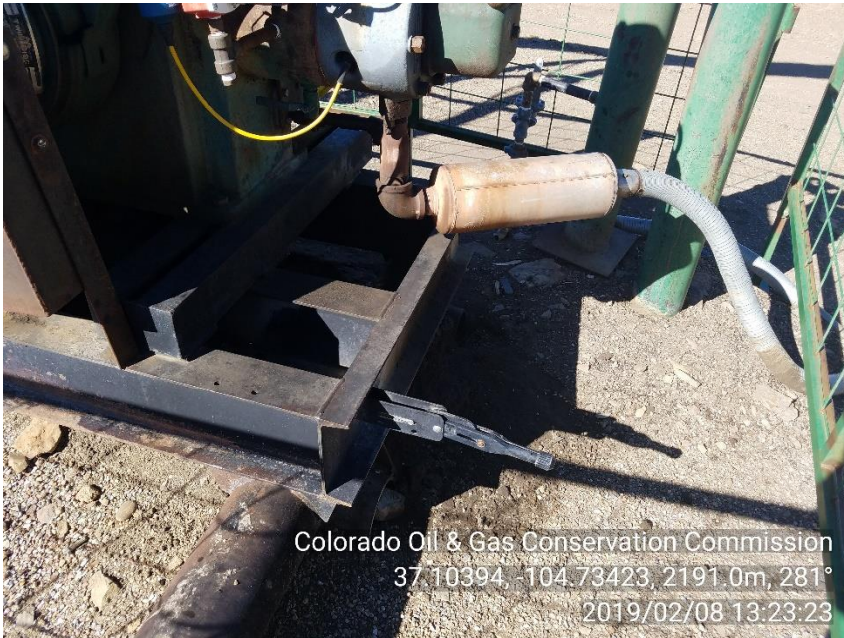
PHOTO 3: STAINED SOIL NEAR PRIME MOVER ON PUMP JACK SKID.

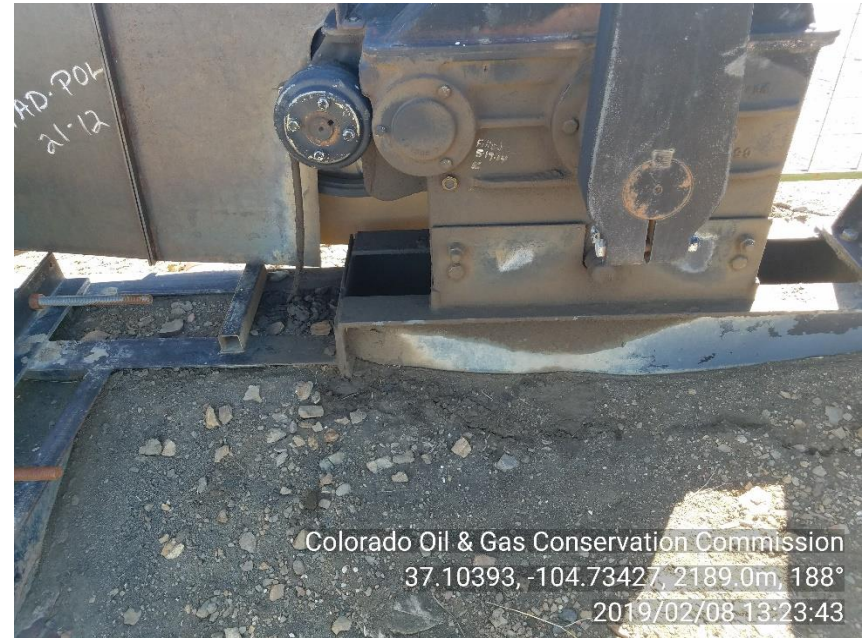
PHOTO 4: STAINED SOIL NEAR PUMP JACK GEAR BOX
