**Reportable Release Photographic Documentation**

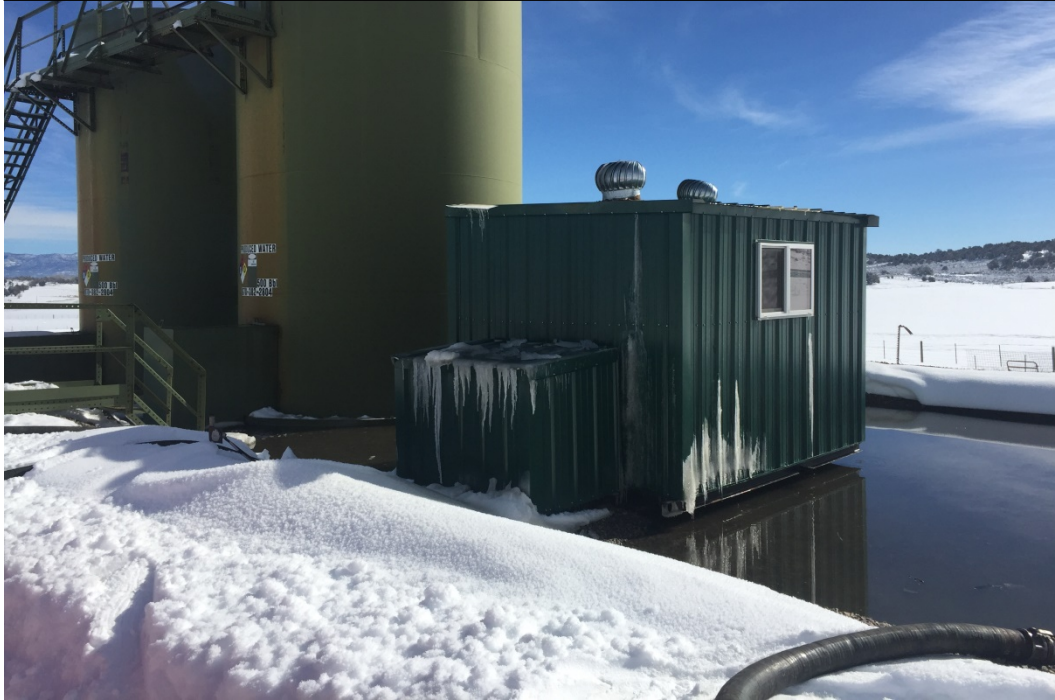
Dodd WTS (#3-2) – 1/5/2019: Source of spill originated from a broken bushing inside the pump building.
