Inspection Photos
Location Name: LORECITO 2-7
API #: 05-071-08140
Insp. Doc. # 695100164

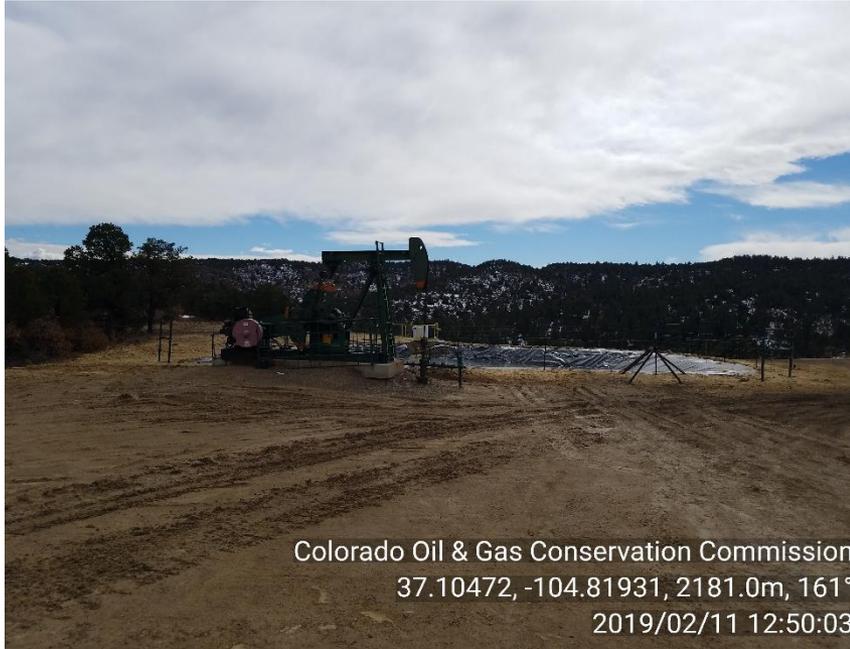
PHOTO 1: WELLHEAD

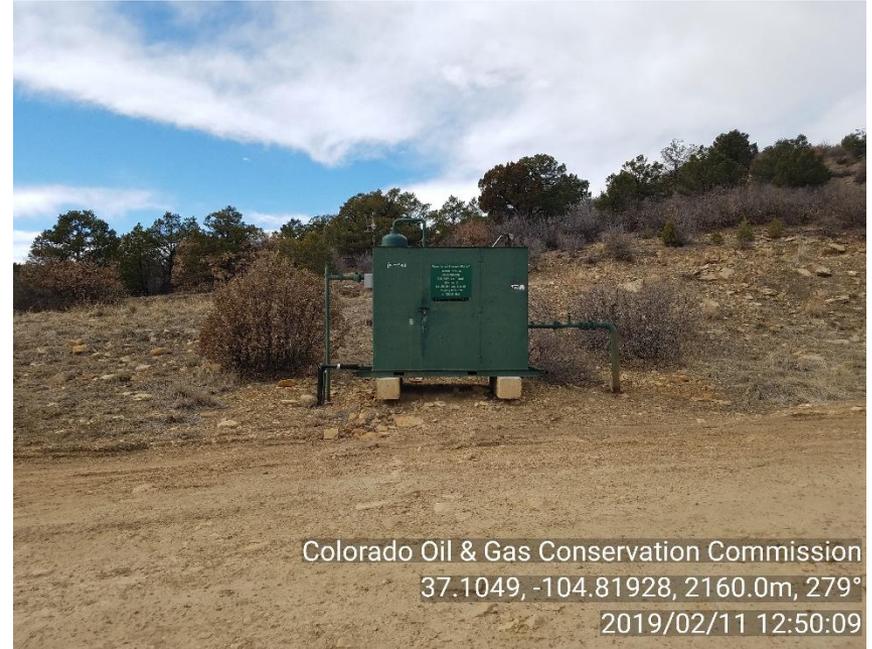
PHOTO 2: WELL SIGN/METER HOUSE

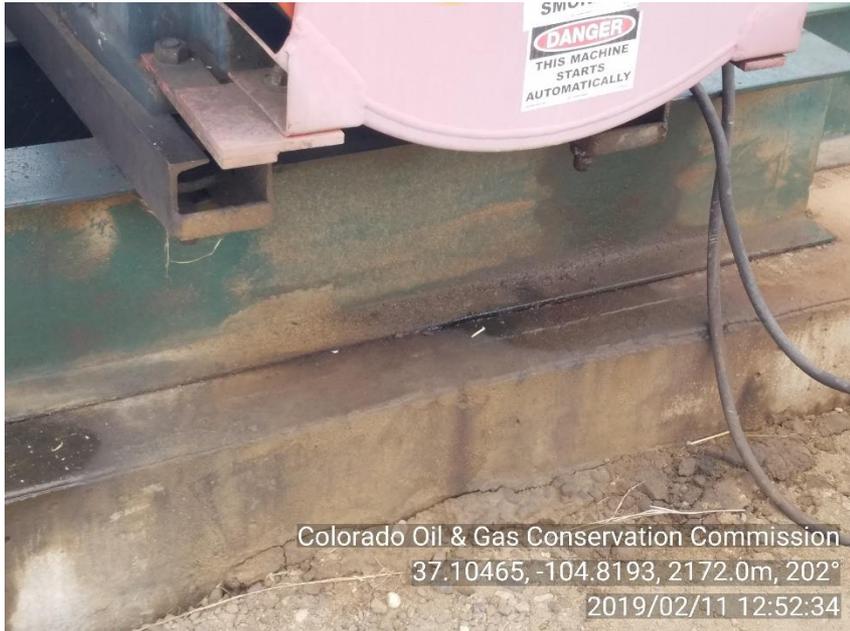
PHOTO 3: STAINED SOIL UNDER GEAR BOX ON PUMP JACK SKID.

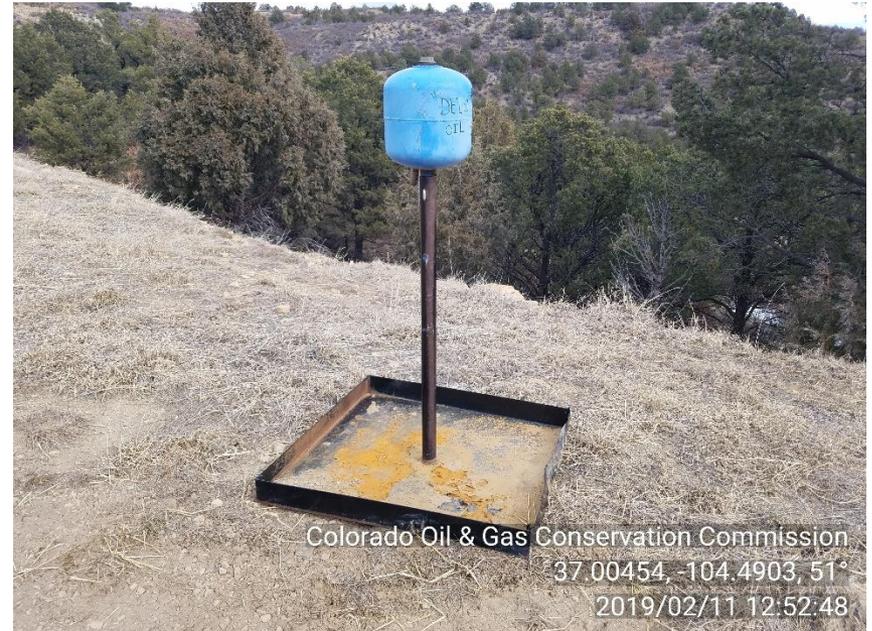
PHOTO 4: UNUSED EQUIPMENT STORED ON LOCATION

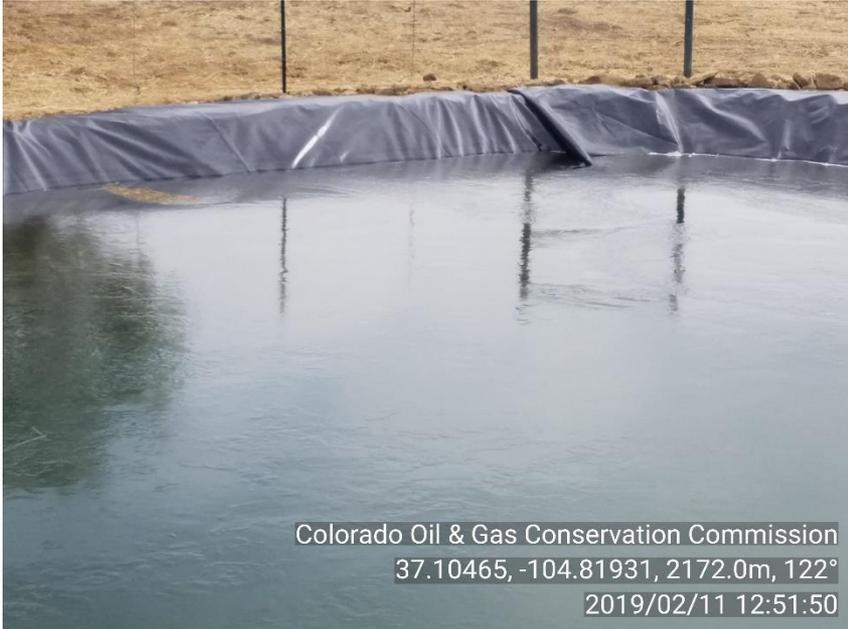
PHOTO 5: PRODUCED WATER APPEARS TO BE ABOVE THE 2' FREEBOARD REQUIREMENT. FREEBOARD MARKER IS NOT INSTALLED ON LOWEST ELEVATION OF PIT.

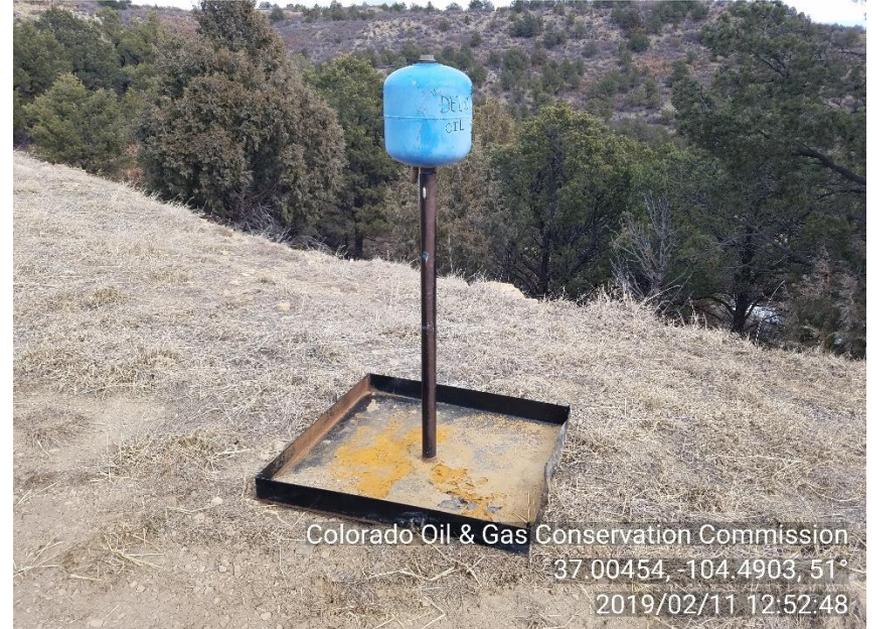
PHOTO 4: UNUSED EQUIPMENT STORED ON LOCATION
