# Interim Reclamation and Stormwater Inspection

February 11, 2019

Operator: ENERPLUS RESOURCES (USA) CORPORATION - #10177

Location ID: 449968

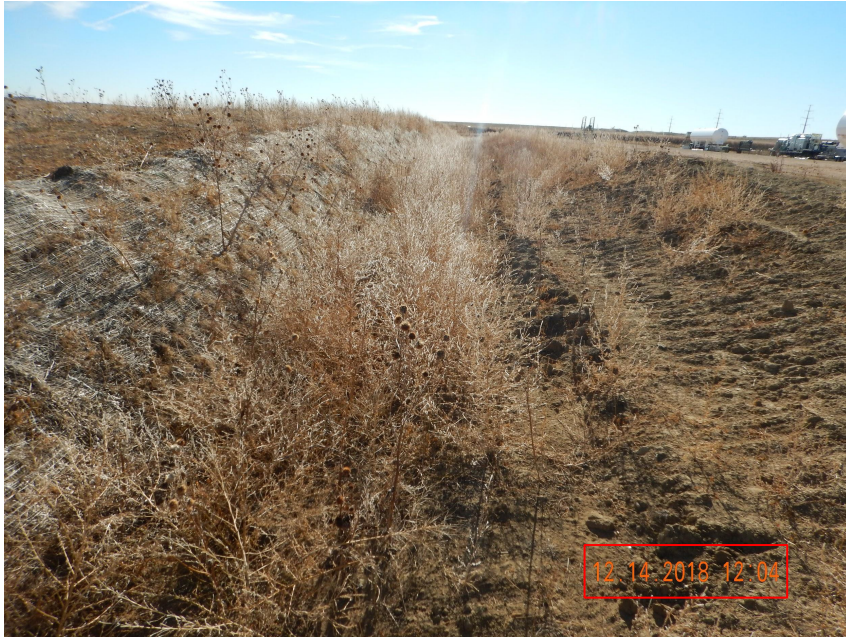
**Photo 1.** Photo taken from the north eastern topsoil stockpile on 12/14/2018, facing South. Operator has failed to prevent weed establishment on the topsoil stockpile. Note: Appears the Operator attempted to seed the topsoil with desirable vegetation (e.g., blue grama) but weedy, annual vegetation (Kochia) was observed throughout most of the stockpile.

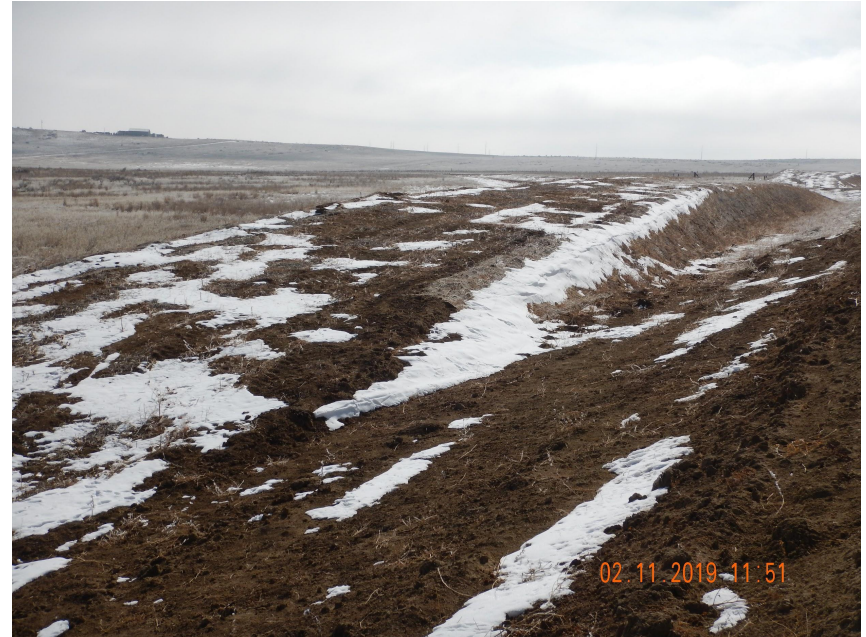
**Photo 2.** Photo taken from the north eastern topsoil stockpile on 2/11/19, facing South. Operator has mowed the weeds from the topsoil stockpiles and other portions of the location. Ongoing weed management and monitoring is required, and needs to occur in accordance to COGCC rules and regulations.

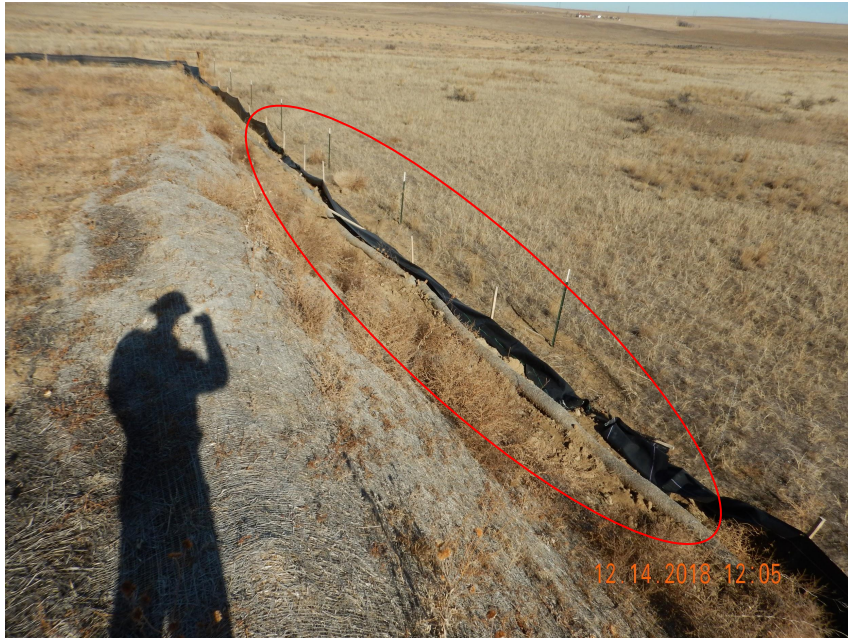
**Photo 3.** Photo taken from the north eastern topsoil stockpile on 12/14/2018, facing Northeast. Silt fence BMP in need of maintenance.

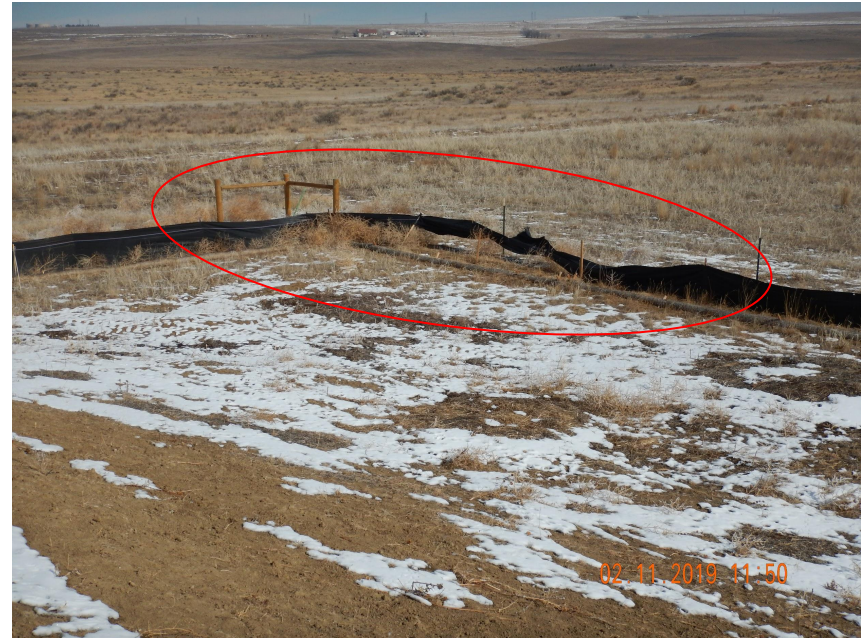
**Photo 4.** Photo taken from the northeastern location on 2/11/19, facing Northeast. Appears the Operator has made repairs to the silt fence that were previously observed; however, BMP is in need of maintenance.

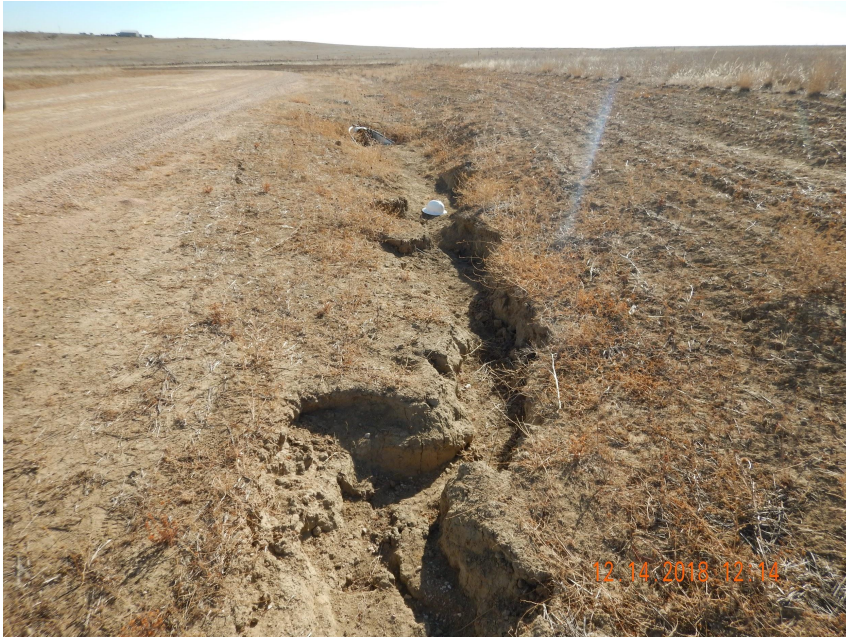
**Photo 5.** Photo taken along the access road just beyond the entrance of the location on 12/14/2018, facing South. Gully erosion has formed along a section of the access road.

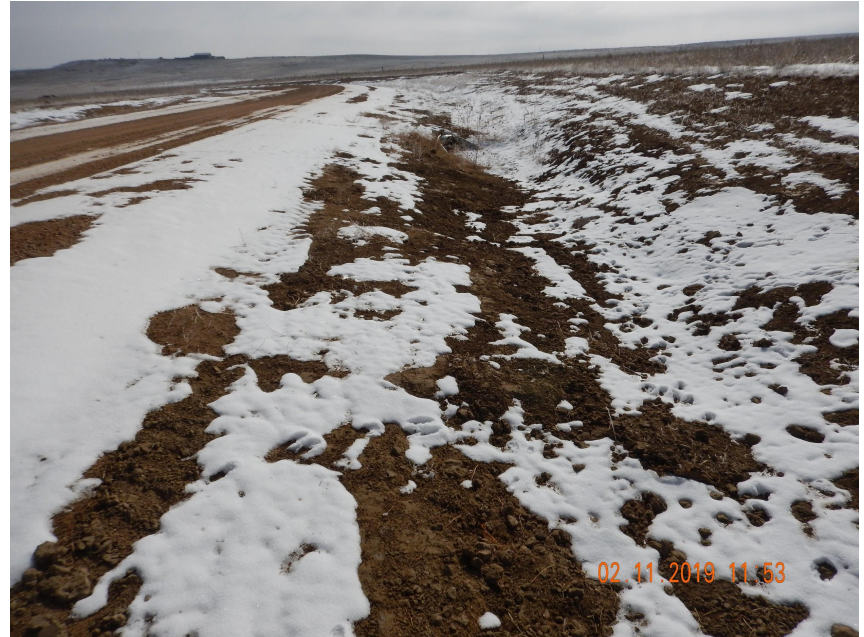
**Photo 6.** Photo taken along the access road just beyond the entrance of the location on 2/11/19, facing South. Operator has made repairs but has failed to install additional BMPs. It is not sufficient to only make repairs.
