Inspection Photo (s)
Specialty 12D
API # 05-045-18649
Inspection # 689303242

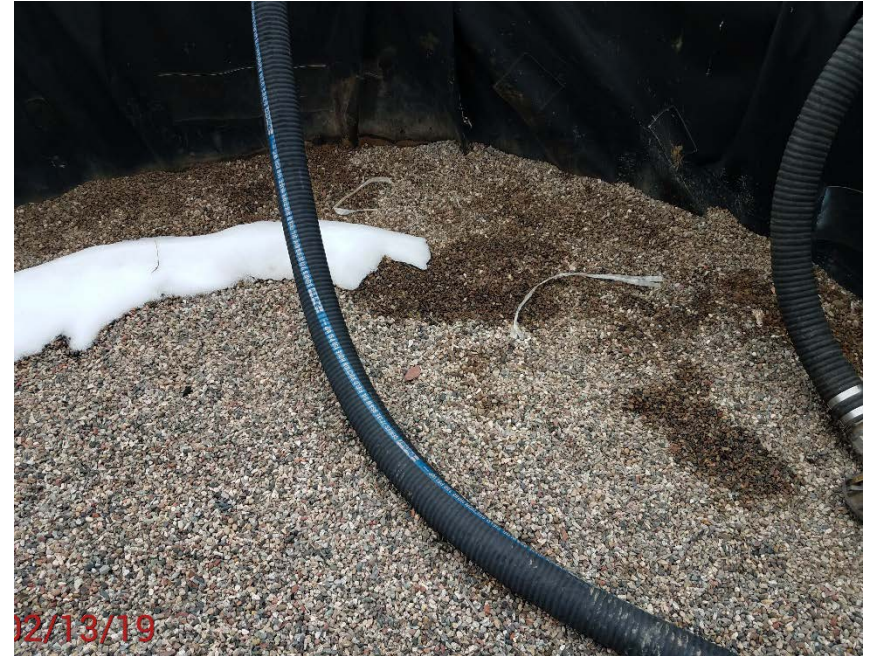
Location Photo #4, Stained material in South West corner of battery containment.

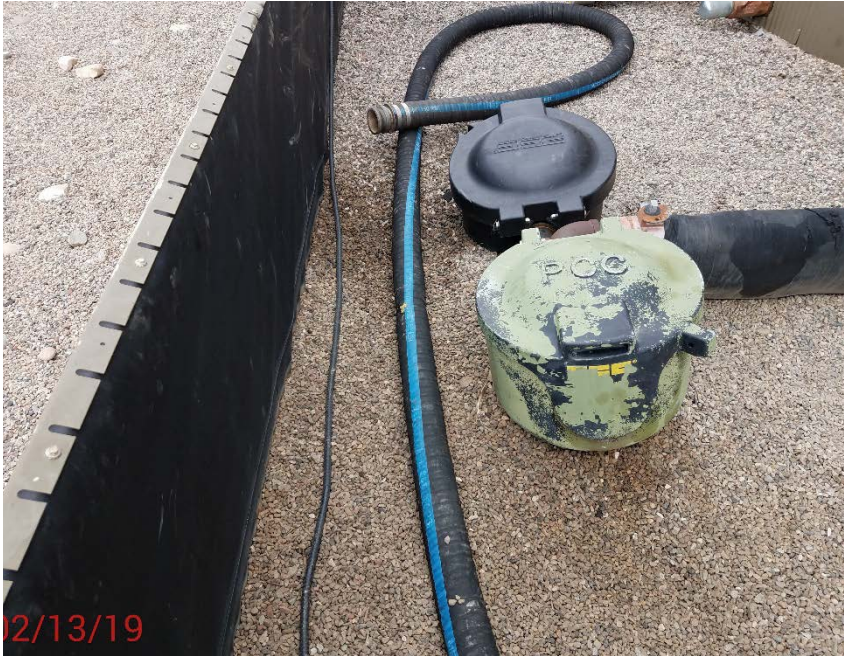
**Location Photo #5, Stained material around
load out basins.**
