Inspection Photos
Operator Name: Mustang Resources
LLC
Location ID: 461615

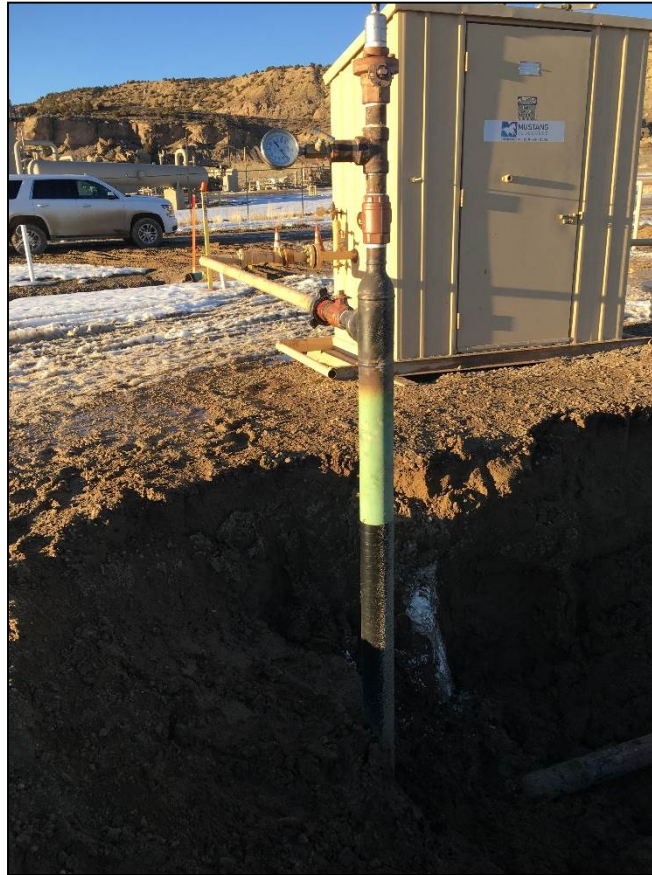
**Sales Flowline was rerouted and pressured
tested**

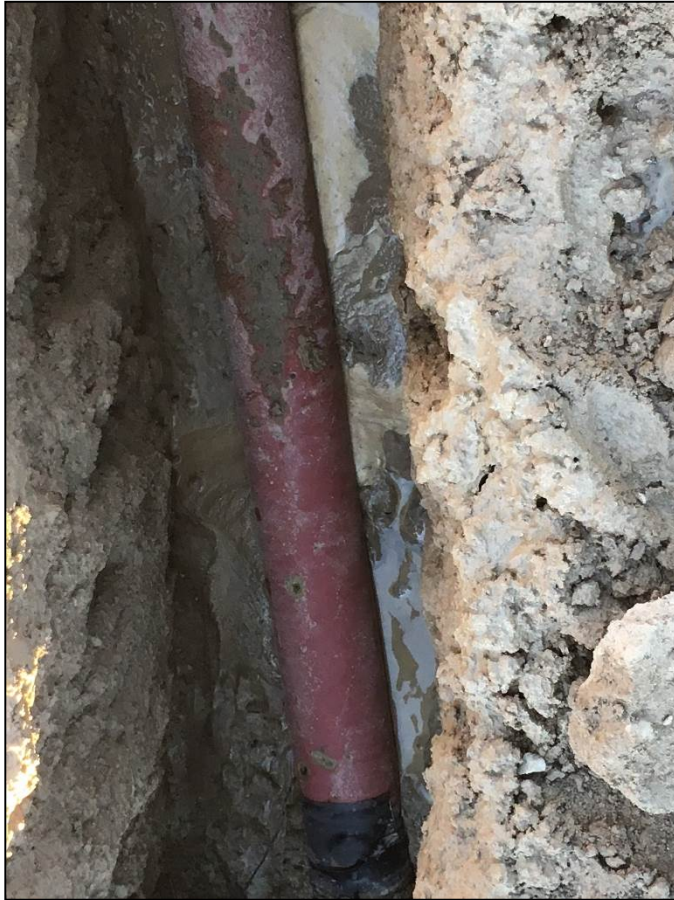
Source of release

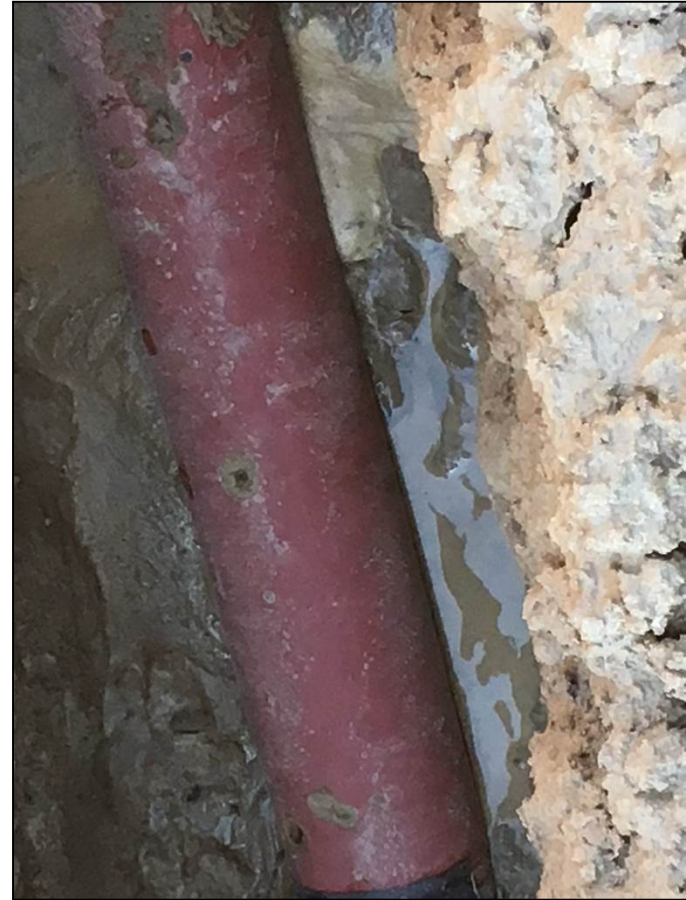
4 Holes on top of flowline

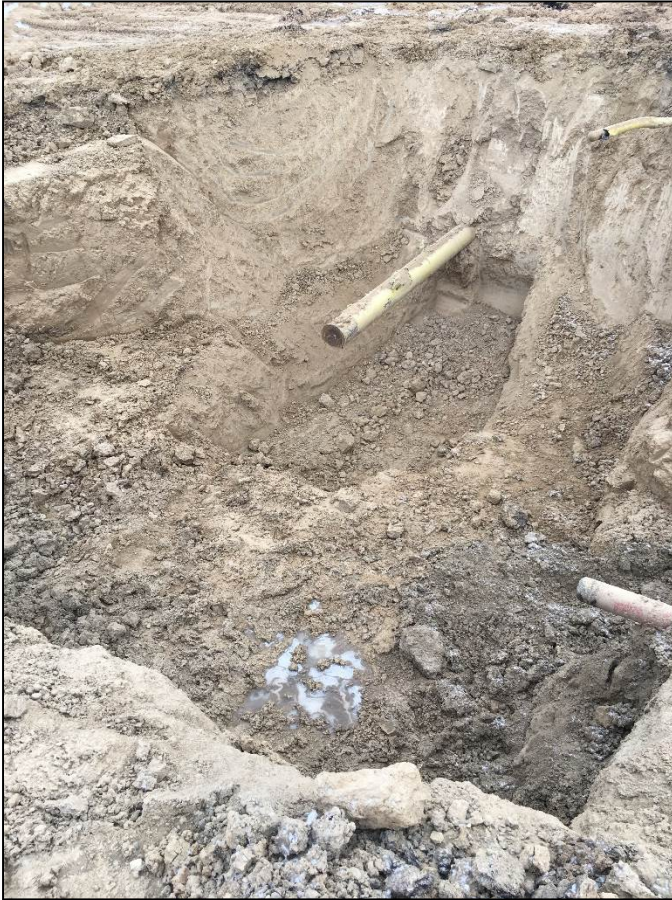
Open exaction hole

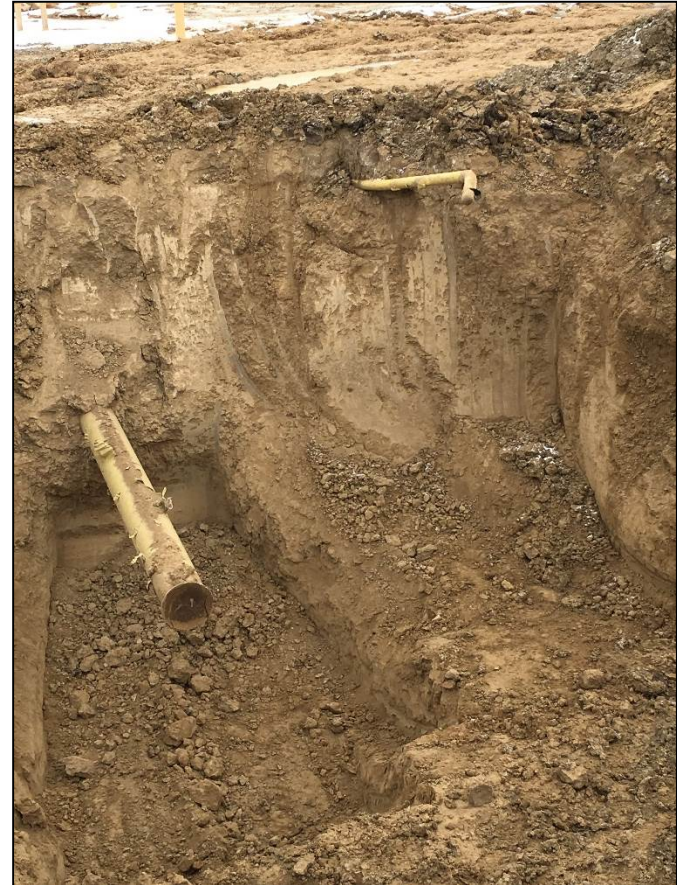
Additional abandoned/unclaimed 2" and 8" pipelines were also capped/removed.

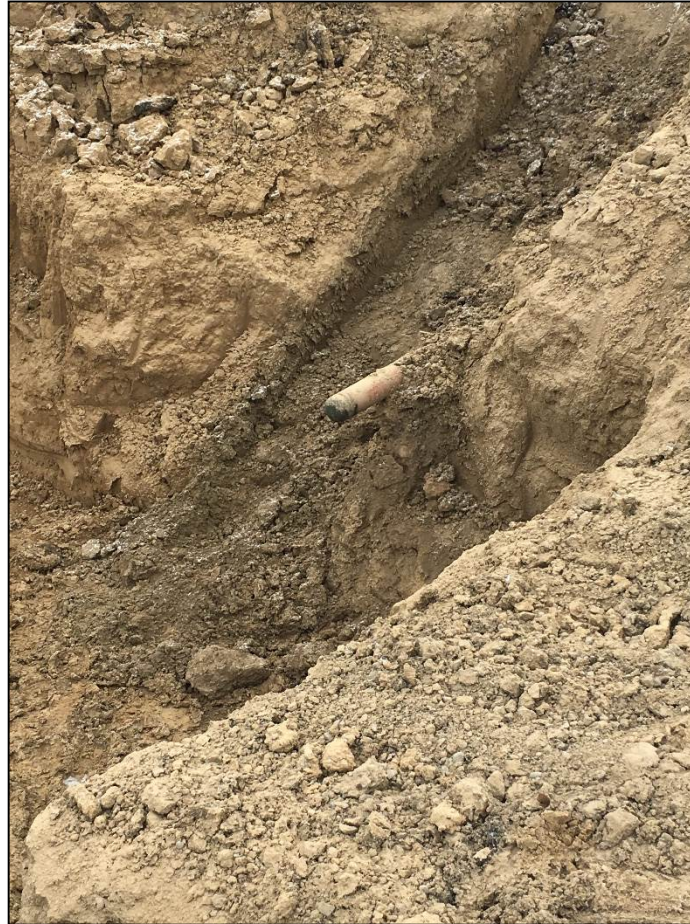
**Mustang Recourses flowline plugged
abandoned**
