Inspection Photos
Operator Name: Laramie Energy LLC
Location ID: 461292

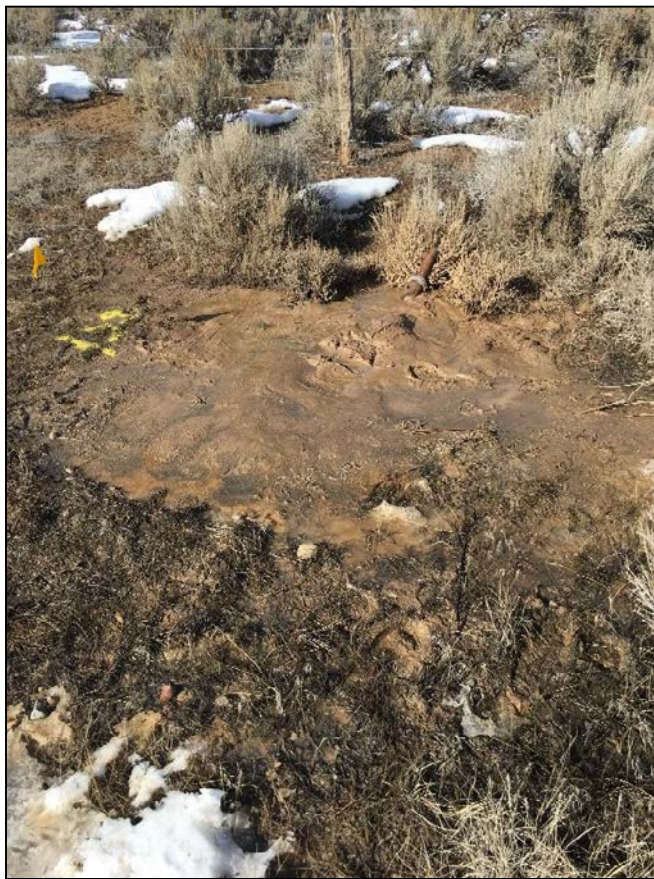
Pipeline leak discovered at the surface

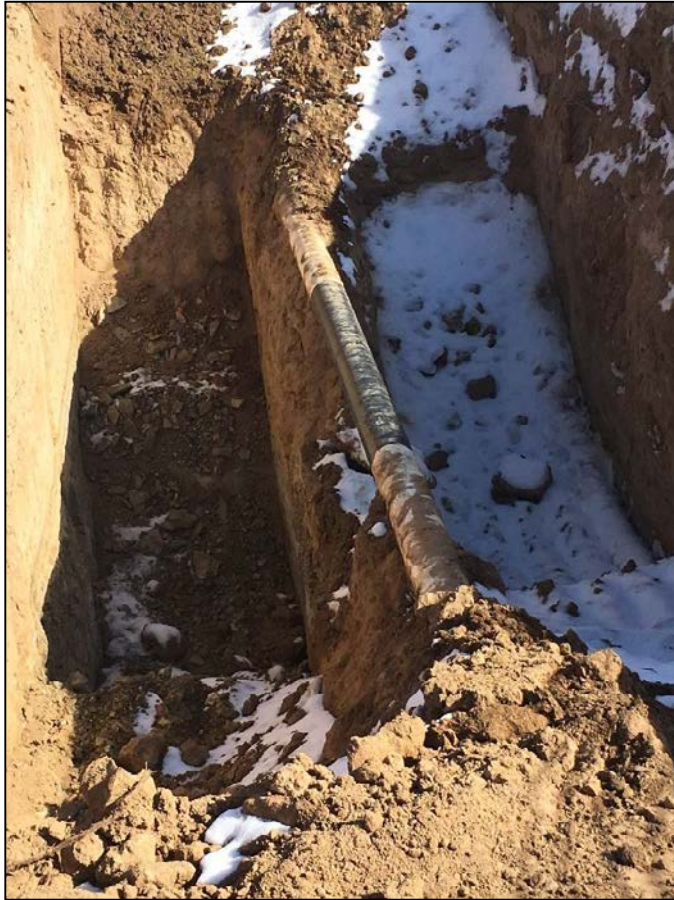
Source of release

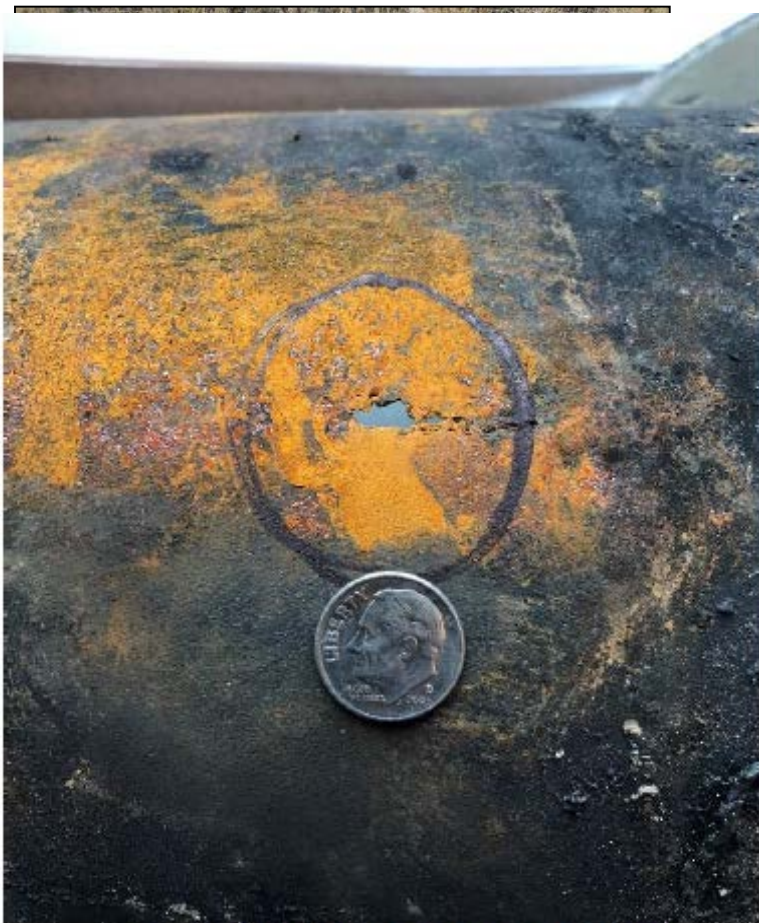
External View of Pipe Corrosion
