Interim Reclamation and Stormwater Inspection

February 1, 2018

Operator: BURLINGTON RESOURCES OIL & GAS LP – 26580

Location ID: 453244

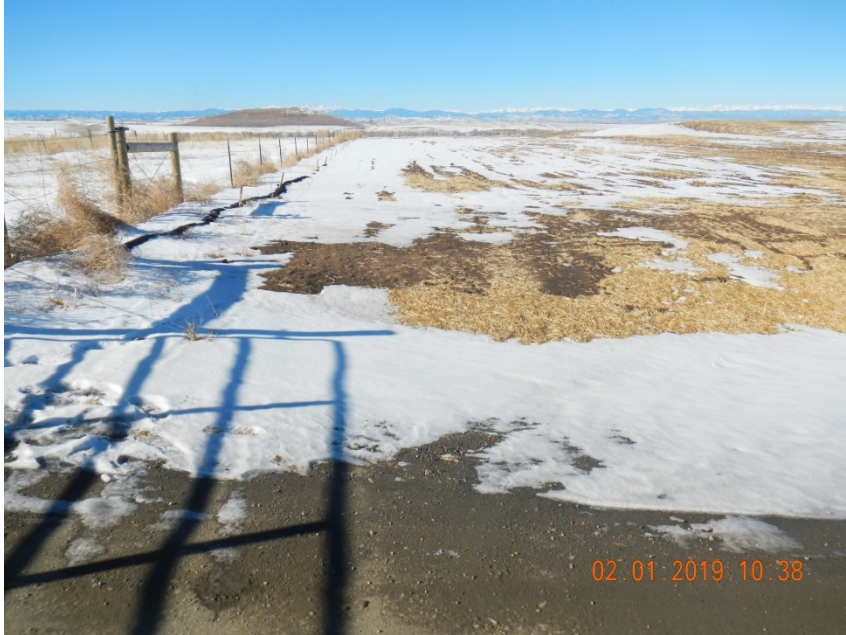
Photo 1. Photo taken from the southern perimeter of the location, facing West. Appears the Operator has performed interim reclamation activities to reduce disturbance areas only needed for production operations at the location, with the evidence of drilling rows and straw crimped mulch.

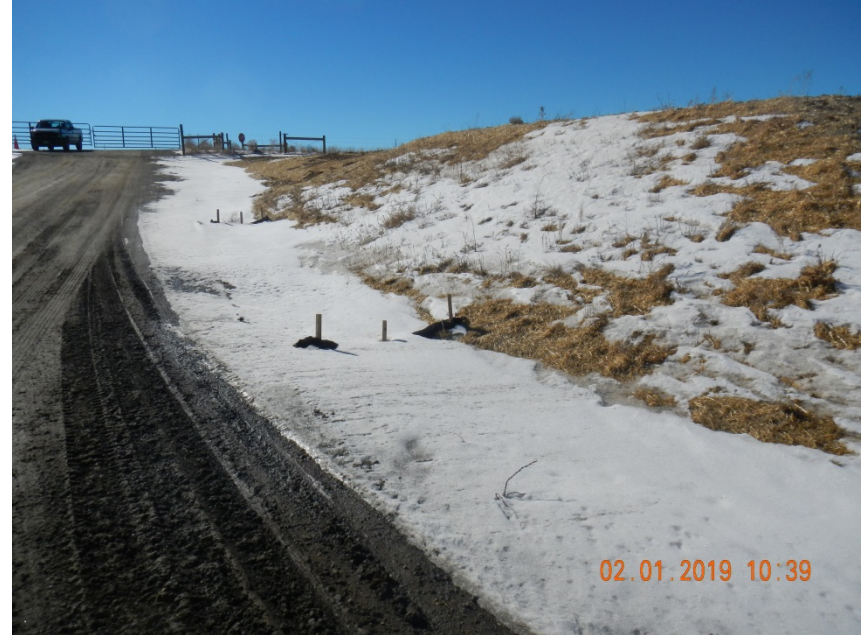
Photo 2. Photo taken from the location, facing South. See comments from Photo 1.

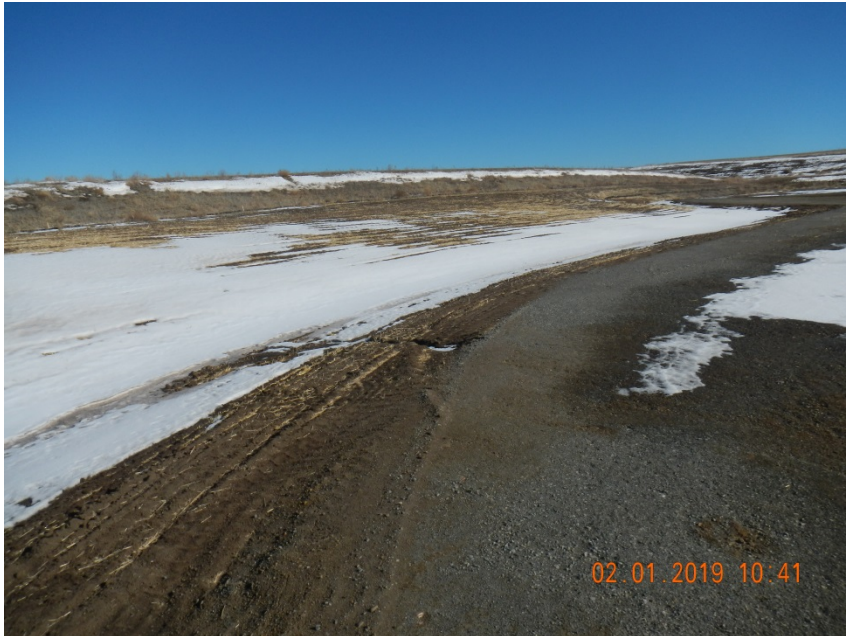
Photo 3. Photo taken from the location, facing Northeast. See comments from Photo 1.

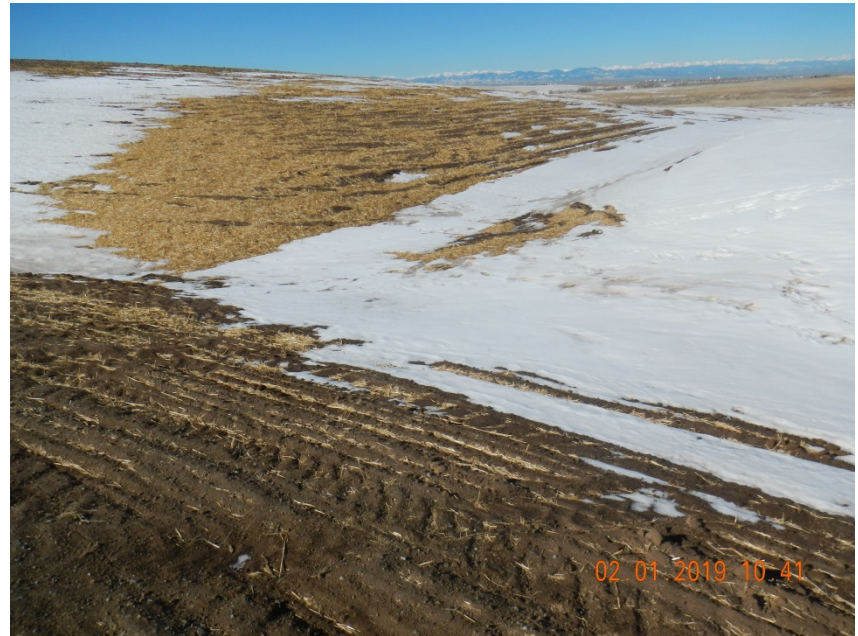
Photo 4. Photo taken from the location, facing West. See comments from Photo 1.

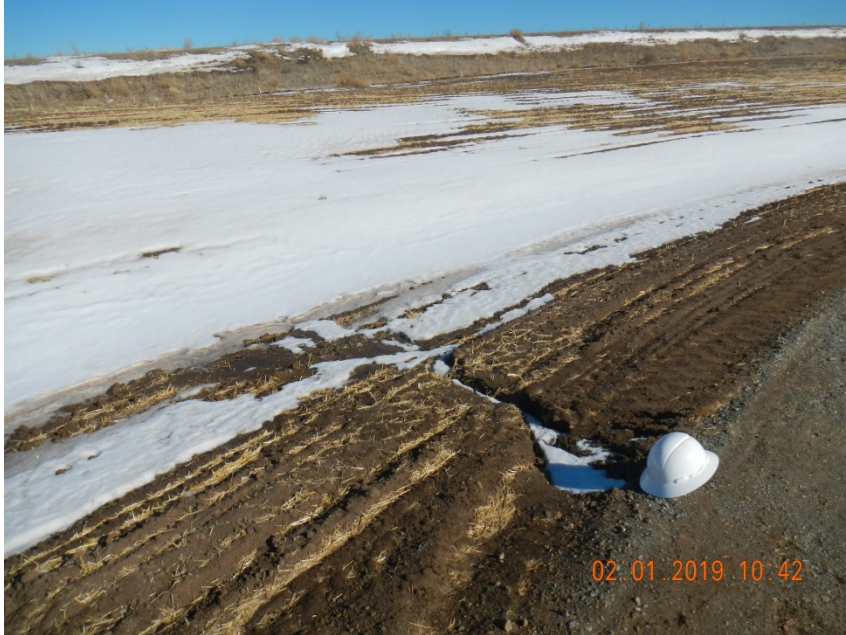
Photo 5. Photo taken from the location, facing Northeast. At the time of this inspection, it appears the Operator has not installed sufficient stormwater and erosion control BMPs in accordance to Rule 1002.f. standards. Photo depicts erosion observed on location.

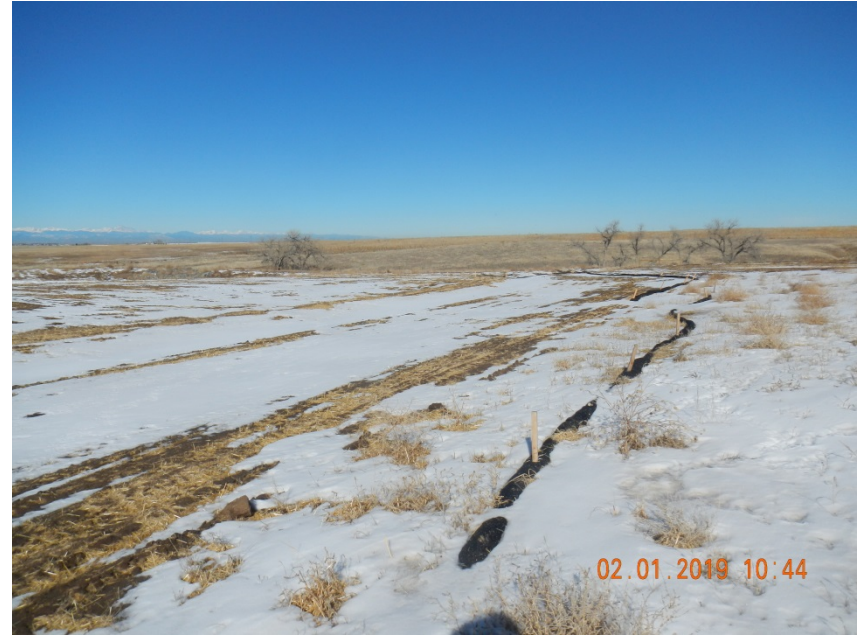
Photo 6. Photo taken from the northern perimeter of the location, facing West. See comments from Photo 1.

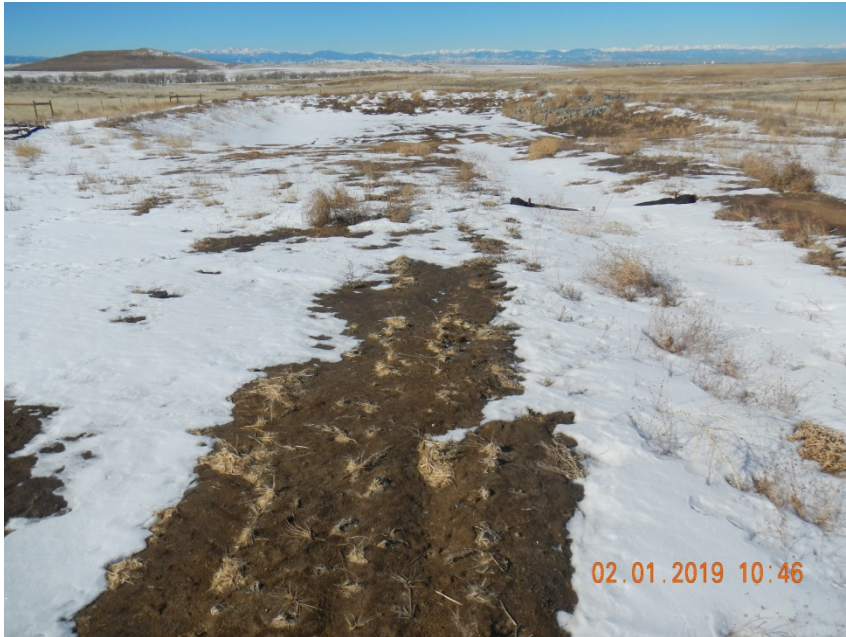
Photo 7. Photo taken from the northern perimeter of the location, facing West. See comments from Photo 1.

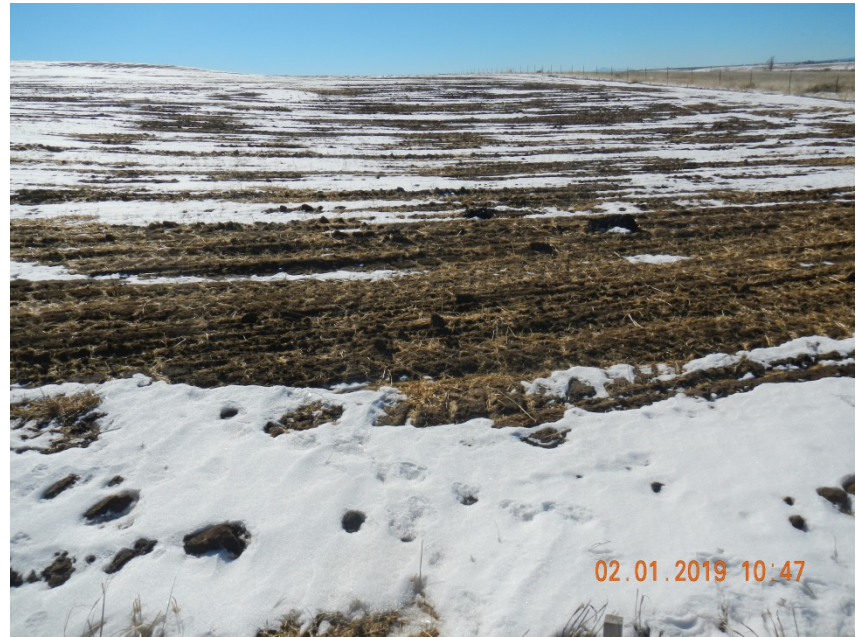
Photo 8. Photo taken from the location, facing Northeast. See comments from Photo 1.

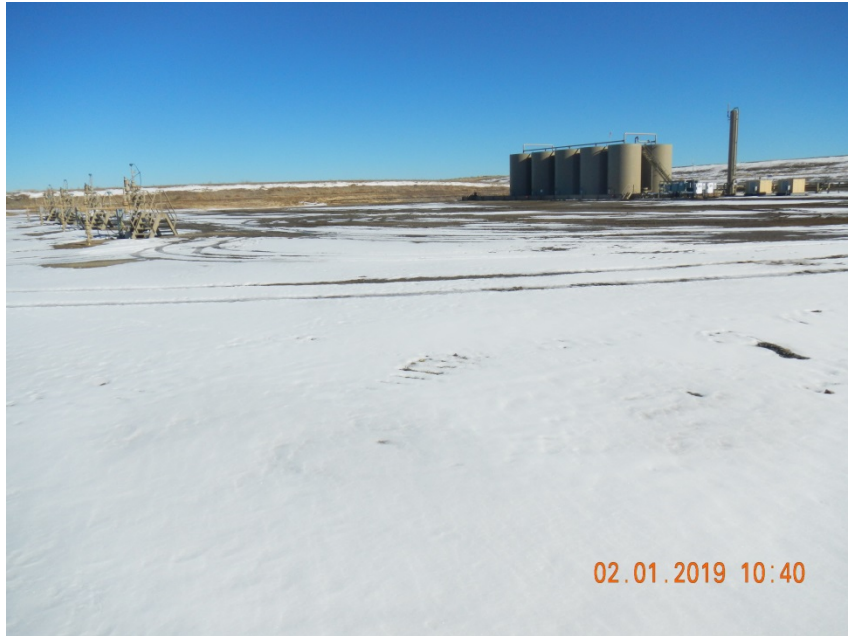
Photo 9. Photo taken from the southern perimeter of the location, facing Northeast. This location has a poor design for implementing Interim Reclamation and not in compliance with Rule 1002.e.(1).

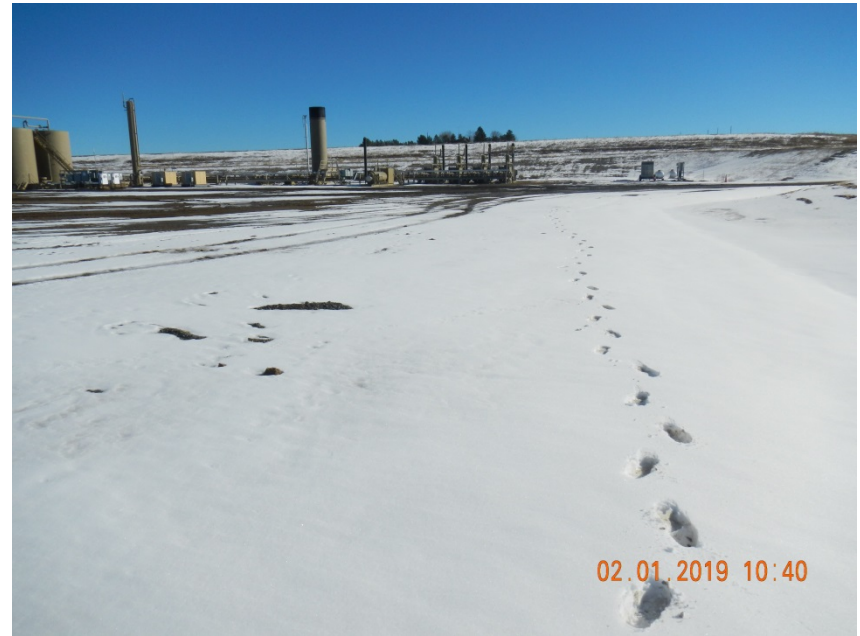
Photo 10. Photo taken from the southern perimeter of the location, facing East. See comments from Photo 9.
