Inspection Photos
Location Name: CHURCH 2
Location ID: 05-103-05331
Inspection: 679703019

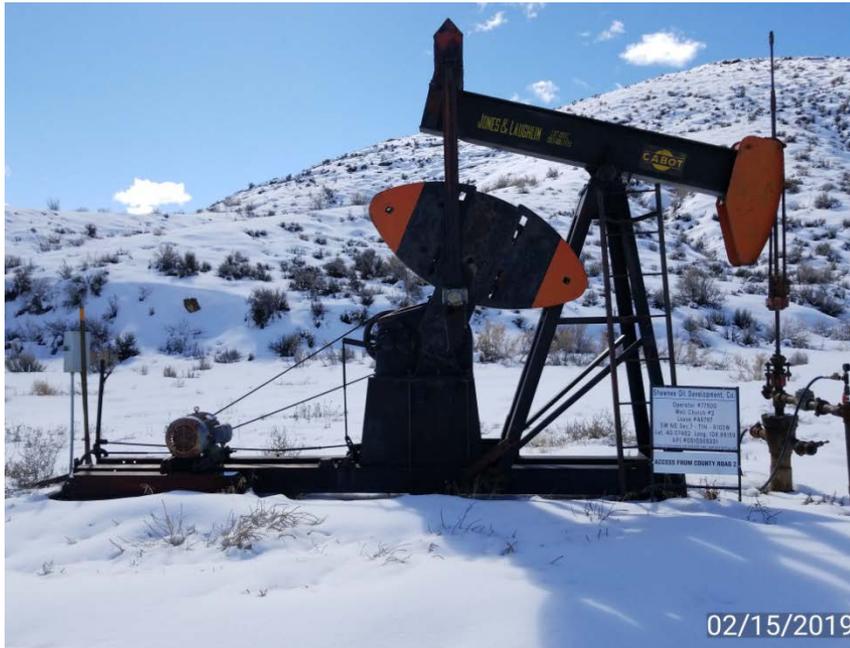
Photo 1. Location looking south.

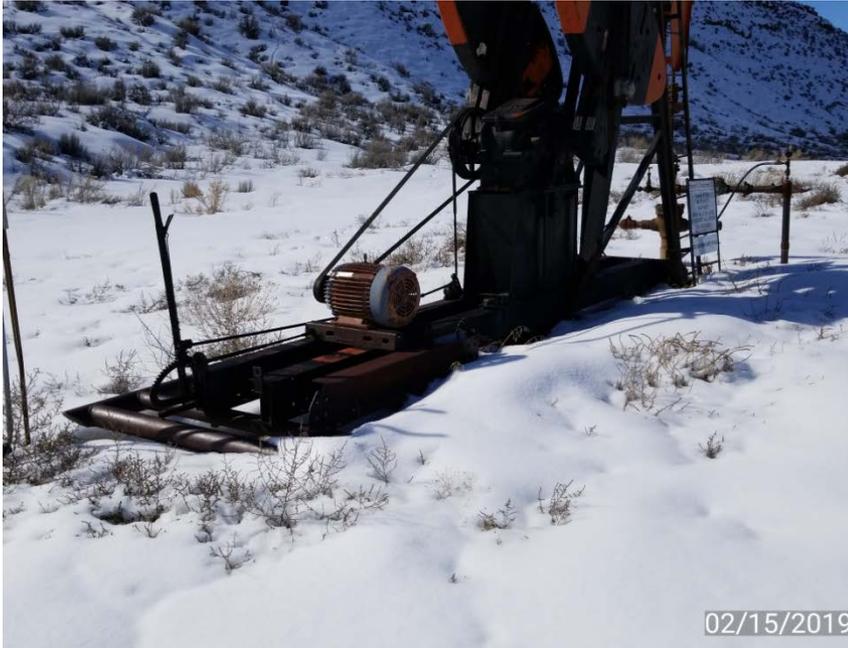
Photo 2. Weeds next to pump jack.

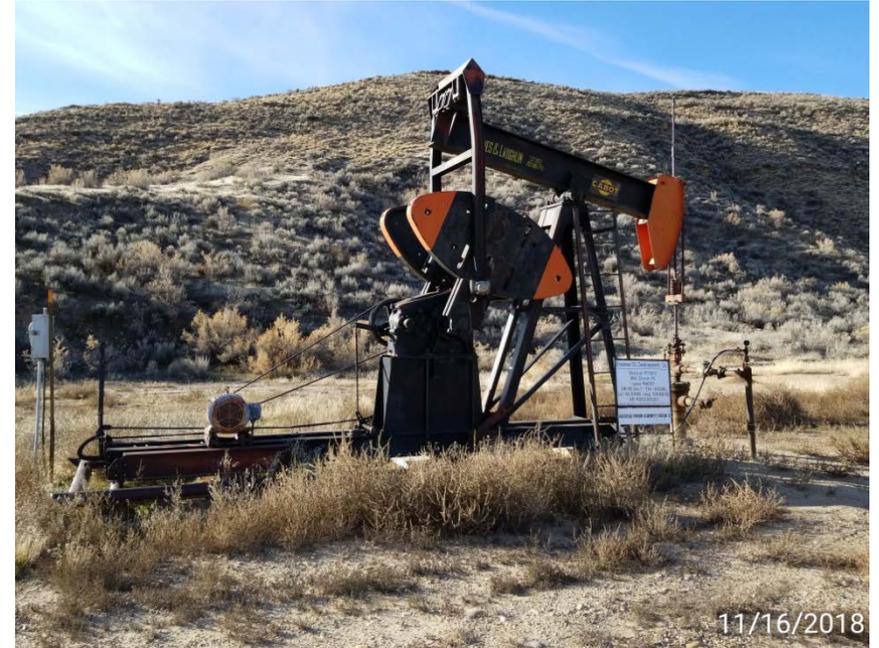
Photo 3. Weeds next to pump during inspection 679701727.

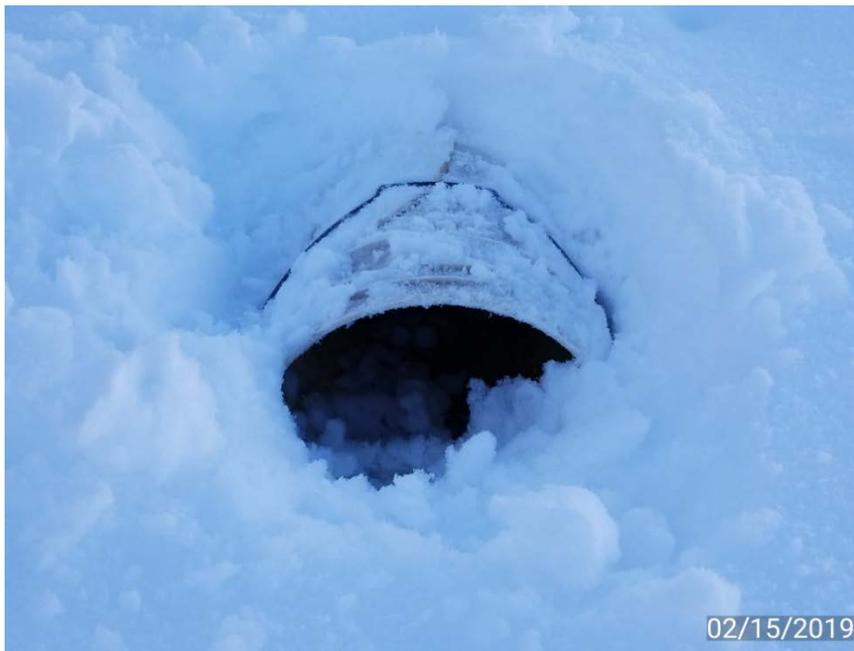
Photo 4. Trash on loading road below tank battery.

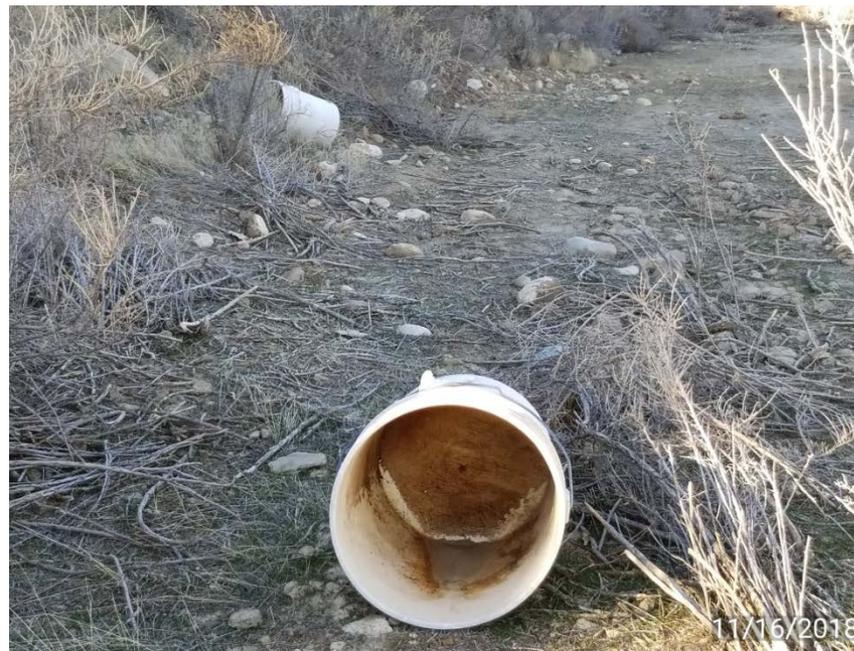
Photo 5. Trash on loading road below tank battery during inspection 67901727.

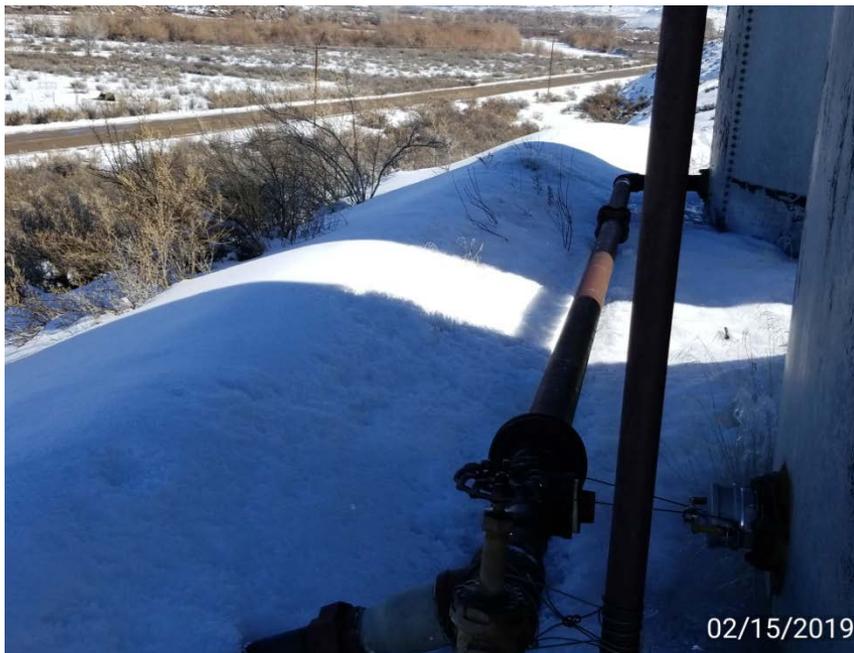
Photo 6. Insufficient berm capacity due to short berm on north side.

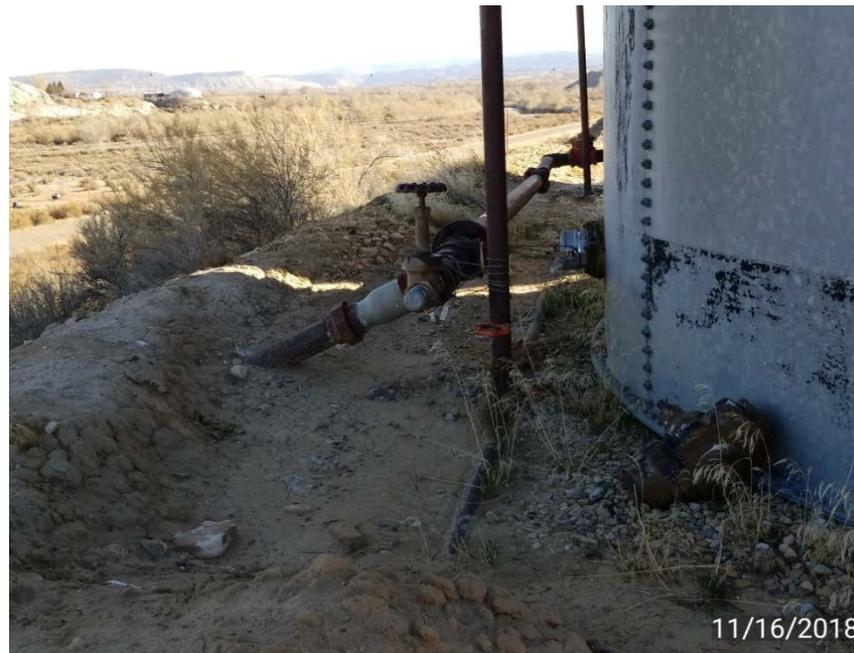
Photo 7. Insufficient berm capacity due to short berm on north side during inspection 679701727.
