Inspection Photos 2/06/19 and 2/08/19
Well: BULTHAUP 39-6
API # 05-123-26884

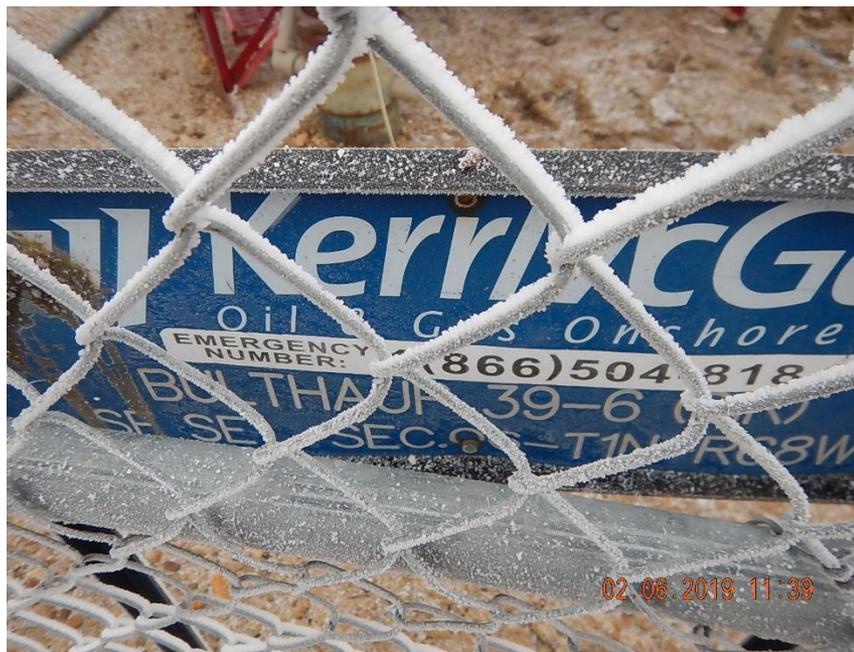
Anadarko signage at wellhead.

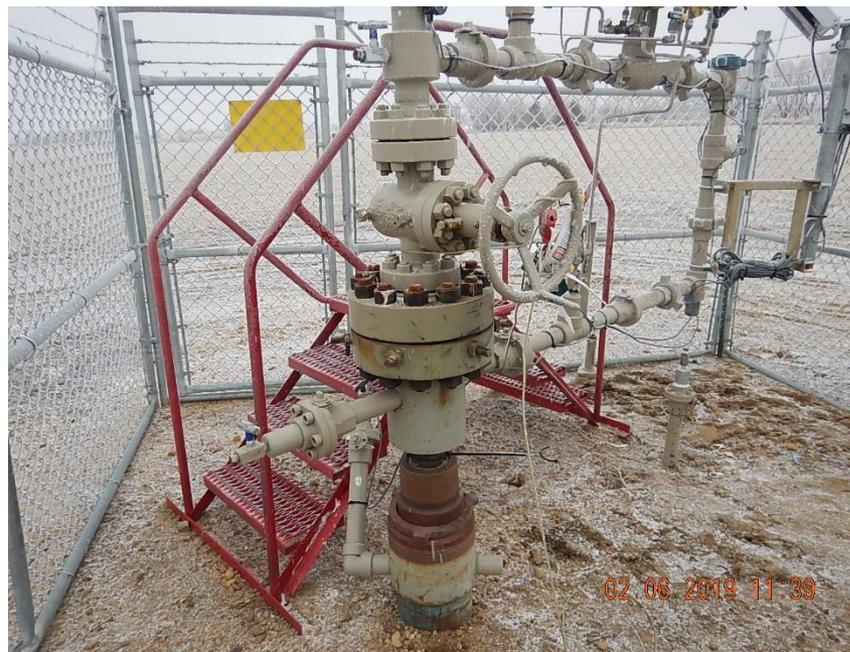
View of (TA) wellhead; flowline has been disconnected.

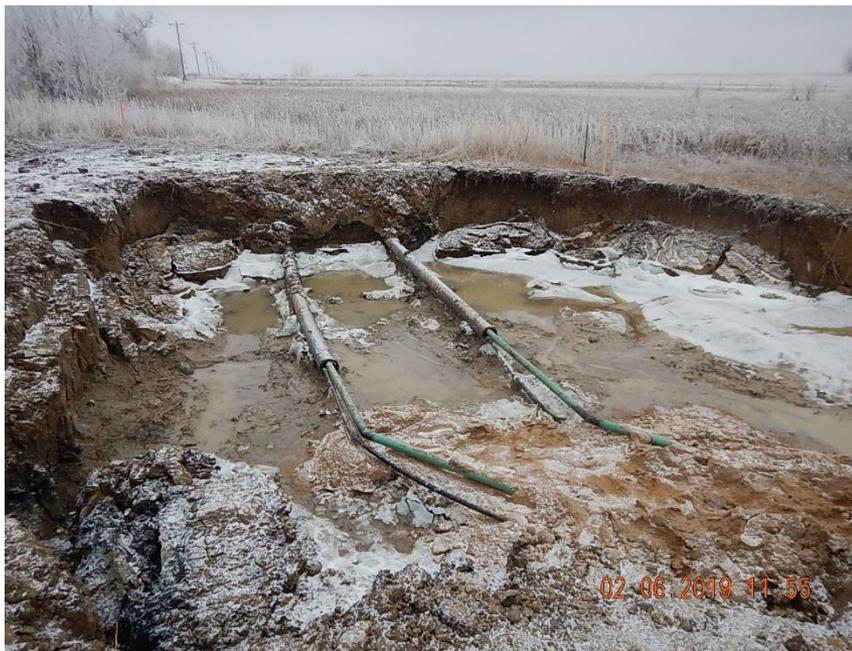
Bulthaup 16-6 and 39-6 flowlines exposed in excavation; The 39-6 flowline (failed) is furthest right. Flowlines enter 4" casing pipe under marshy area. View south to wellheads.

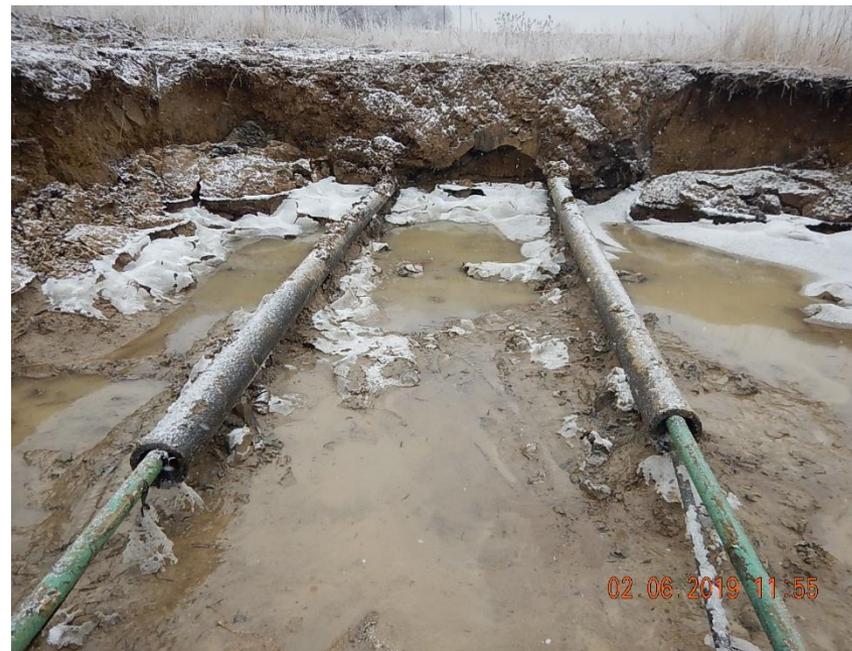
Closer view of the 2" FBE CS flowlines and 1" HDPE gas supply/ return flowlines entering the 4" steel casing pipes
