Inspection Photos

API: 05-043-06231

Operator: AUSCO PETROLEUM INC

Inspection Date: 2/15/2019

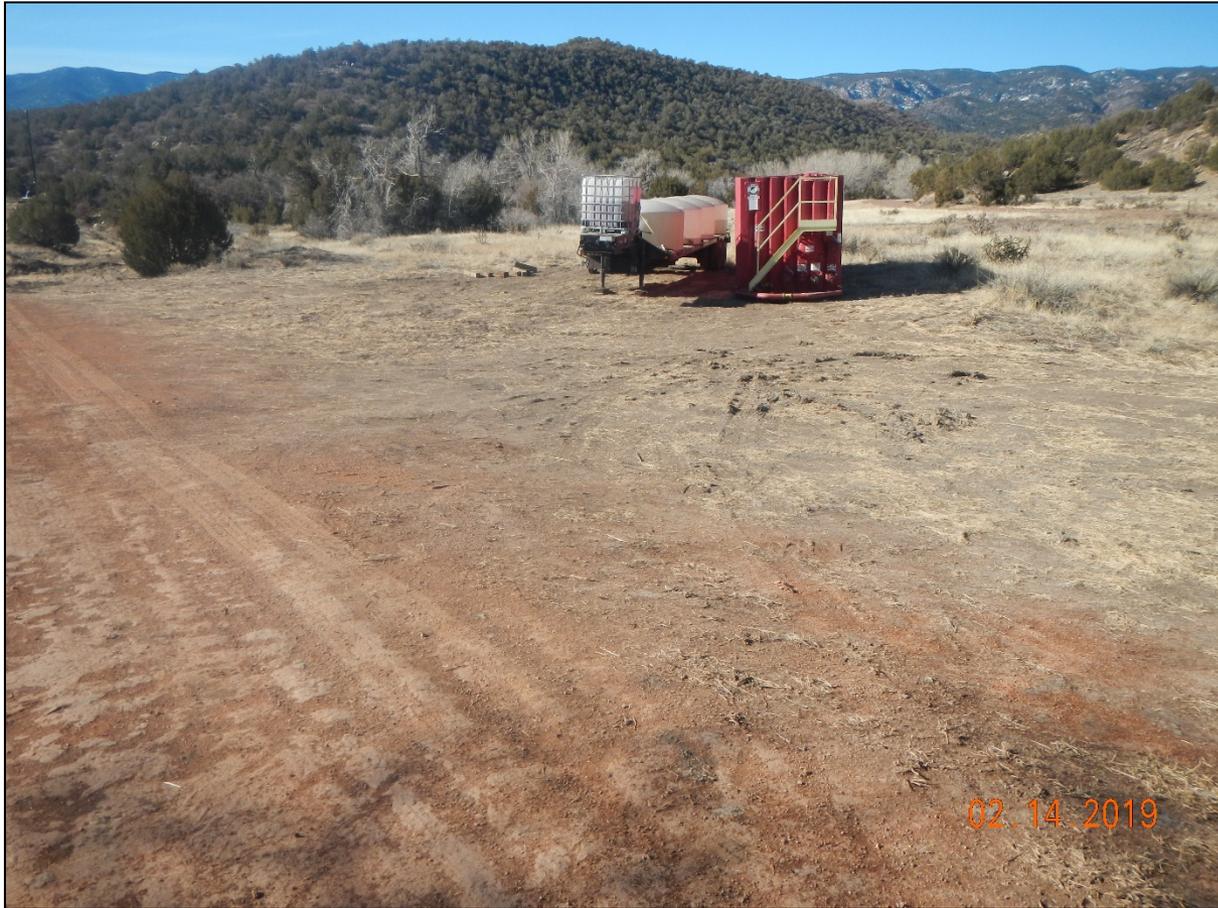
Photo 1. Facing southwest from the access road. Equipment has created additional disturbance outside of the location.

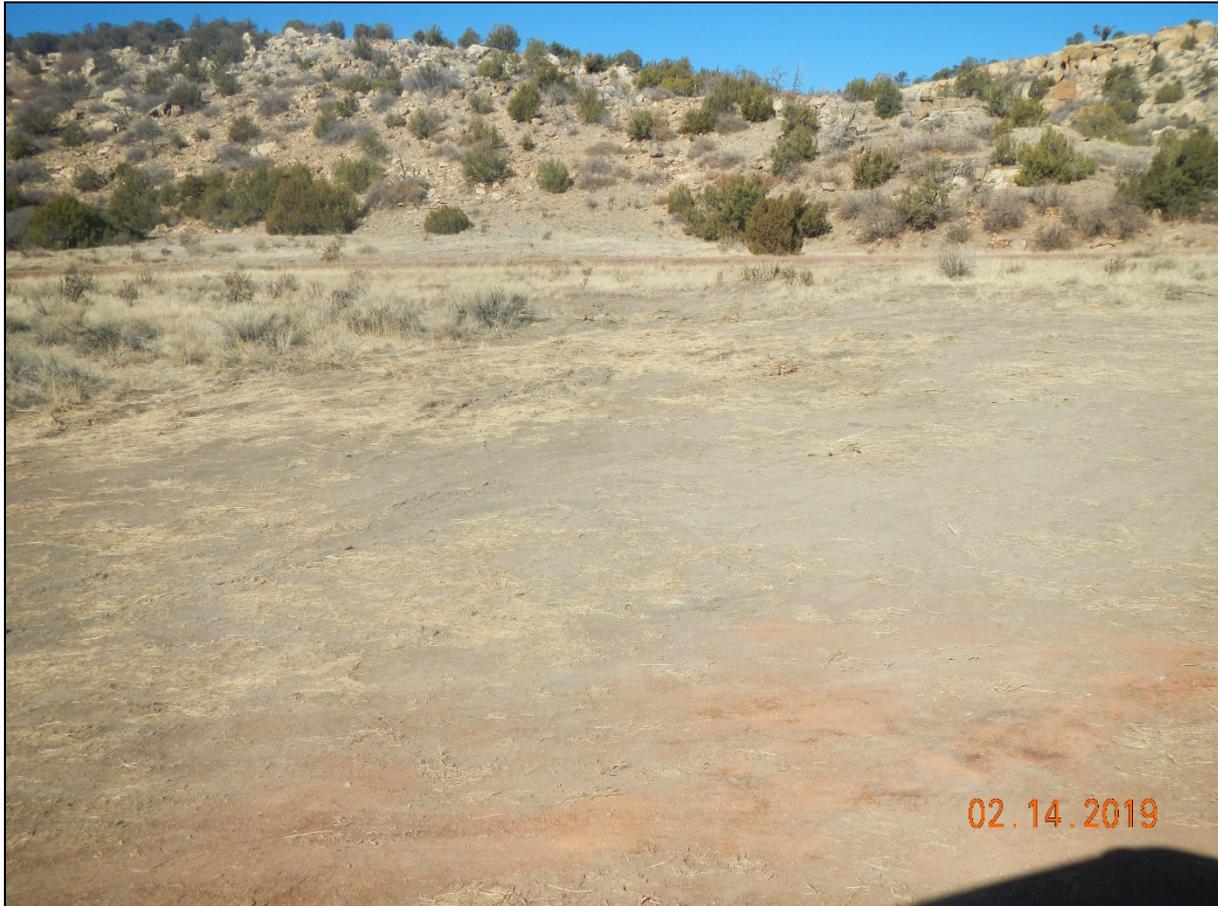
Photo 2. Facing west from the access road. Operations have created additional disturbance outside of the location.

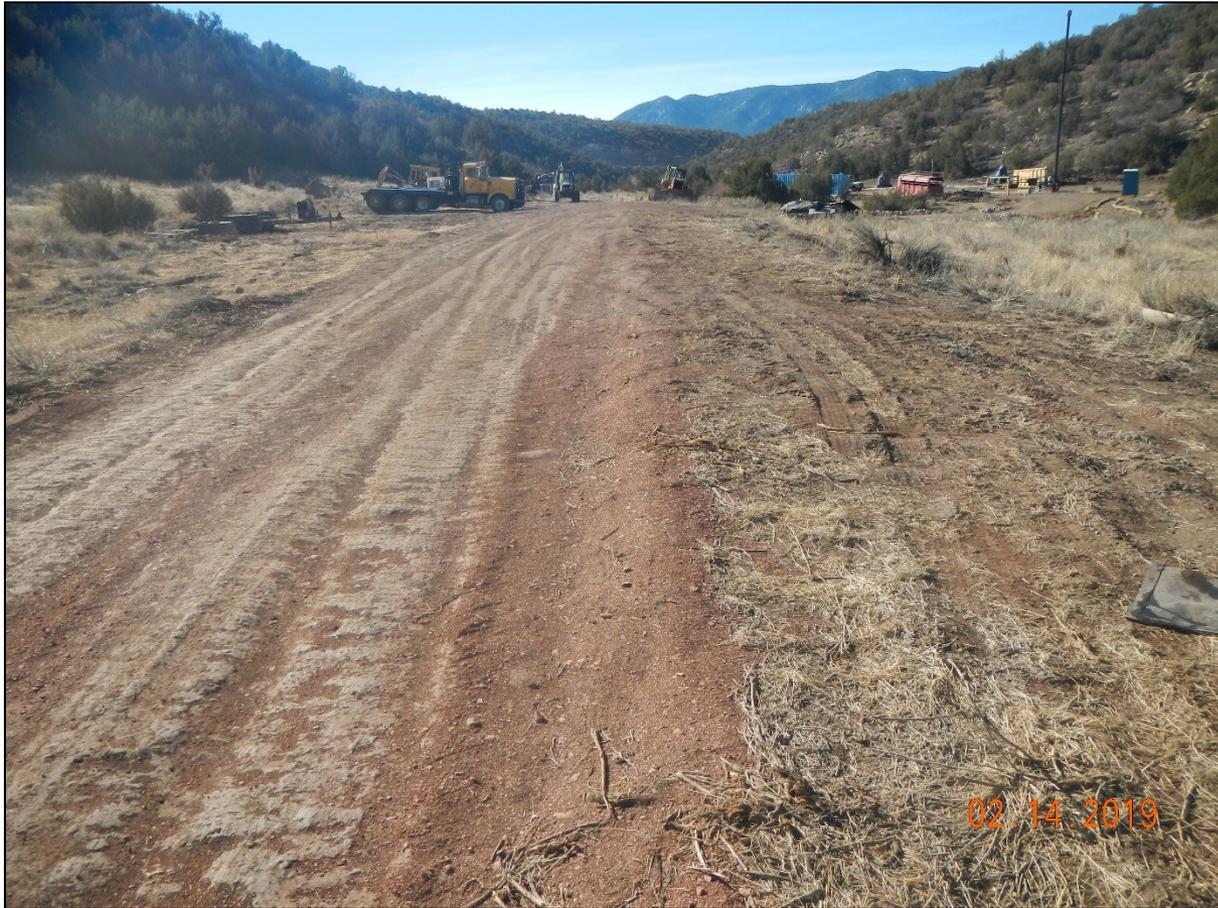
Photo 3. Vehicle equipment parking off the access road has created additional disturbance.

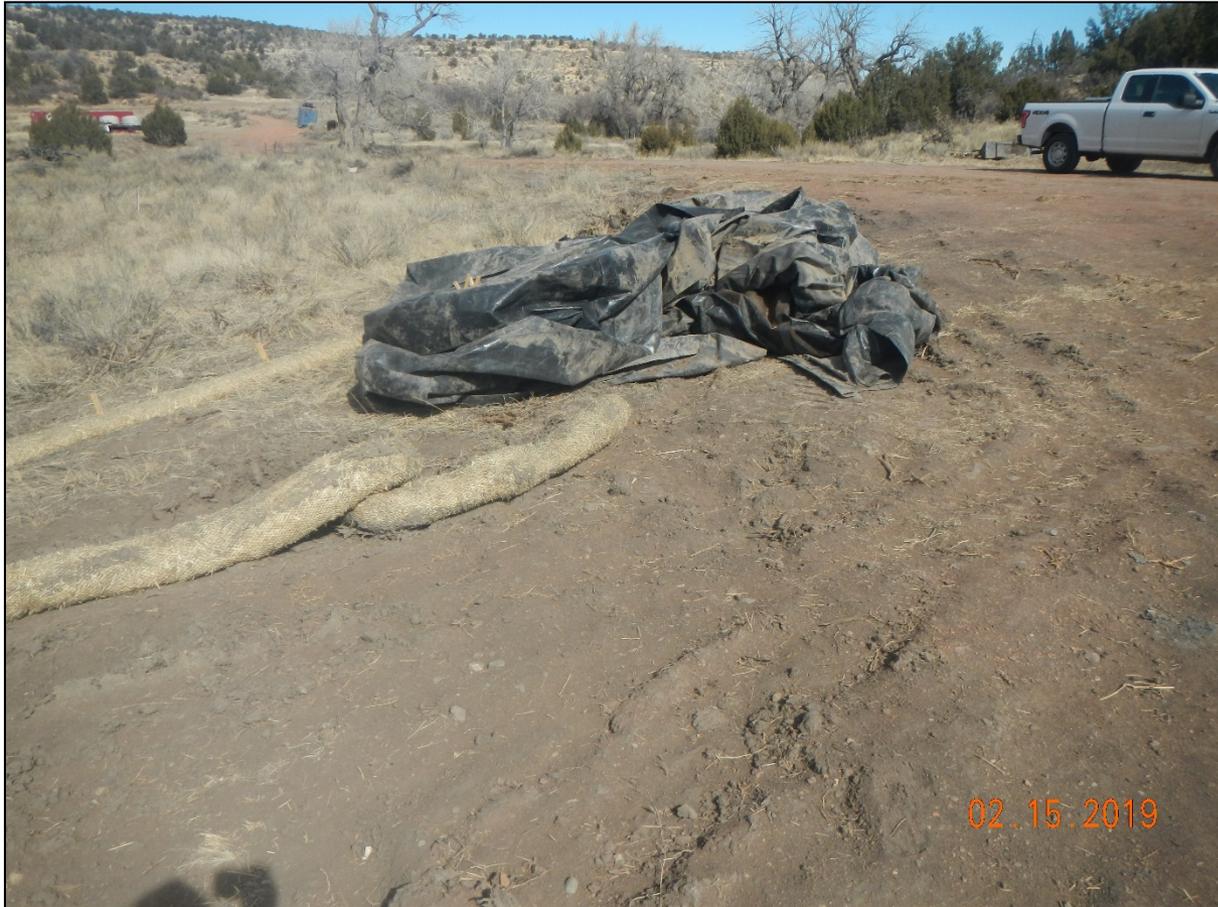
Photo 4. Plastic liner debris remains on the side of the access road. Wattles are displaced and not properly installed. Connection between the wattles were not properly overlapped.

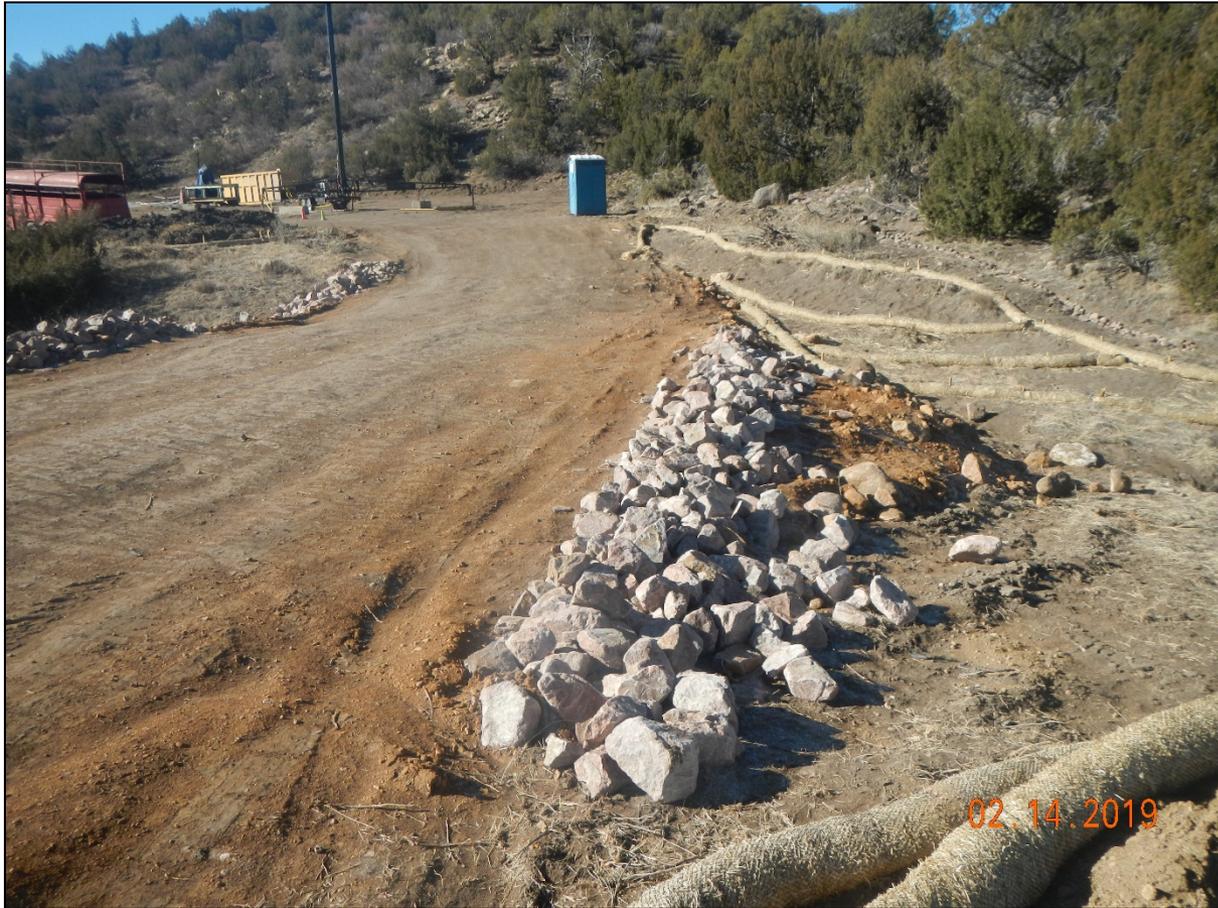
Photo 5. Facing southwest along access road toward the location. The road crosses the stream at this point. The stream crossing is inadequate.

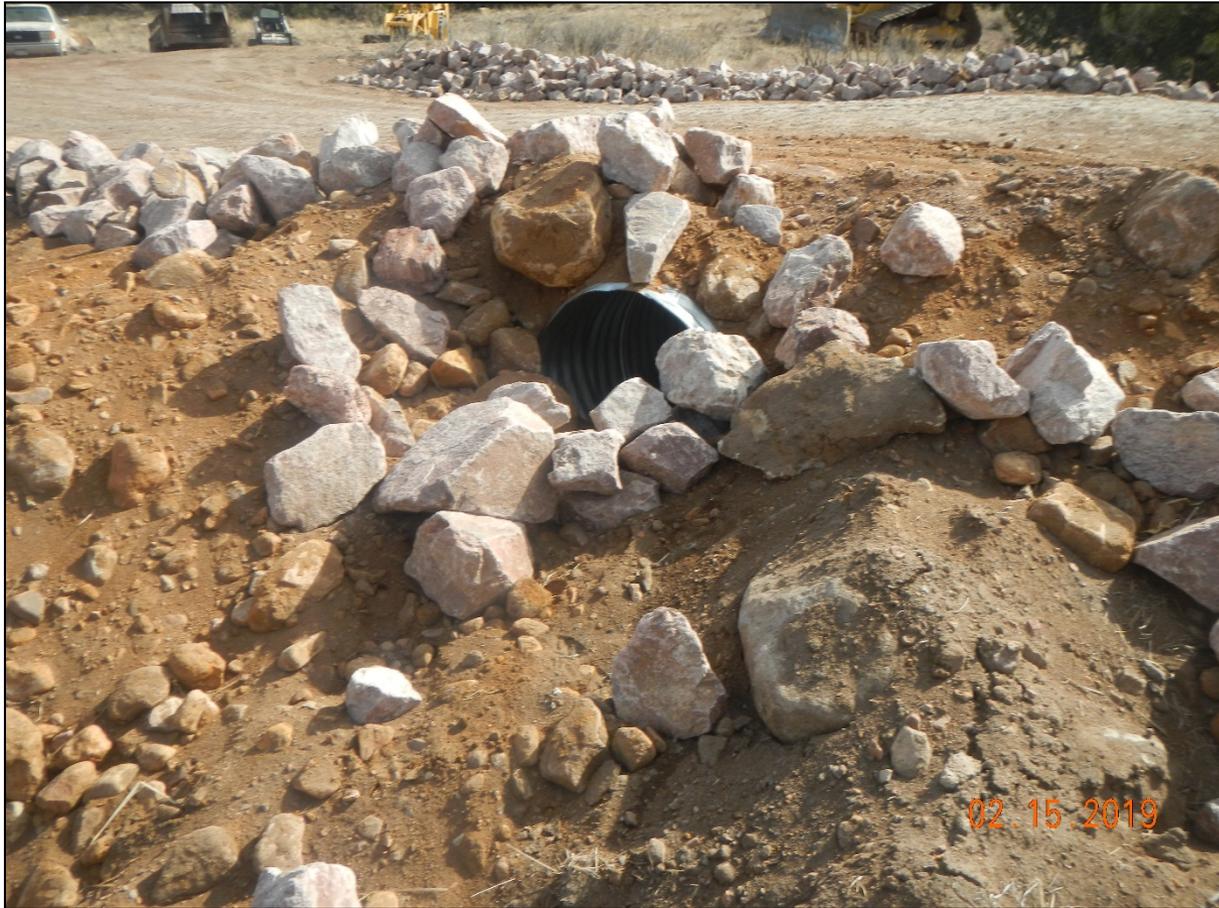
Photo 6. The outlet culvert at the stream crossing is obstructed with material and is improperly installed (See Photo 7).

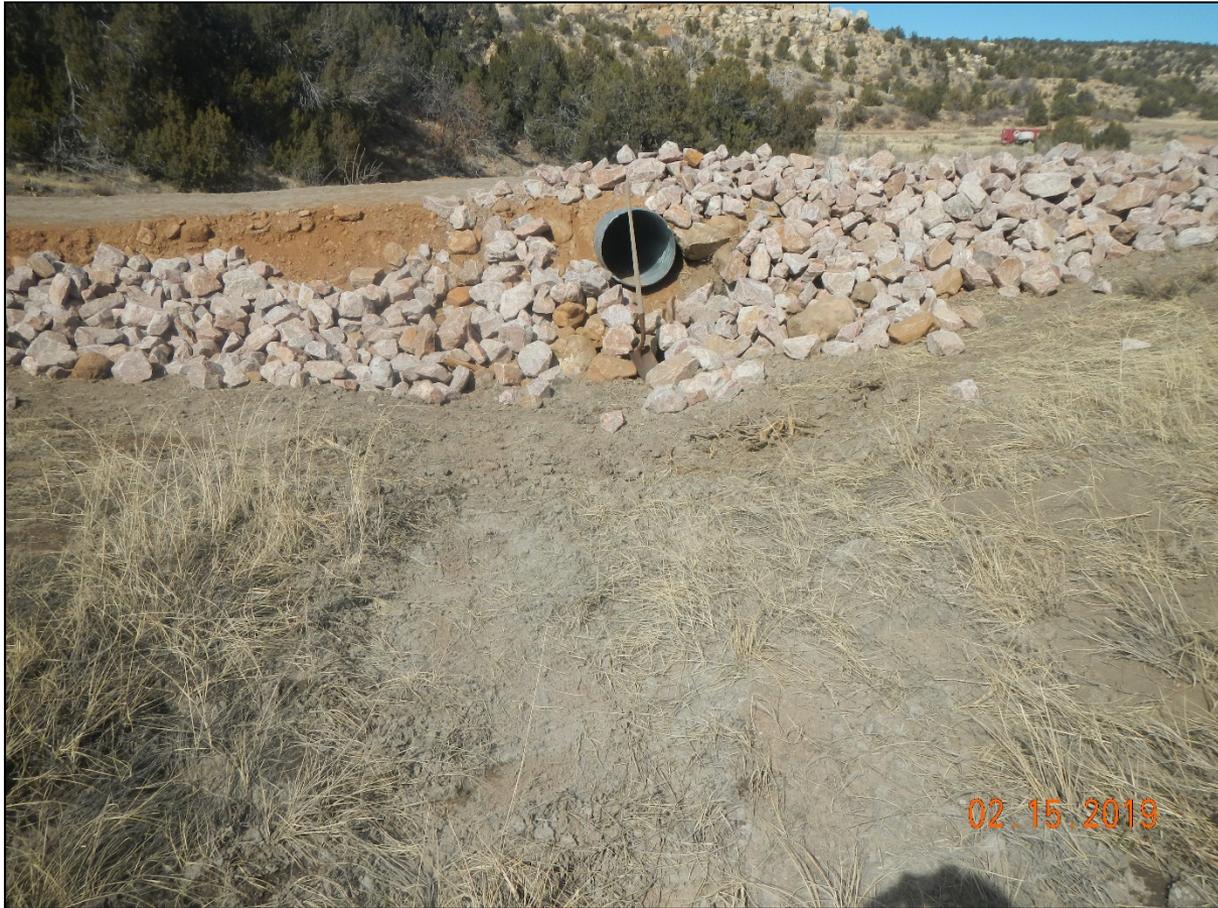
Photo 7. The inlet culvert at the stream crossing appears to be installed too high above the channel which will create pooling of the water and potential water overflow across the access road. This also shows improper installation and armoring.

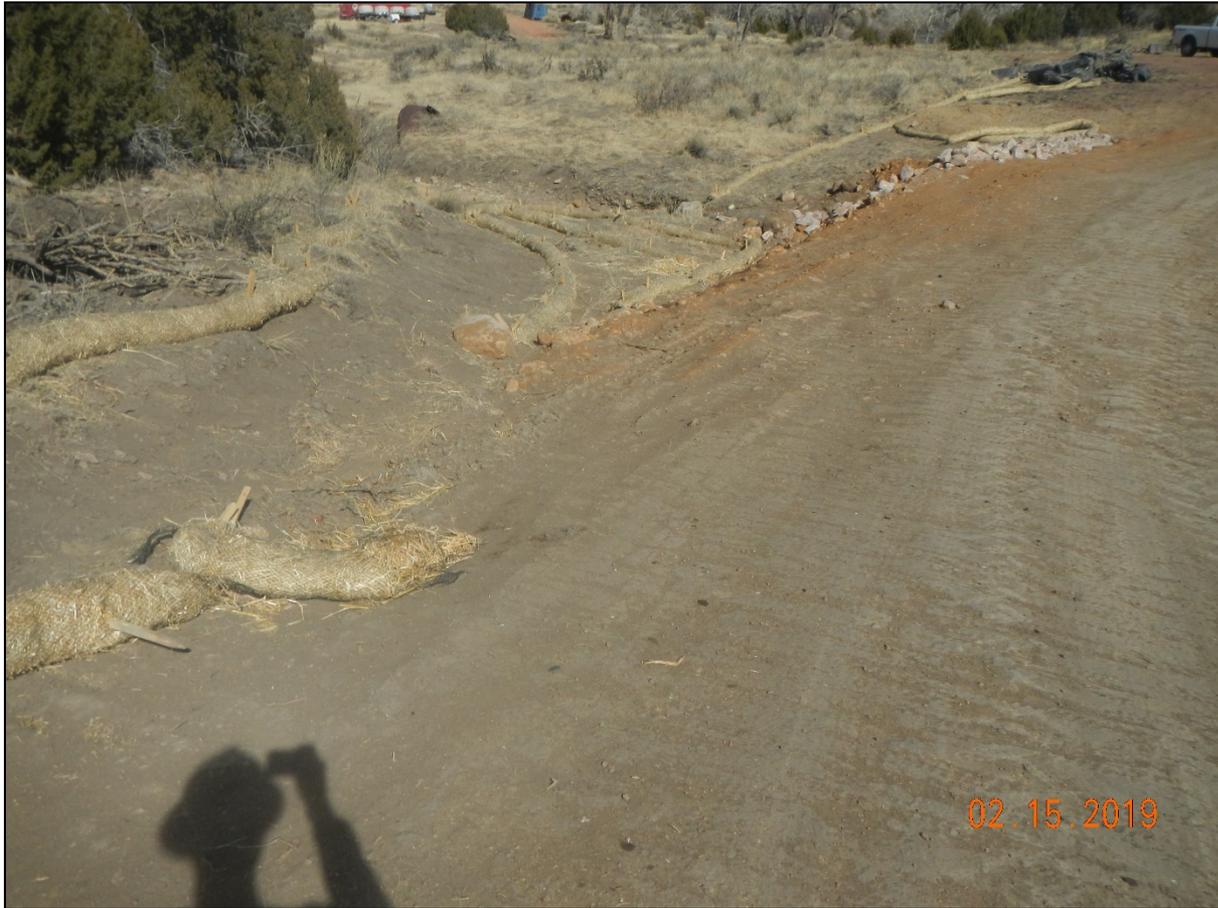
Photo 8. The wattles are displaced and improperly installed along the access road.

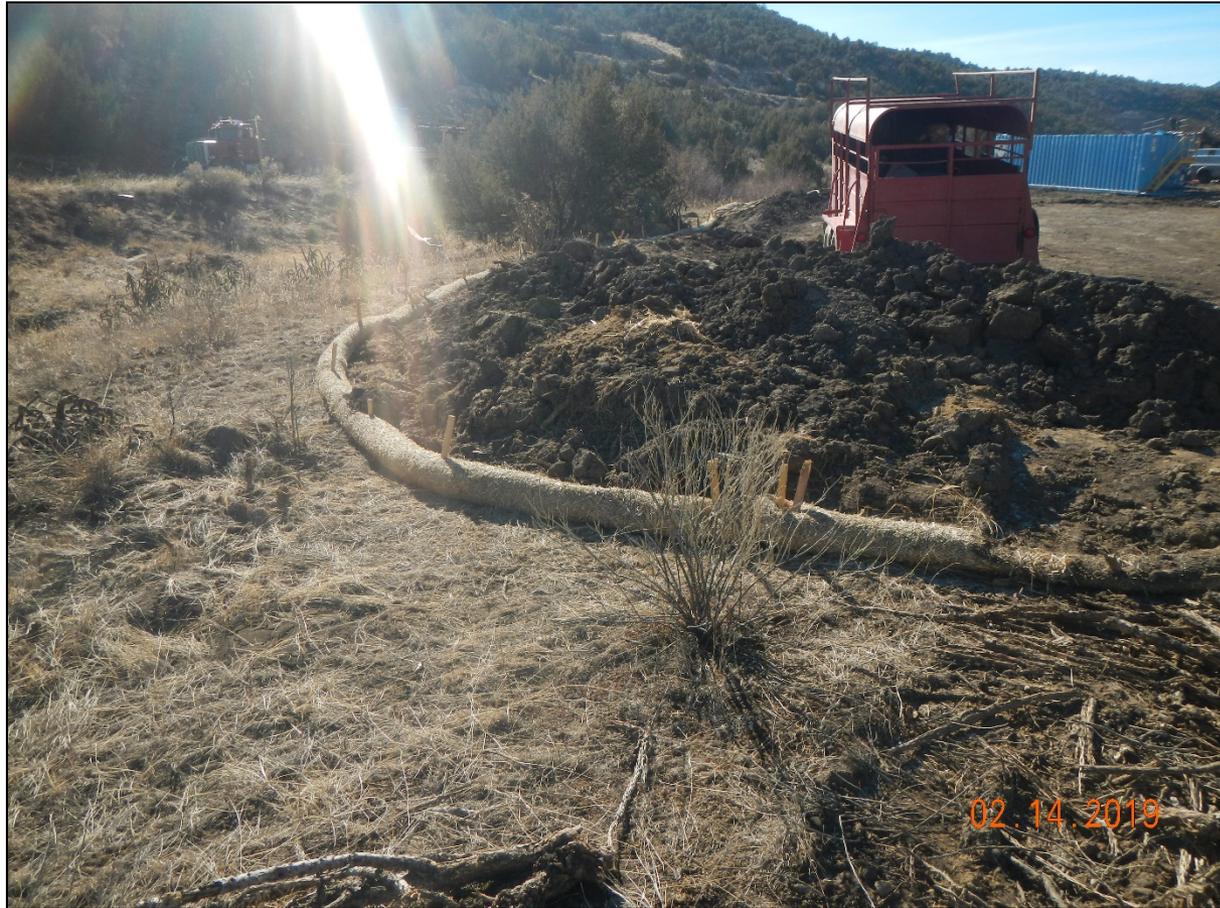
Photo 10. Wattles are placed along the eastern side of the location. Loose soil is pushed up covering the berm and can potentially overtop the wattles. There is no tertiary containment along the down gradient parameters of the location.

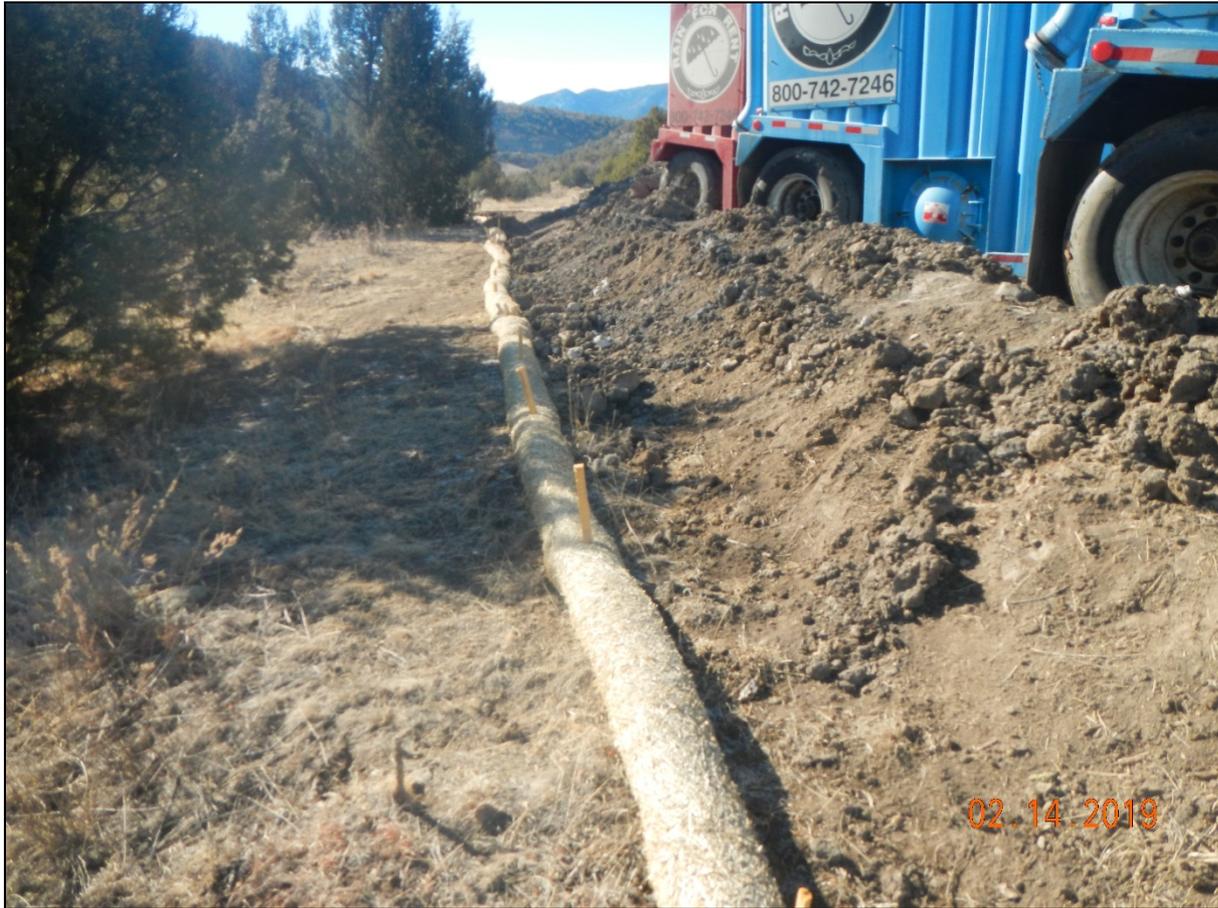
Photo 11. Facing south along the east side of the location. Loose soil is pushed up covering the berm and can potentially overtop the wattles. There is no tertiary containment along the down gradient parameters of the location. Connection between the wattles were not properly overlapped.

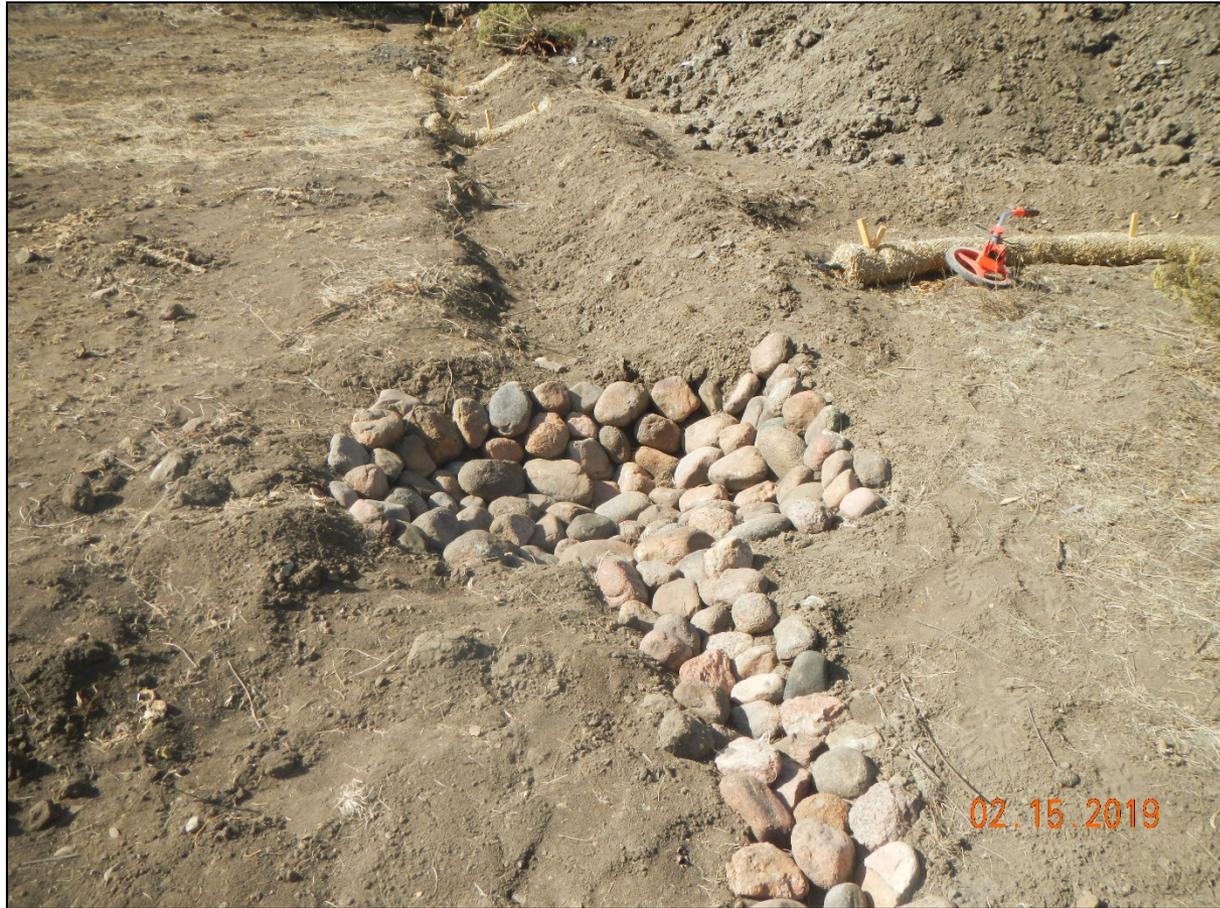
Photo 12. Sediment trap at the southeast corner of the location is drastically undersized to handle runoff. Dimensions are 5'L x 4'W x 2'depth.

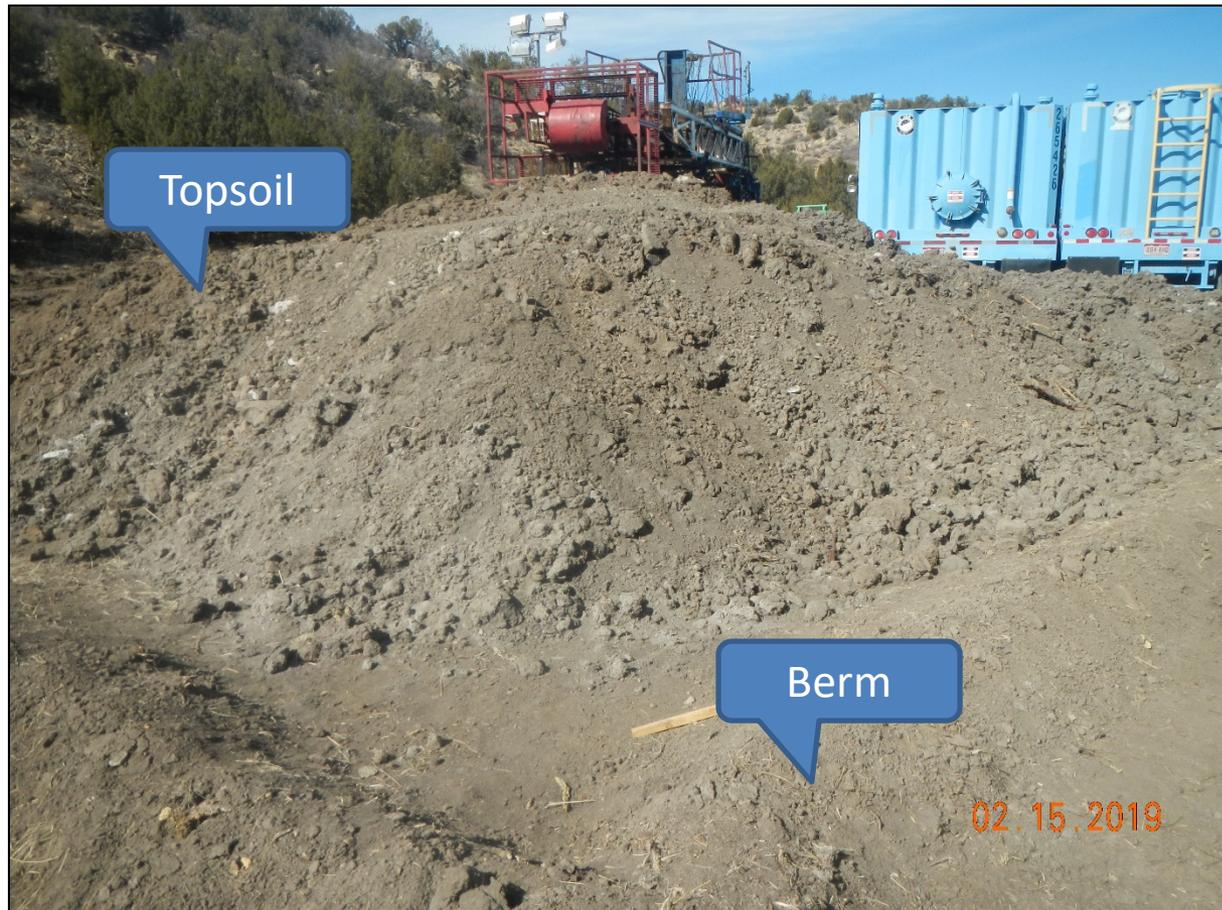
Photo 13. Topsoil pile in the southeast corner of the location.
Approximate Dimensions: $10\text{yd} \times 10\text{yd} \times 1.5\text{yd} = 150\text{cyd}$.

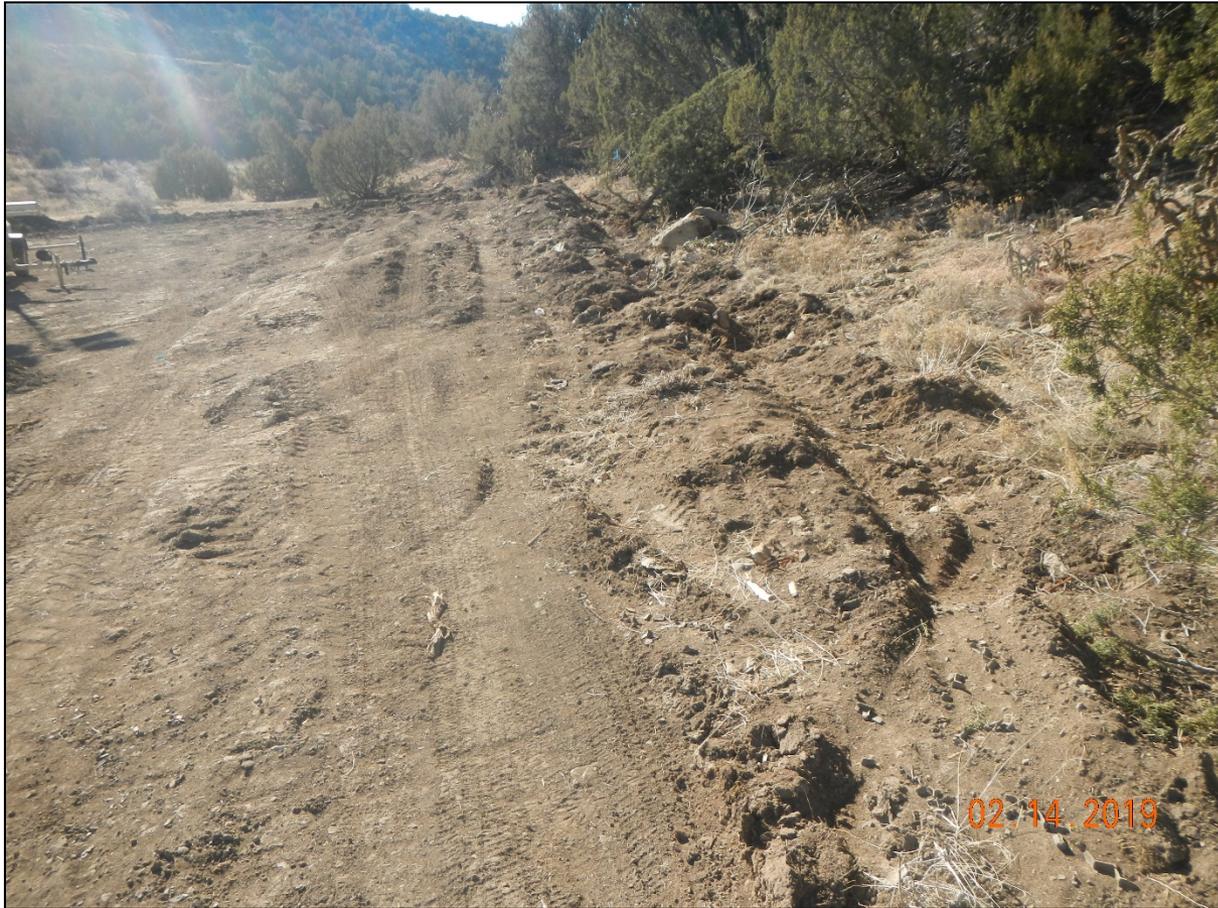
Photo 14. The ditch along the west side of the location is not properly installed. The gradient of the ditch will drain water toward this low area allowing stormwater to flow onto the pad. Ditch is not properly excavated in this area.

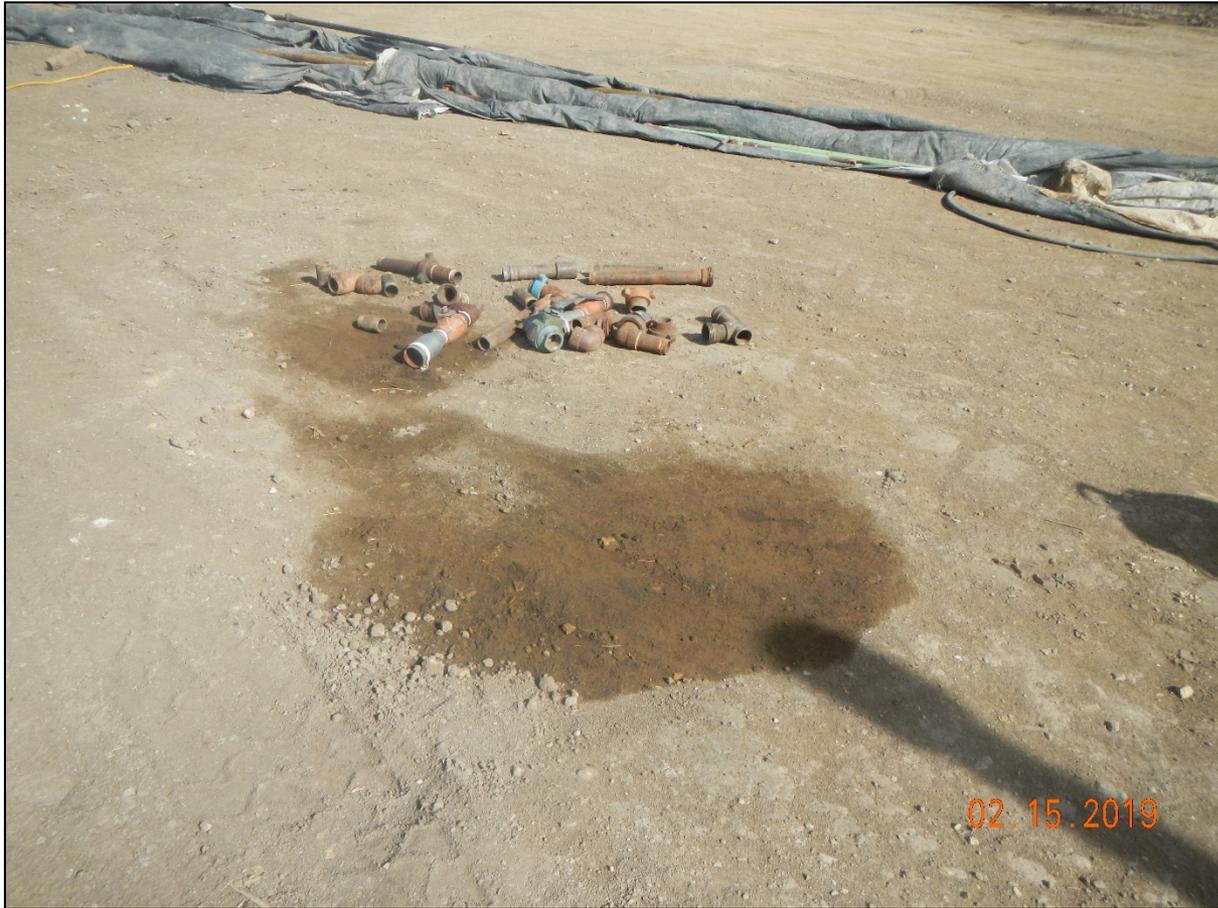
Photo 15. Oil stained soil was found near the wellhead approximately 3'x3' area. Various pipe fittings are left in this area.

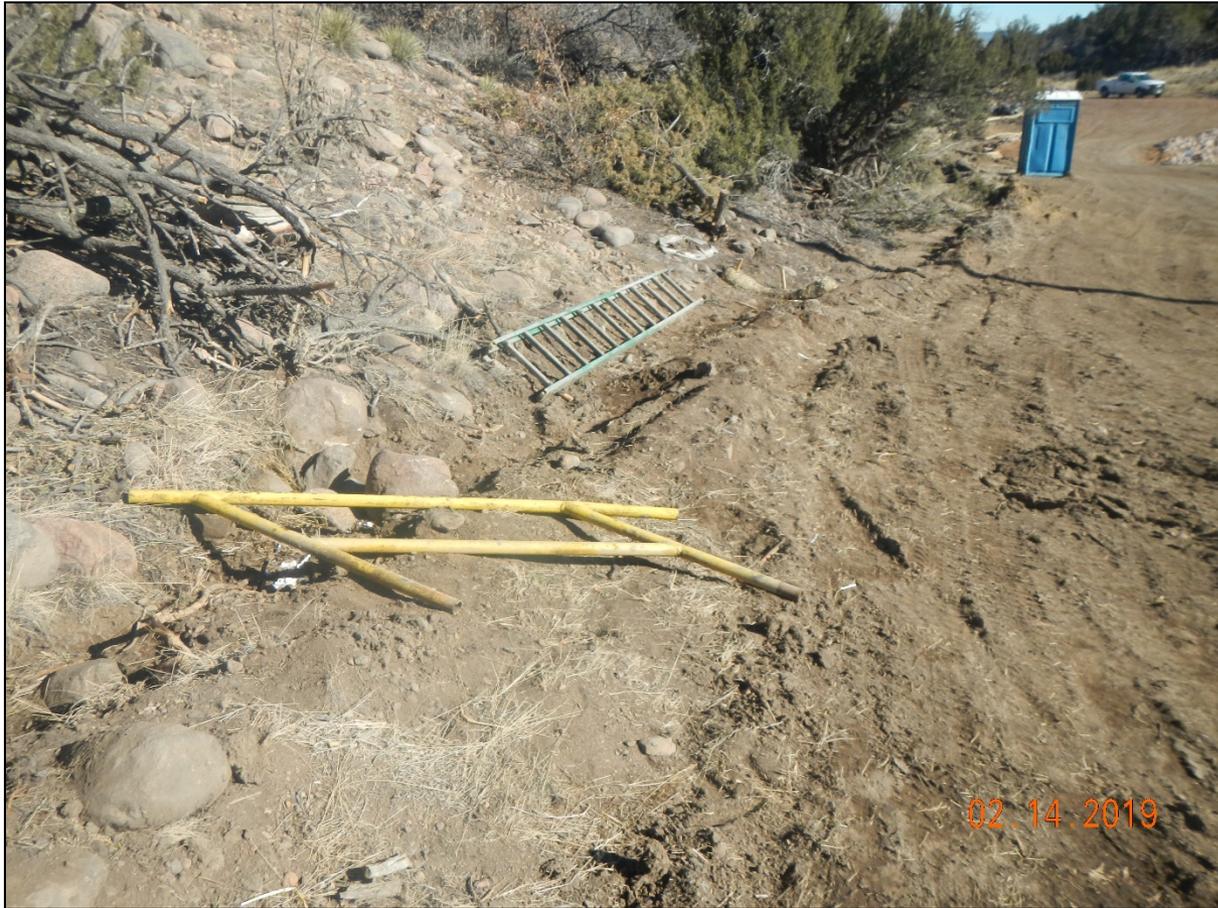
Photo 16. Various equipment debris lay's along the stormwater ditch. The ditch is not properly excavated in this area.

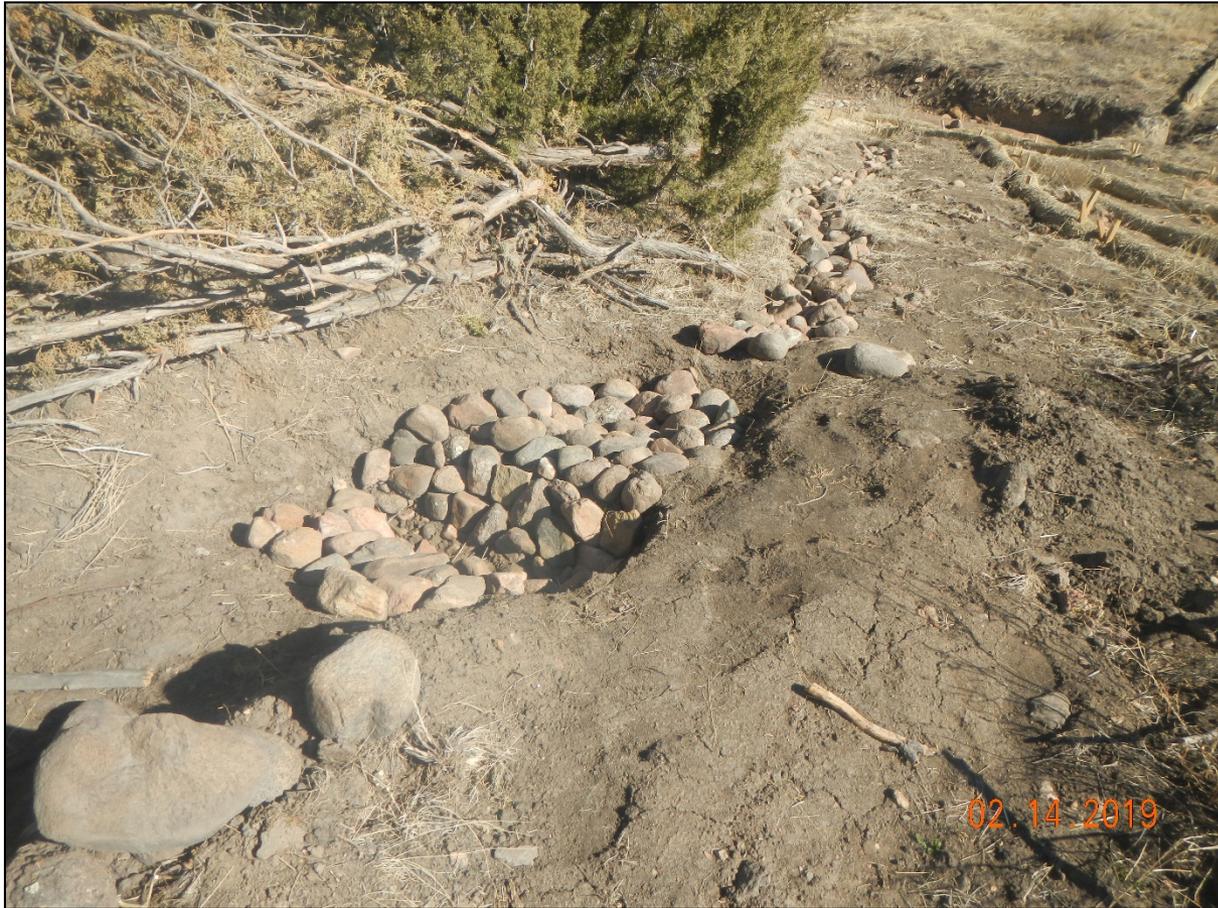
Photo 17. Sediment trap at the north side of the location is drastically undersized to handle runoff. Dimensions are 4'L x 3'W x 2'depth.

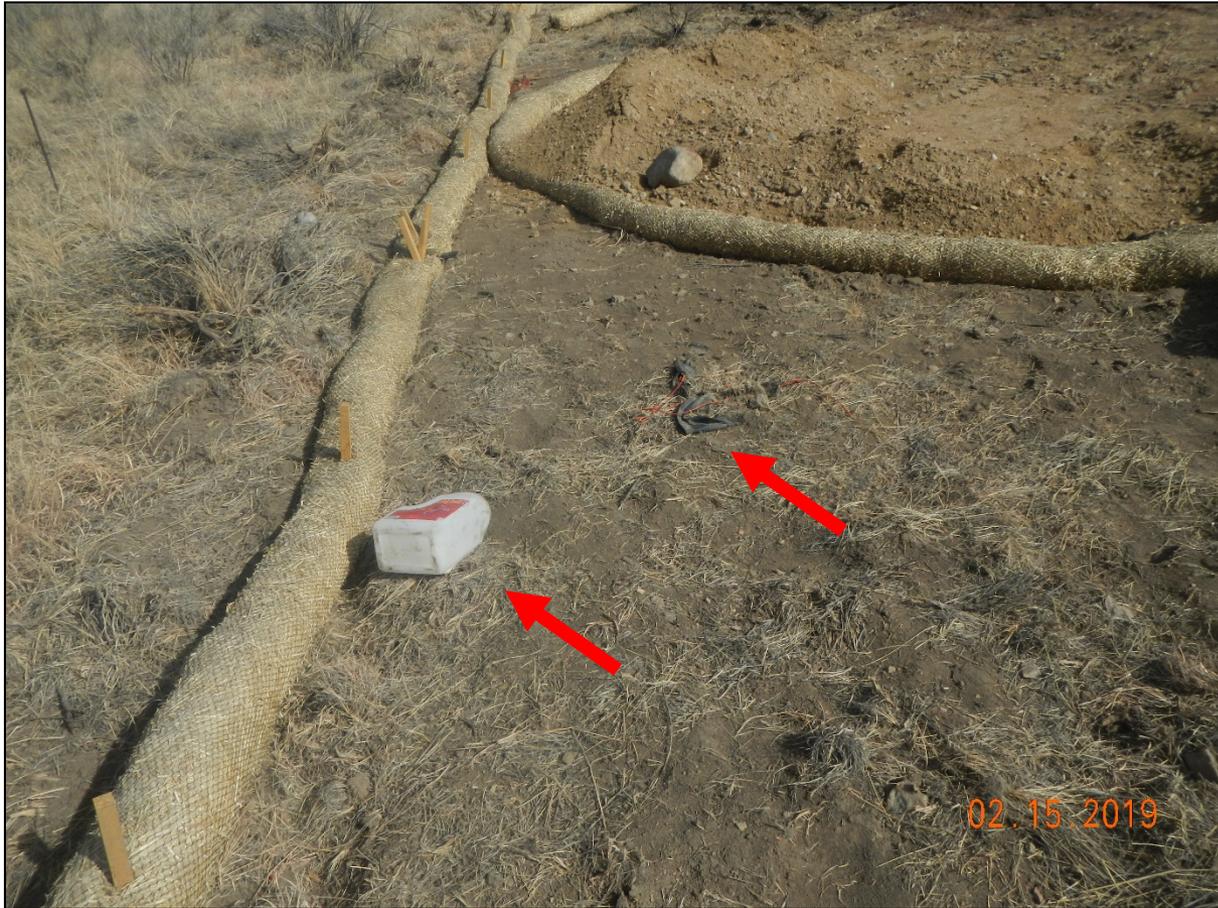
Photo 18. Various trash debris was noticed around the location.
