**Inspection Photo (s)**  
**Clough RMV 26-21**  
**API # 05-045-06976**  
**Inspection # 689303285**

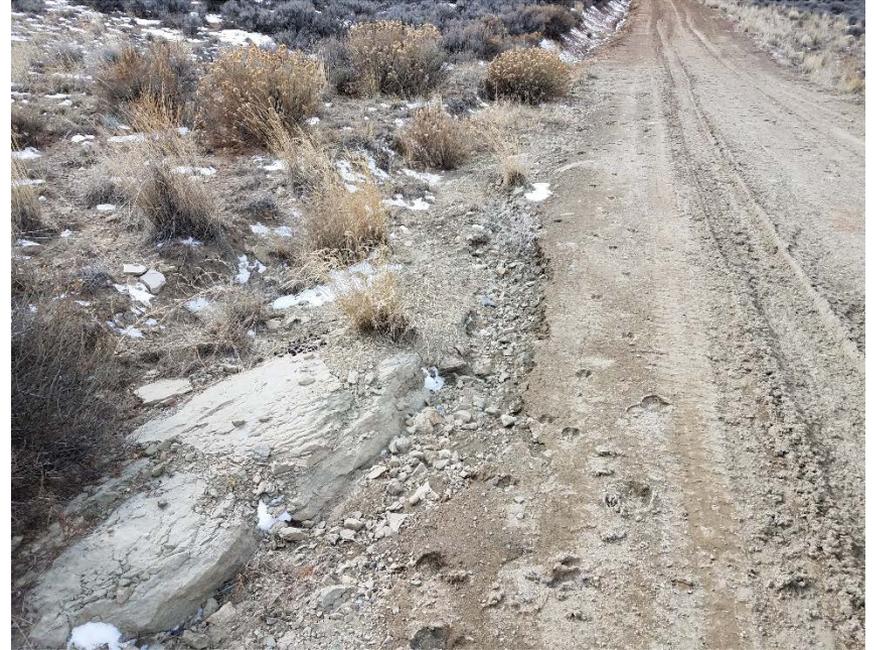
**Location Photo #2, Rilling occurring along access road.**

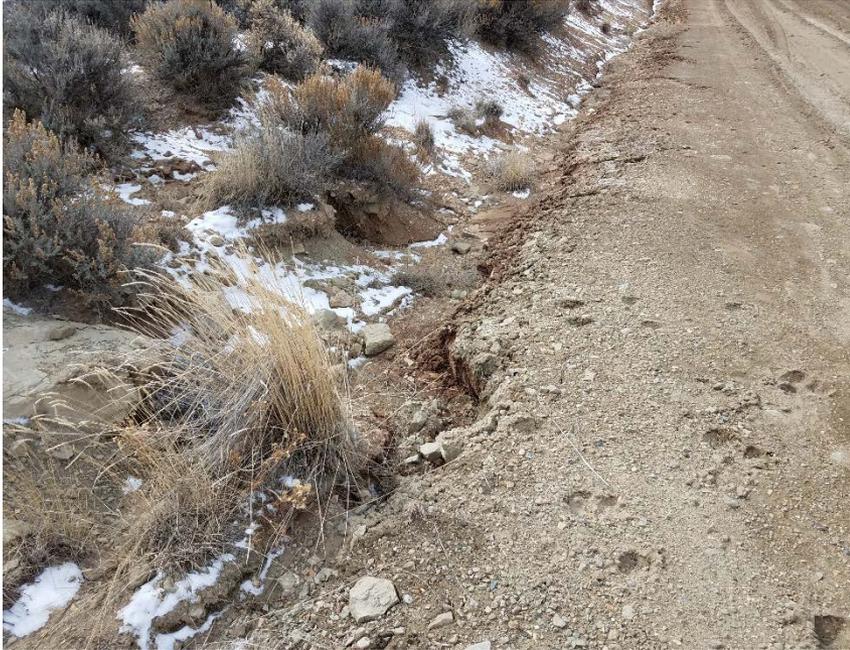
**Location Photo #3, Rilling occurring along access road.**

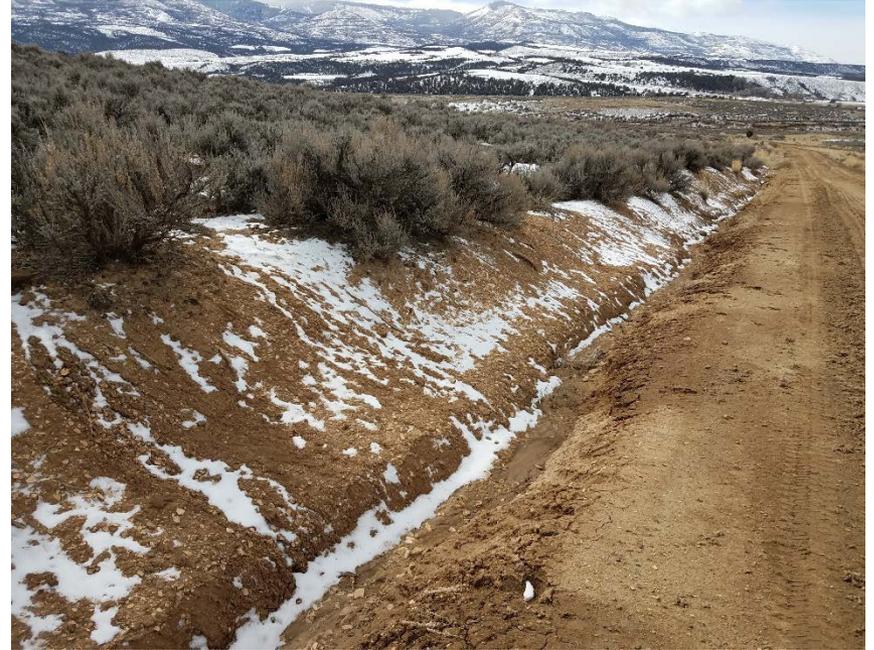
**Location Photo #4, Rilling occurring along access road.**

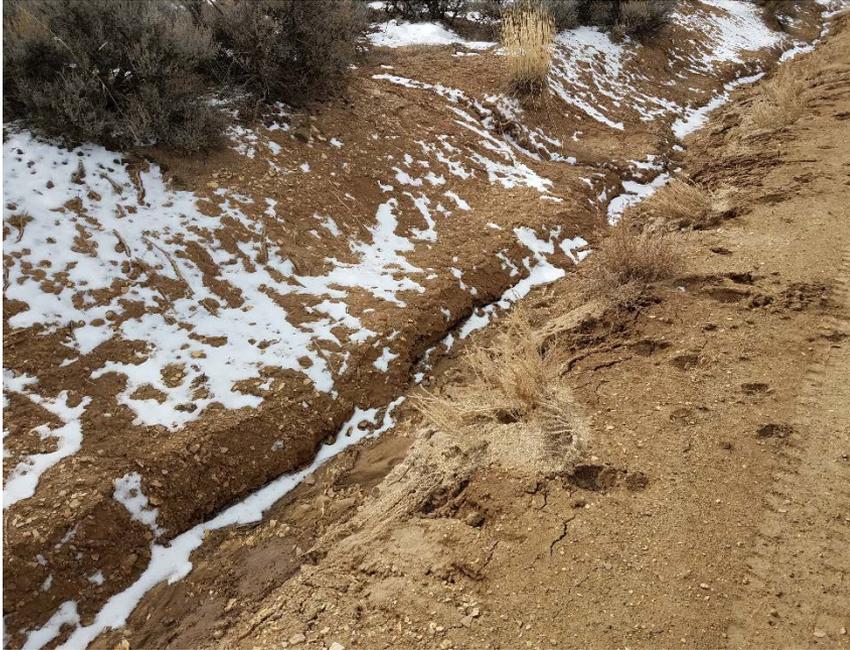
**Location Photo #5, Rilling occurring along access road.**

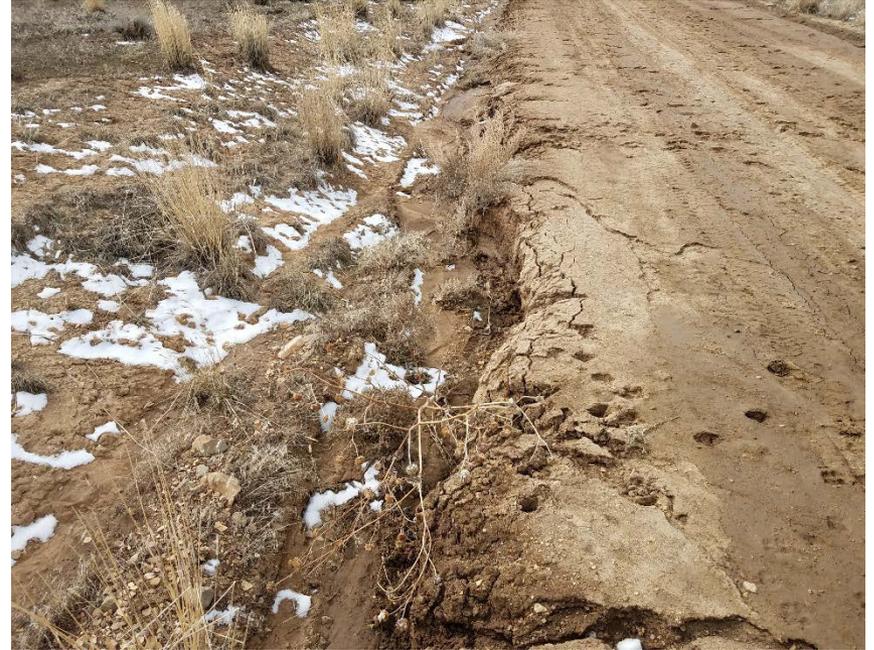
**Location Photo #6, Rilling occurring along access road.**

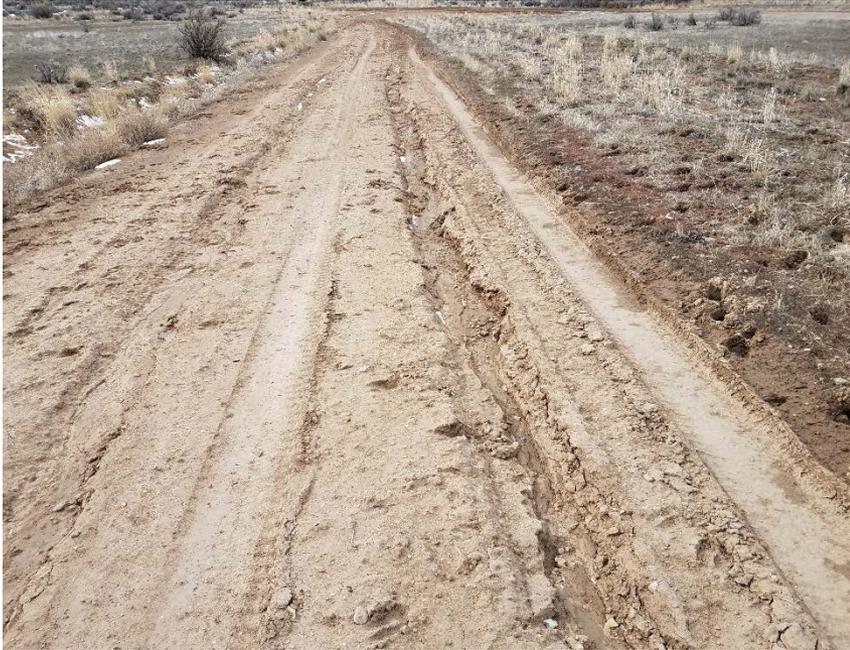
**Location Photo #7, Rilling occurring along access road.**

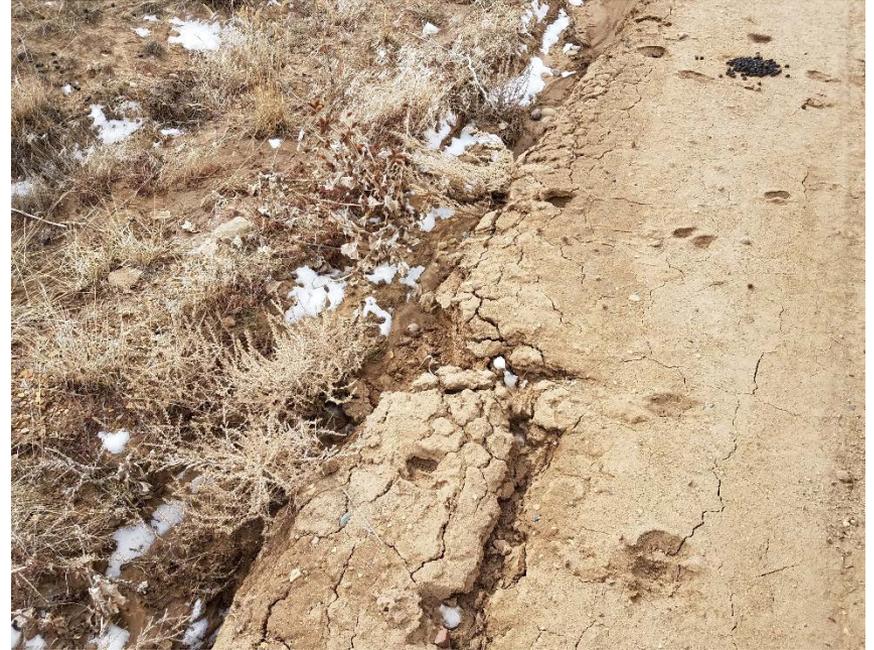
**Location Photo #8, Rilling occurring along access road.**

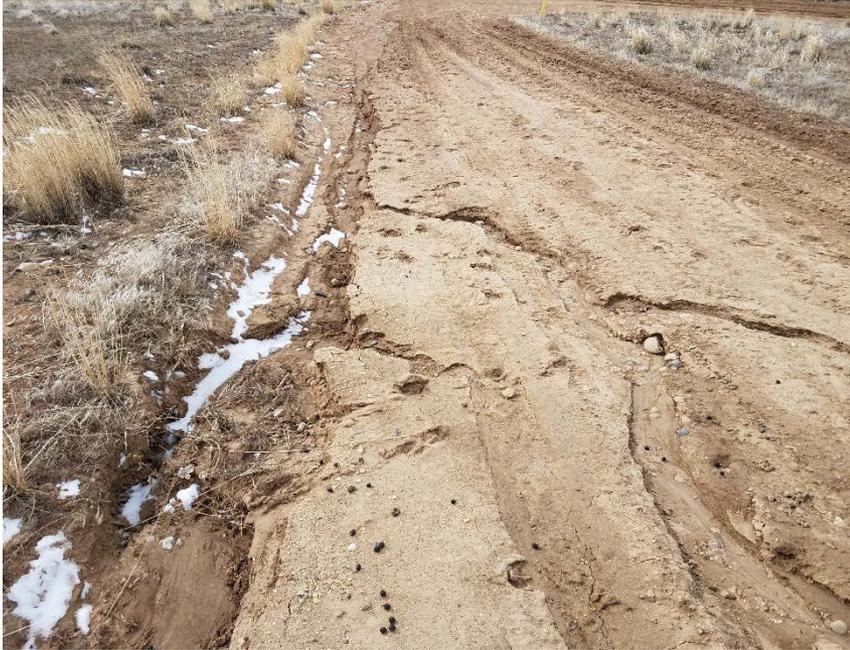
**Location Photo #9, Rilling occurring along access road.**

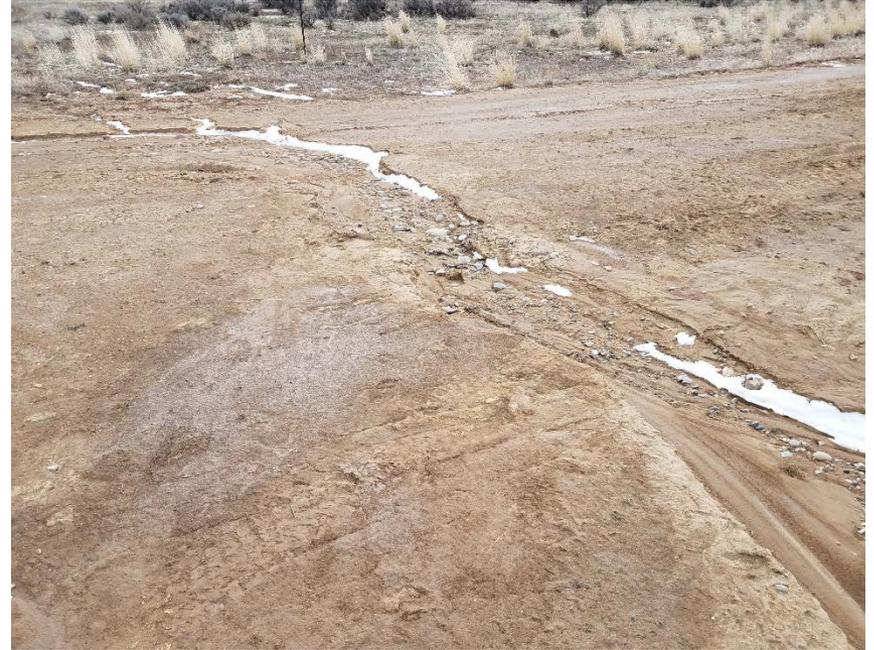
**Location Photo #10, Sediment being moved across road.**

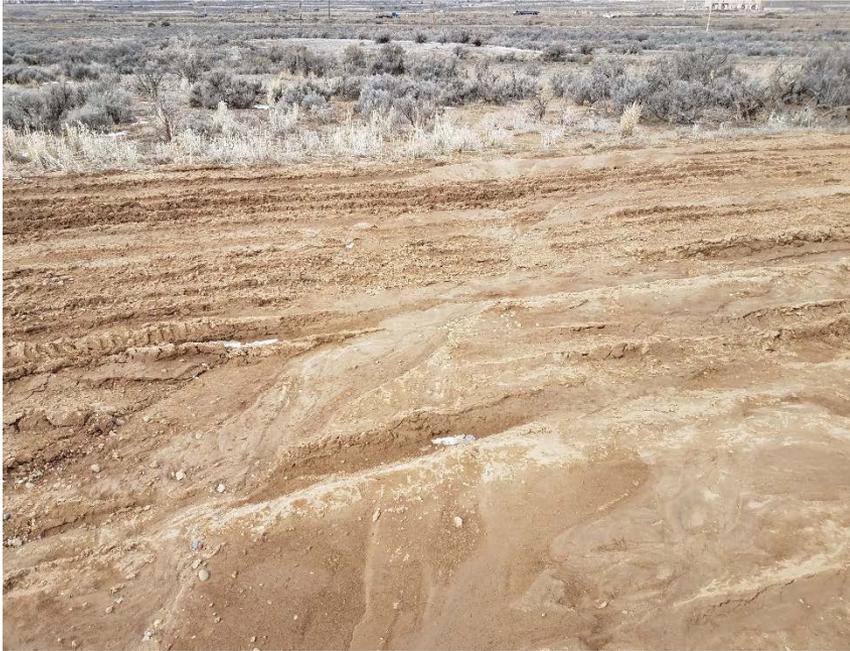
**Location Photo #11, Sediment being moved across road.**

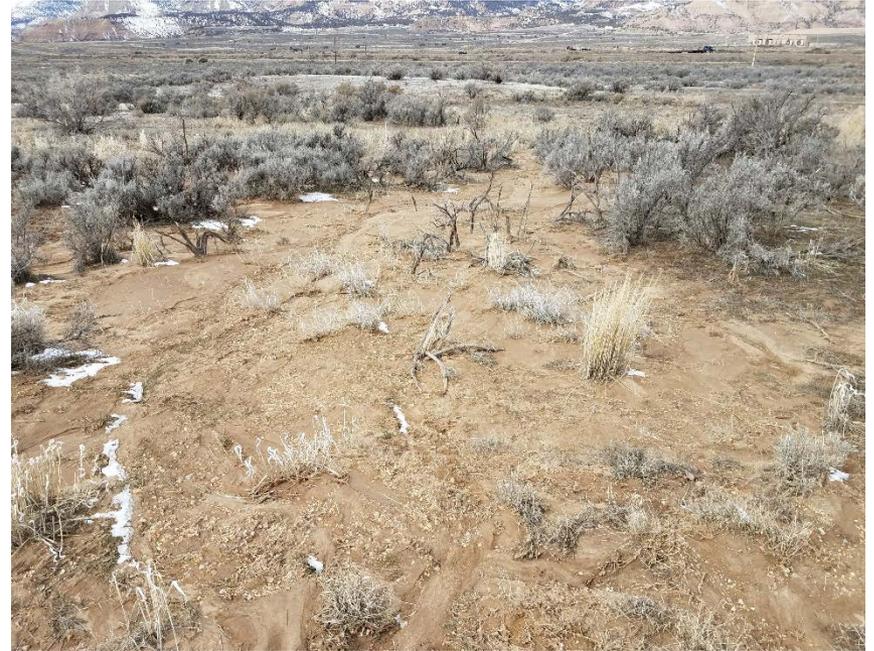
**Location Photo #12, Sediment is being carried into vegetation.**
