Inspection Photo (s)
Clough 128
API # 05-045-06384
Inspection # 689303297

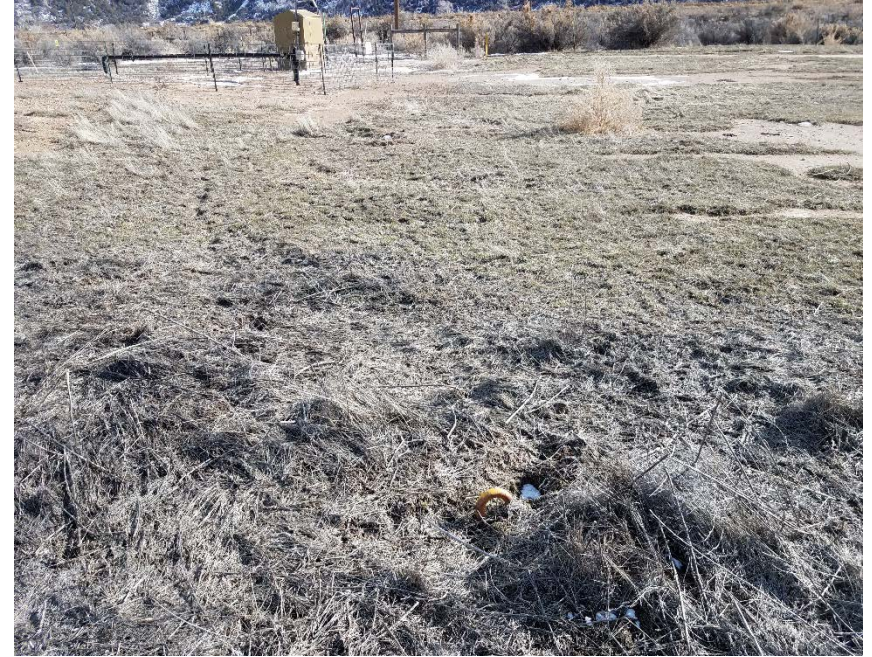
Location Photo #2, Unmarked dead man anchor.

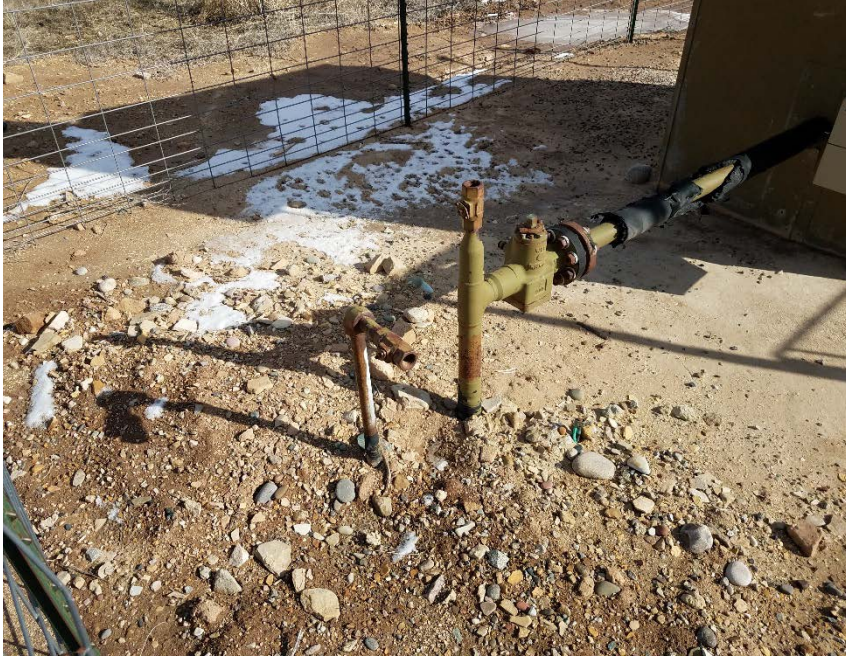
**Location Photo #3, Unmarked/unused flow
line riser.**
