Inspection Photos

Operator: NOBLE ENERGY INC - 100322

Location ID: 460414

Inspection Doc. Number: 682504514

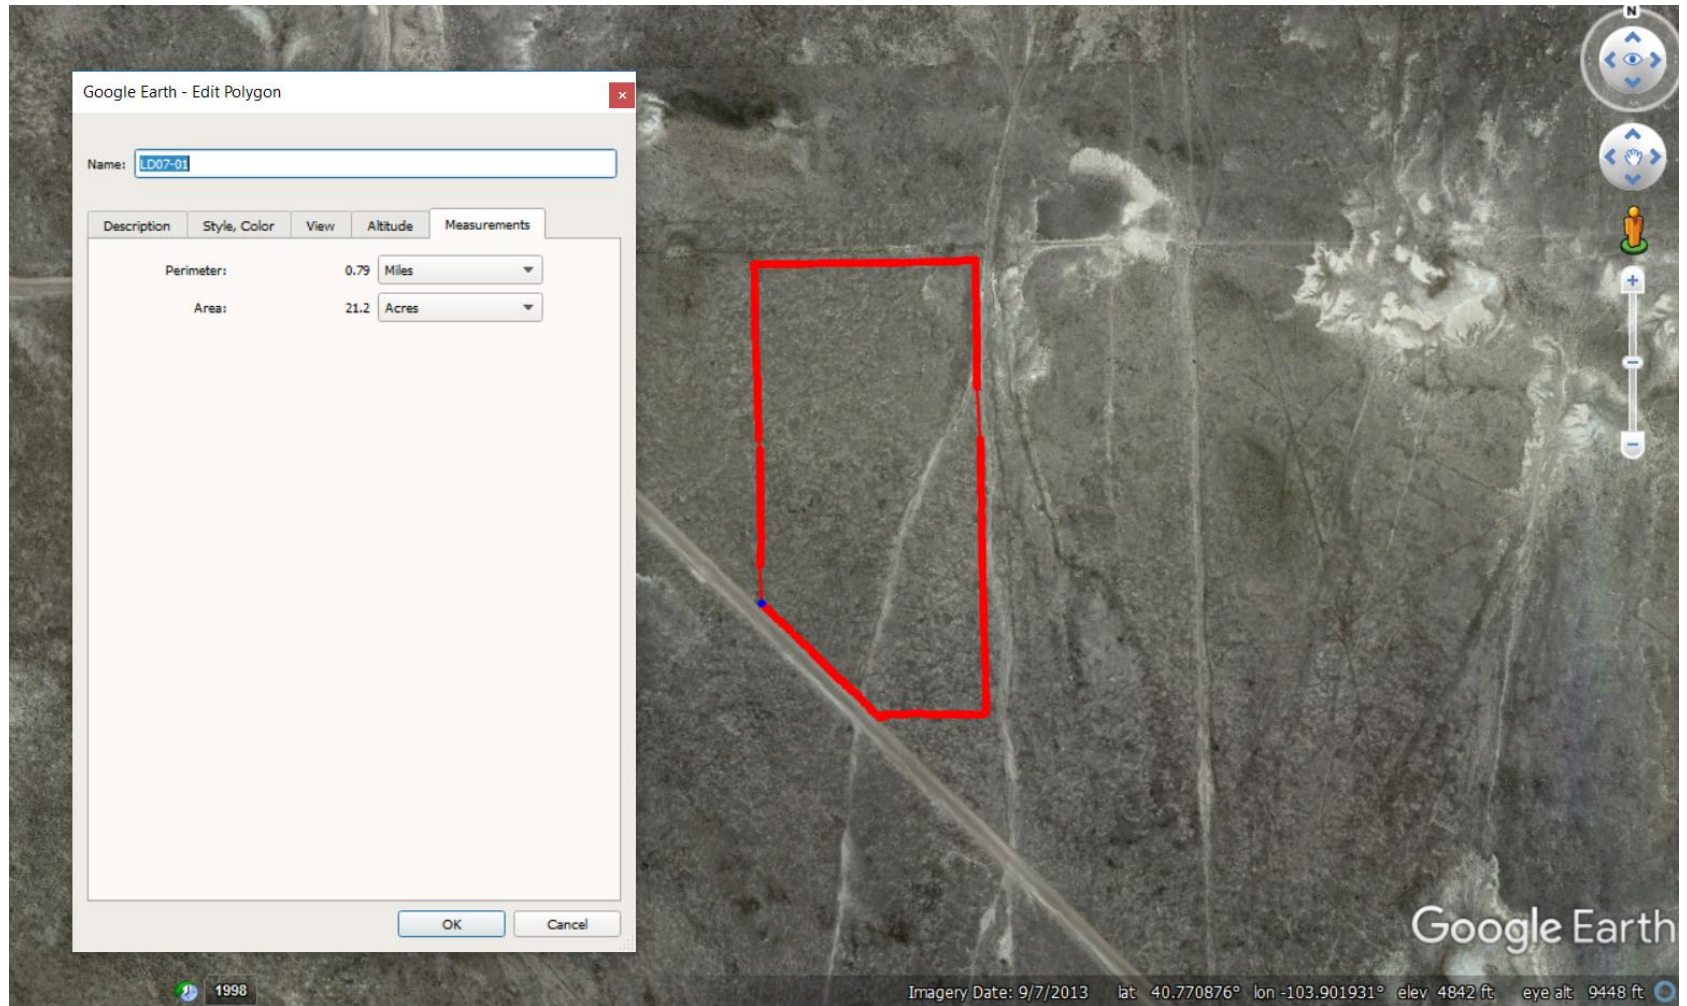
Photo 1: 2013 Google Earth aerial image. Photo shows location disturbance to be 21.2 acres (measured via handheld Trimble GPS unit).

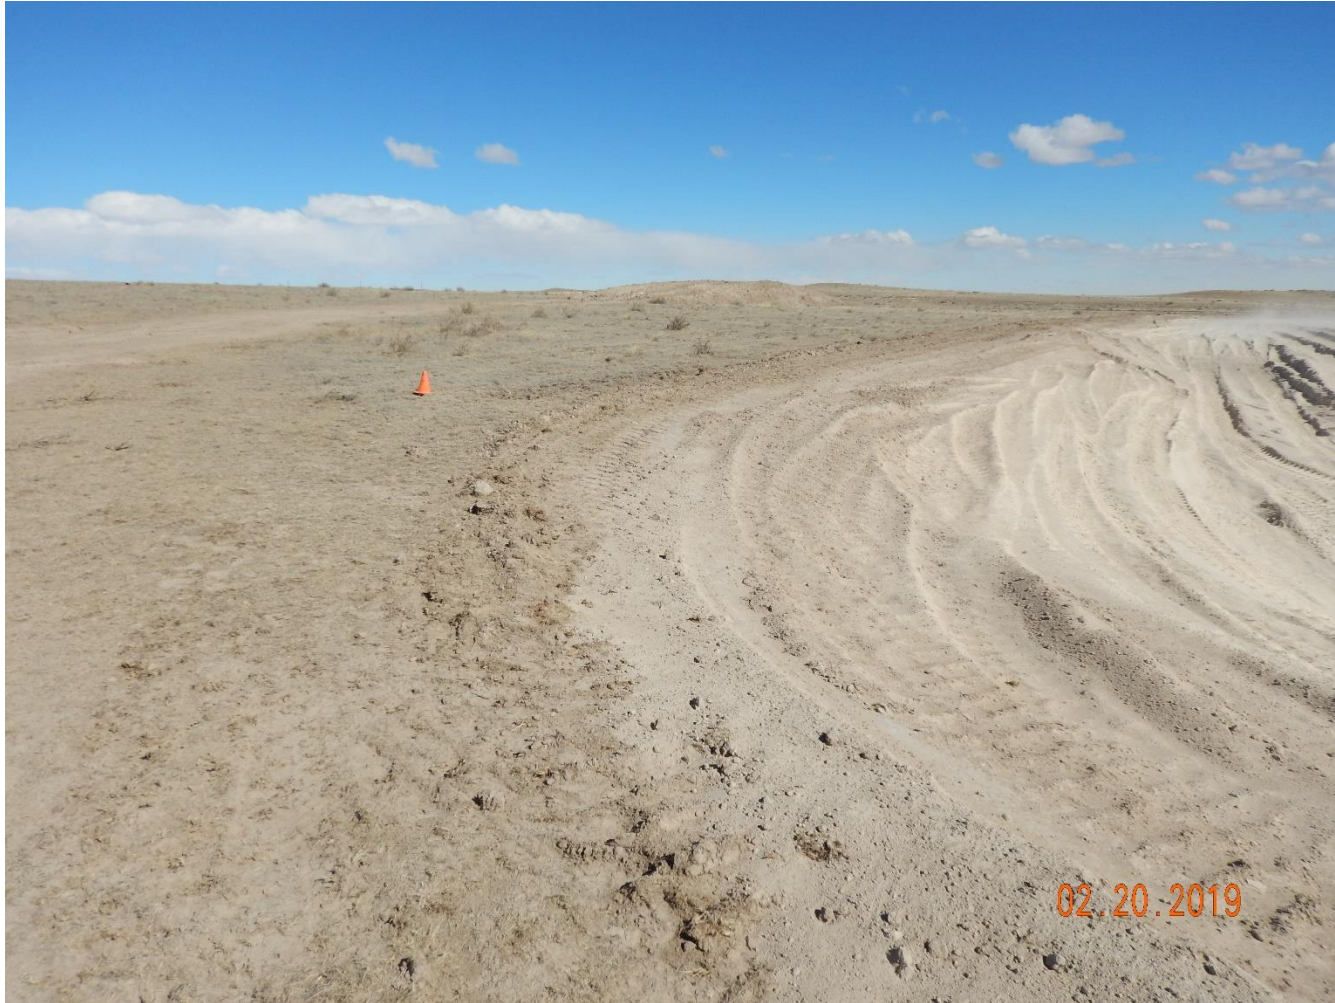
Photo 2: Photo taken from the west end of the location, facing northeast. Photos 2-4 provides an overview of the current disturbance area from northeast, east to south.

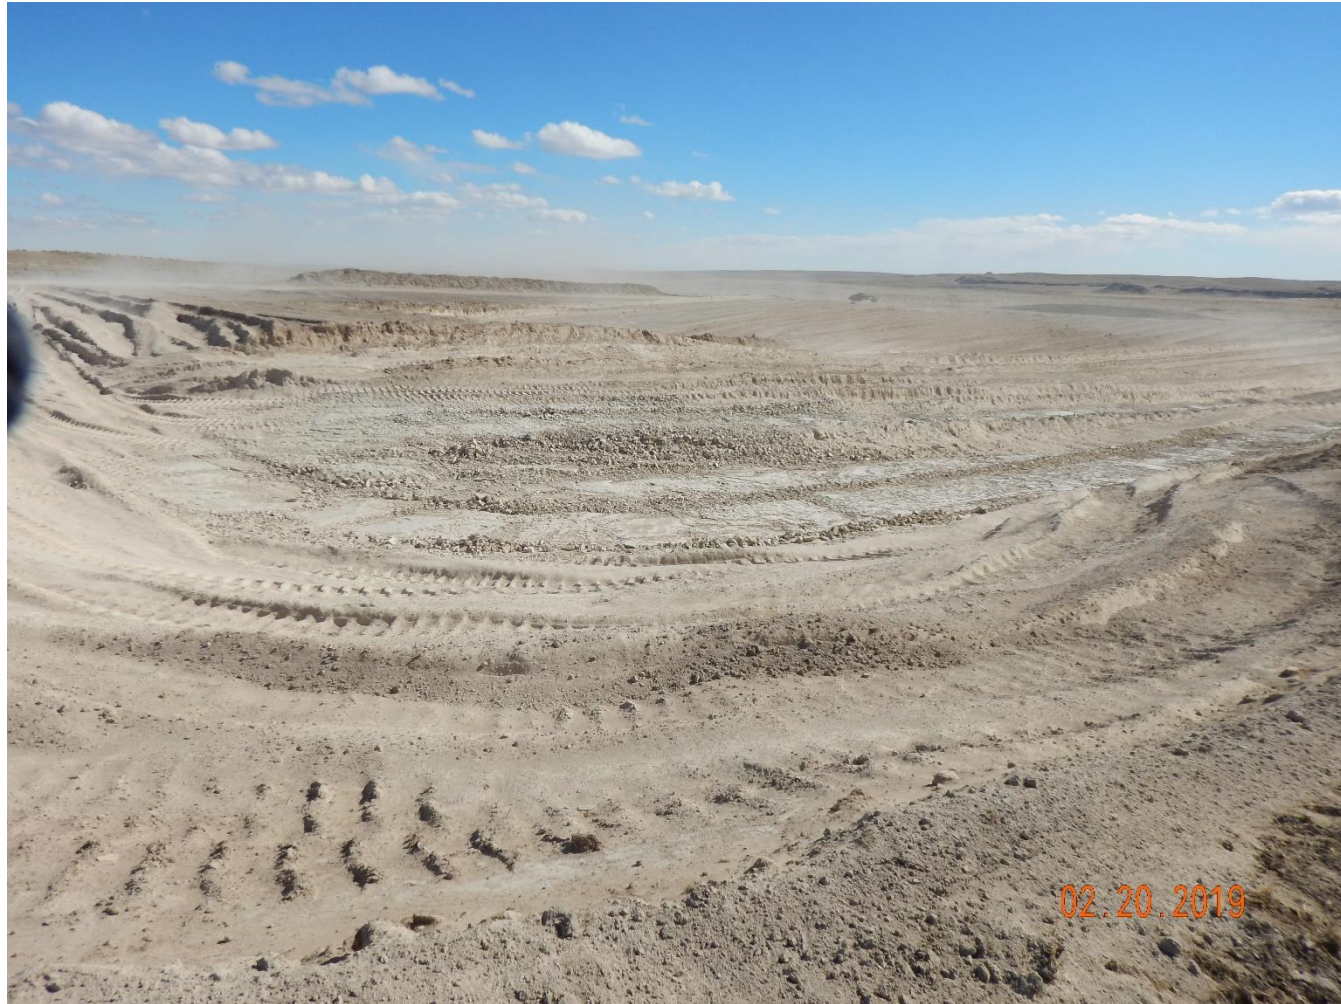
Photo 3: See comments under photo 2.

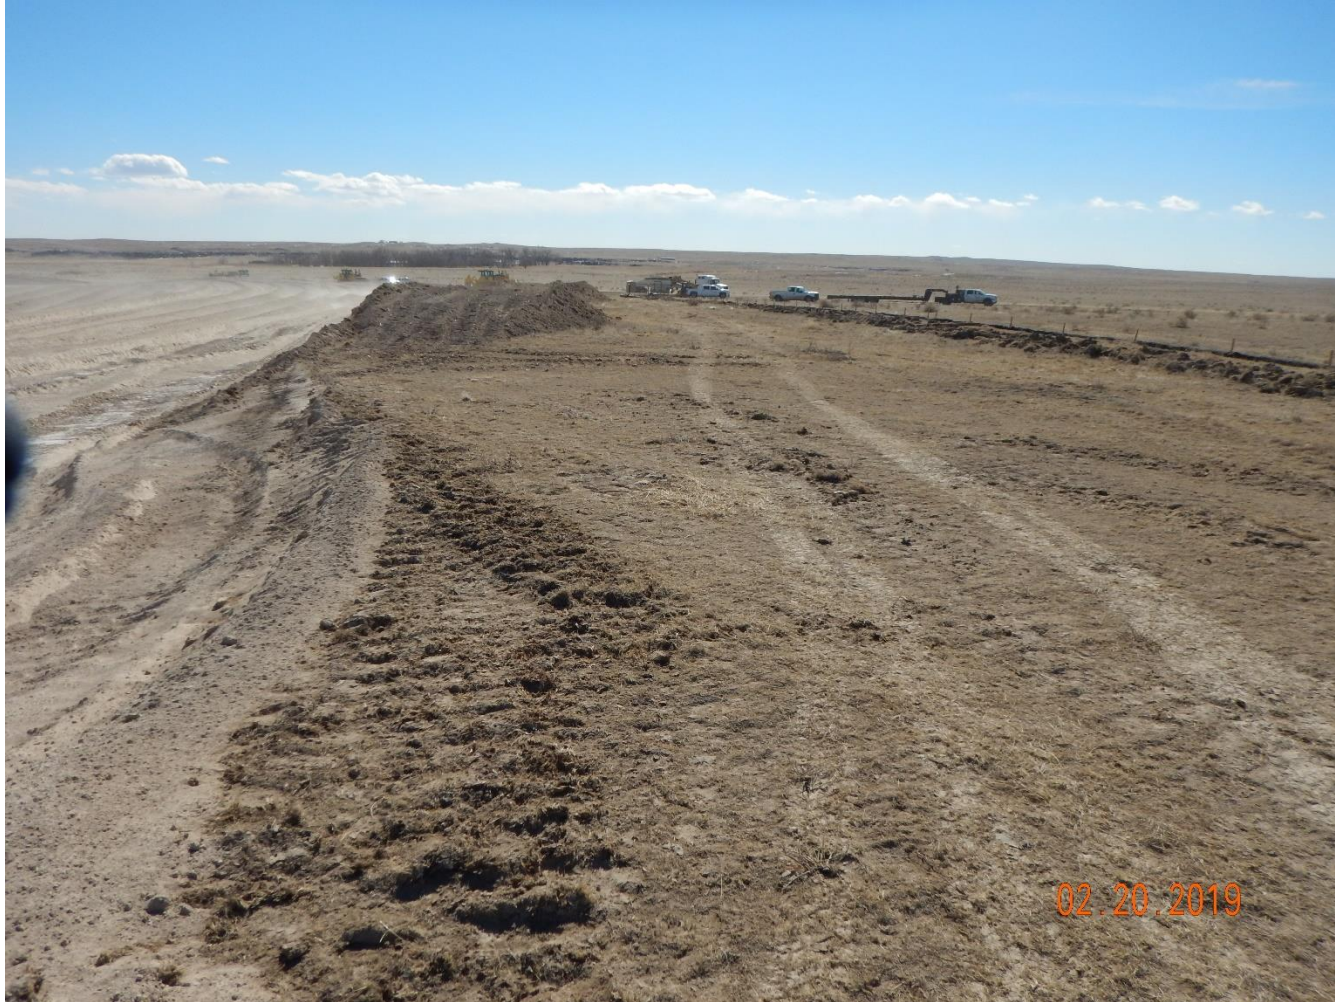
Photo 4: See comments under photo 2.

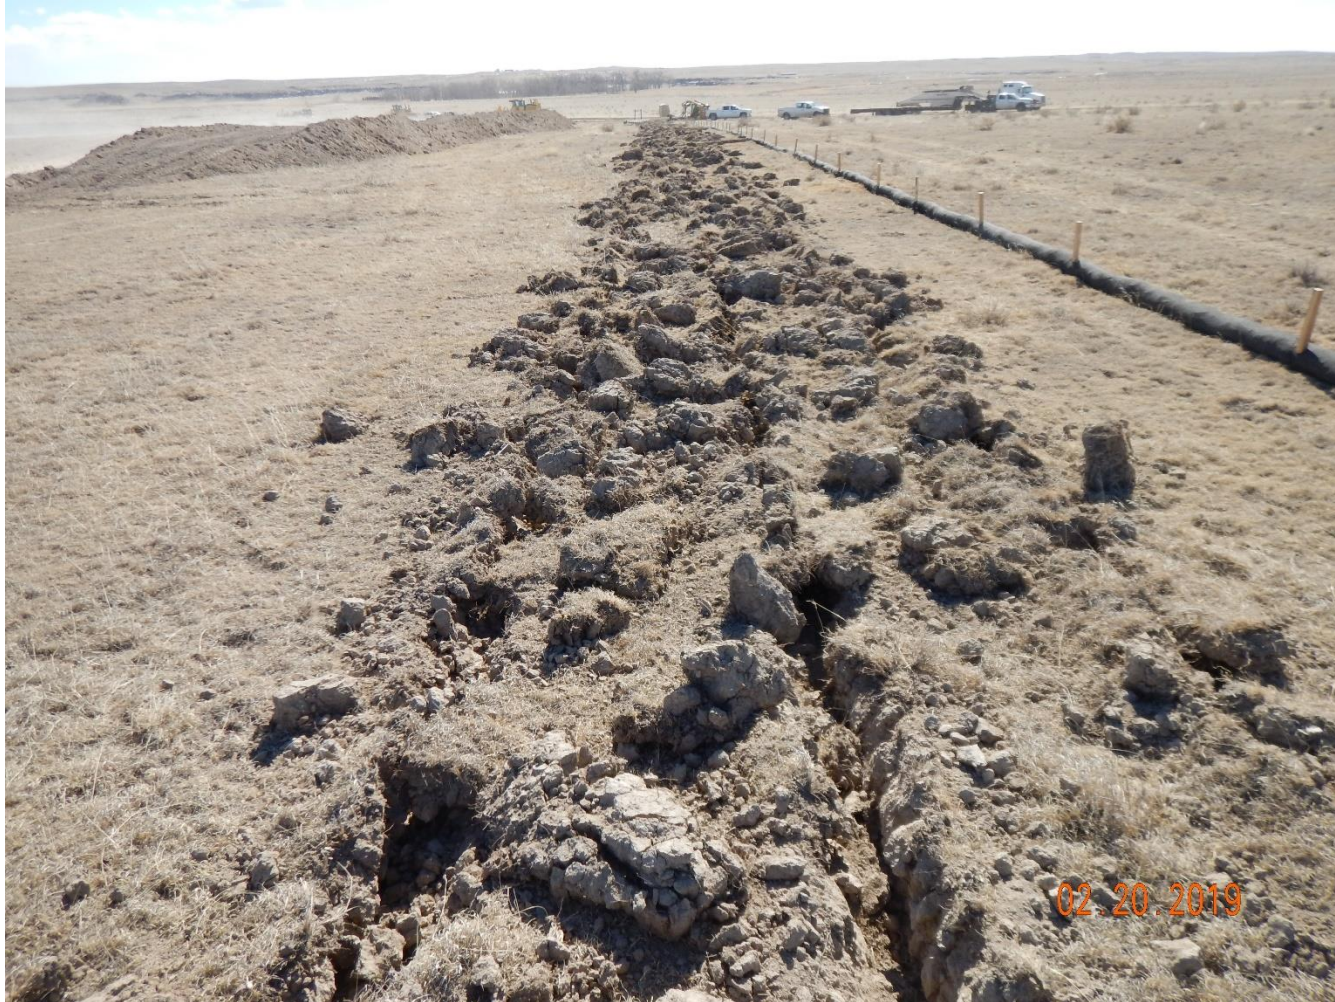
Photo 5: Photo taken from the west end of the location. Photo shows operator has implemented surface roughening as a perimeter stormwater BMP. Surface roughening is a temporary BMP that should be used in conjunction with other BMPs.

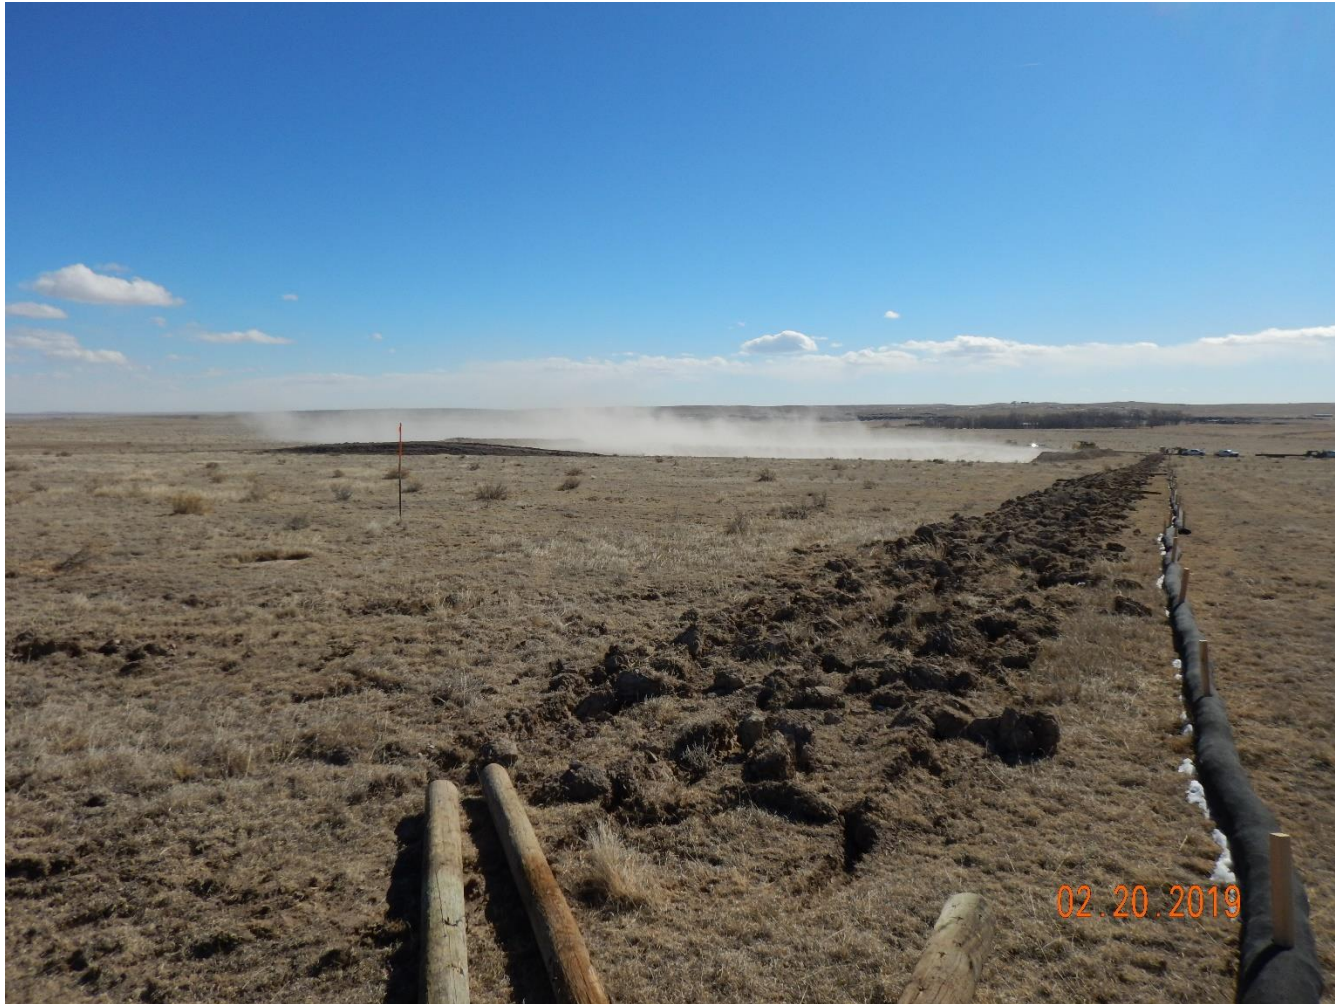
Photo 6: Photo taken from the northwestern area of the disturbance area, facing southeast. Photo shows ongoing wind erosion transporting sediment offsite. This does not comport with rule 1002.e and 1002.f

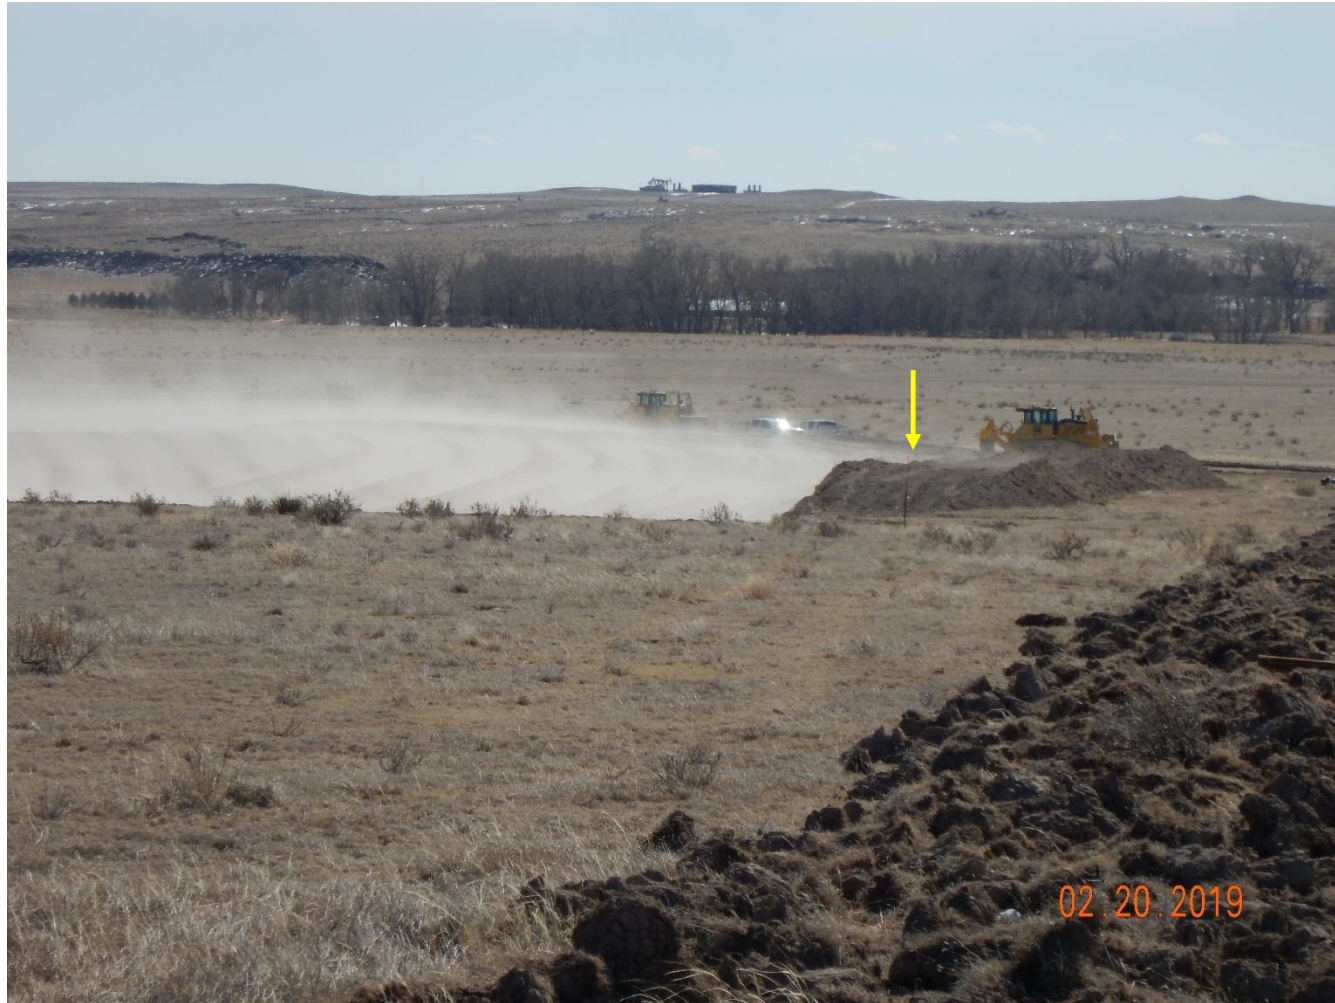
Photo 7: Photo taken from the west end of the location, facing south. Photo shows ongoing wind erosion transporting sediment offsite from an un-stabilized soil stockpile (arrow). This does not comport with rule 1002.e and 1002.f

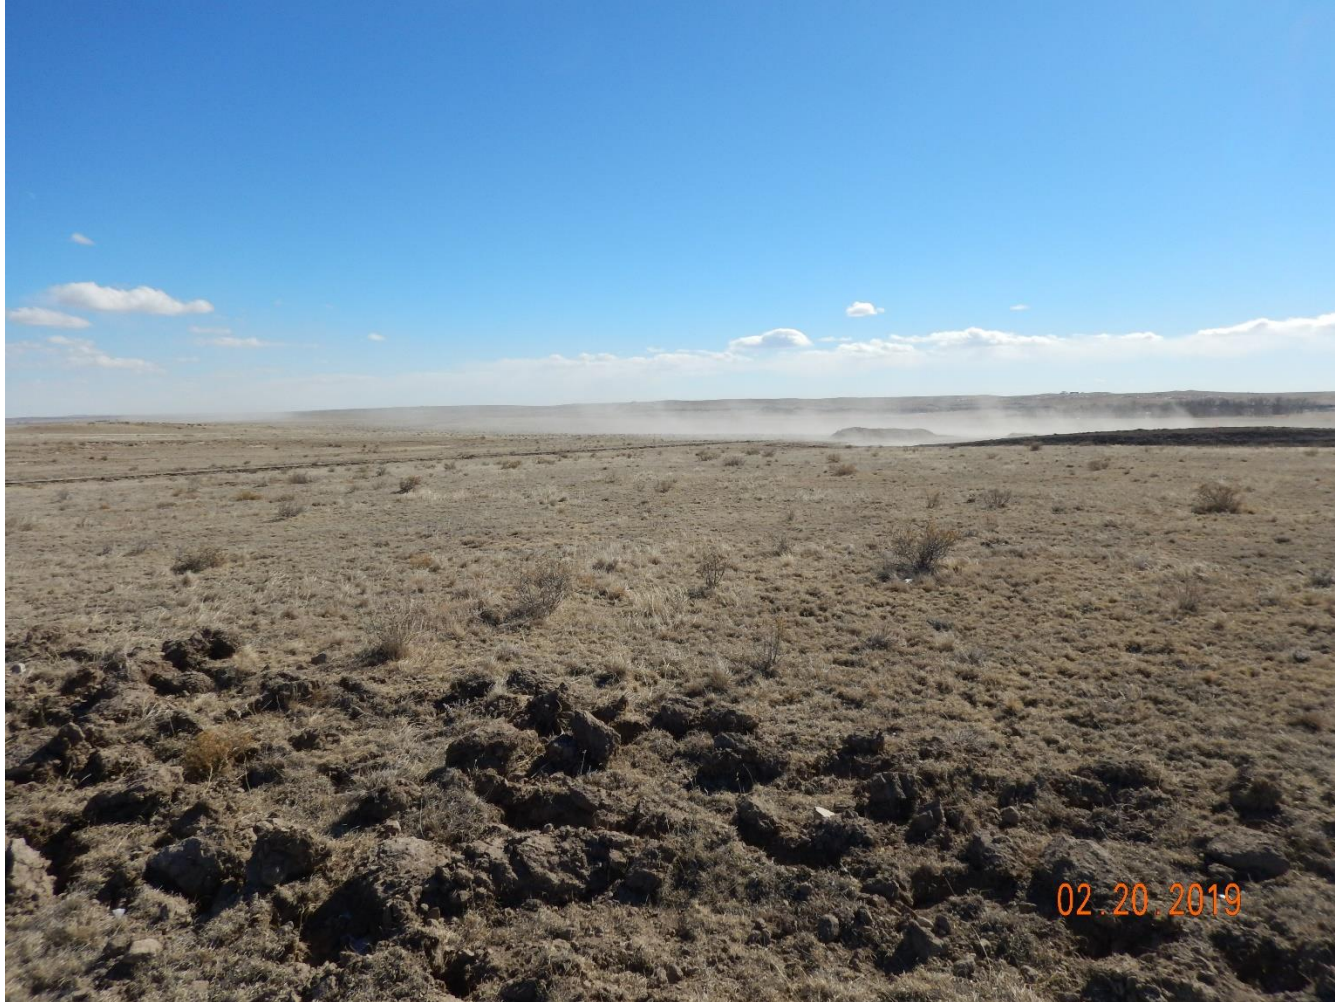
Photo 8: Photo taken from the north end of the disturbance area, facing southeast. Photo shows ongoing wind erosion transporting sediment offsite. This does not comport with rule 1002.e and 1002.f

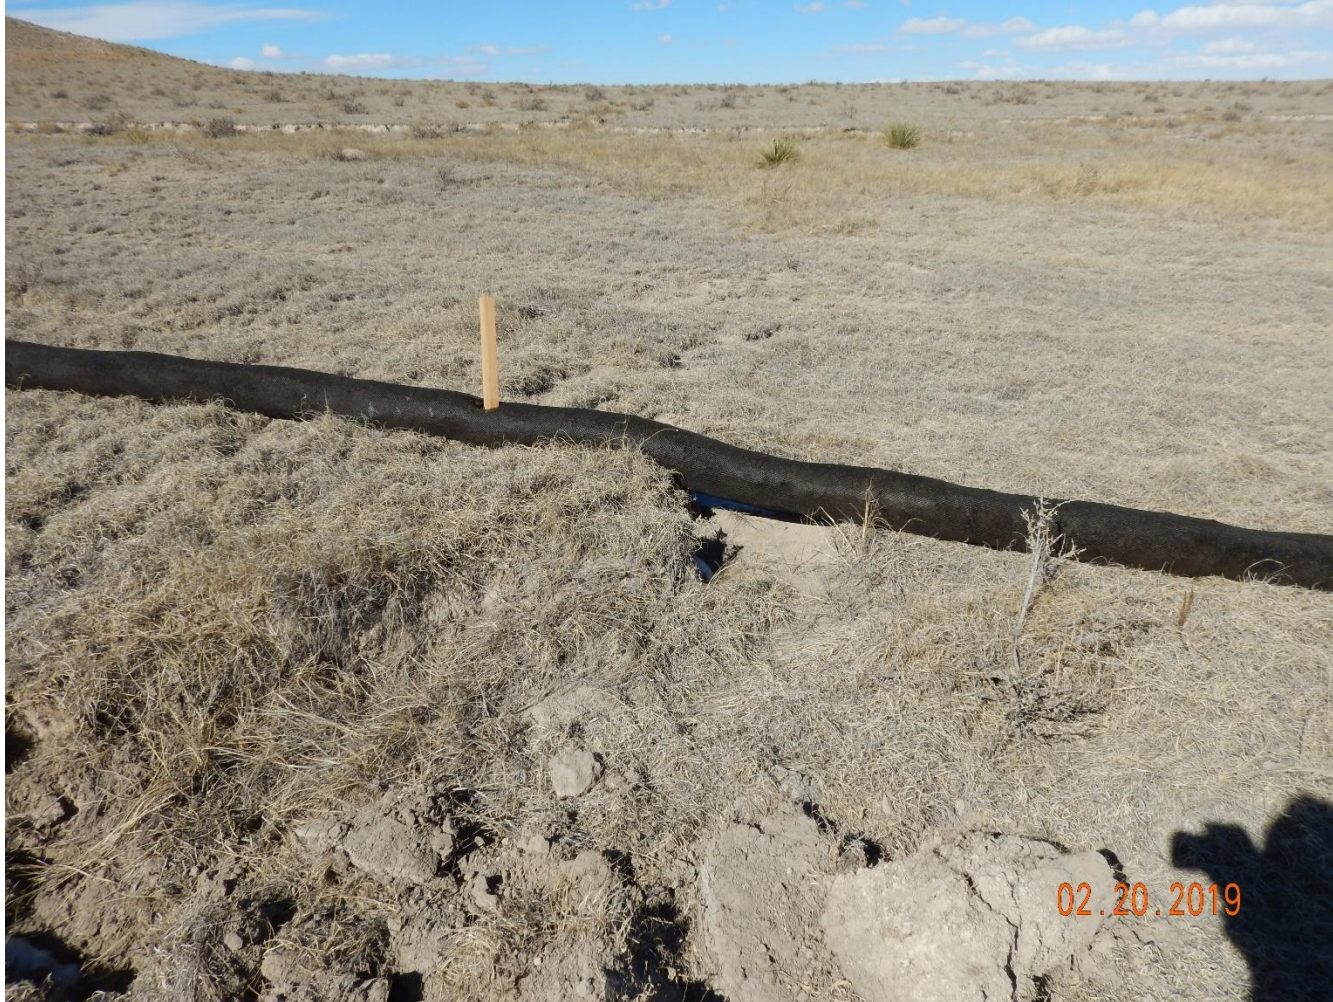
Photo 9: Photo taken from the north end of the location, facing north. Photo shows operator has implemented a “Filtrexx” perimeter control wattle BMP. Based on site conditions (topography), BMP does not appear to be sufficient; BMP does not achieve a 100% soil surface contact, or appear to have the weight to mitigate stormwater runoff and allow for stormwater ponding without trenching and backfilling. Photo shows one example of areas observed on location where BMP has not achieved sufficient soil surface contact.

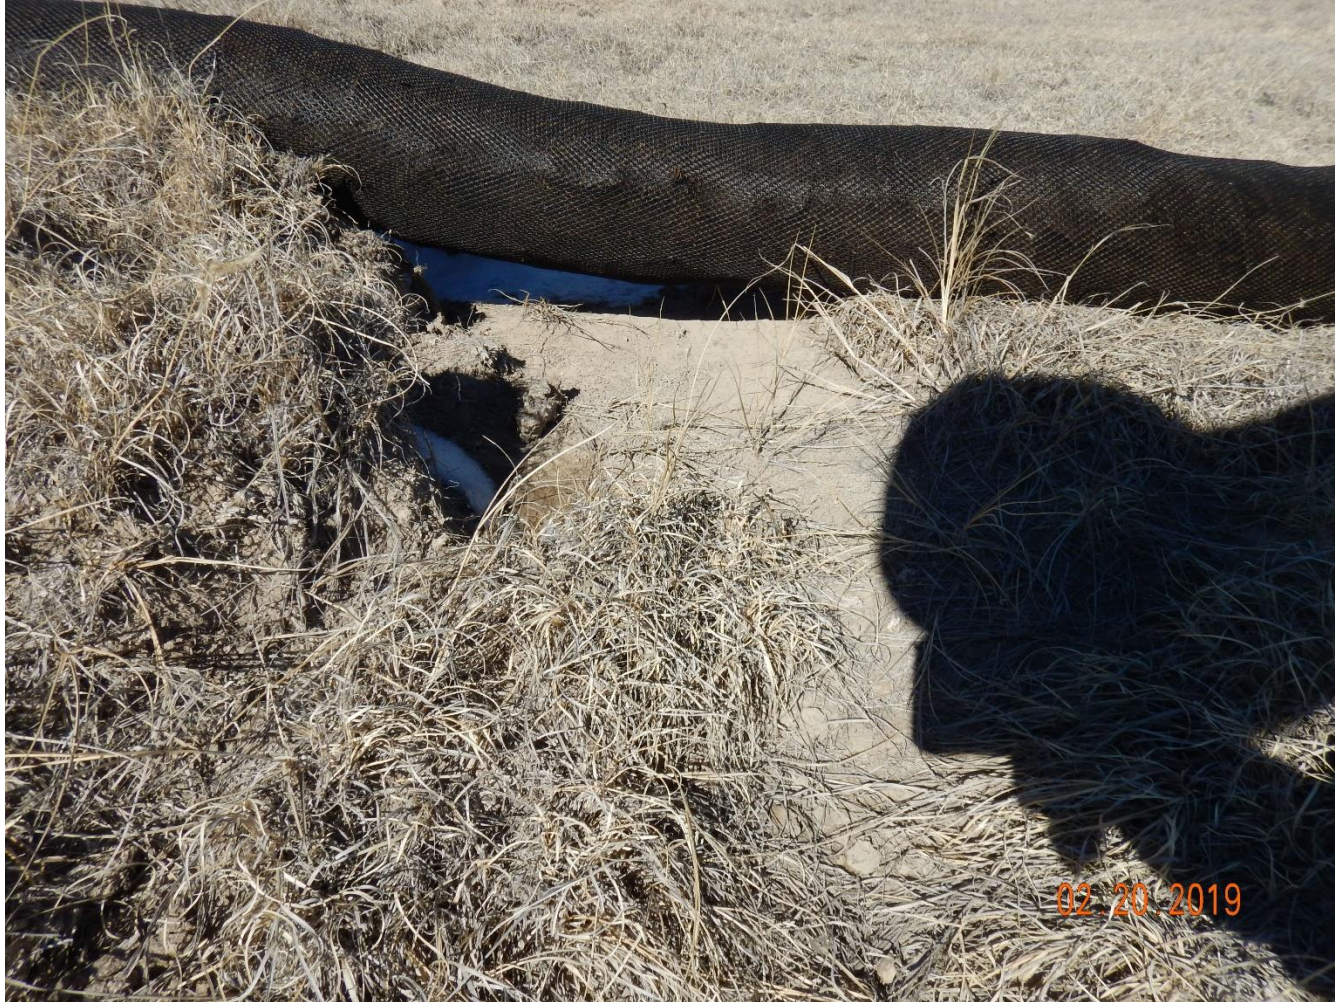
Photo 10: Continued from photo 9. See comments under photo 9.

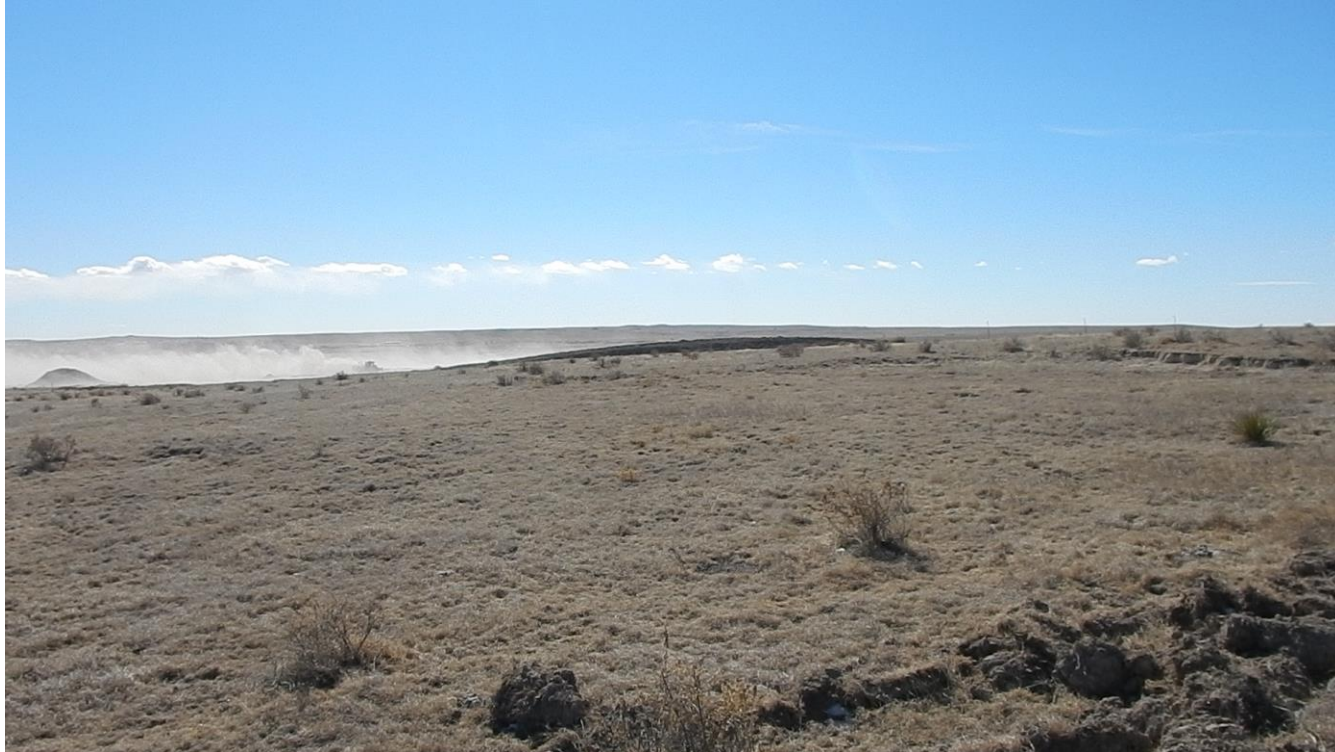
Photo 11: Photo taken from the northeast end of the disturbance area, facing southwest. Photo shows ongoing wind erosion transporting sediment offsite. This does not comport with rule 1002.e and 1002.f

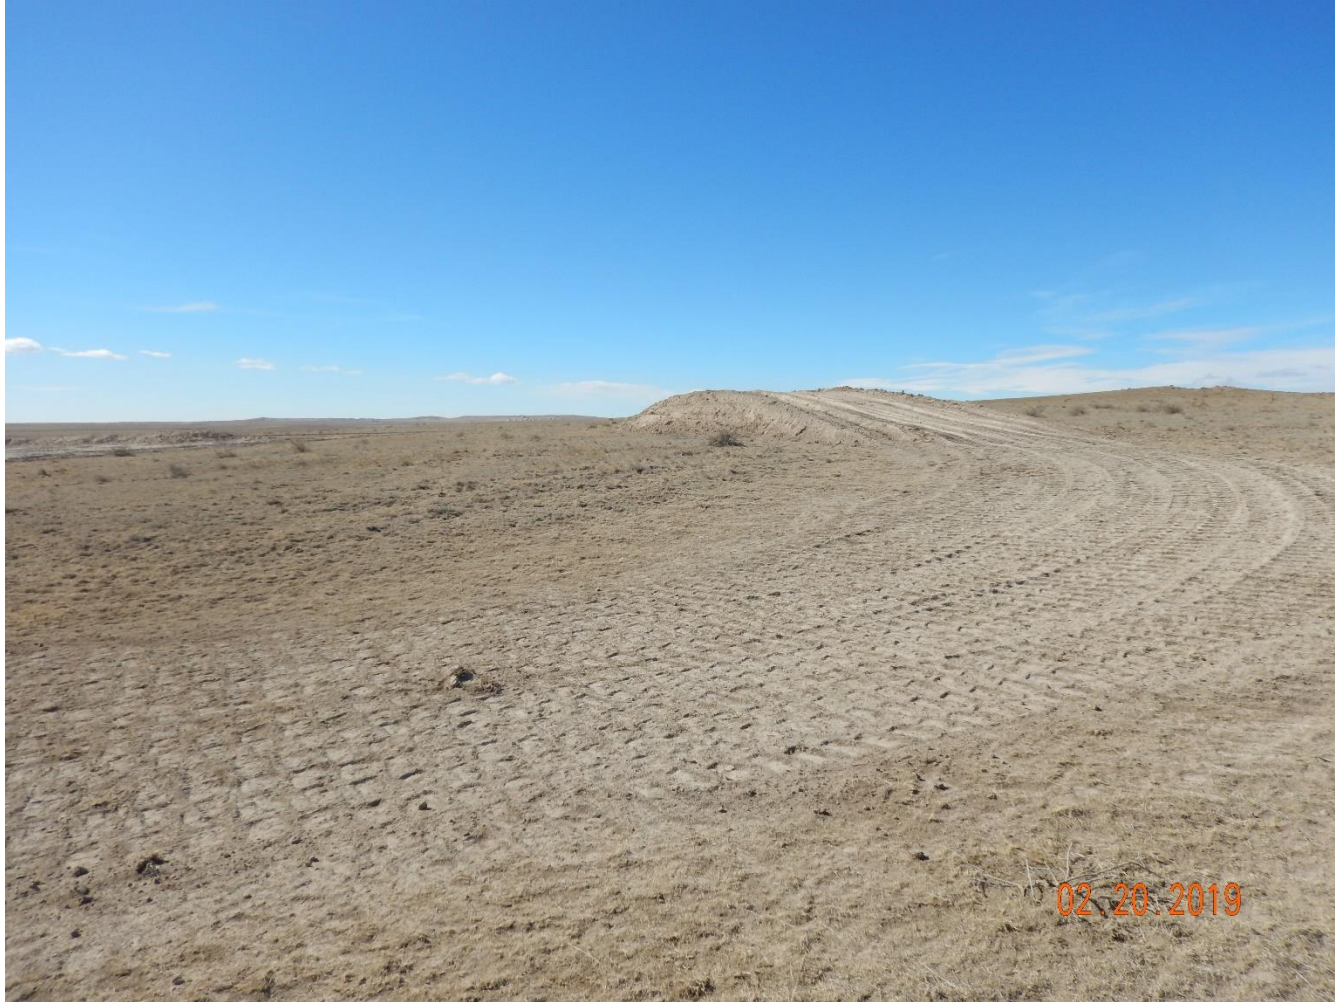
Photo 12: Photo taken from the east end of the location, facing west. Photo shows one of the soil stockpiles for the location. Soil stockpile has not been sufficiently stabilized, is currently loose material and at risk to erosion degradation.

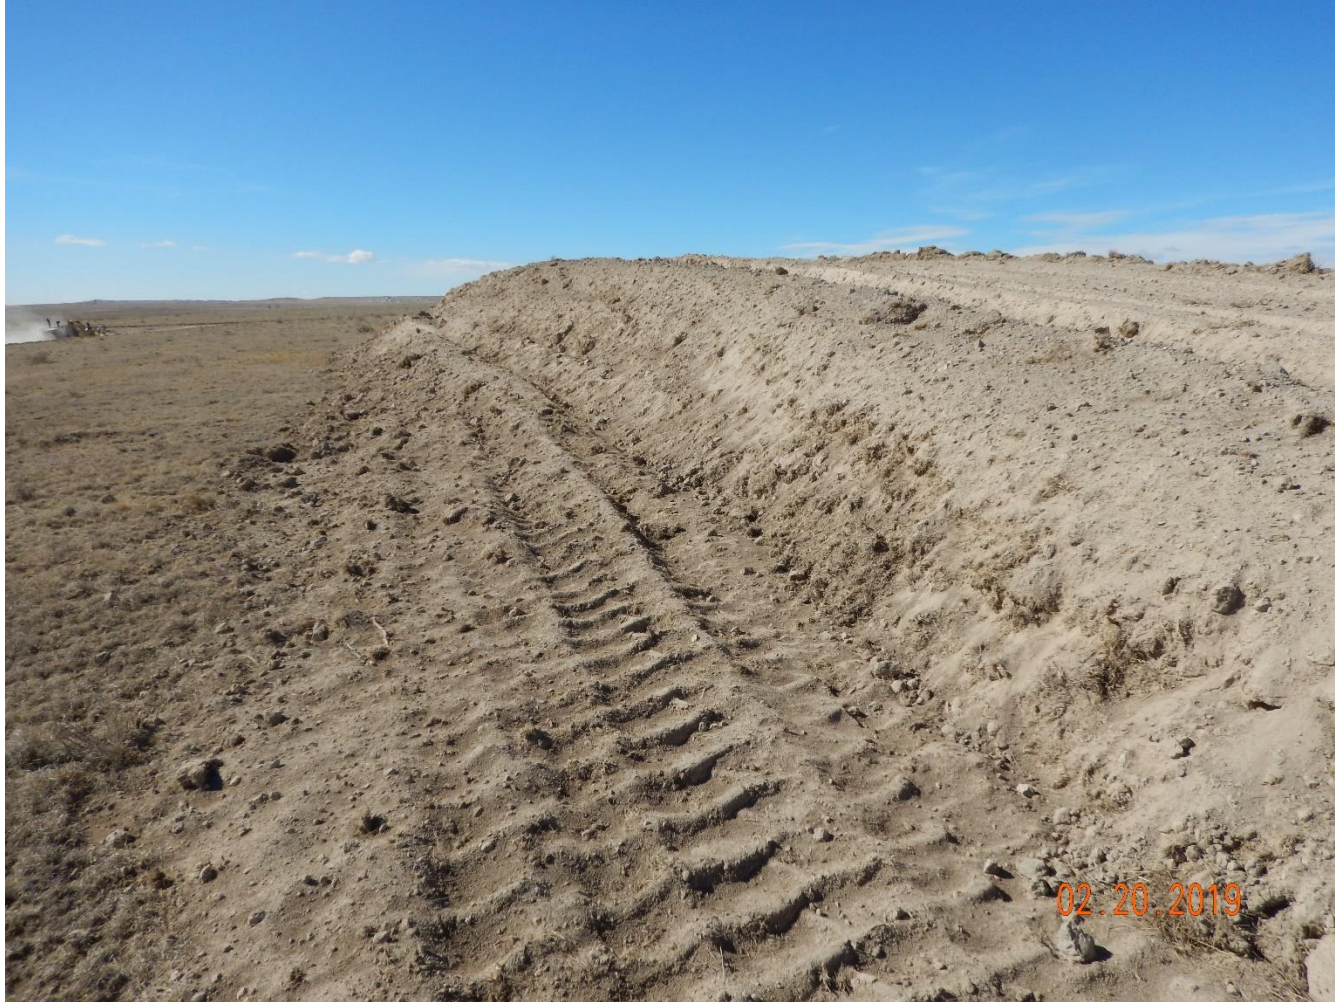
Photo 13: Photo of soil stockpile on the north end of the location. See comments under photo 12.

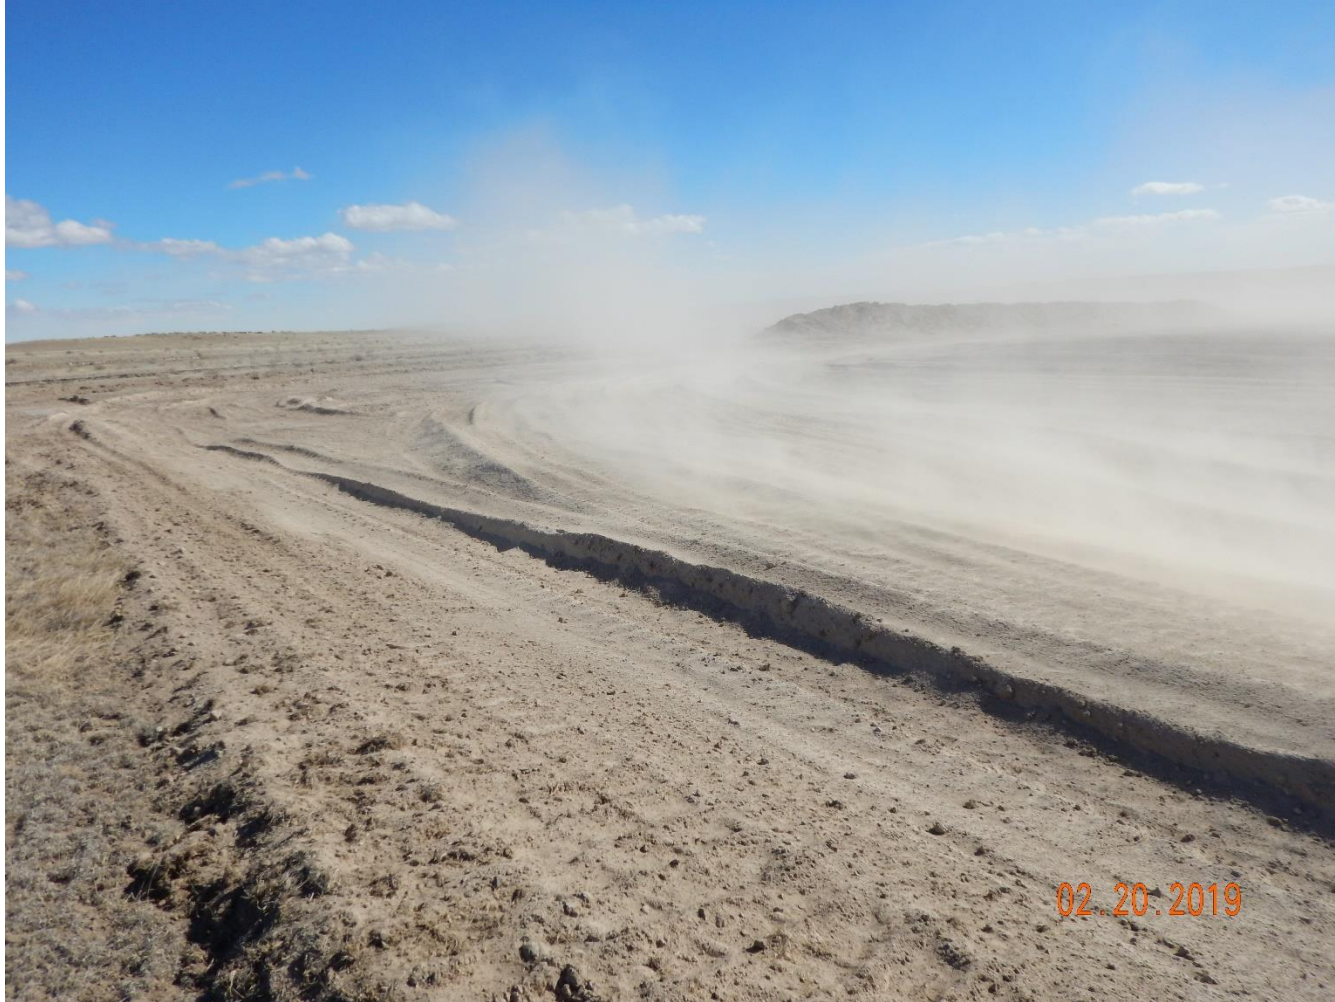
Photo 14: Photo taken from the north end of the disturbance area, facing east. Photo 14-16 shows overview of the current disturbance area from east, to south, to west. Photos also show ongoing wind erosion transporting sediment offsite. This does not comport with rule 1002.e and 1002.f

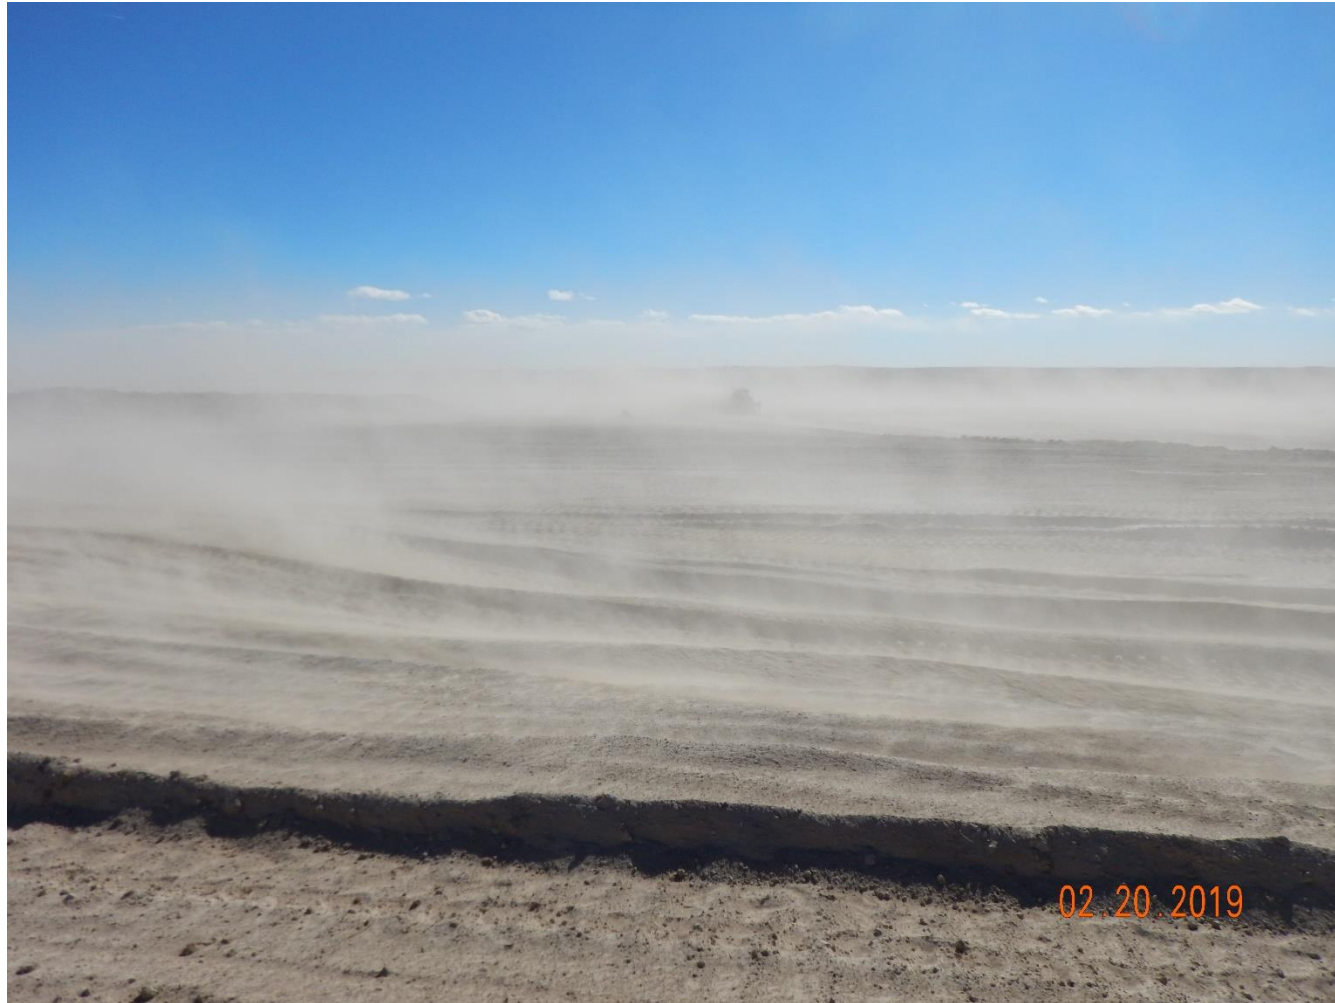
Photo 15: See comments under photo 14.

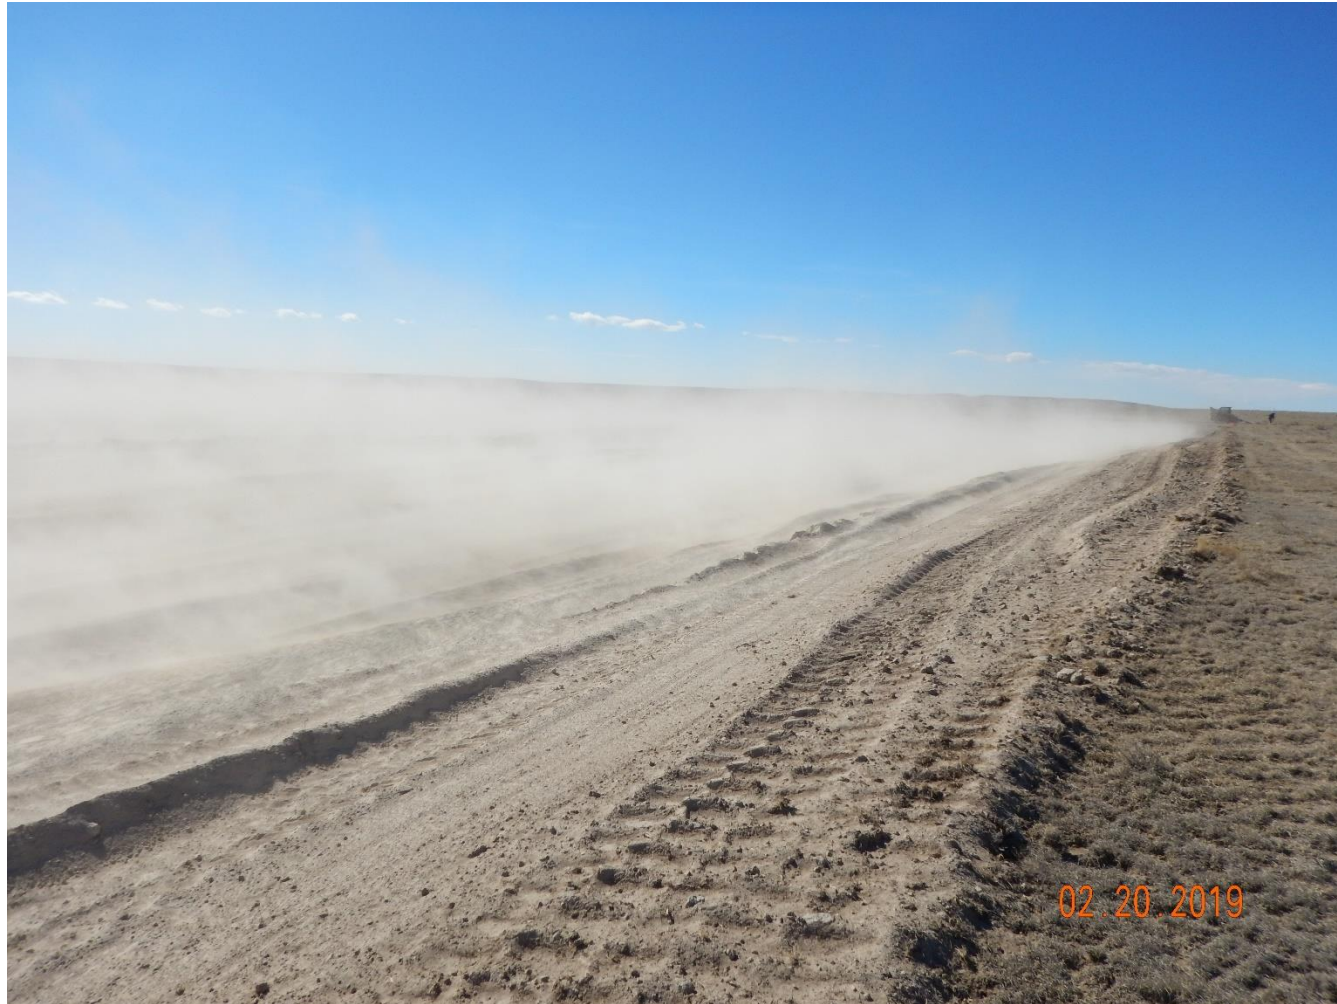
Photo 16: See comments under photo 14.
