Inspection Photos

Operator: NOBLE ENERGY INC - 100322

Location ID: 460414

Inspection Doc. Number: 682504514

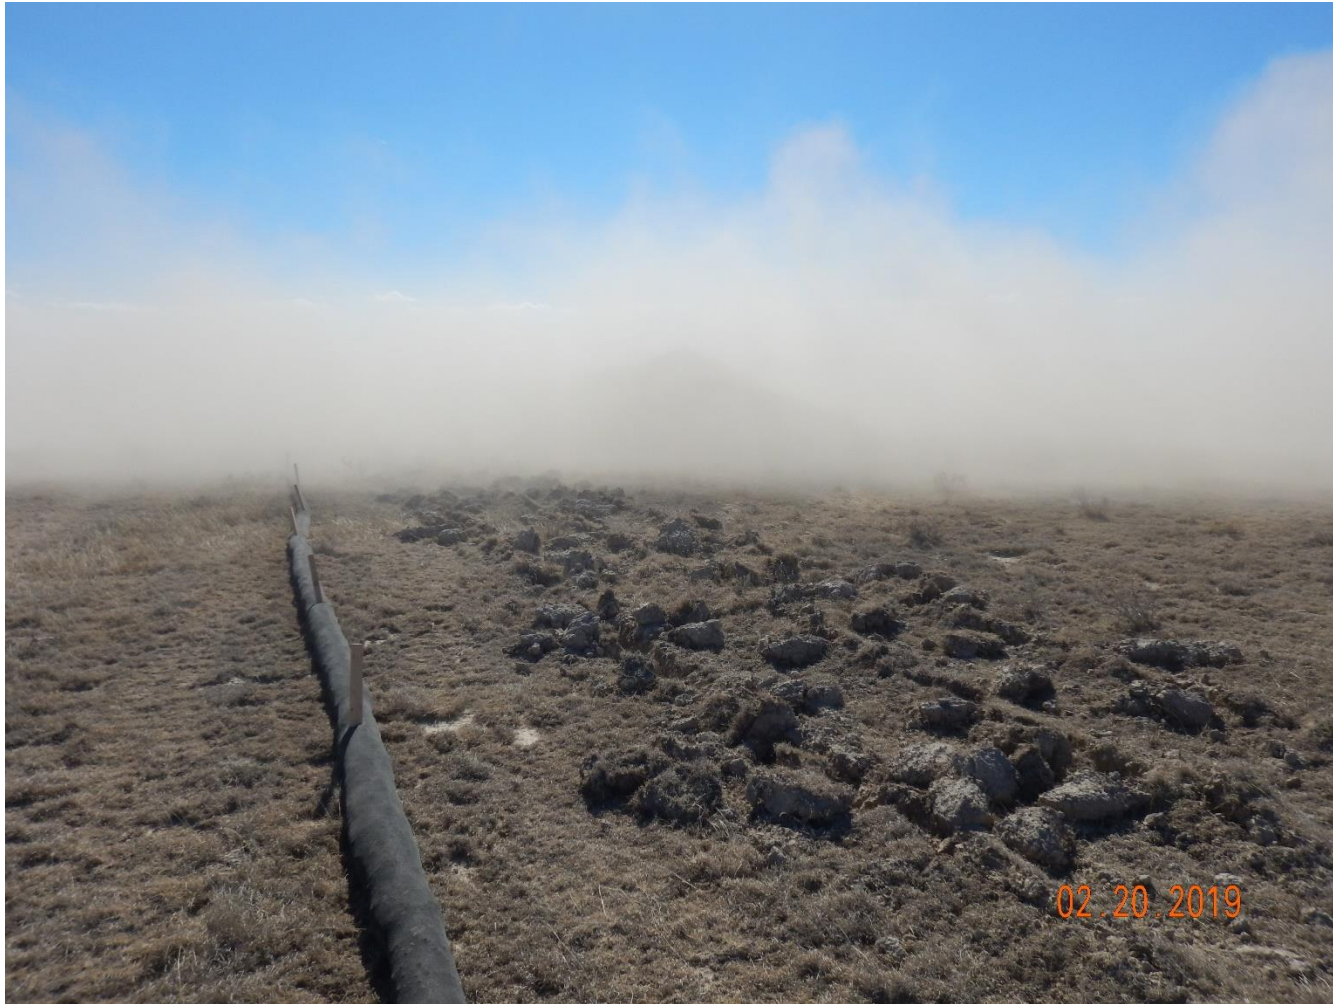
Photo 17: Photo taken from the east end of the location. Photo shows topsoil stockpile on the east end of the location (arrow). Stockpile ~50 feet from inspector, however ongoing wind erosion from the pad has drastically reduced visibility.

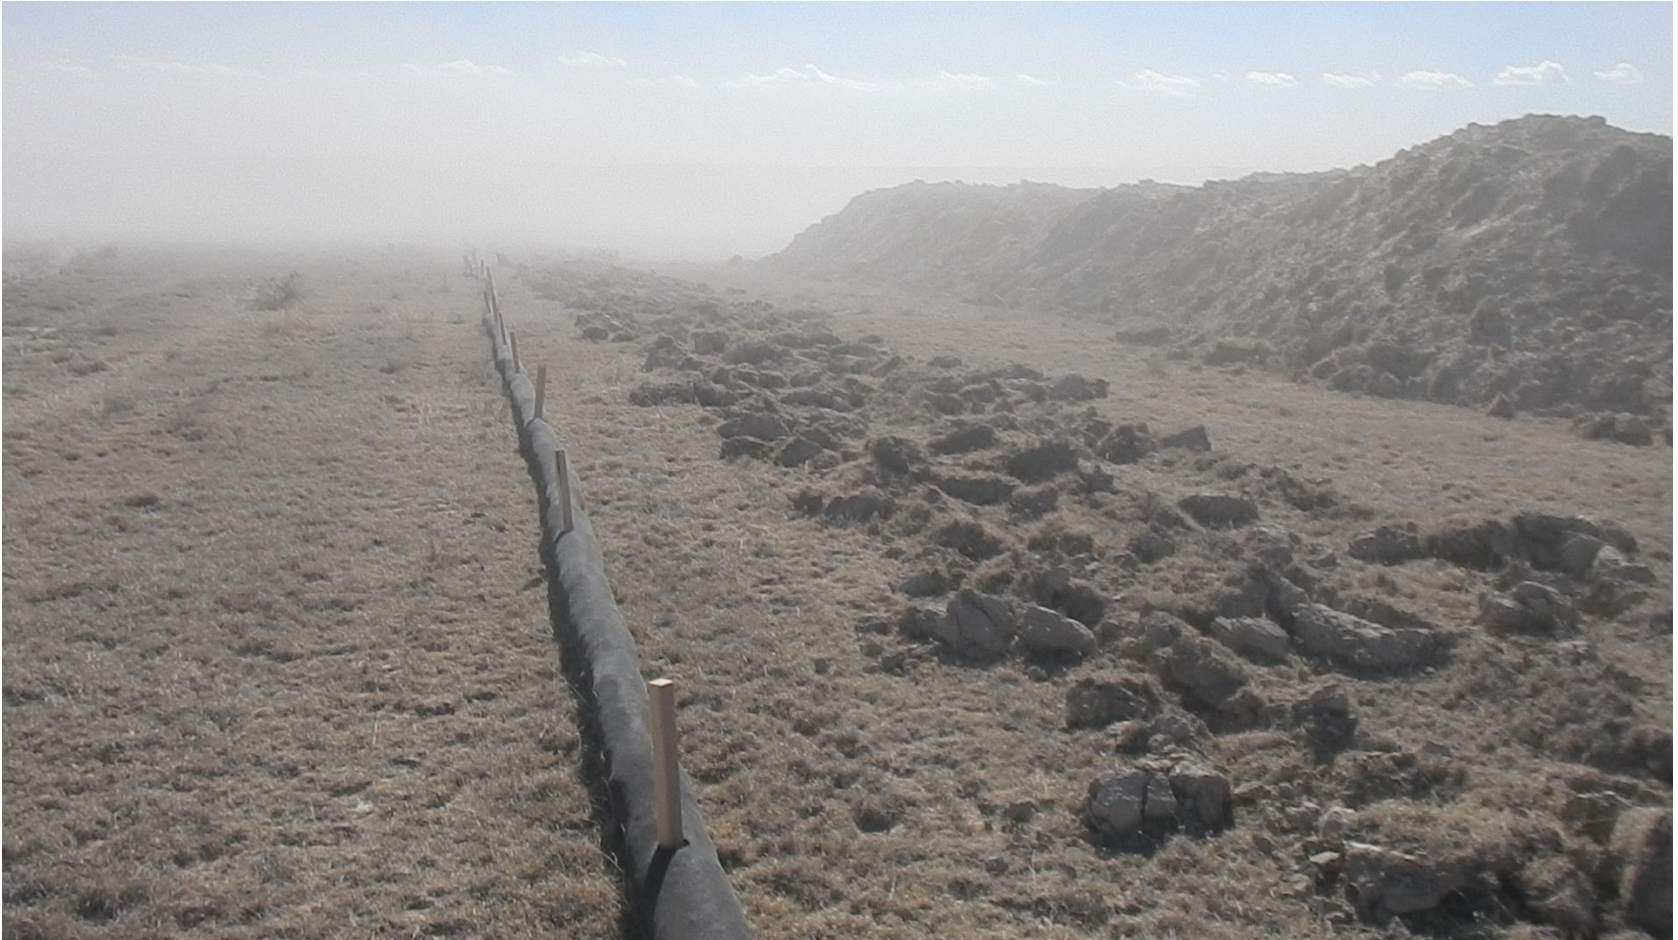
Photo 18: Photo taken from the east end of the location, facing south. Photo of topsoil stockpile and wind erosion.

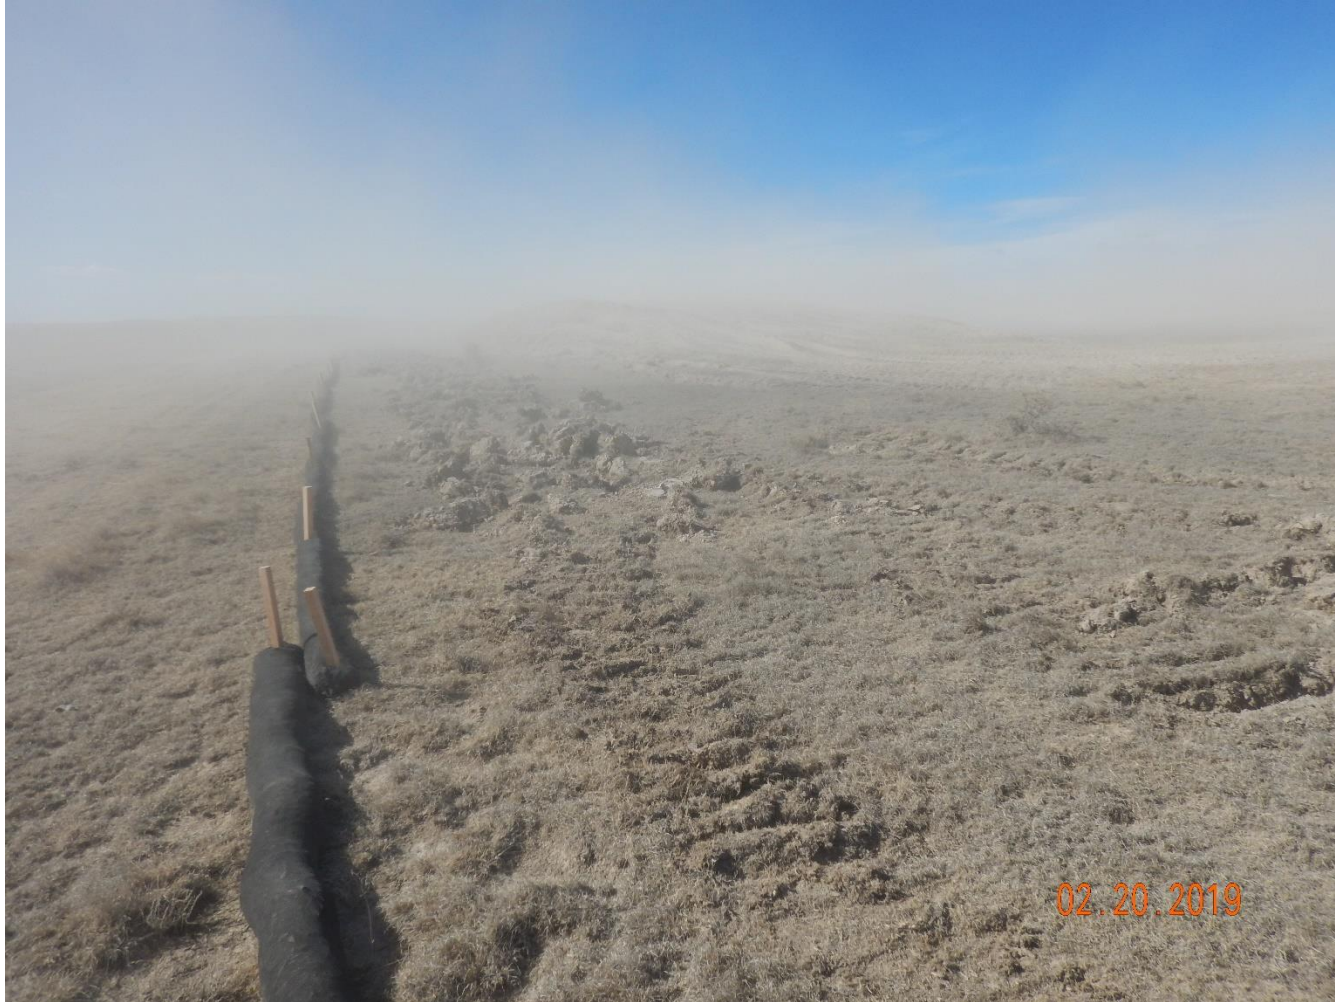
Photo 19: Photo taken from the southeast corner of the location, facing west. Photo shows wind erosion has drastically reduced visibility.

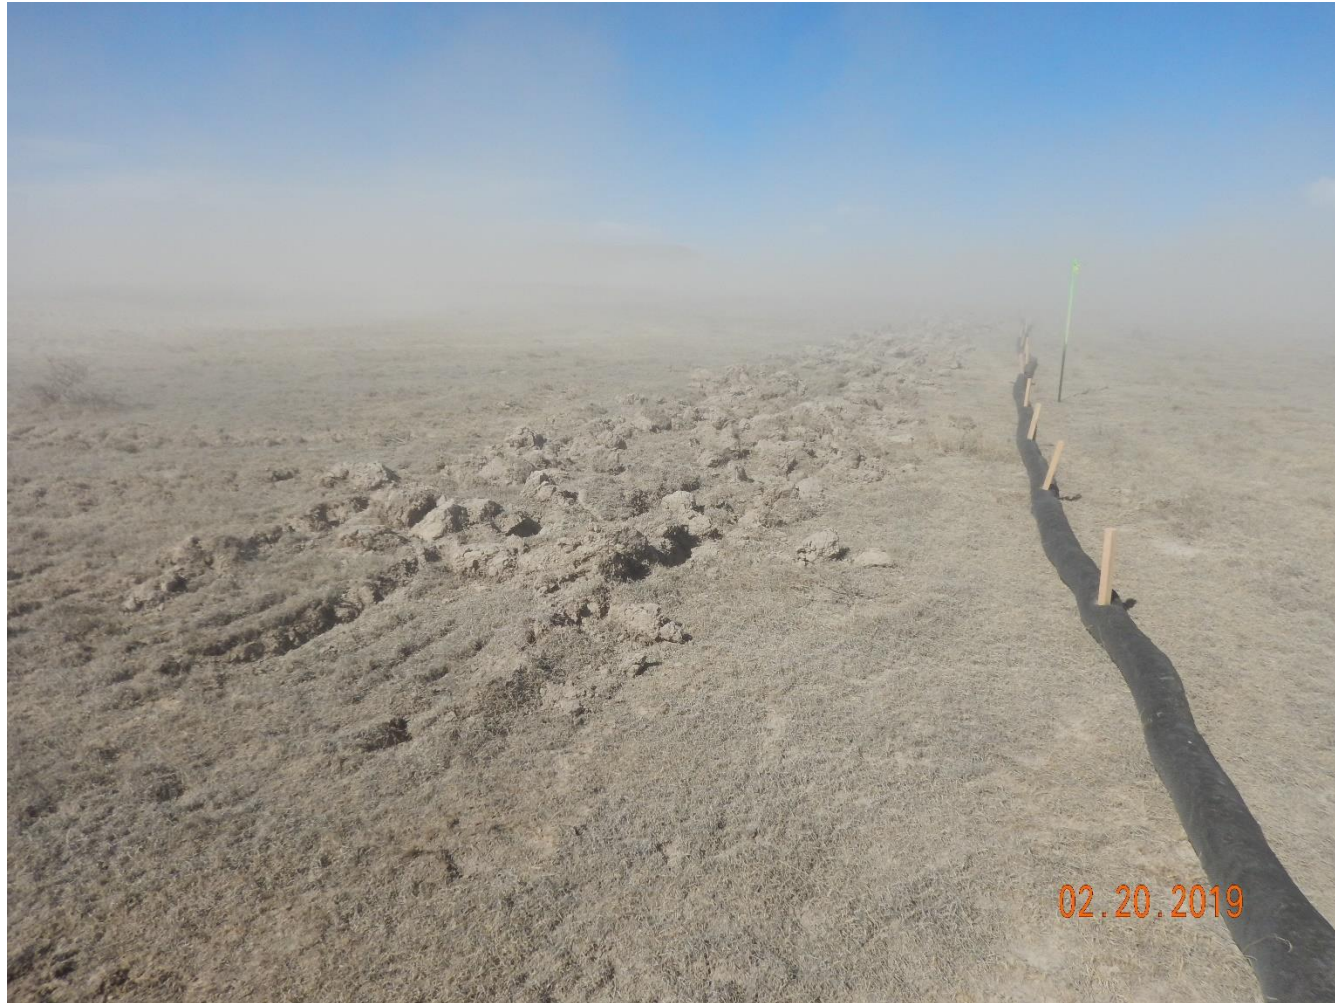
Photo 20: Photo taken from the southeast corner of the location, facing north. Photo shows wind erosion has drastically reduced visibility.

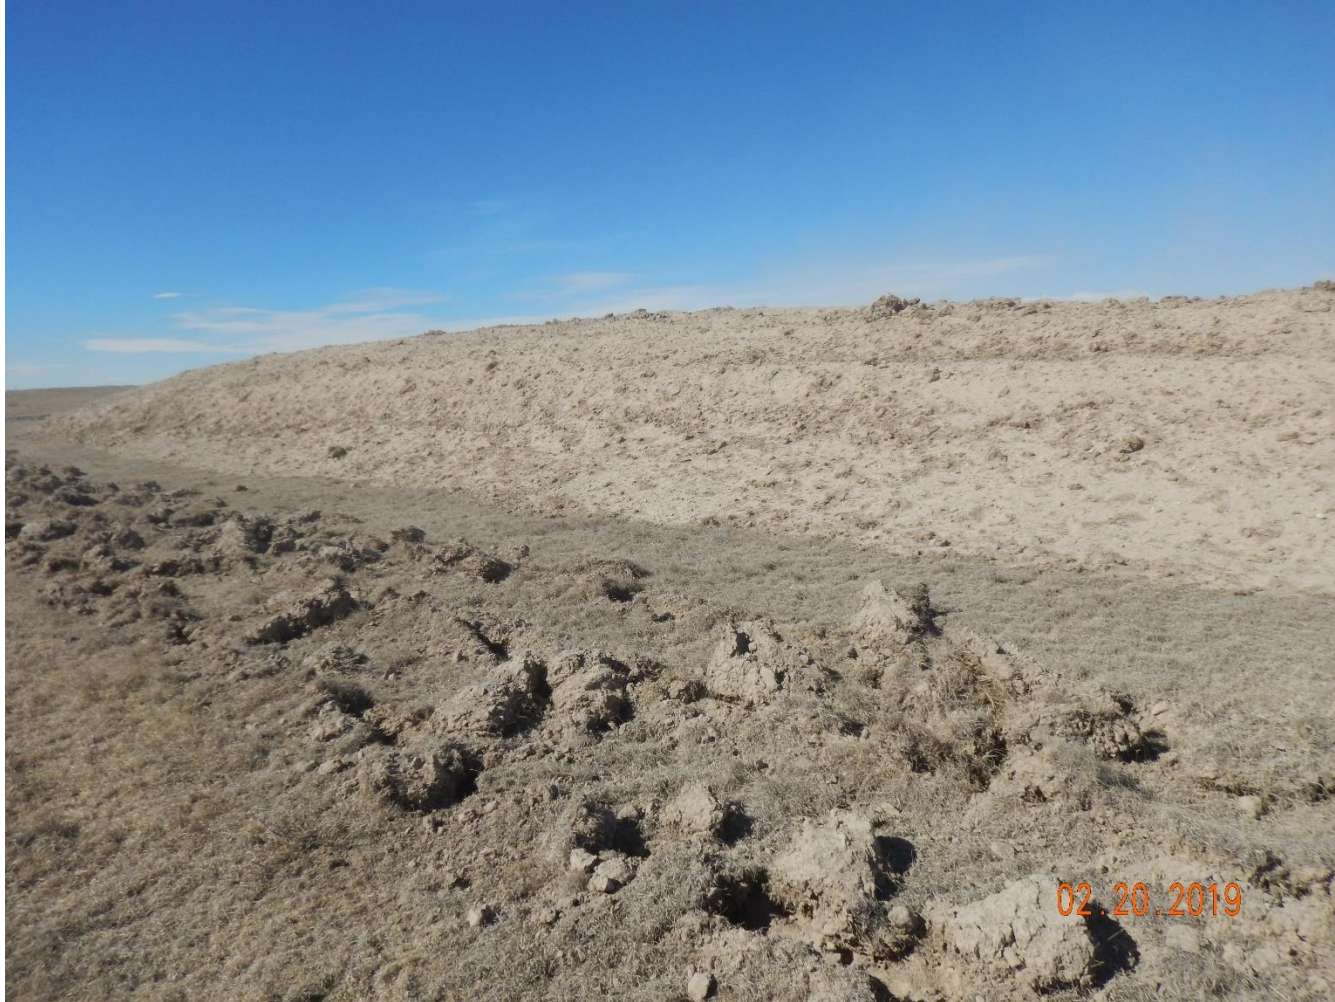
Photo 21: Photo taken from the south end of the location. Photo shows topsoil stockpile. Soil stockpile has not been sufficiently stabilized, is currently loose material and at risk to erosion degradation.

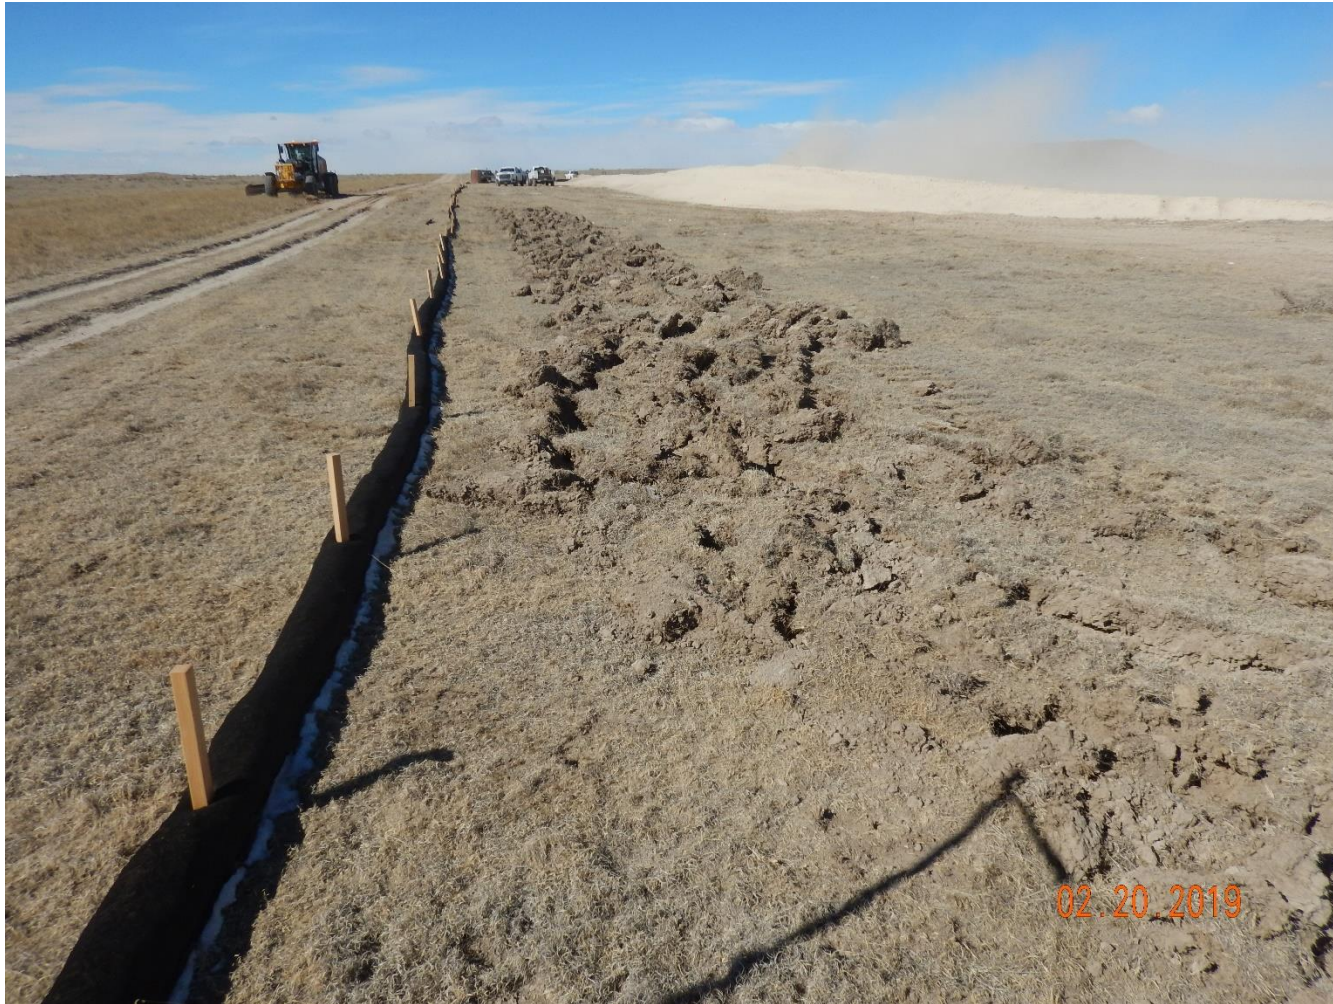
Photo 22: Photo taken from the southwest end of the location, facing northwest. Photos 22-24 provide an overview of the location from northwest, northeast, to east. Photo also shows wind erosion.

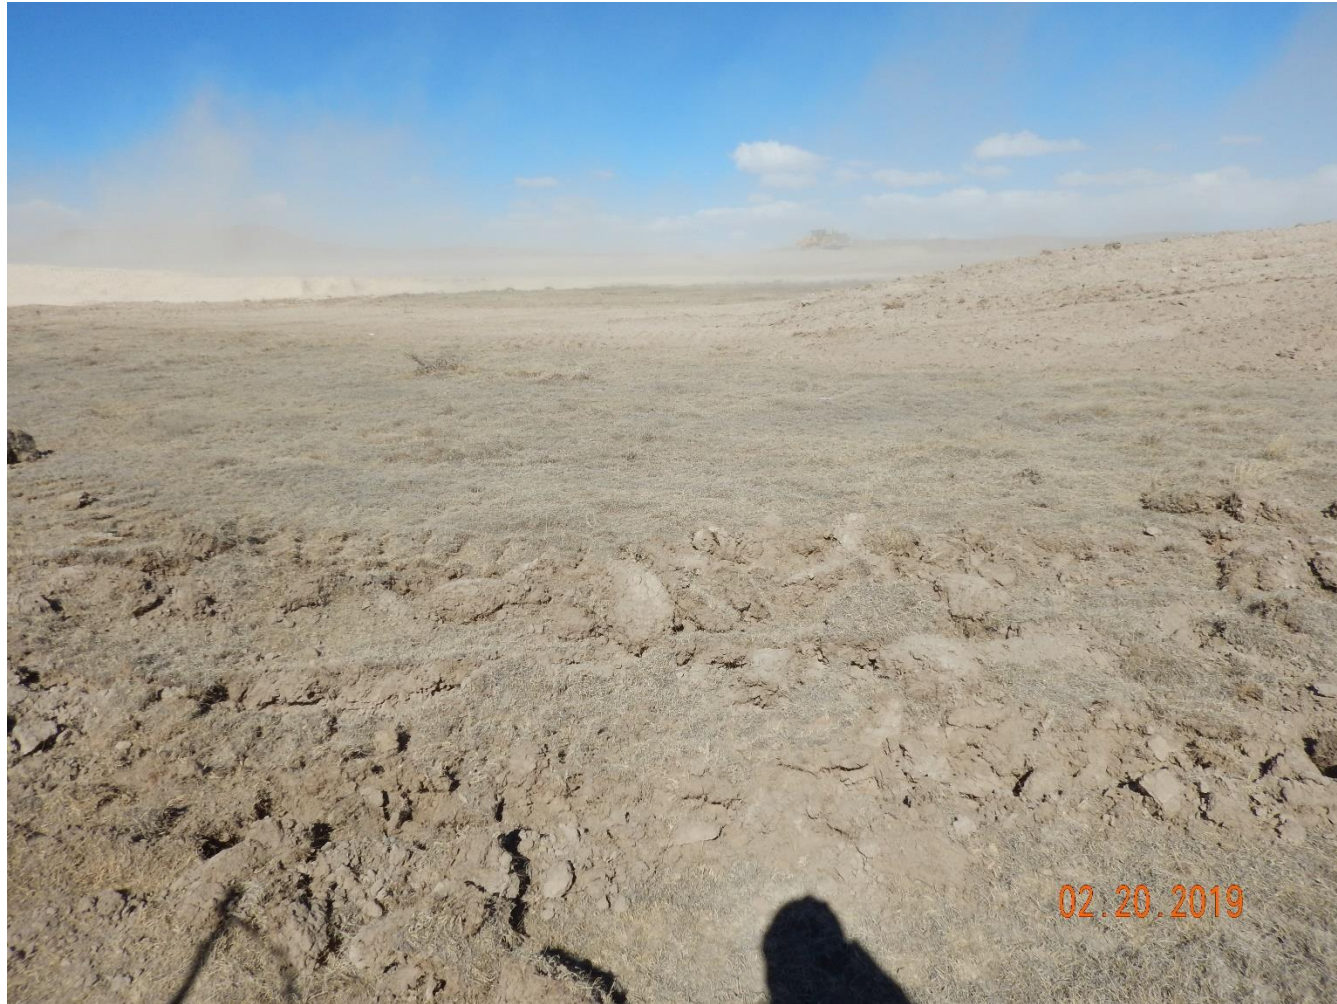
Photo 23: See comments under photo 22.

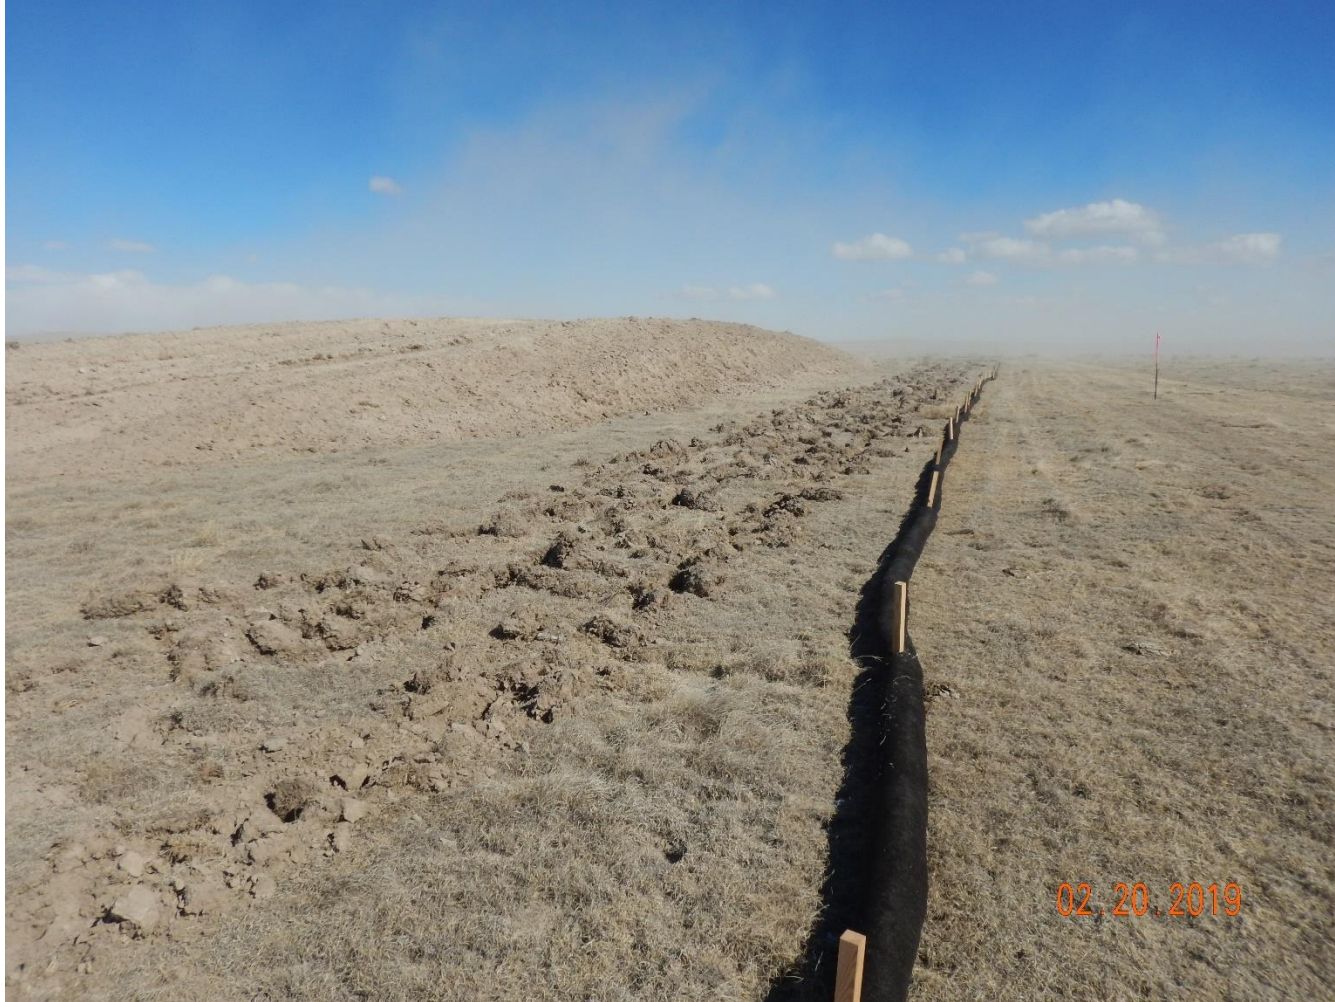
Photo 24: See comments under photo 22.

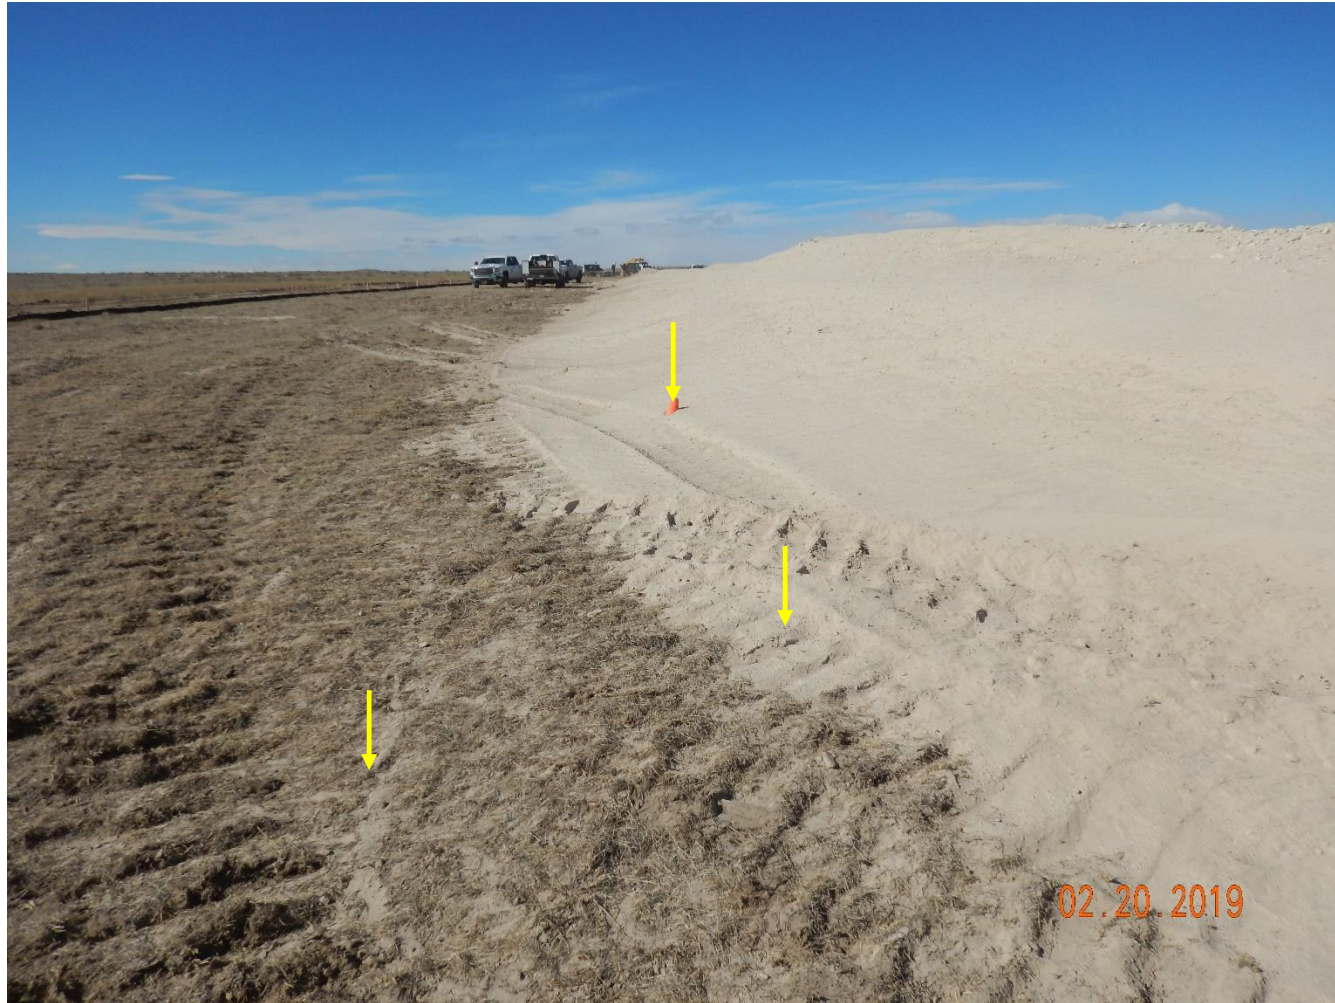
Photo 25: Photo taken from the southwest end of the location, facing northwest. Photo shows sediment deposition from the pad appears to have almost covered an orange cone. Photo also shows sediment transport and deposition from the pad

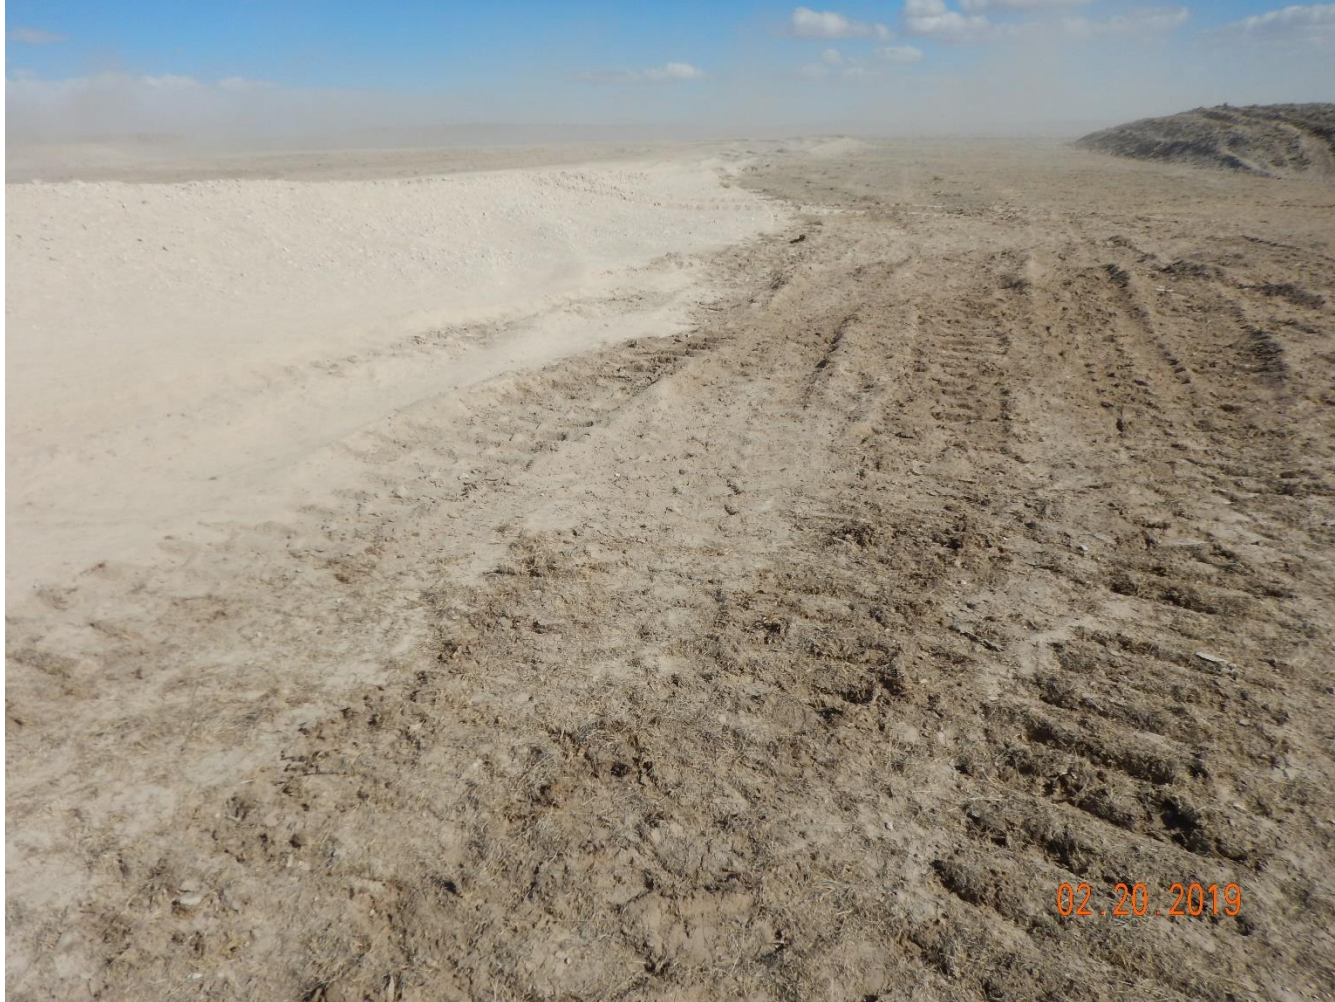
Photo 26: Photo taken from the southwest end of the location, facing east. Photo shows on going wind erosion and sediment transport off site.

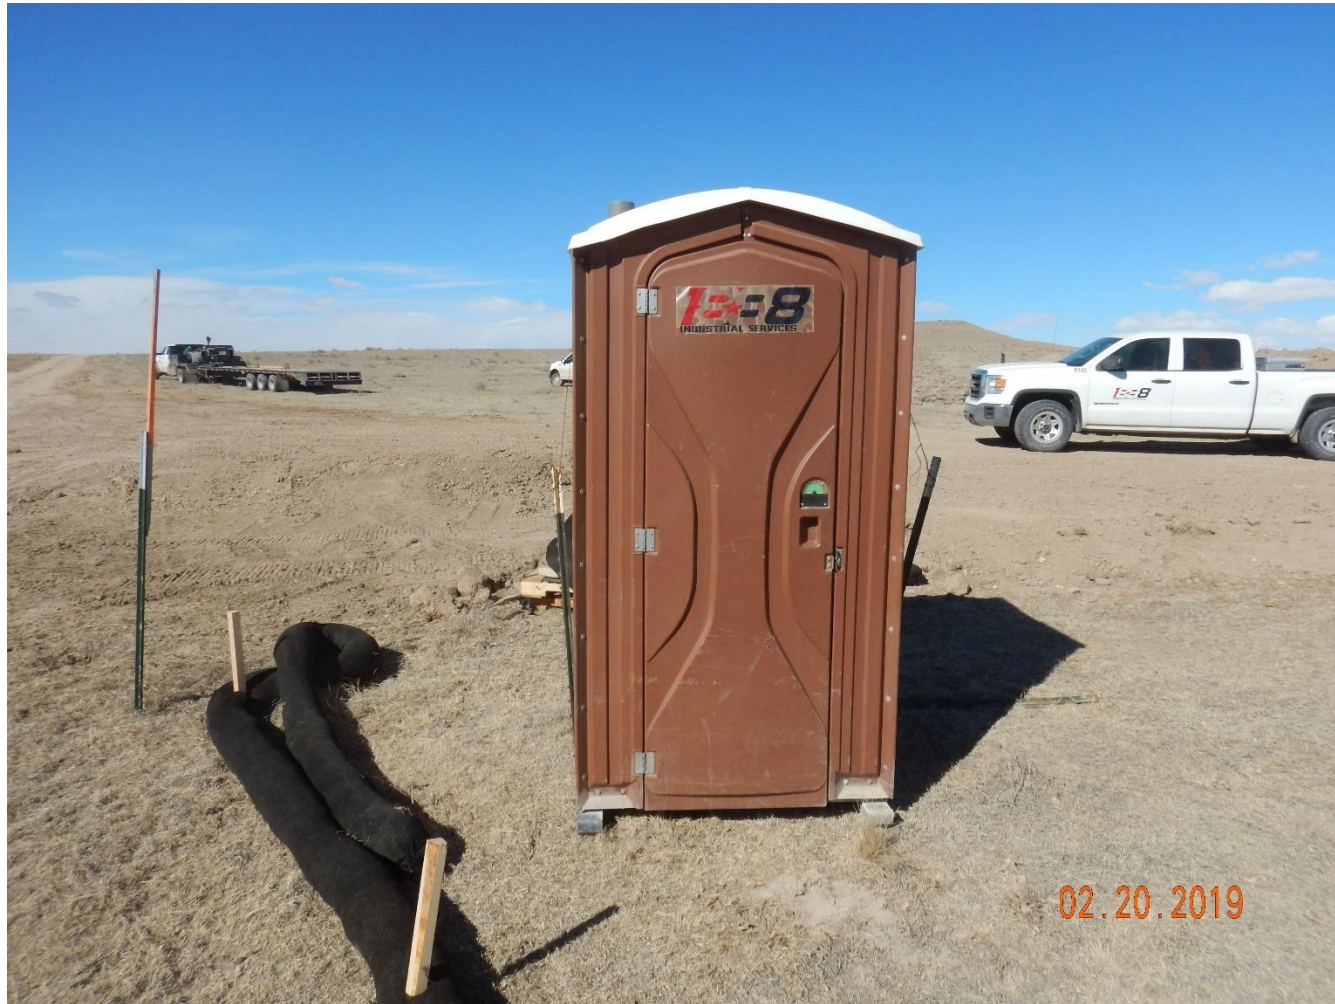
Photo 27: Photo taken from the southwest corner of the location, facing north. Photo of porta-john that appears to be sufficiently secured.

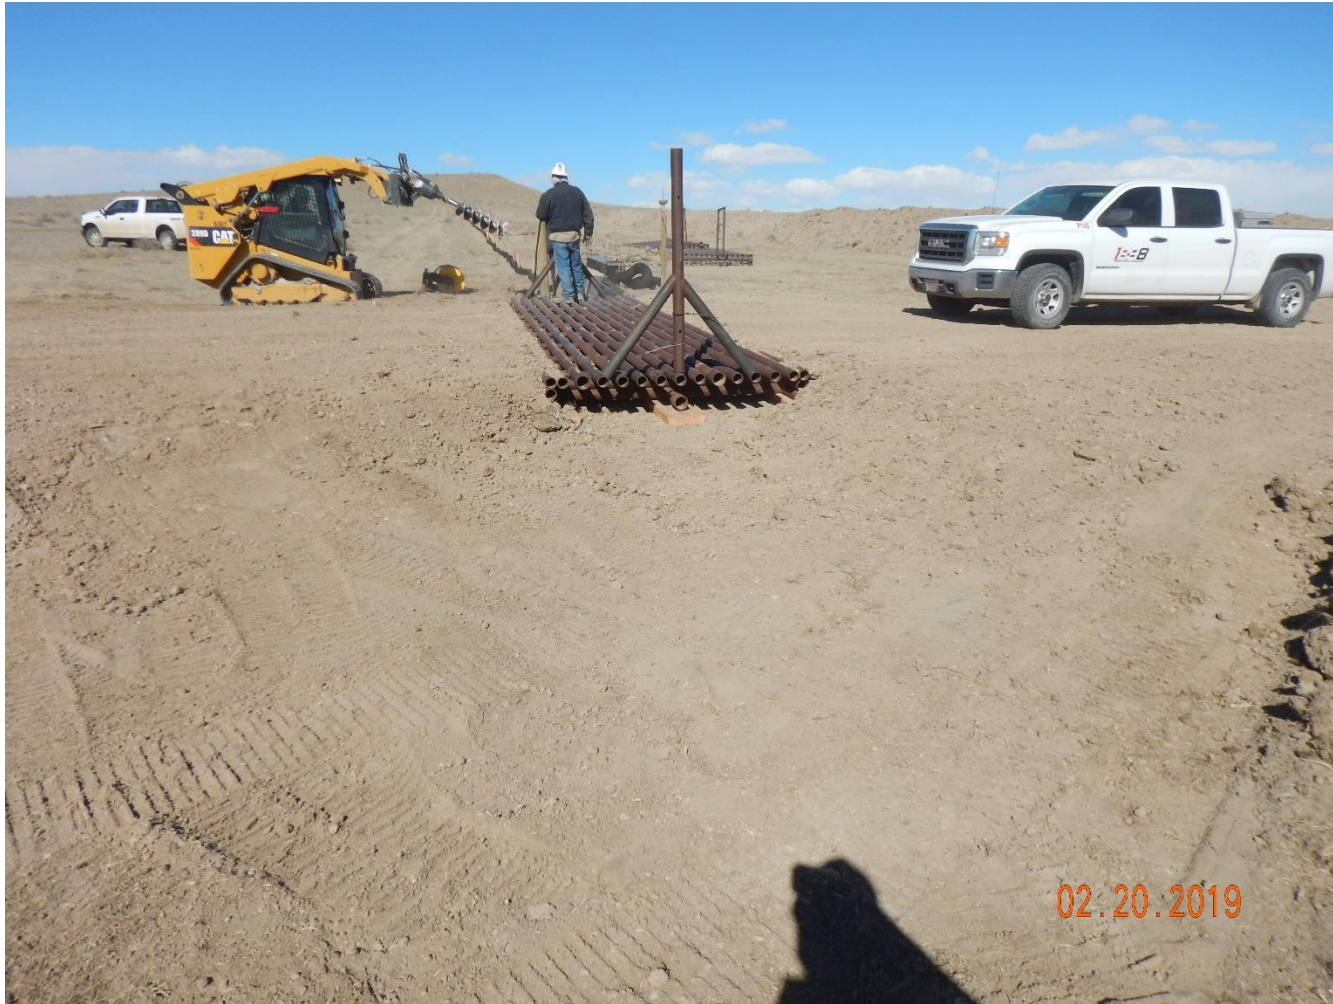
Photo 28: Photo taken from the southwest corner of the location. Photo shows workers installing a cattle guard on the site.
