Inspection Photos

Operator: WESTERN OPERATING COMPANY -
95620

Location ID: 312292

Inspection Doc. Number: 682504516
Logan County, CO

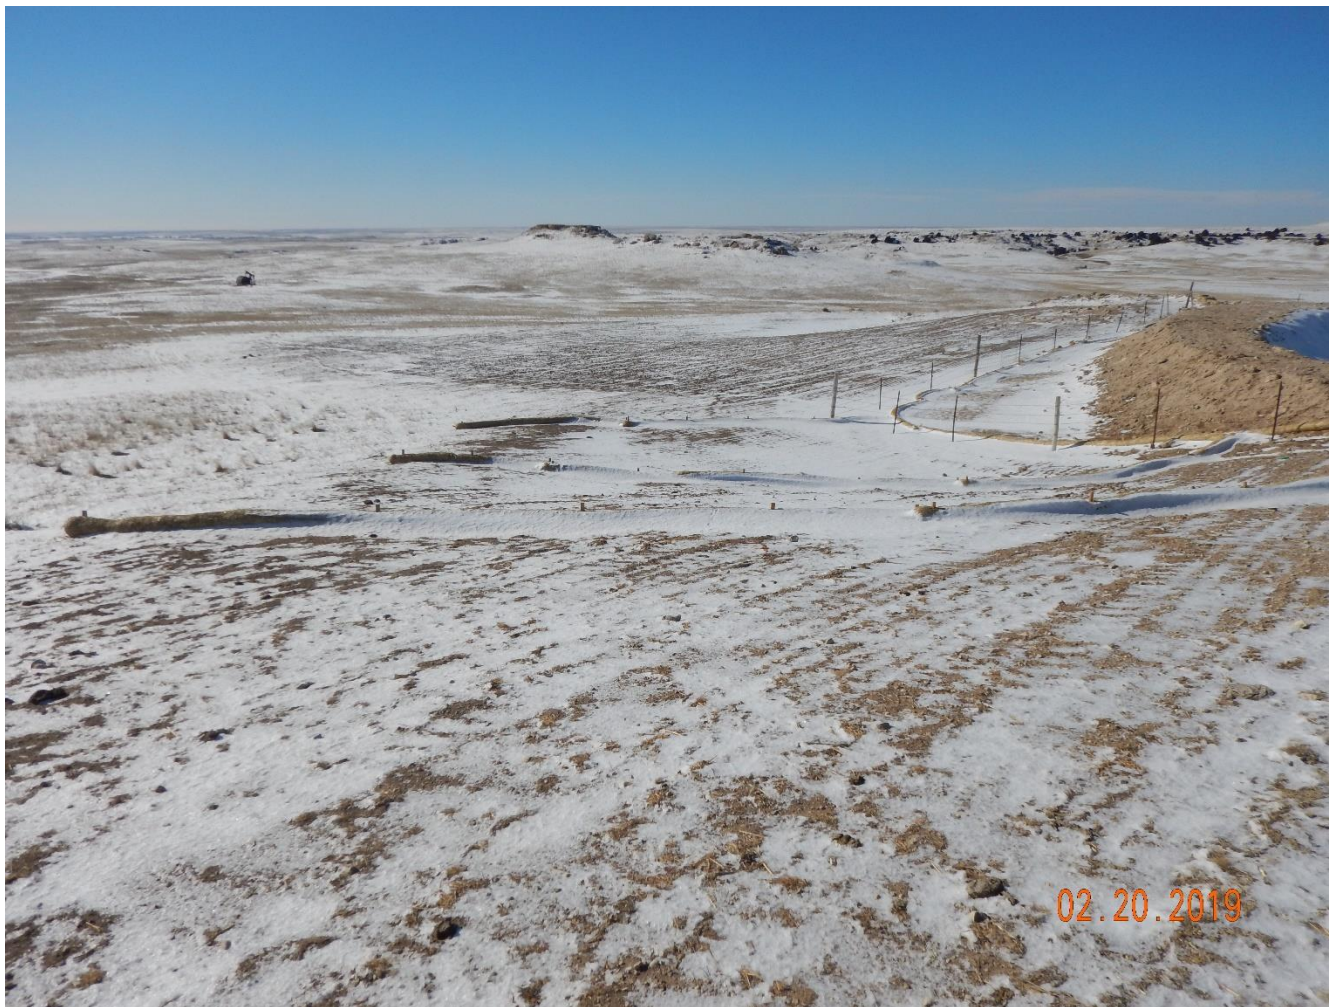
Photo 1: Photo taken from the south end of the production area, facing southwest. Photo shows the disturbed areas down gradient of the pit and production areas. Photo shows operator appears to have placed erosion logs around the perimeter of the pit, and portions of the interim areas

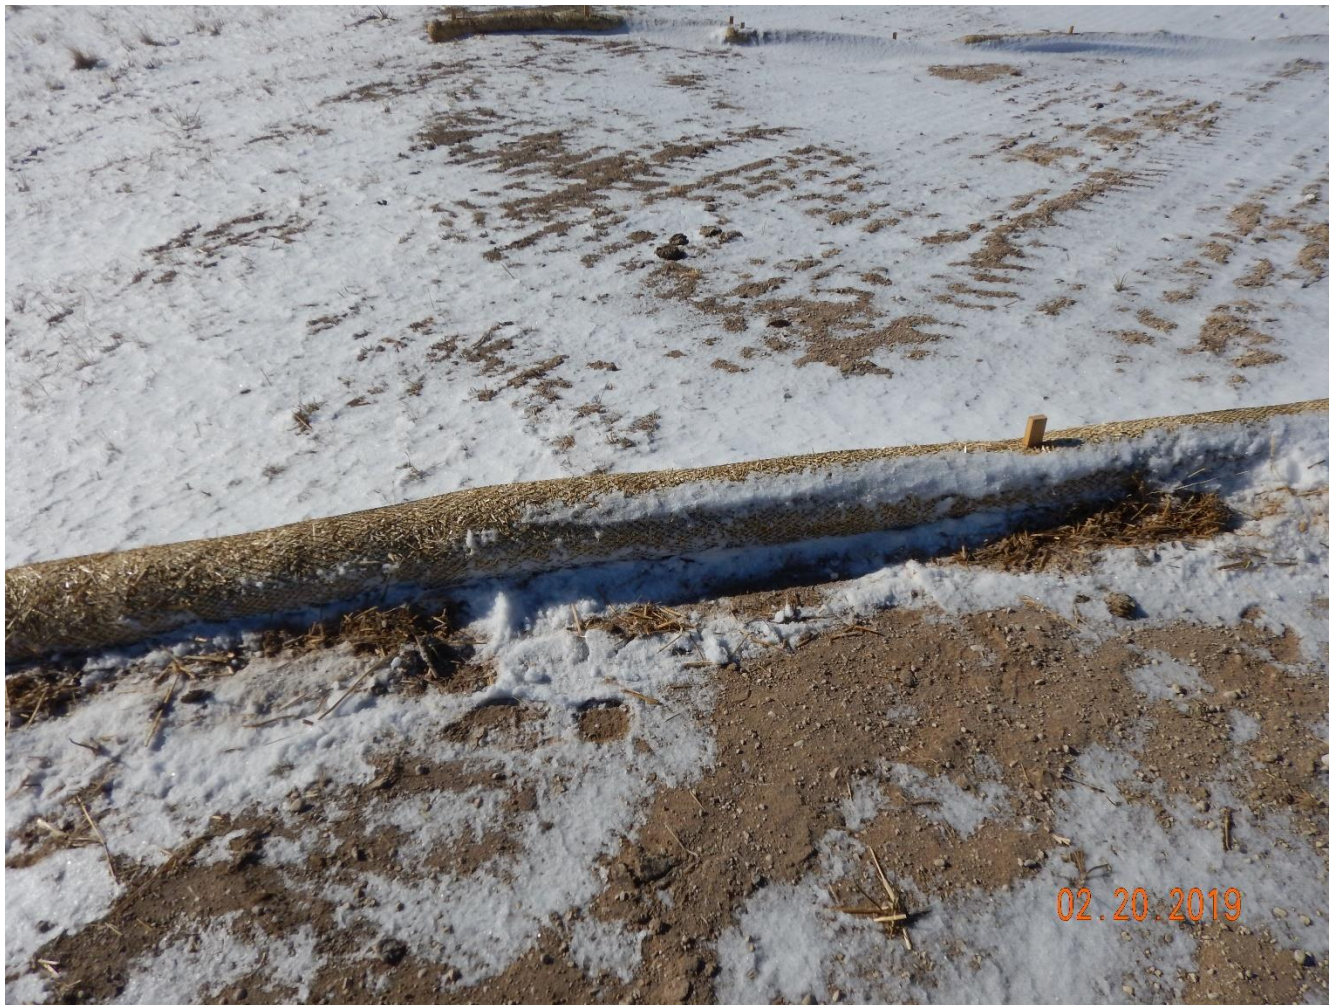
Photo 2: Continued from photo 1. Photo shows erosion log BMP. Erosion logs are sediment control barriers and ponding BMPs that intercept sheet flow runoff from disturbed areas, and are required to be trenched and back-filled in order to be in proper functioning condition. Photo shows Operator appears to have only placed/staked the erosion logs upon the surface of the soil; BMPs have not been trenched and back-filled in accordance with good engineering practices and are not in proper functioning condition.

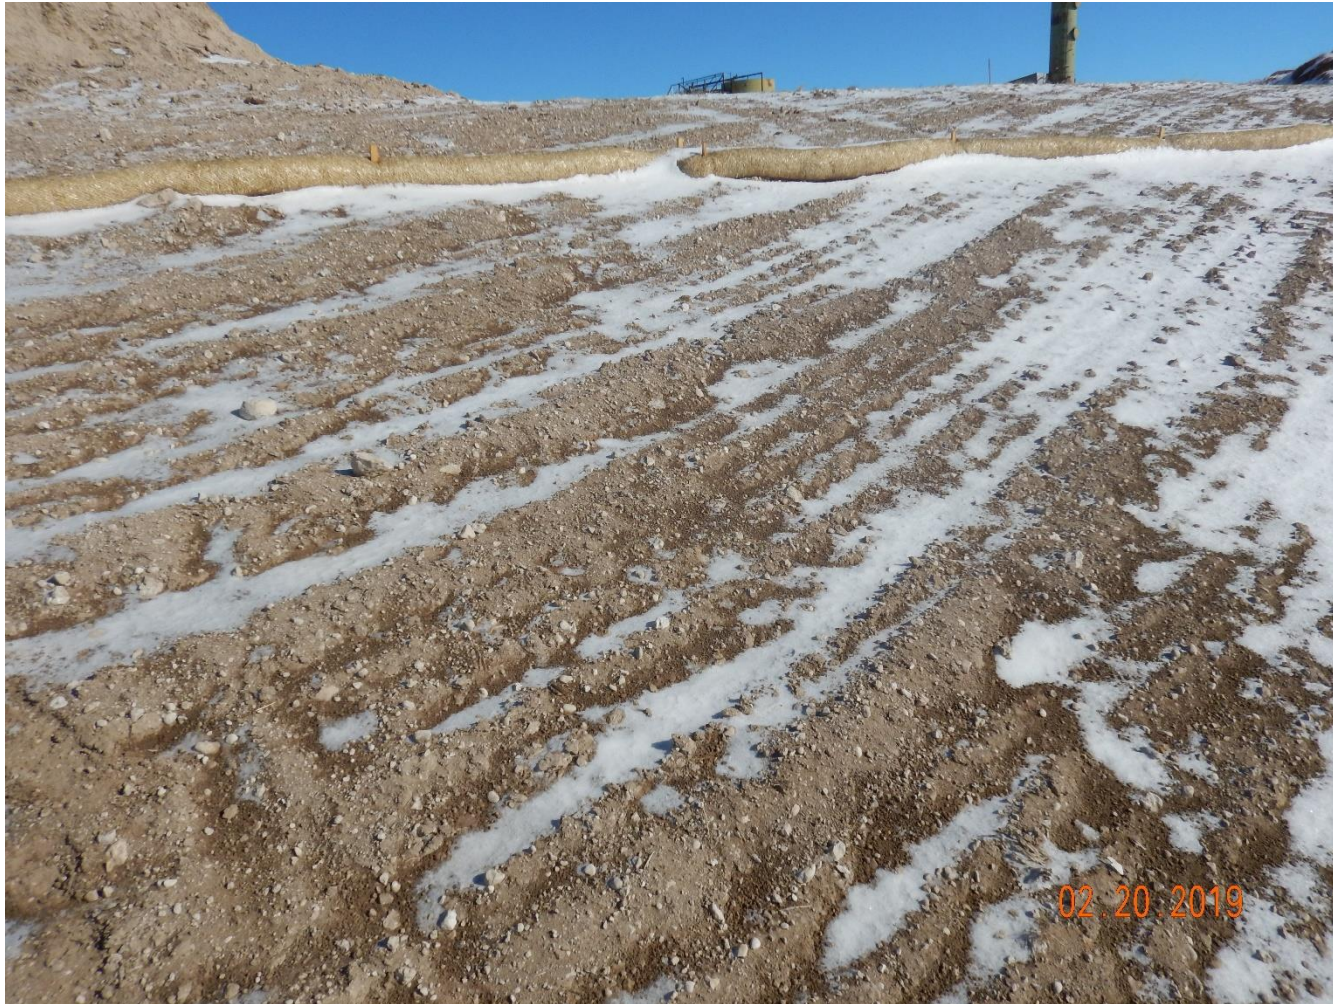
Photo 3: Photo taken from the disturbed interim areas on the east end of the pit. erosion log. Photo also show the seeded soils of the interim areas remain bare and exposed. Previous inspections required stabilization control BMPs to stabilize the seeded soils to mitigate further erosion degradation. Unable to find evidence that stabilization controls have been installed/maintained; Areas downgrade of the pit and location remain at risk to erosion degradation. Parallel striations observed in the soils are likely a result from seeding activities using a no-till drill and are not considered to be (or suitable as) a stormwater and erosion control BMP.

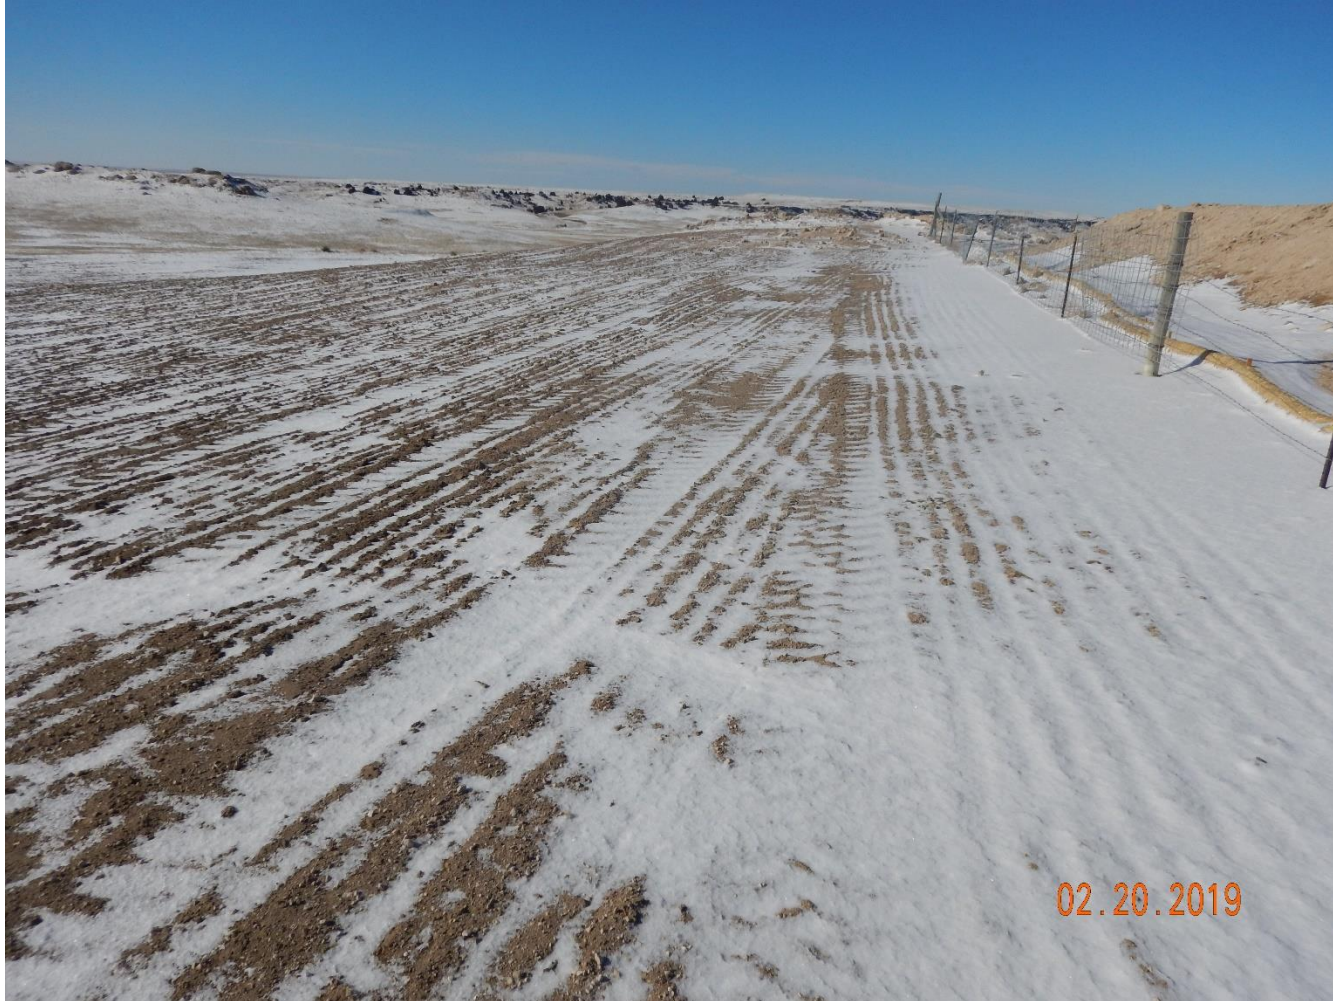
Photo 4: Photo taken from the interim areas on the south end of the pit, facing west. See comments under photo 3. Parallel striations observed in the soils are likely a result from seeding activities using a no-till drill and are not considered to be (or suitable as) a stormwater and erosion control BMP.

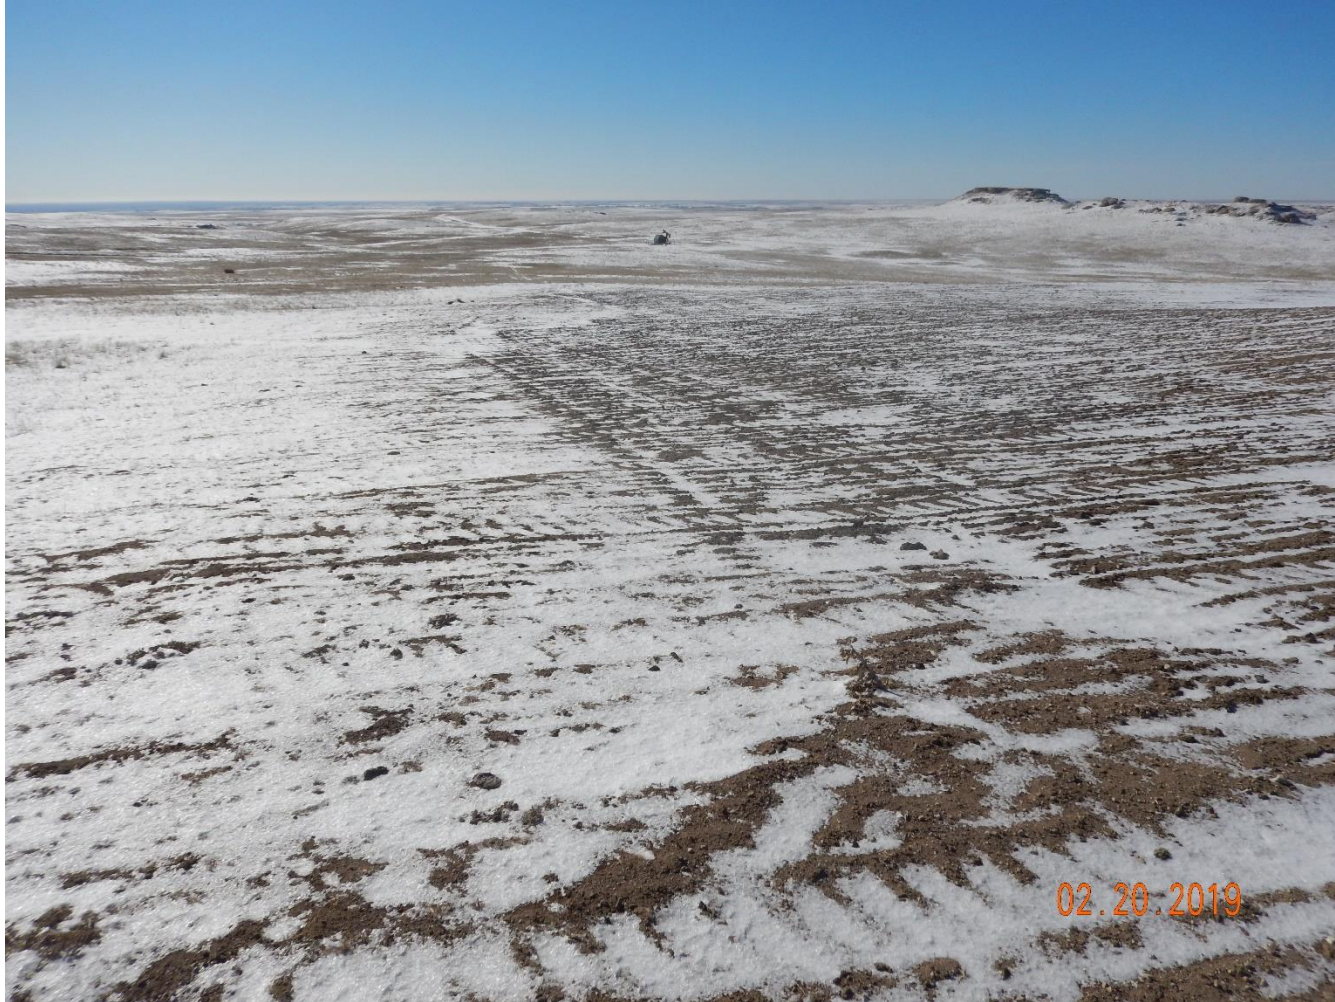
Photo 5: Photo taken from the interim areas on the south end of the pit, facing south. See comments under photo 3.

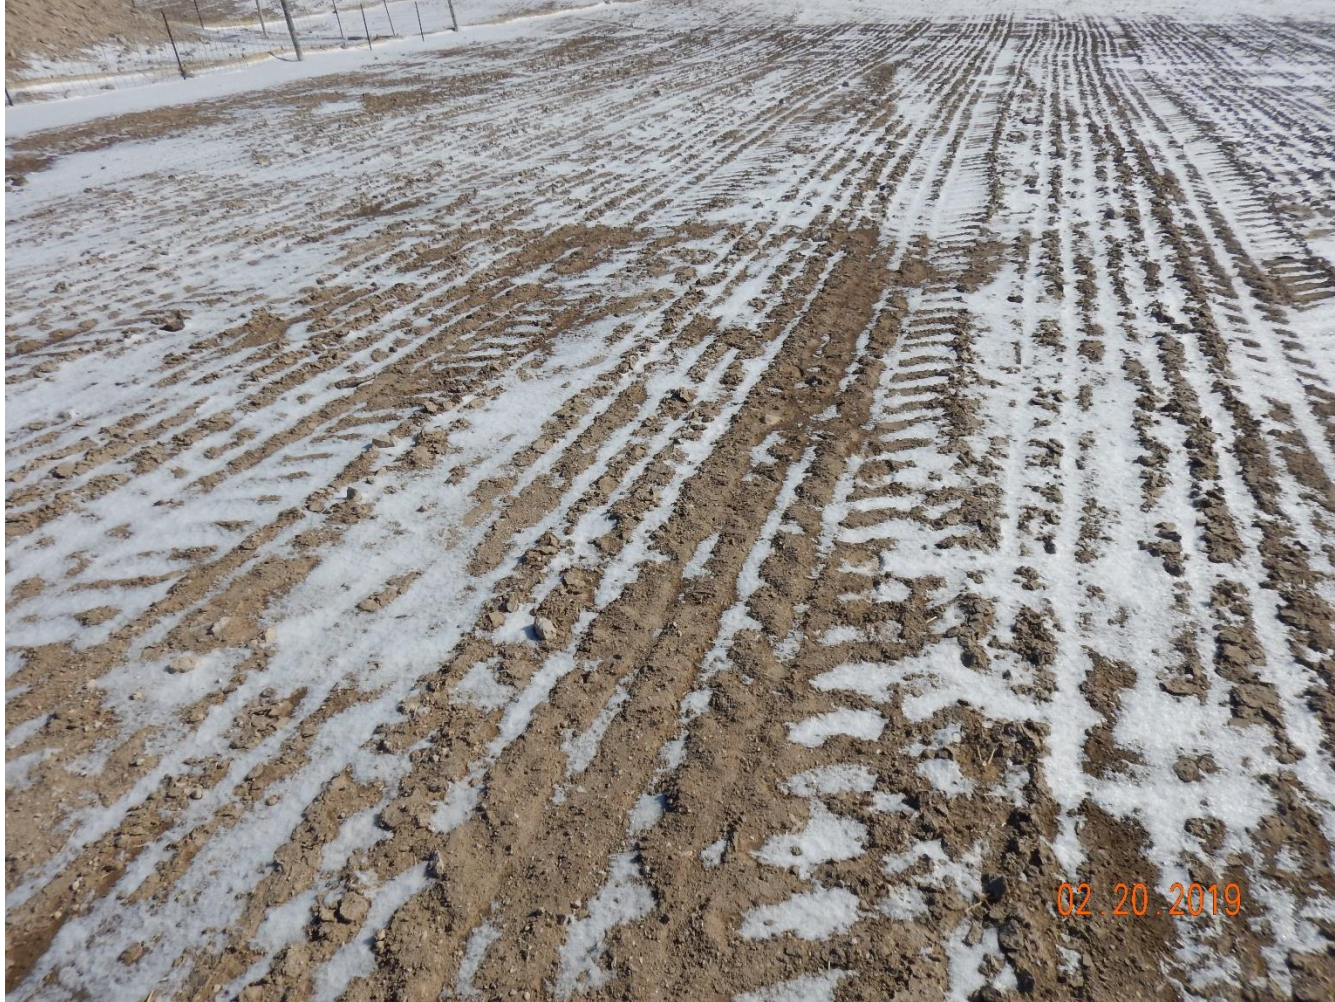
Photo 6: Photo taken from the interim areas on the south end of the pit. See comments under photo 3.

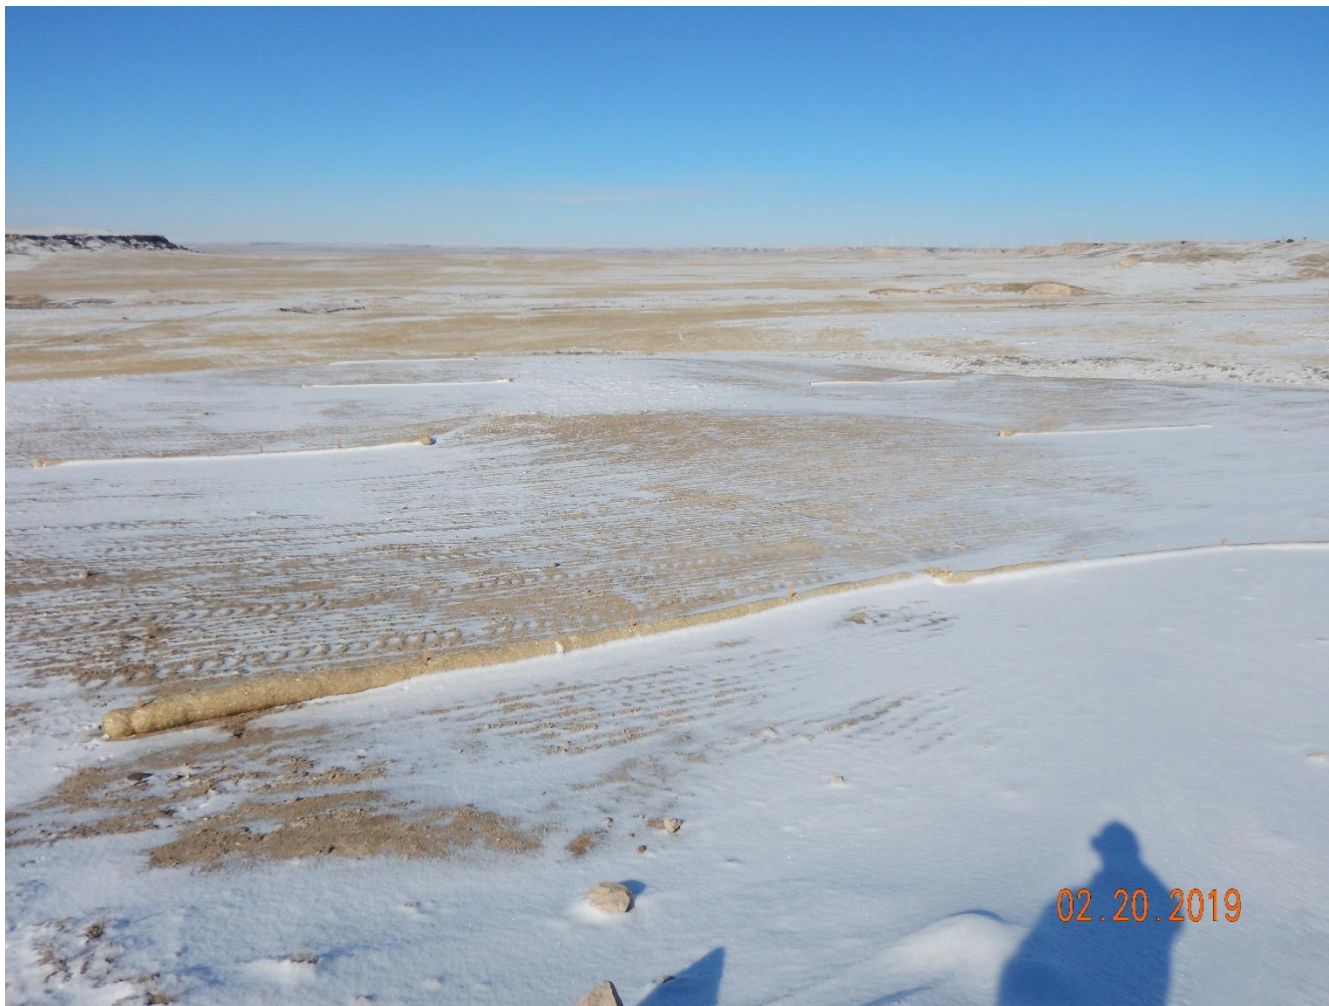
Photo 7: Photo taken from the west end of the production area/pit, facing west. Photo shows the disturbed areas down gradient of the pit and production areas. Photo shows operator appears to have placed erosion logs around the perimeter of the pit, and portions of the interim areas

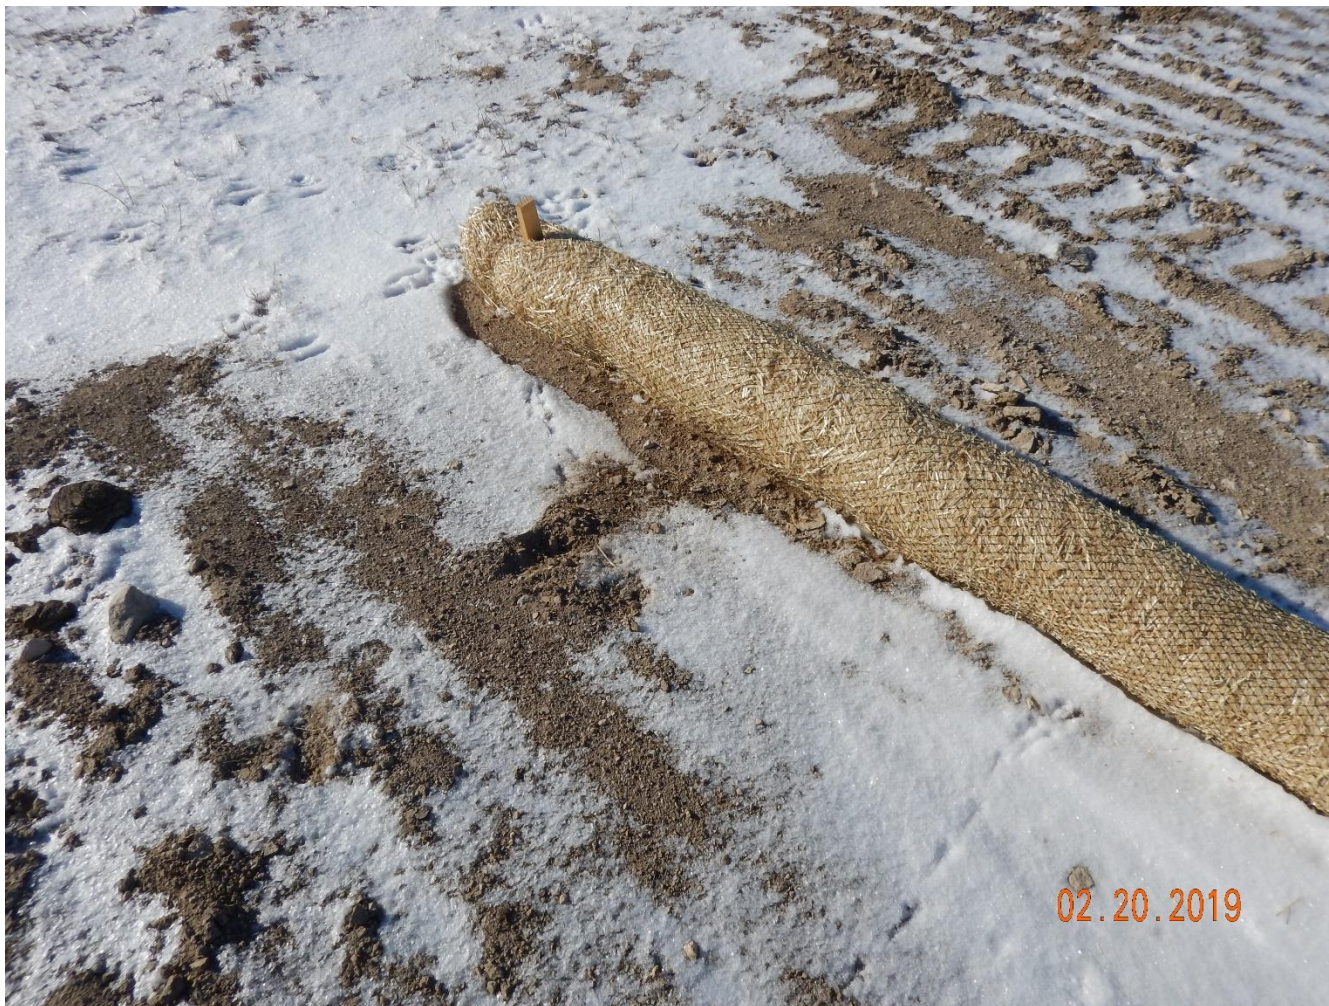
Photo 8: Continued from photo 7. Photo shows erosion log BMP. Erosion logs are sediment control barriers and ponding BMPs that intercept sheet flow runoff from disturbed areas, and are required to be trenched and back-filled in order to be in proper functioning condition. Photo shows Operator appears to have only placed/staked the erosion logs upon the surface of the soil; BMPs have not been trenched and back-filled in accordance with good engineering practices and are not in proper functioning condition.

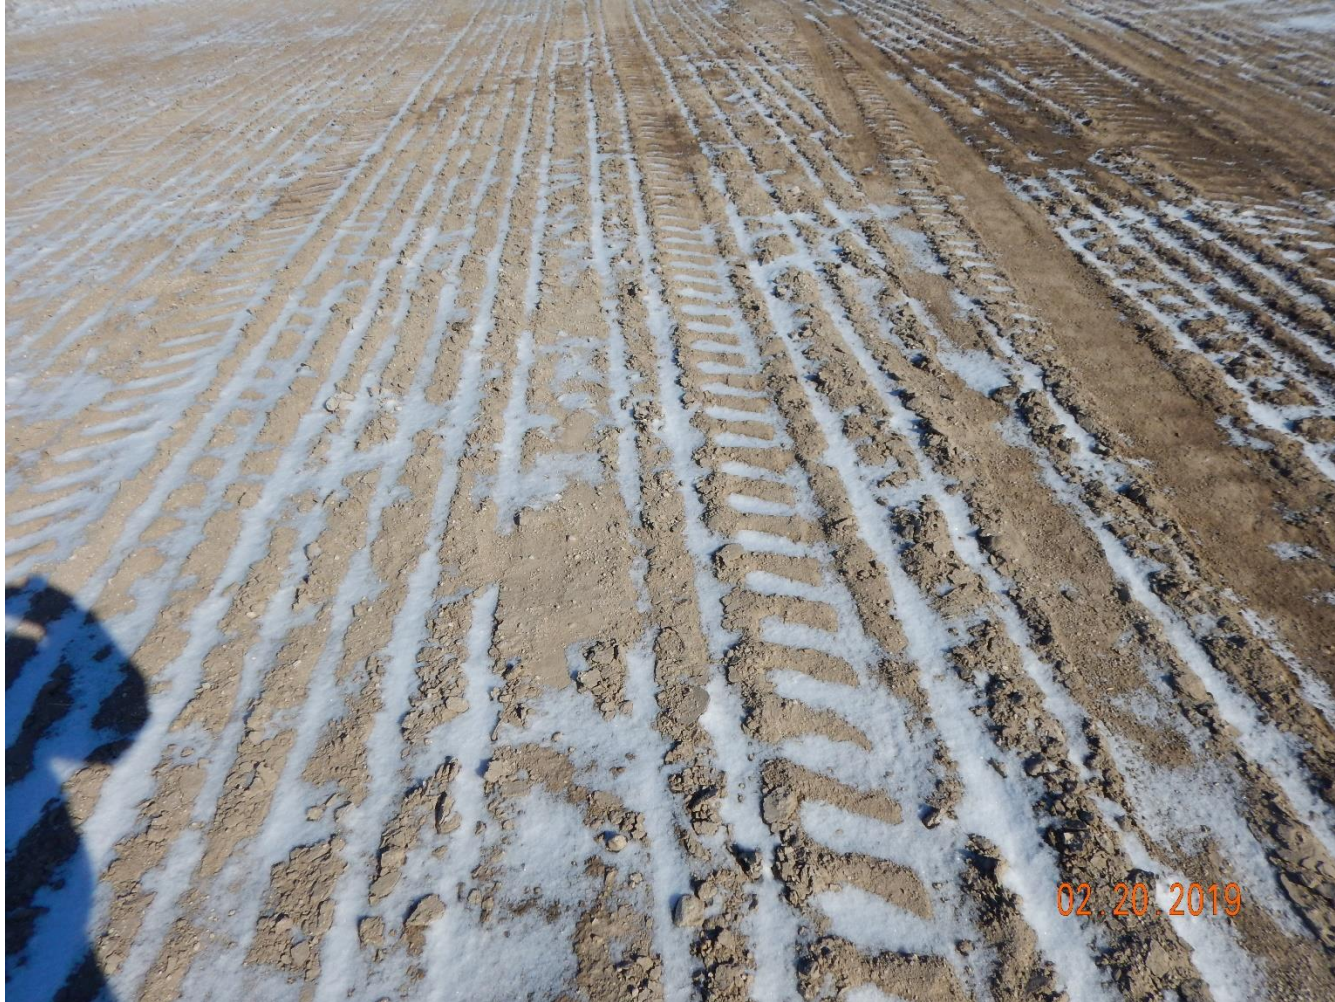
Photo 9: Photo taken from the interim areas west of the location. Photo shows the seeded soils of the interim areas remain bare and exposed. See comments under photo 3 regarding previous requirements for required stabilization controls.

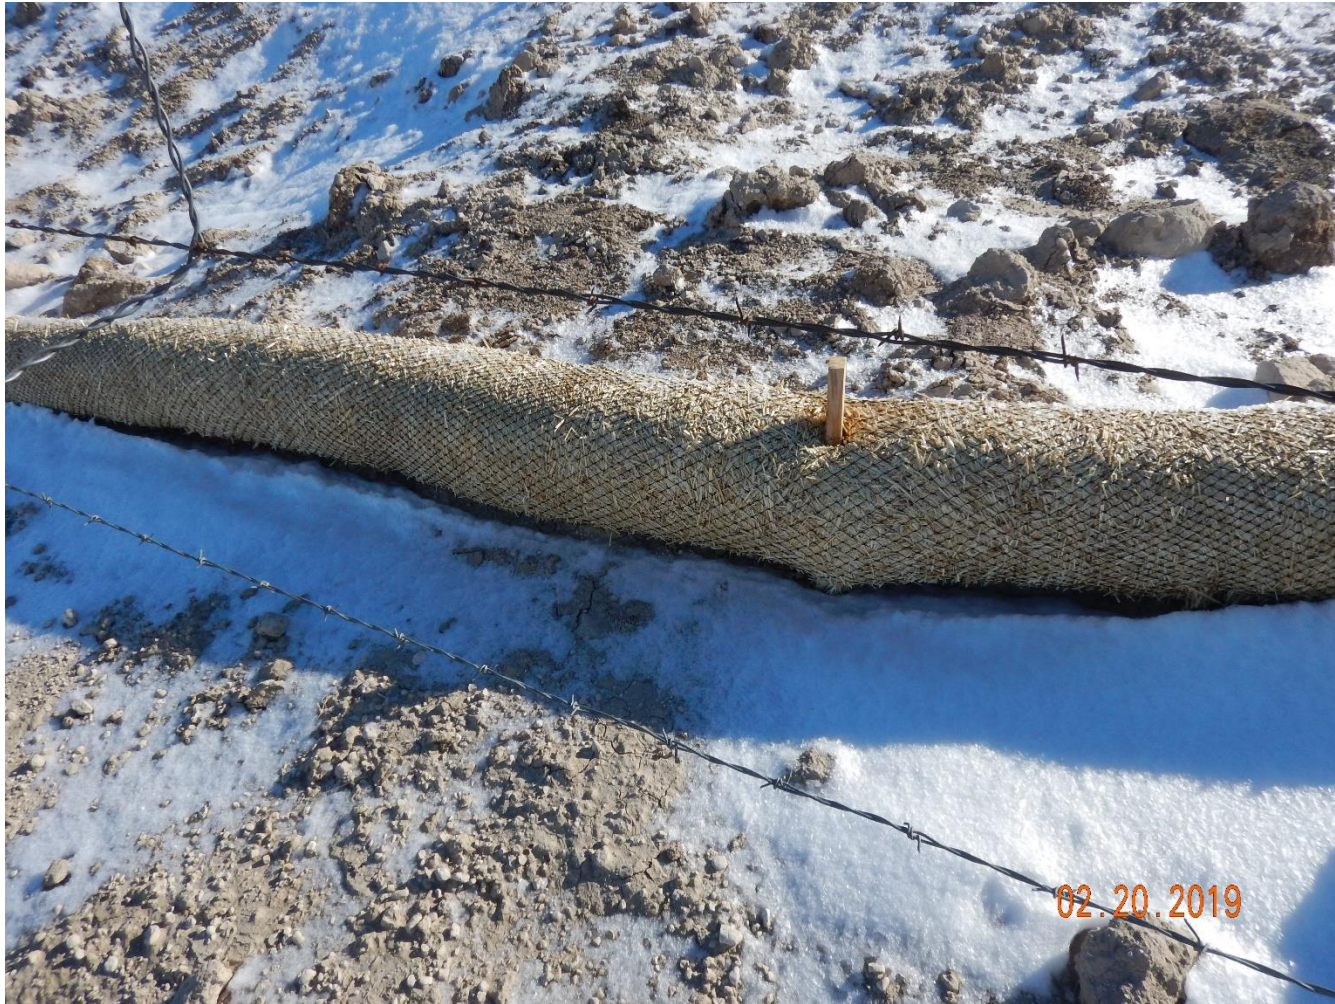
Photo 10: Photo taken from the base of the pit. Photo of erosion log. See comments under photo 8.

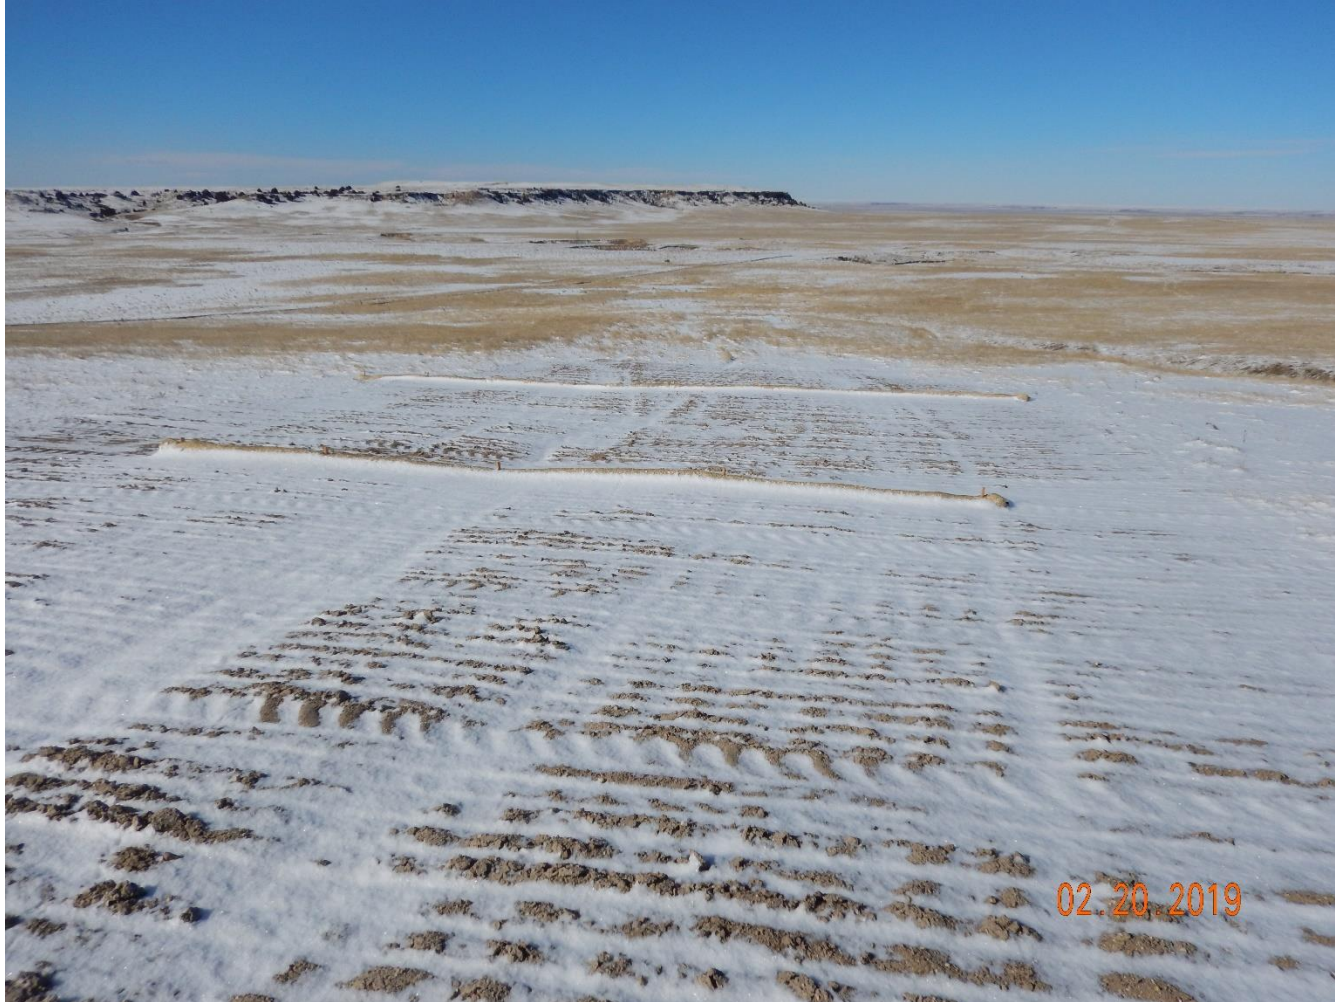
Photo 11: Photo taken from the interim areas west of the pit, facing west. See comments under photo 7.

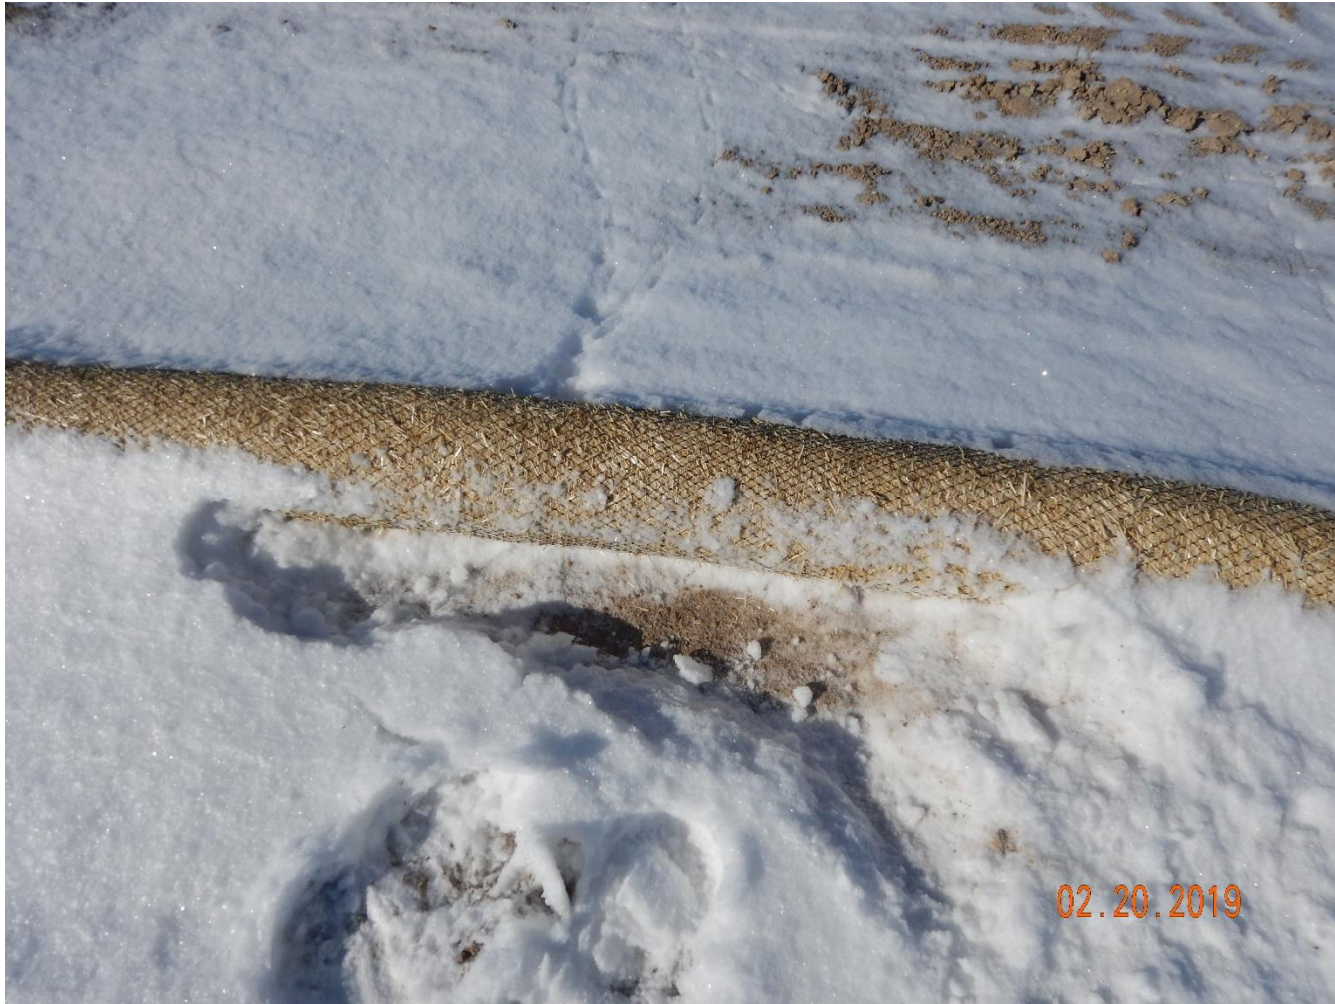
Photo 12: Continued from photo 11. Photo shows erosion log BMP. See comments under photo 8.
