# Inspection Photos

2/20/2019

Operator: WESTERN OPERATING COMPANY -  
95620

Location ID: 312291

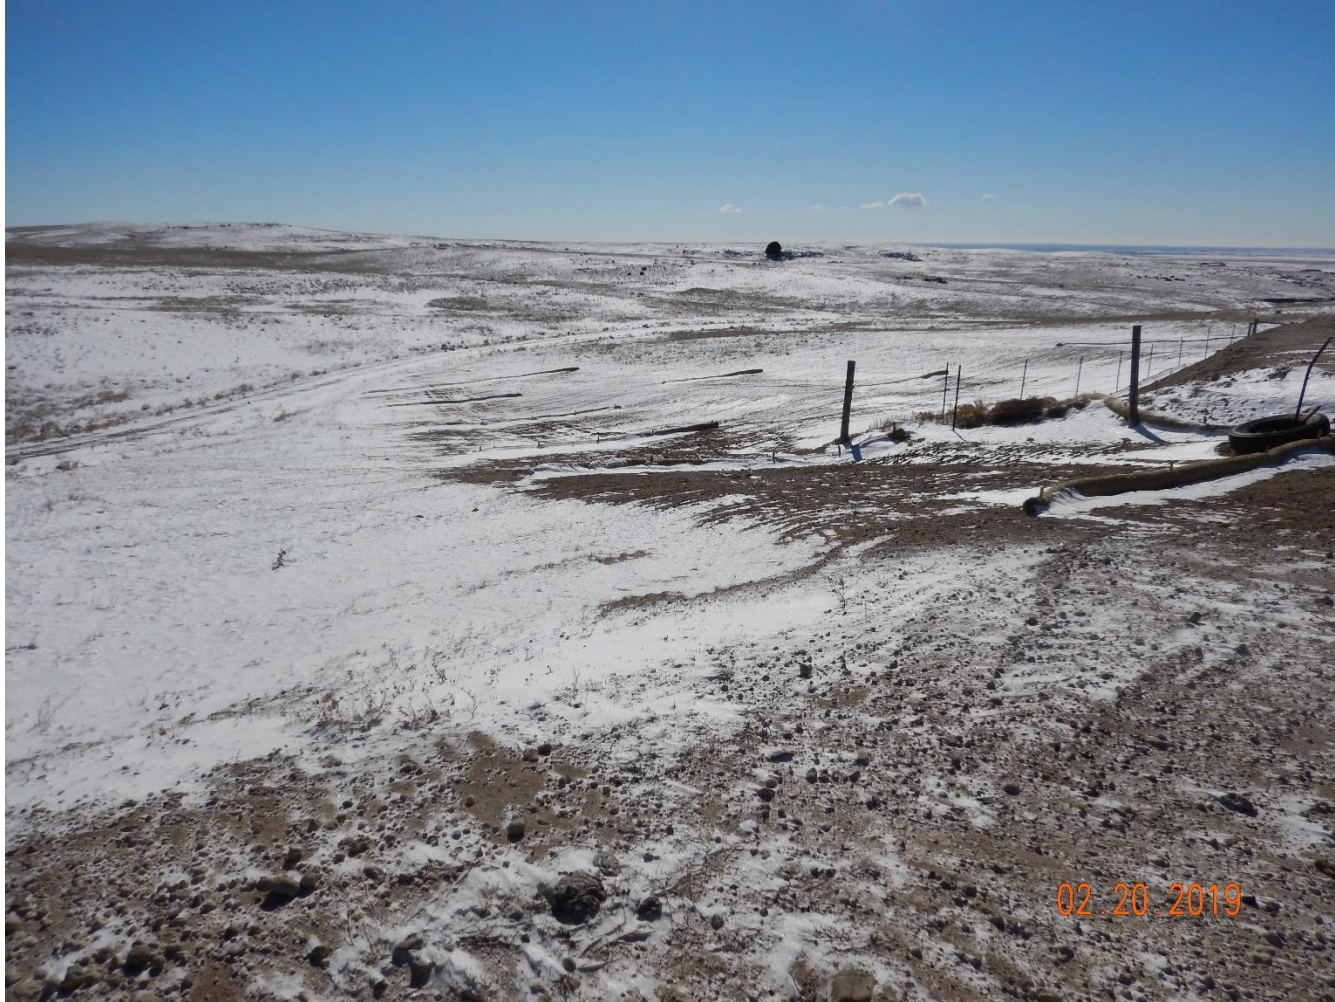
**Photo 1:** Photo taken from the end end of the location, facing southeast. Photo shows the disturbed areas down gradient of the pit and production areas. Photo shows operator appears to have placed erosion logs around the perimeter of the pit, and portions of the interim areas

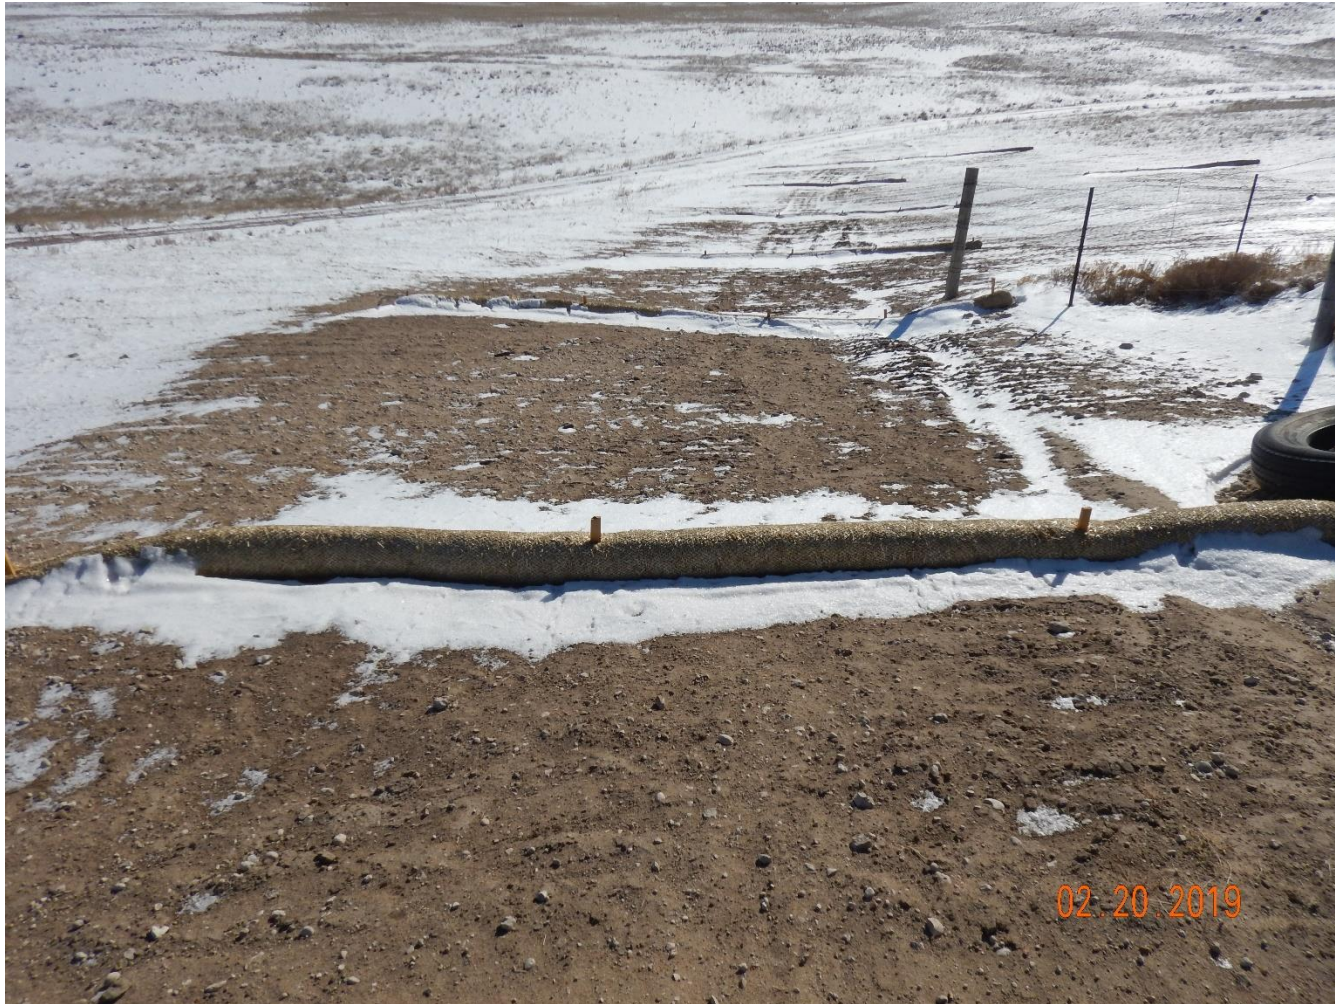
**Photo 2:** Continued from photo 1. Photo shows erosion log BMP. Erosion logs are sediment control barriers and ponding BMPs that intercept sheet flow runoff from disturbed areas, and are required to be trenched and back-filled in order to be in proper functioning condition. Photo shows Operator appears to have only placed/staked the erosion logs upon the surface of the soil; BMPs have not been trenched and back-filled in accordance with good engineering practices and are not in proper functioning condition.

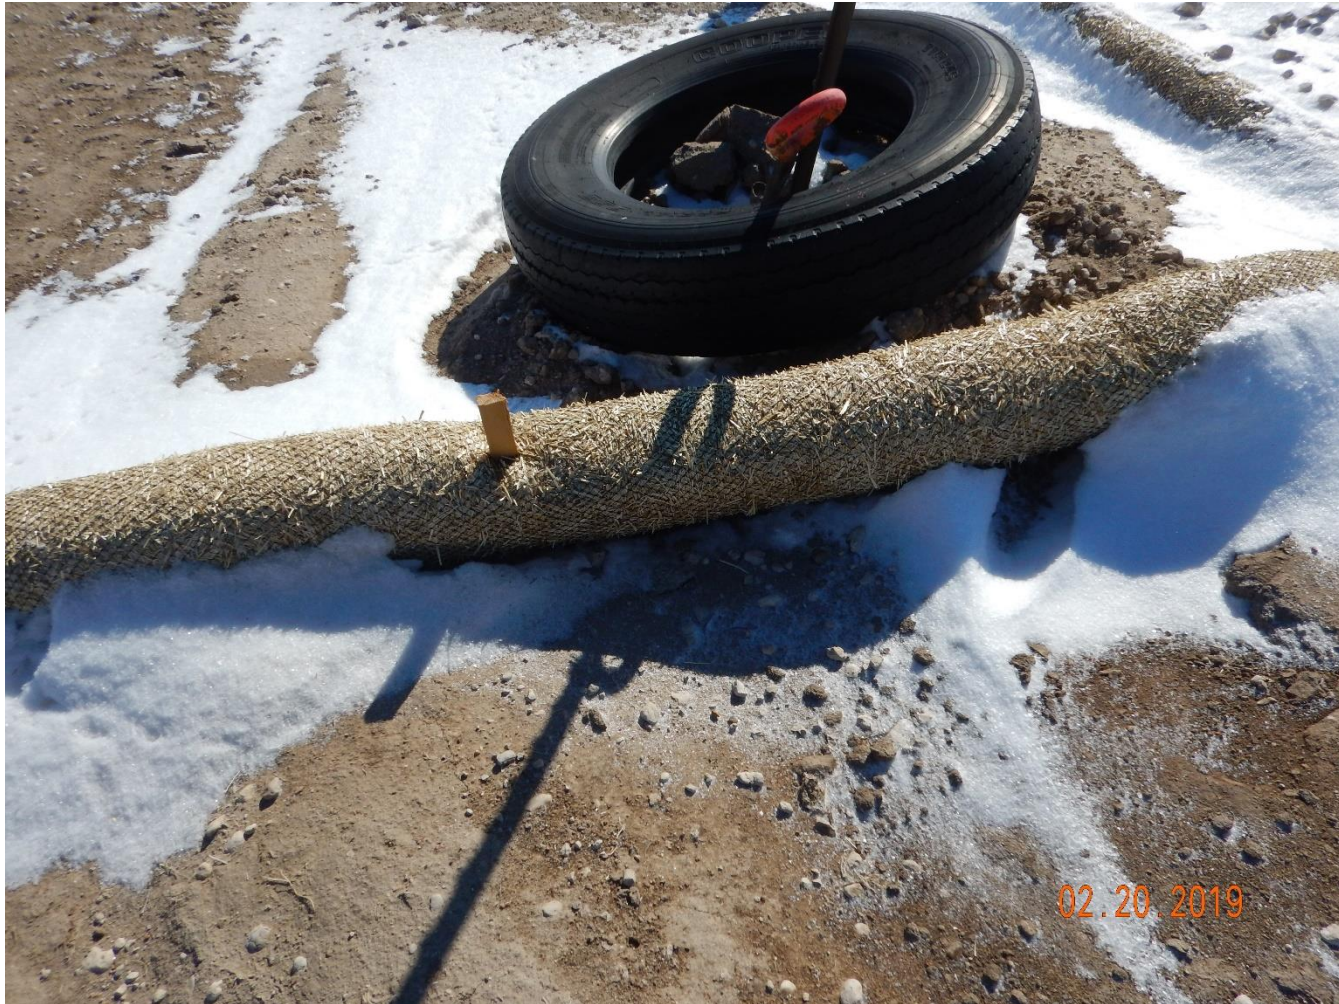
**Photo 3:** See comments under photo 2.

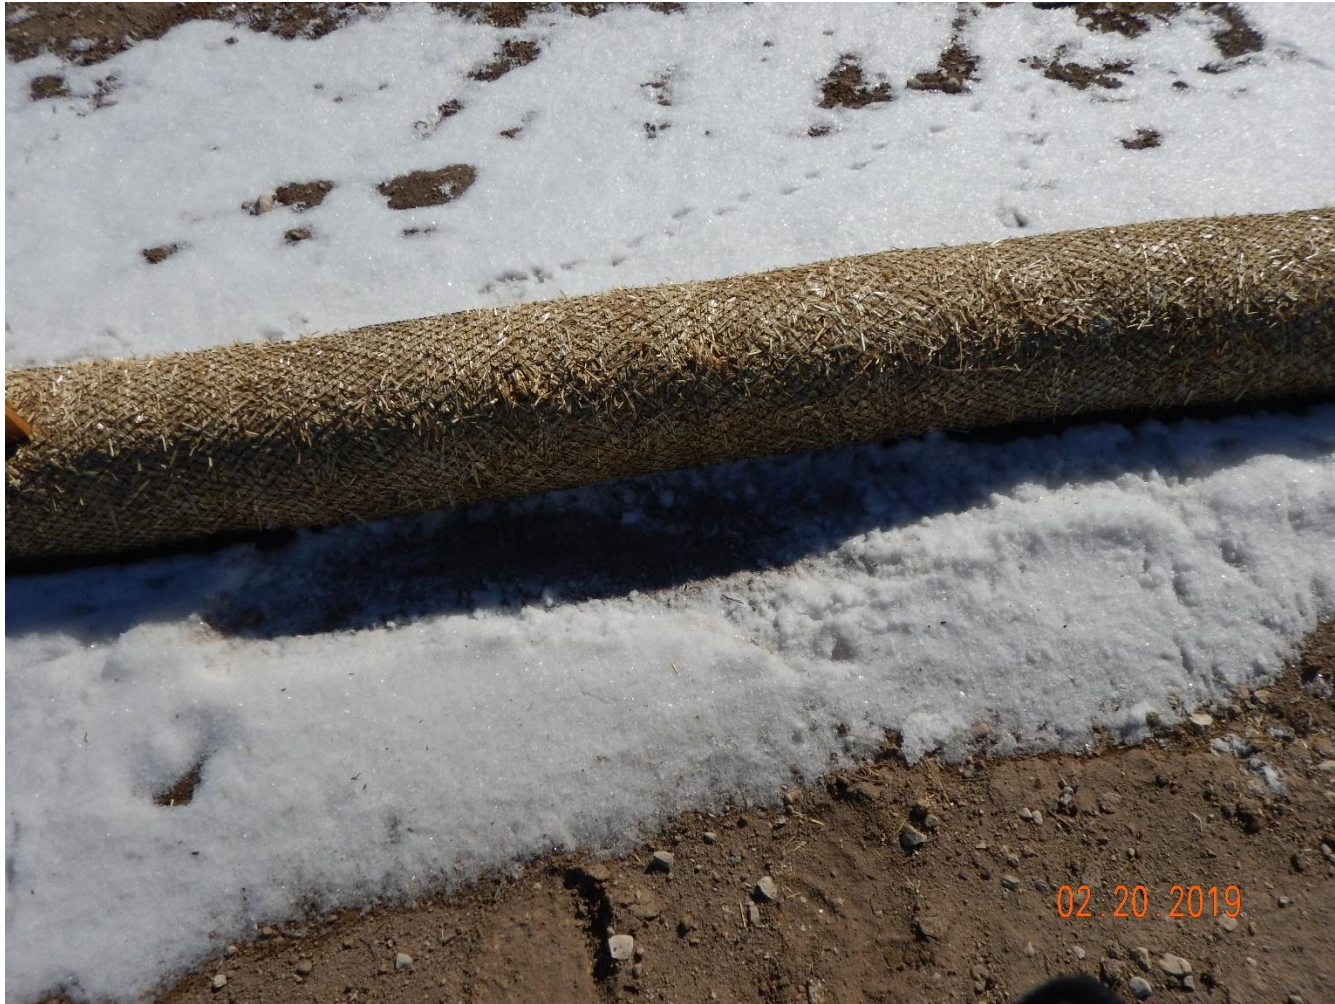
**Photo 4:** See comments under photo 2.

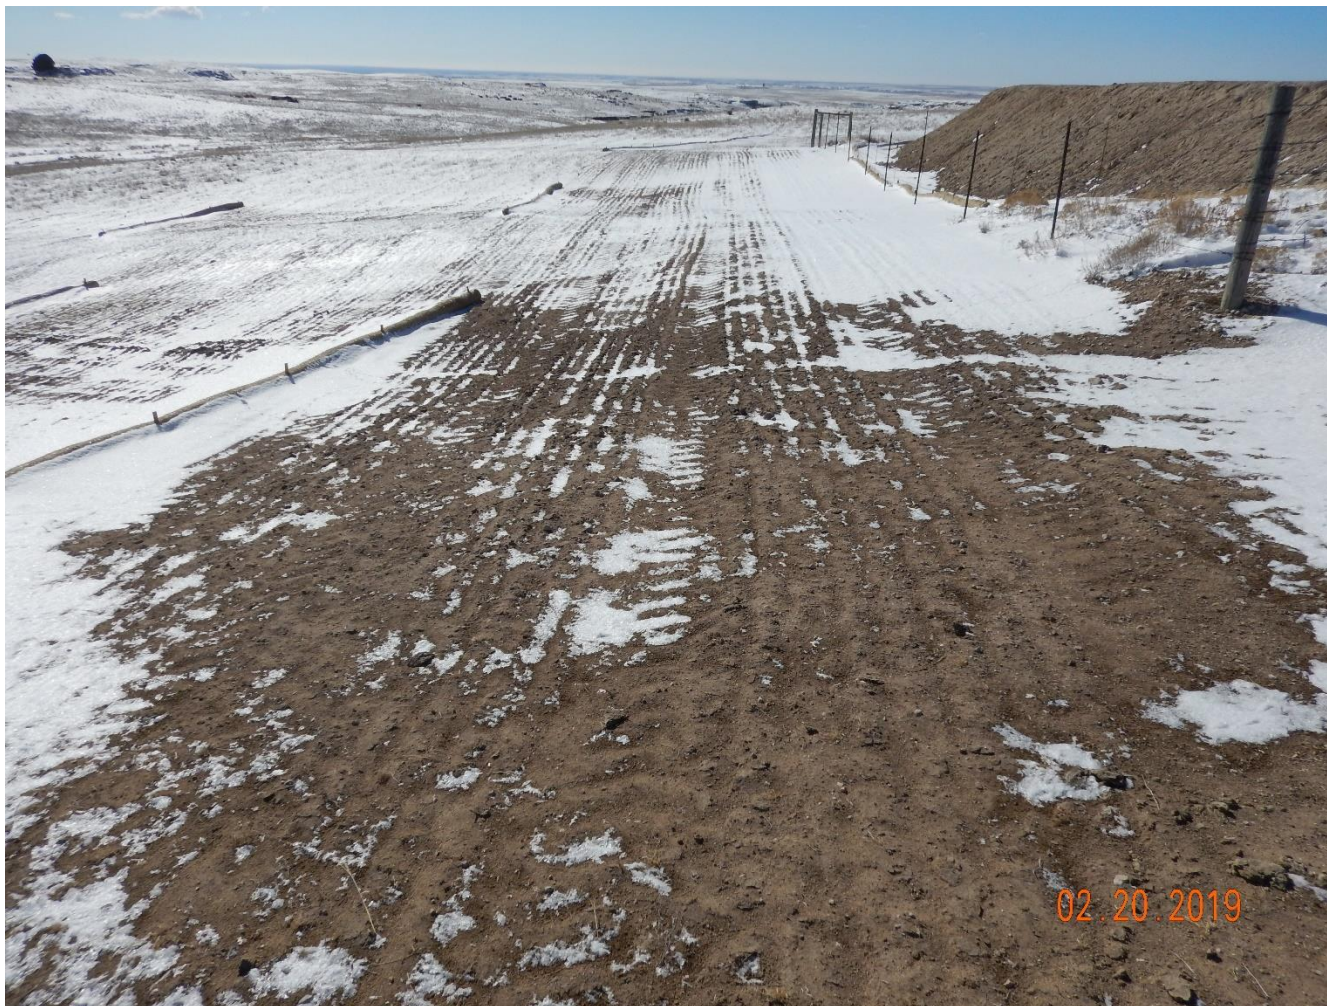
**Photo 5:** Photo taken from the disturbed interim areas on the east end of the pit. Photo shows the seeded soils of the interim areas remain bare and exposed. Previous inspections required stabilization control BMPs to stabilize the seeded soils to mitigate further erosion degradation. Unable to find evidence that stabilization controls have been installed/maintained; Areas downgrade of the pit and location remain at risk to erosion degradation. Parallel striations observed in the soils are likely a result from seeding activities using a no-till drill and are not considered to be (or suitable as) a stormwater and erosion control BMP.

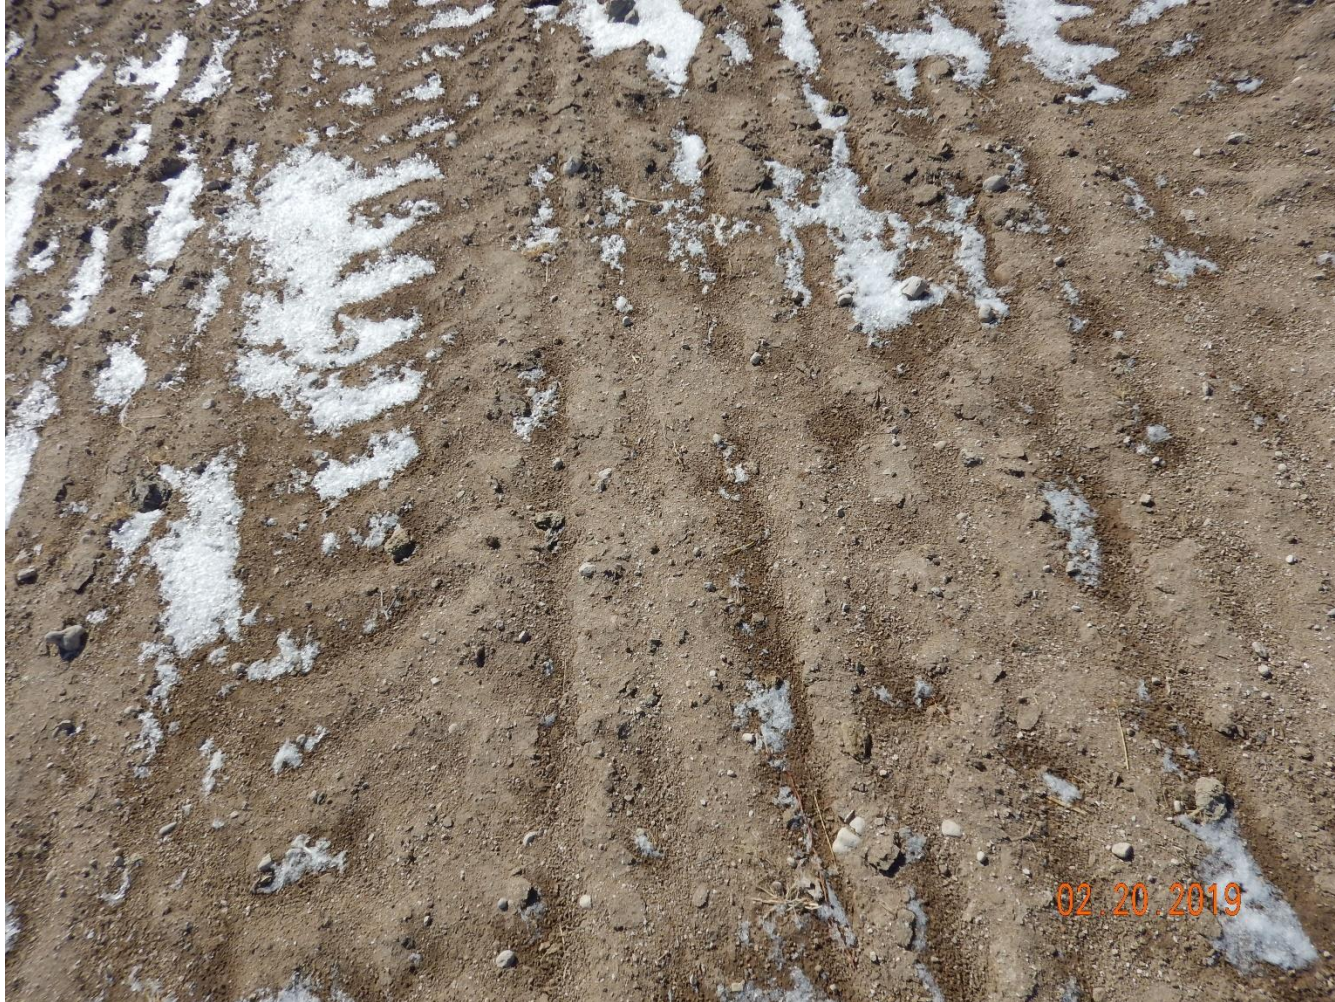
**Photo 6:** Continued from photo 5. See comments under photo 5.

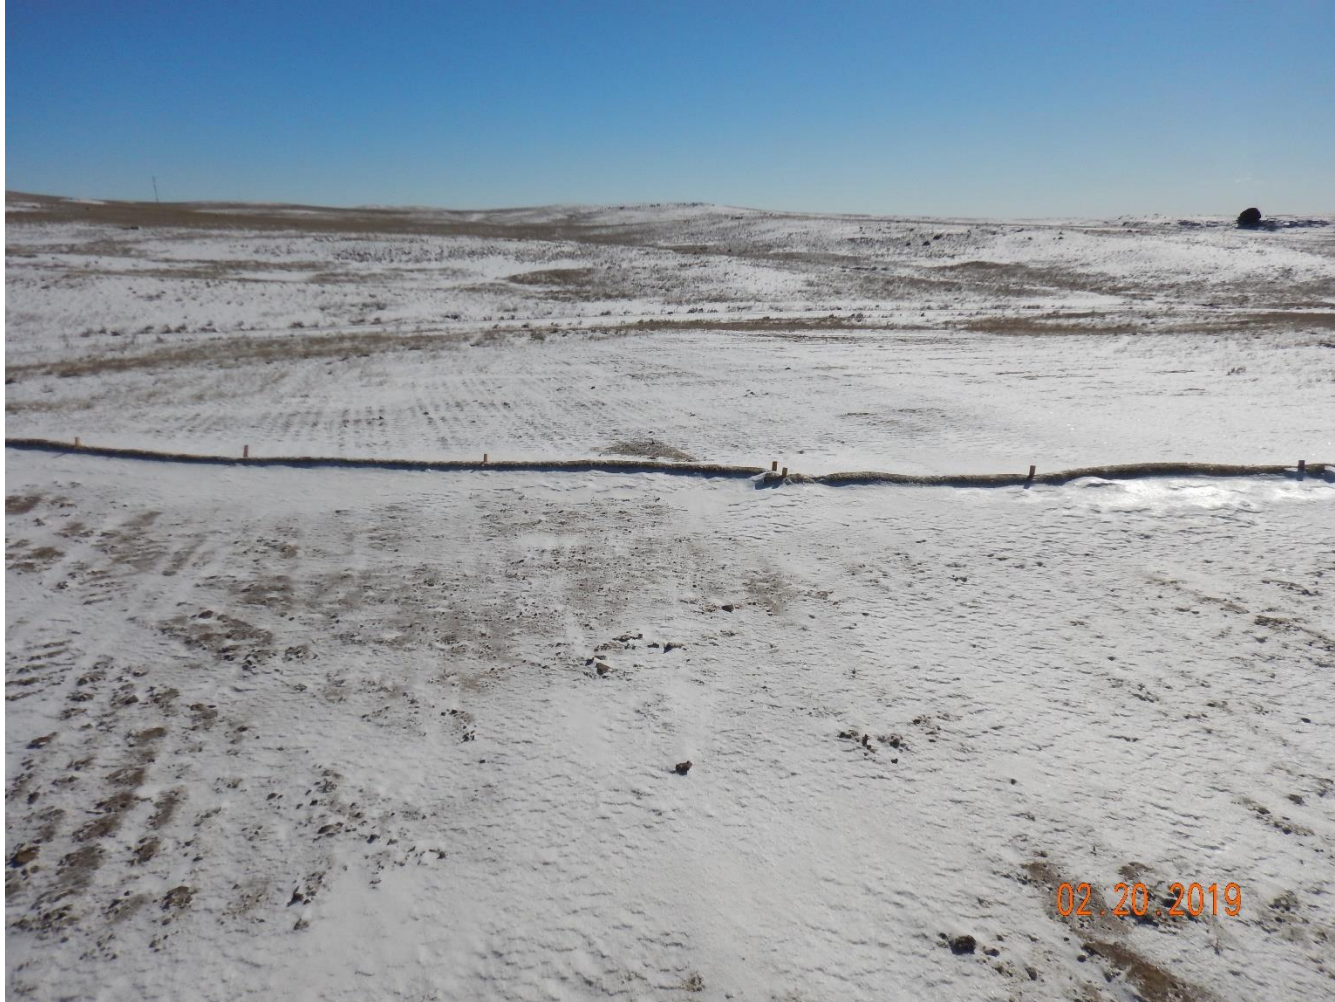
**Photo 7:** Photo taken from the southeast interim areas (Southeast end of pit), facing southeast. Photo of erosion log. See comments under photo 2.

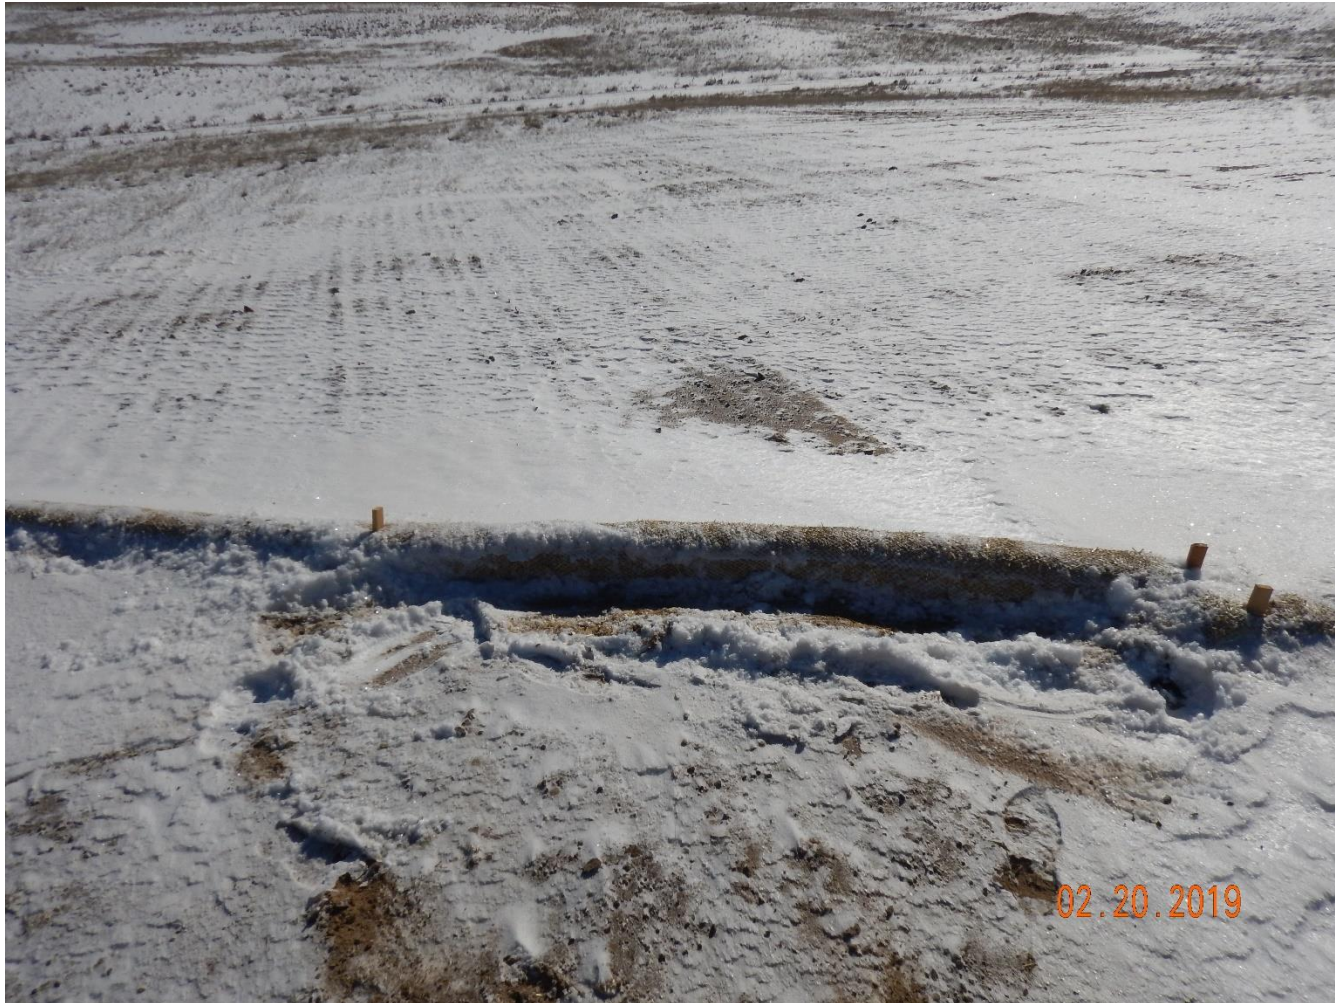
**Photo 8:** Continued from photo 7. Photo shows erosion log has not been trenched and backfilled in accordance with good engineering practices. See comments under photo 2. Photo also shows operator appears to have seeded with the contour of the slope, rather than along the contour. This is not advised as seed rows can concentrate stormwater flows down the slope and facilitate rill and gully erosion.

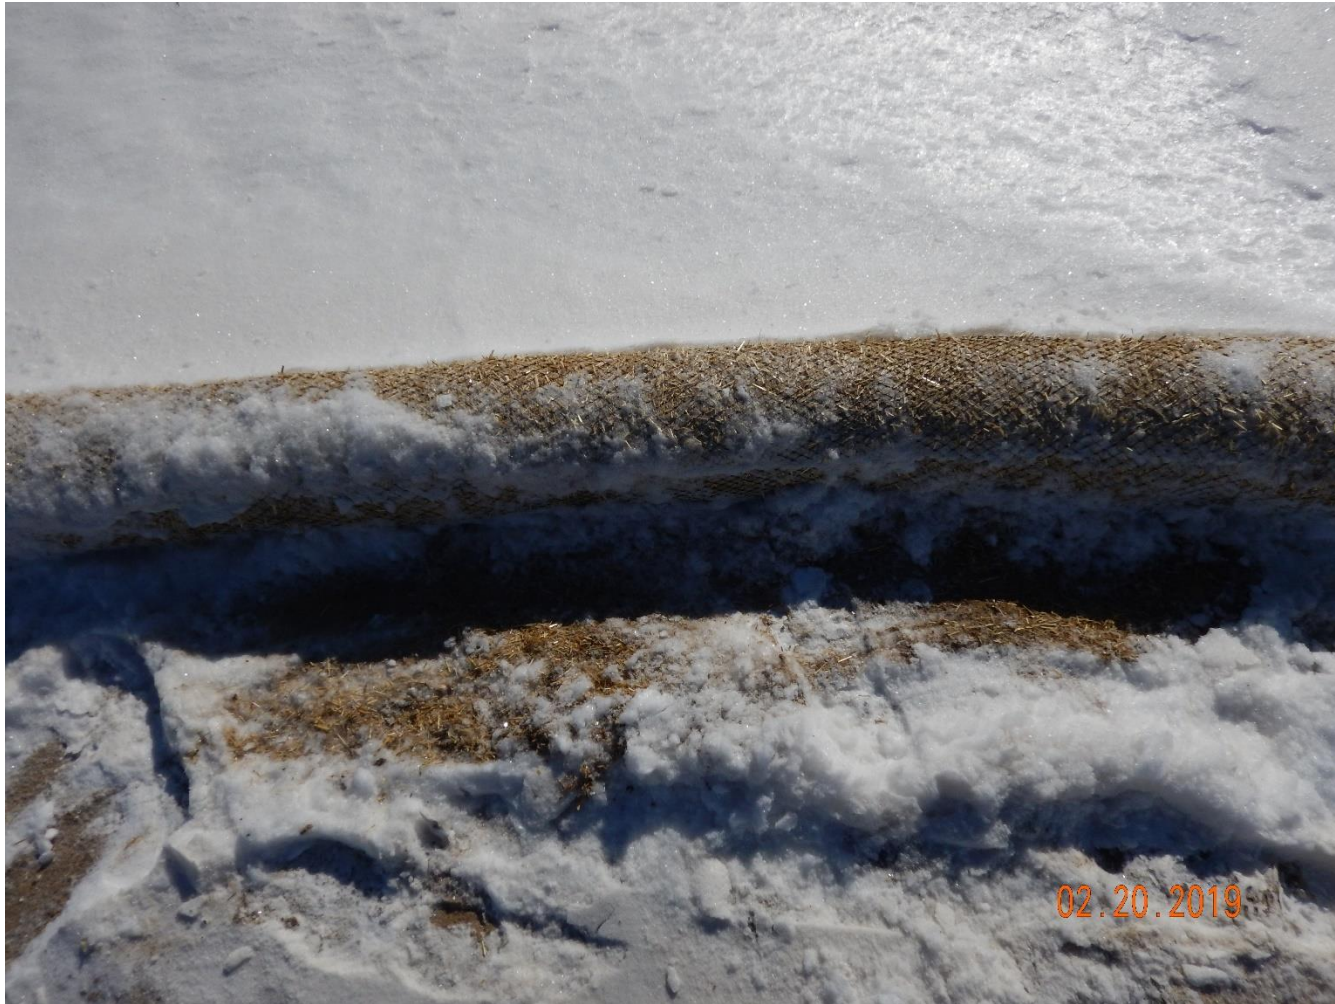
**Photo 9:** Continued from photo 8. Photo shows erosion log has not been trenched and backfilled in accordance with good engineering practices. See comments under photo 2

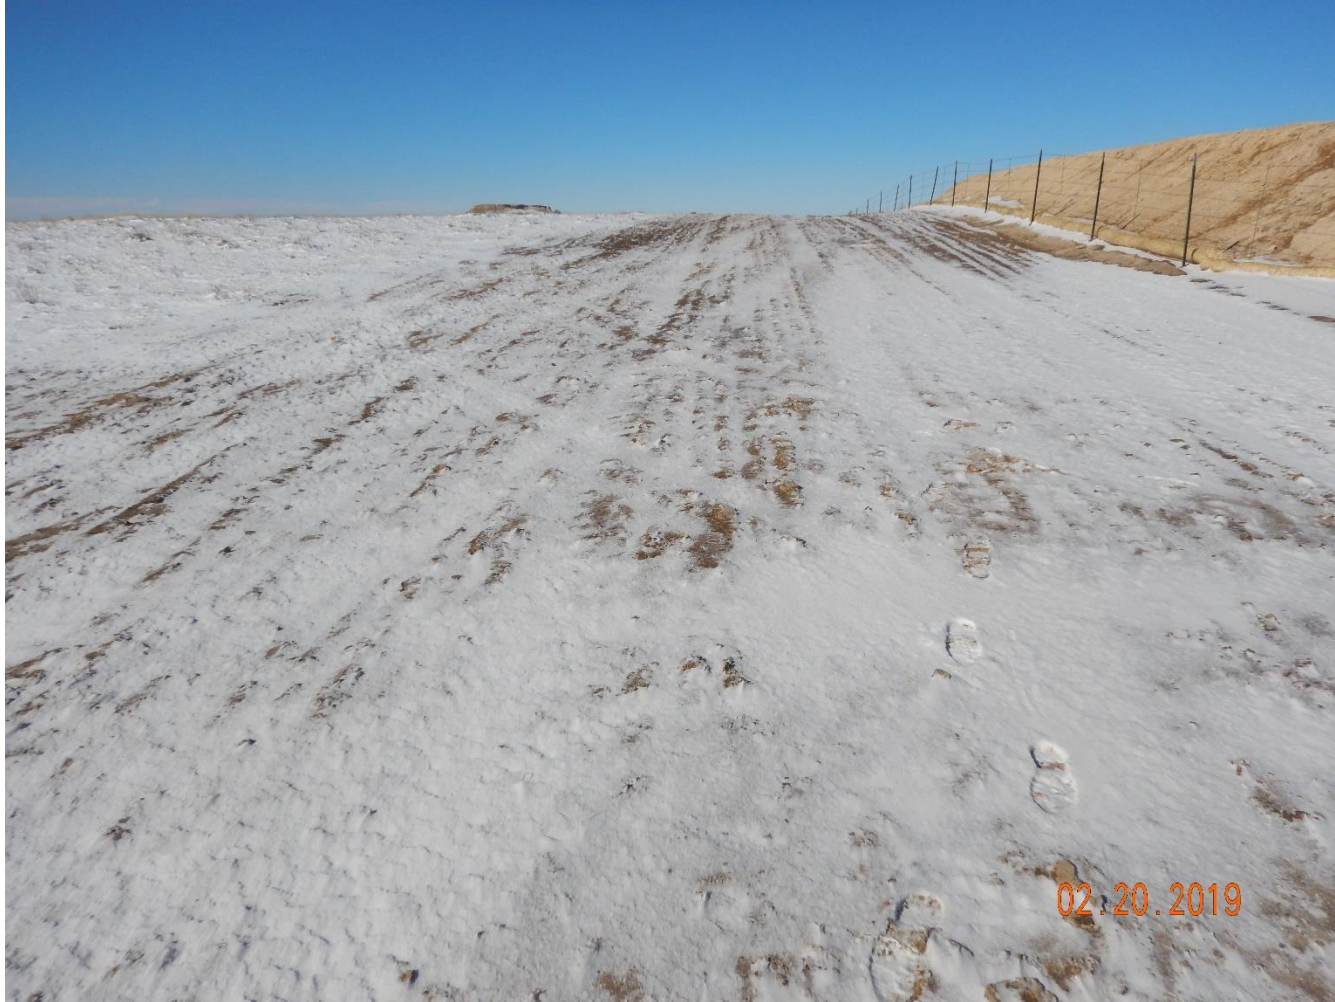
**Photo 10:** Photo taken from the southeast interim areas (Southeast end of pit), facing west. See comments under photo 5.

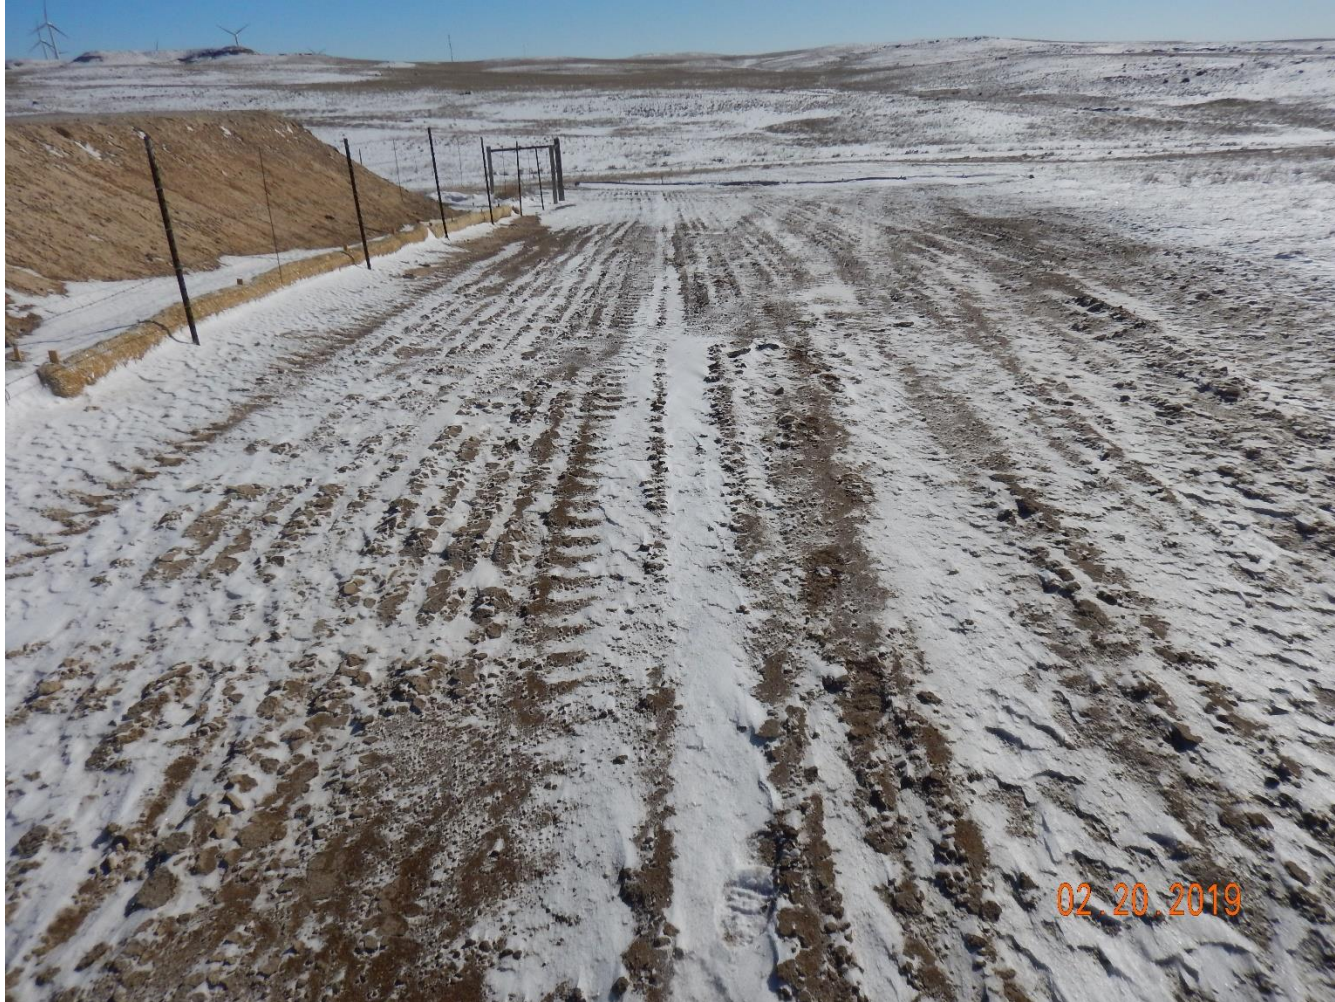
**Photo 11:** Photo taken from the south end of the pit, facing east. See comments under photo 5.

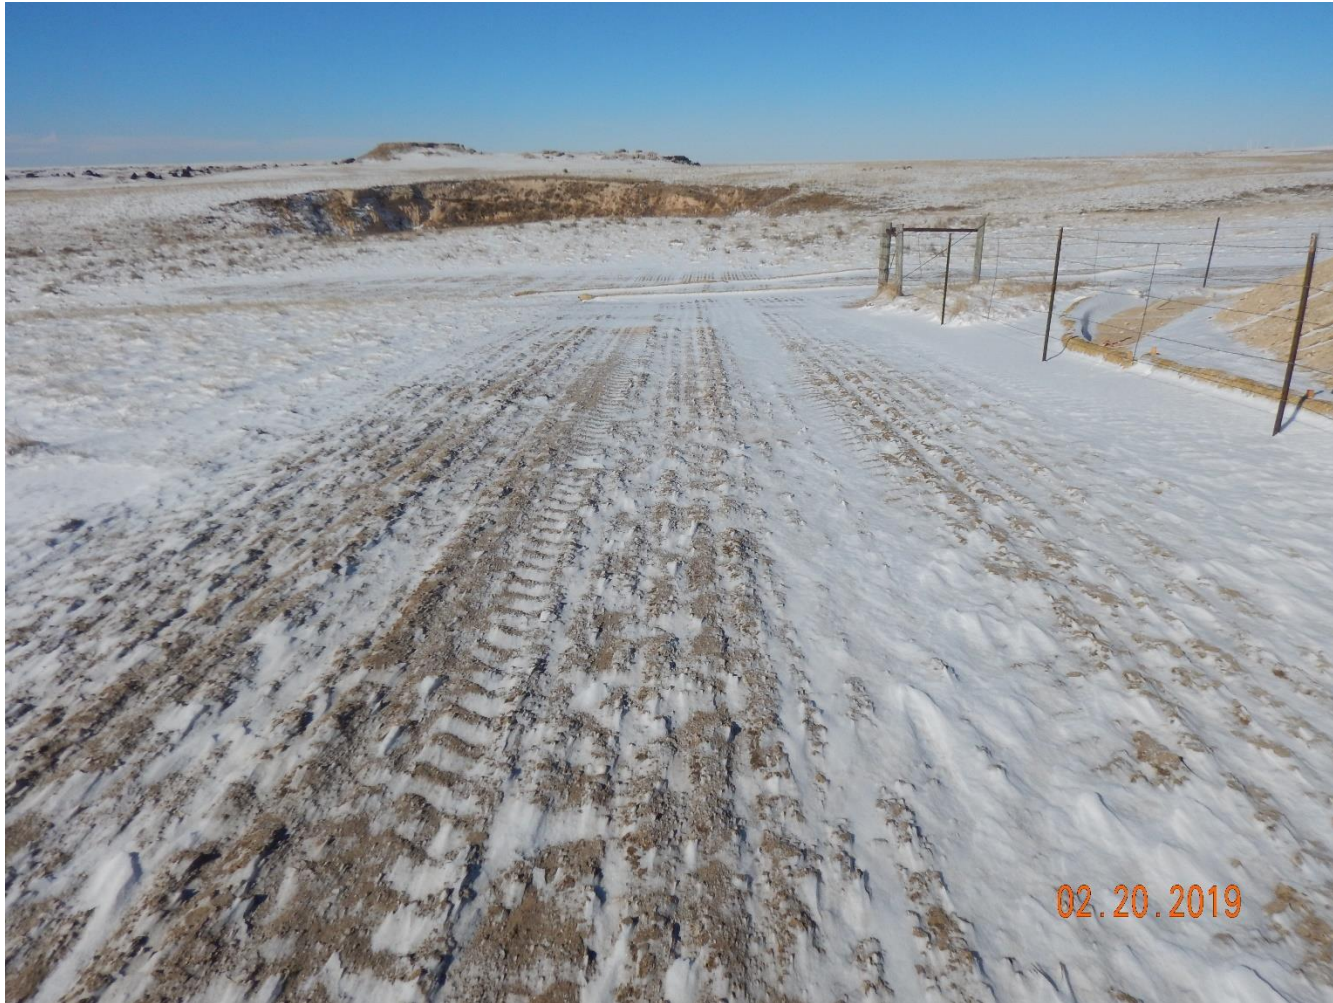
**Photo 12:** Photo taken from the south end of the pit, facing west. See comments under photo 5.

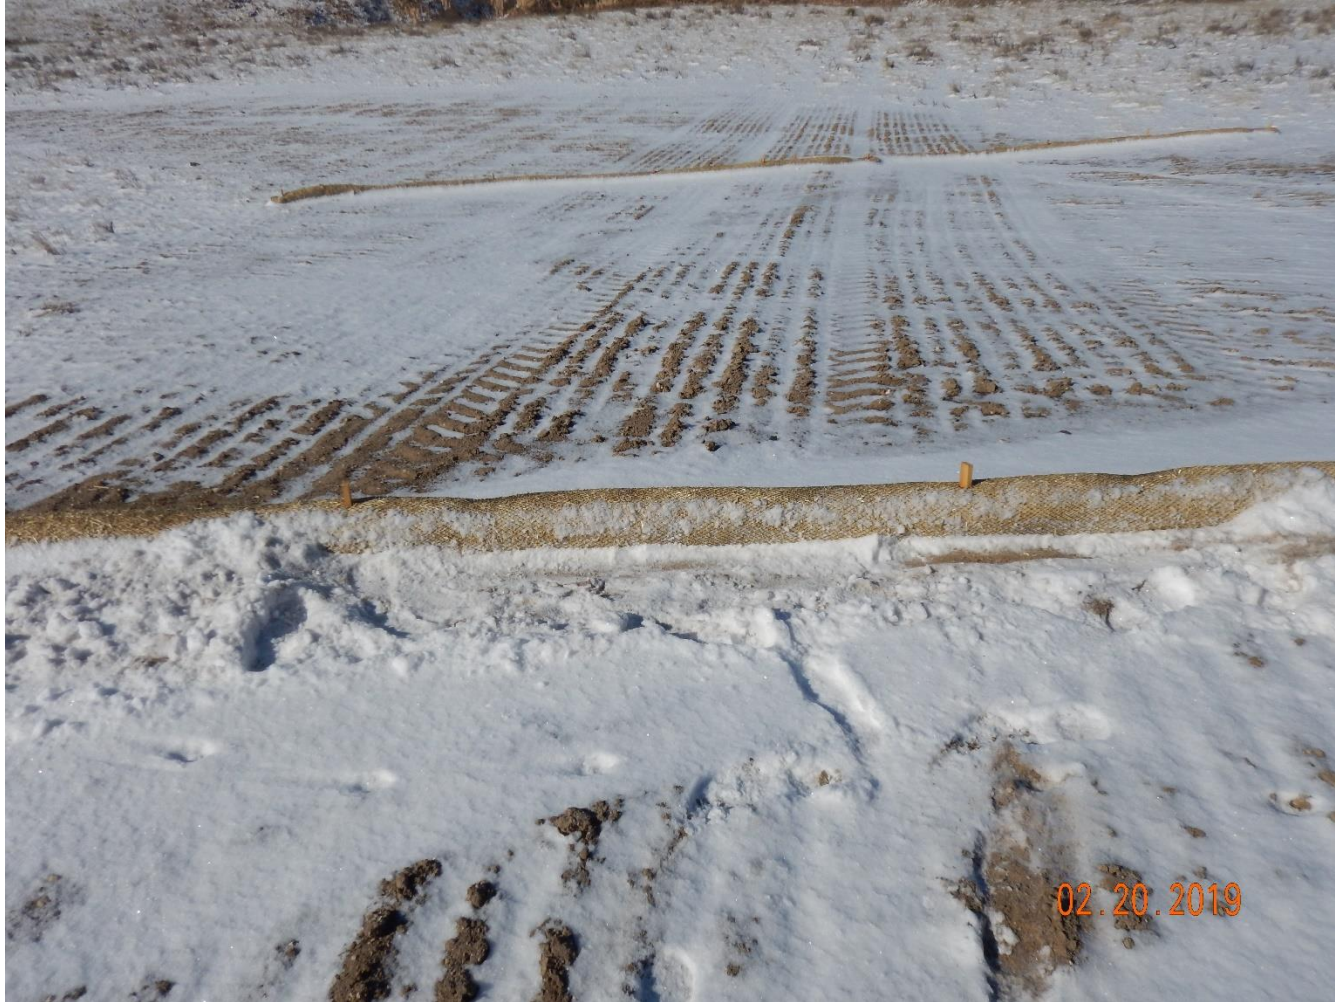
**Photo 13:** Photo taken from the southwest interim areas (southwest of pit) facing west. Photo shows erosion log has not been trenched and backfilled in accordance with good engineering practices. See comments under photo 2.

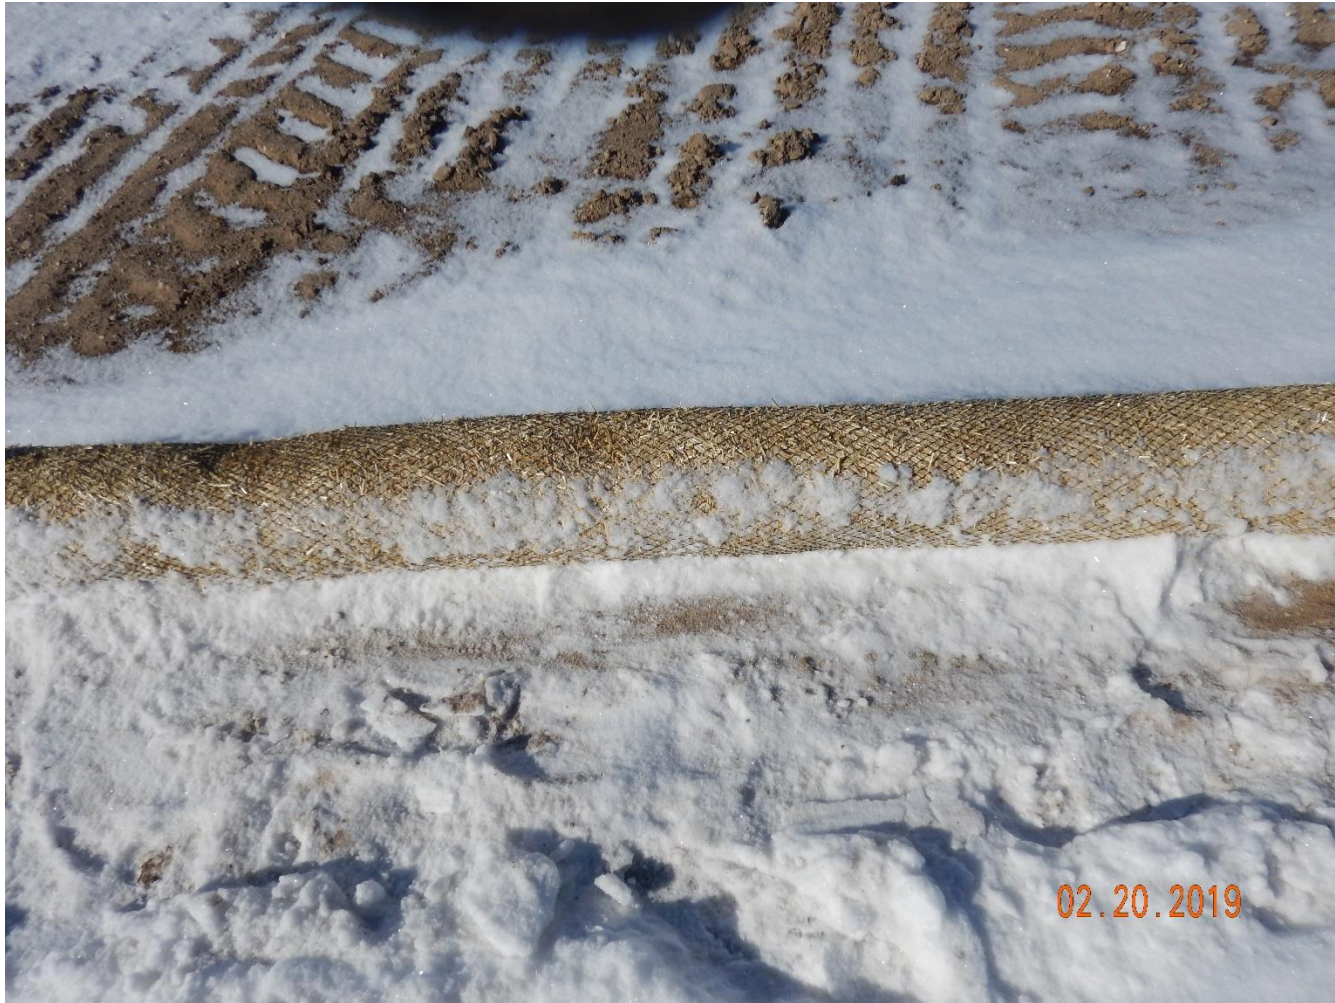
**Photo 14:** Continued from photo 13. Photo shows erosion log has not been trenched and backfilled in accordance with good engineering practices

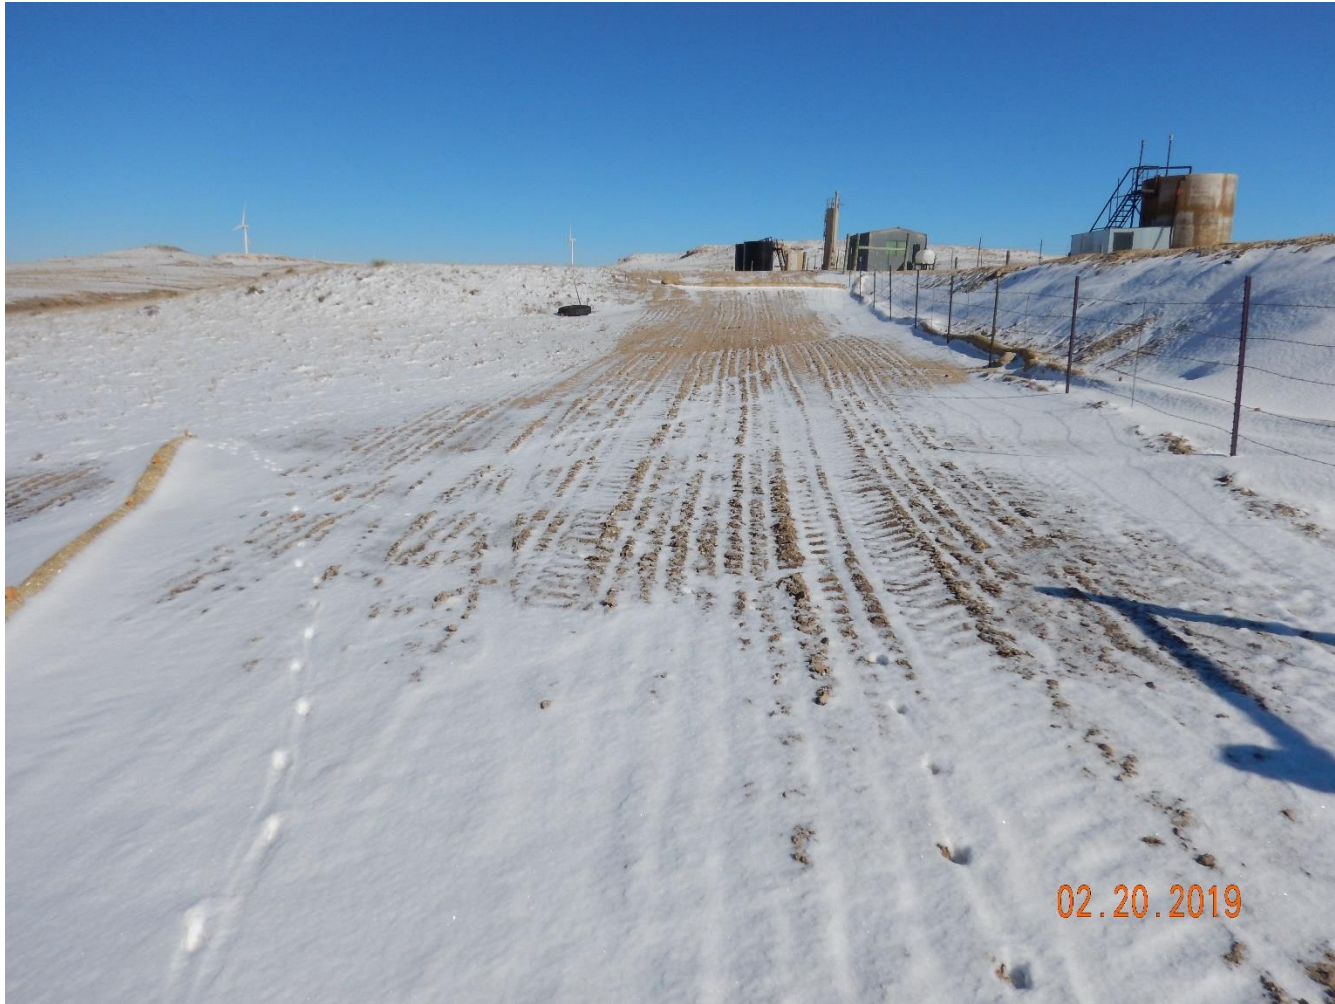
**Photo 15:** Photo taken from the southwest interim areas (southwest of pit) facing north. See comments under photo 5.

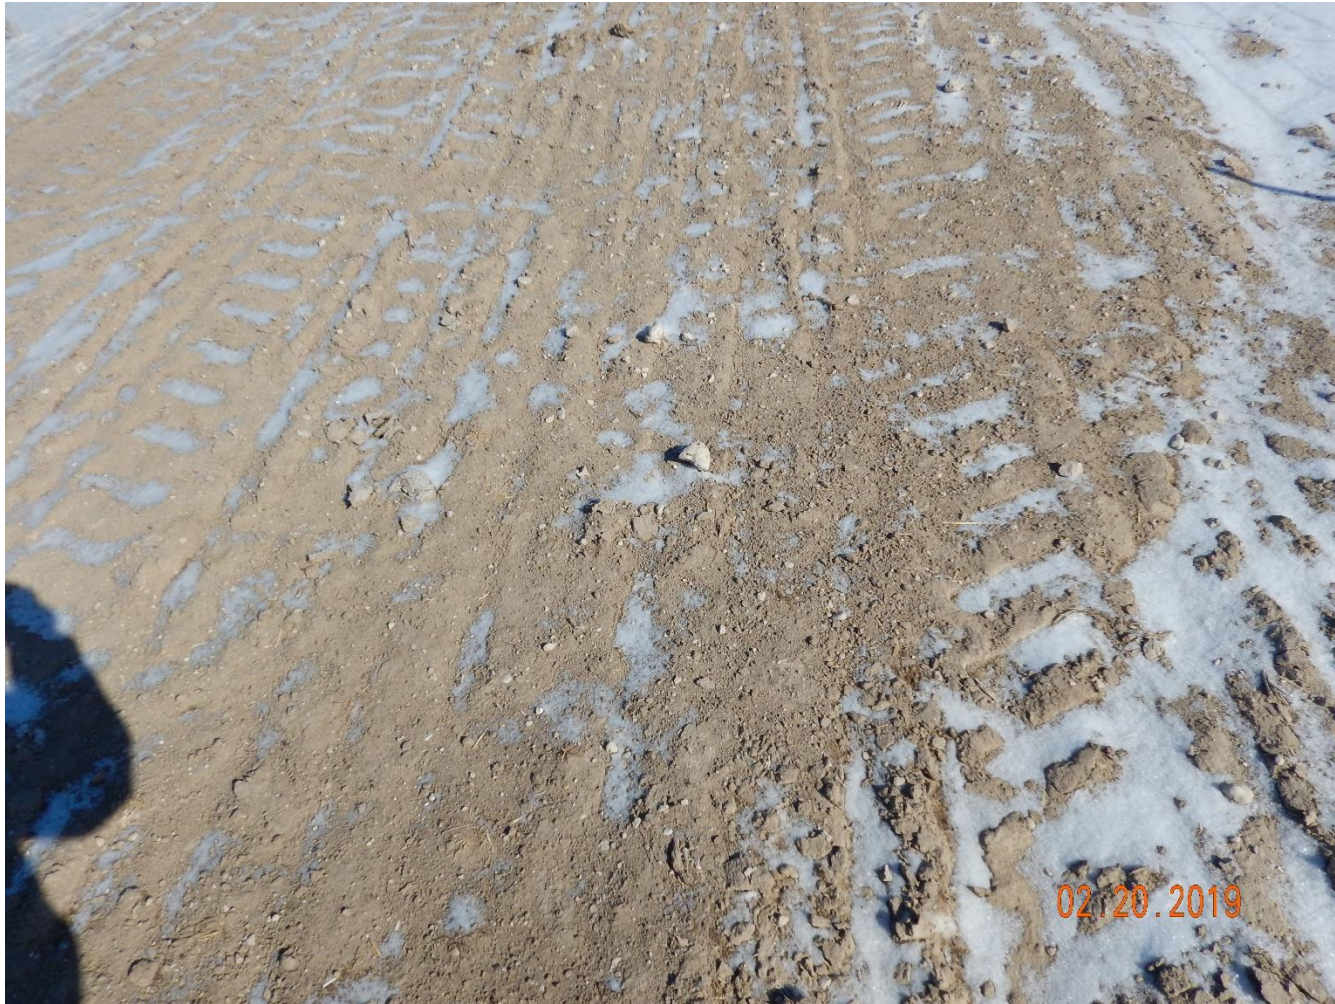
**Photo 16:** Photo taken from the disturbed interim areas on the west end of the pit. Photo shows the seeded soils of the interim areas remain bare and exposed. Previous inspections required stabilization control BMPs to stabilize the seeded soils to mitigate further erosion degradation. Unable to find evidence that stabilization controls have been installed/maintained; Areas downgrade of the pit and location remain at risk to erosion degradation.
