Inspection Photos

API: 05-071-06559

Operator: PIONEER NATURAL RESOURCES

Inspection Date: 2/14/2019

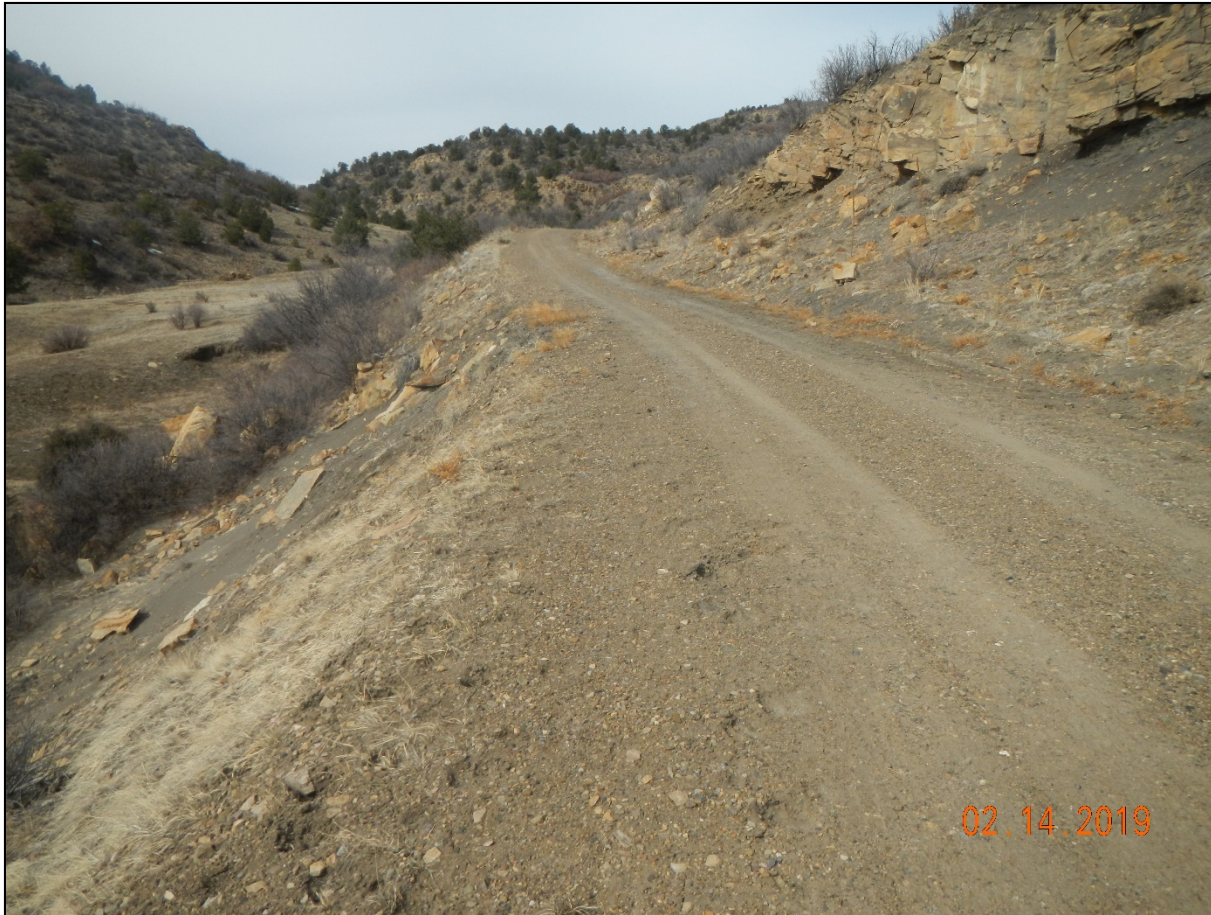
Photo 1. Facing northwest along the access road.

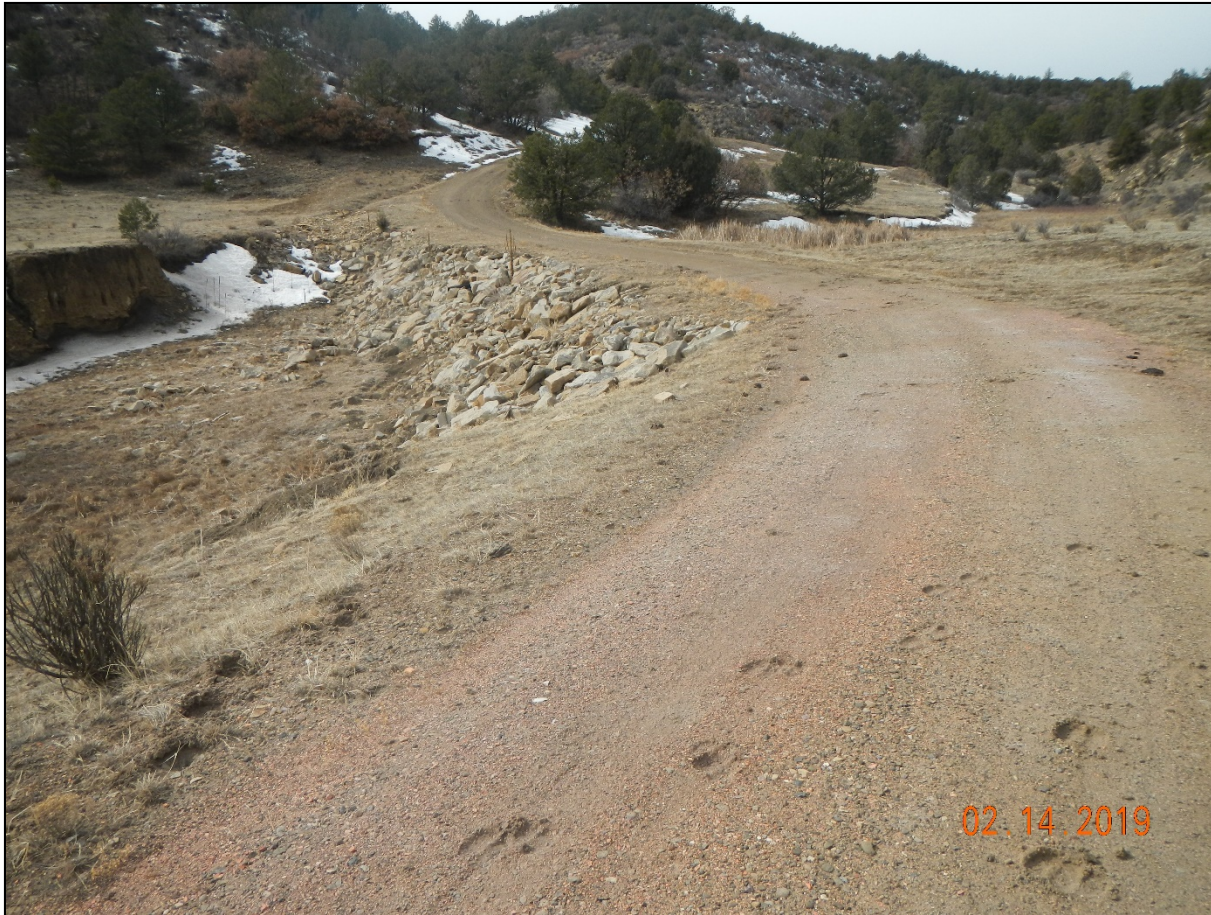
Photo 2. Facing northwest along the access road.

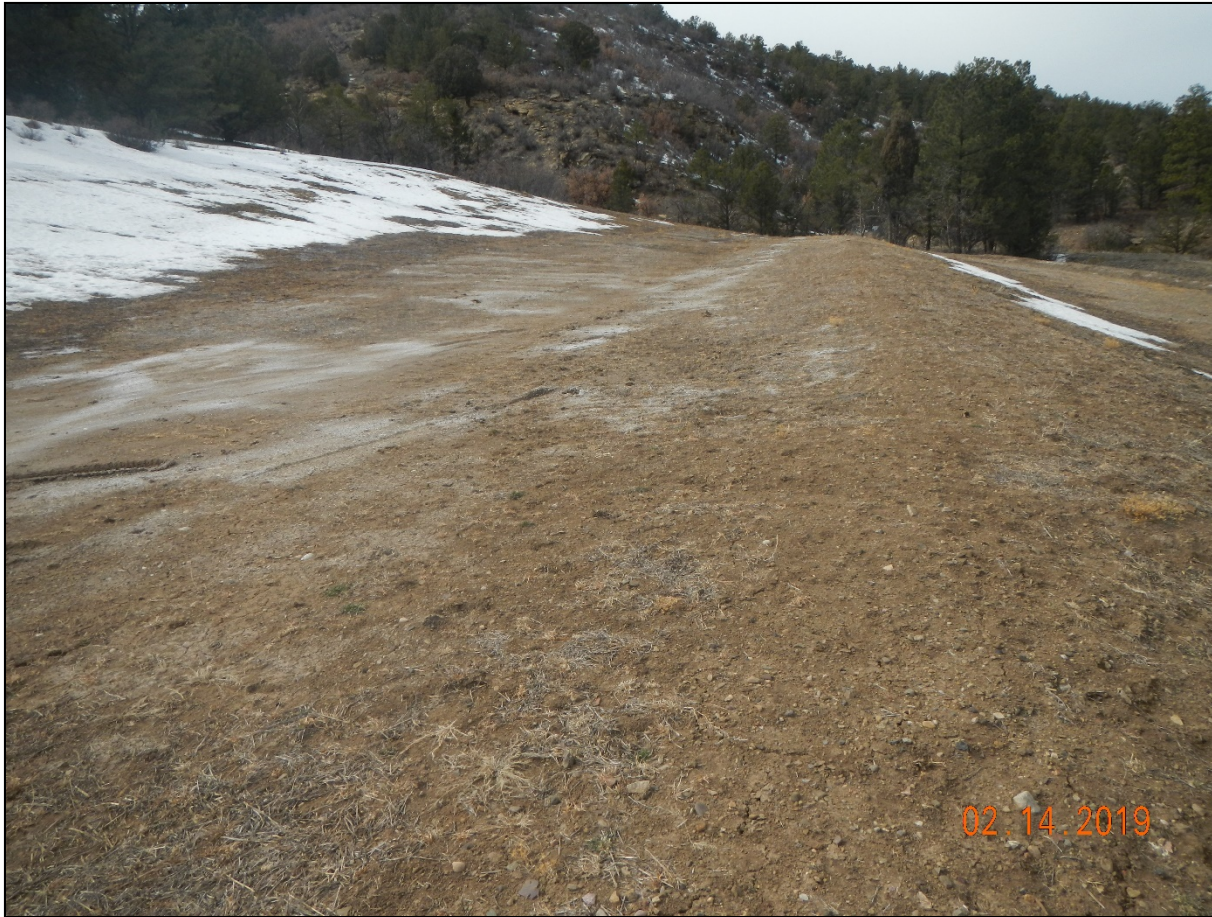
Photo 3. Facing northwest toward the location.

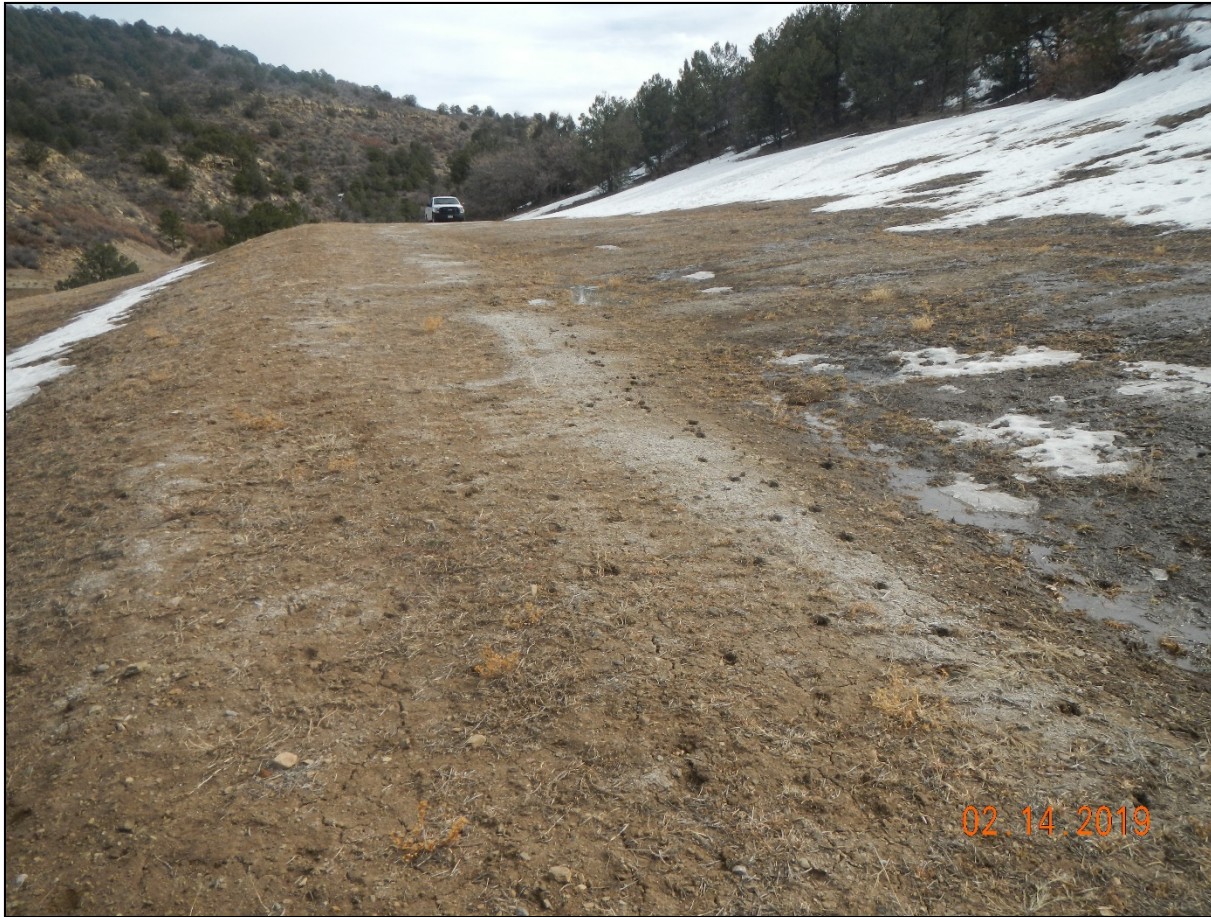
Photo 4. Facing southeast toward the location.

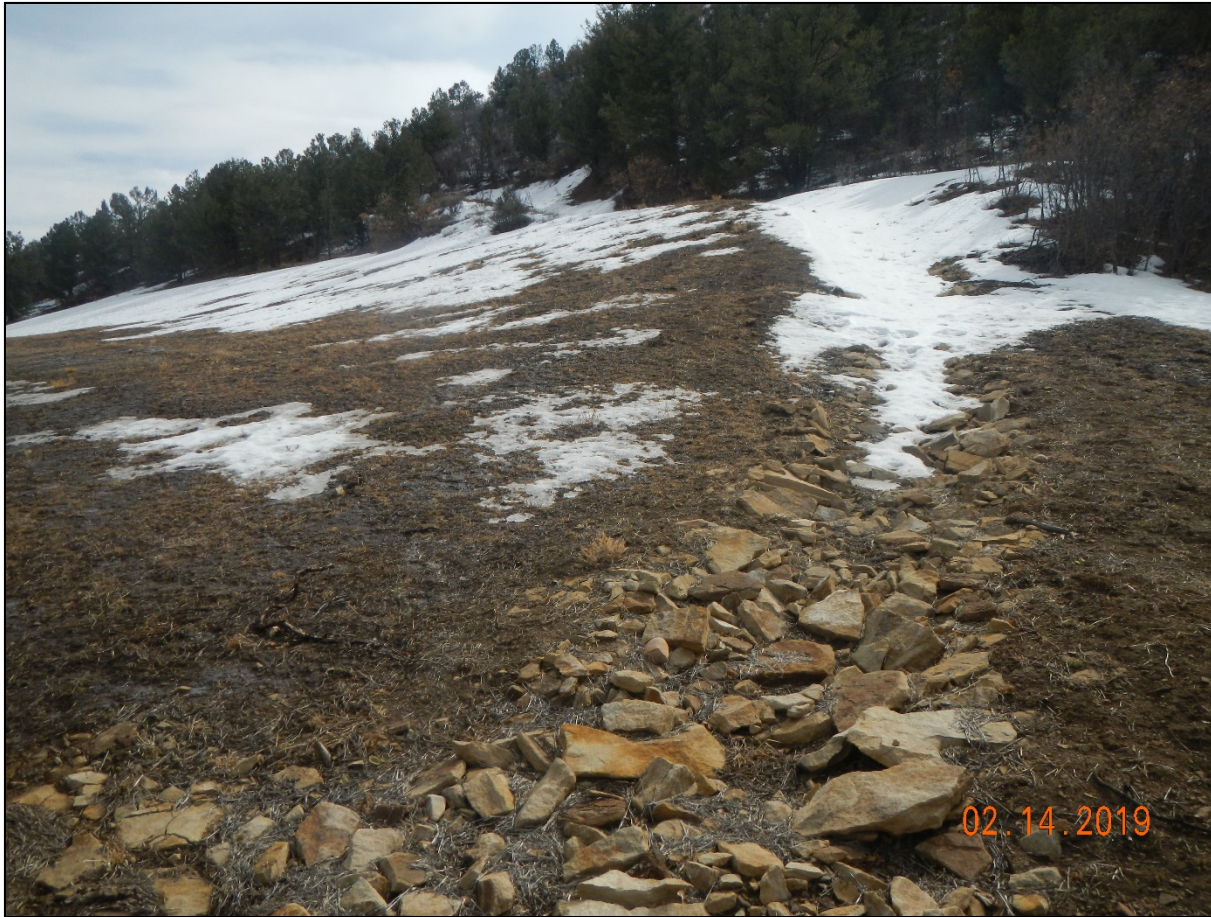
Photo 5. Facing southeast toward the cutslope.

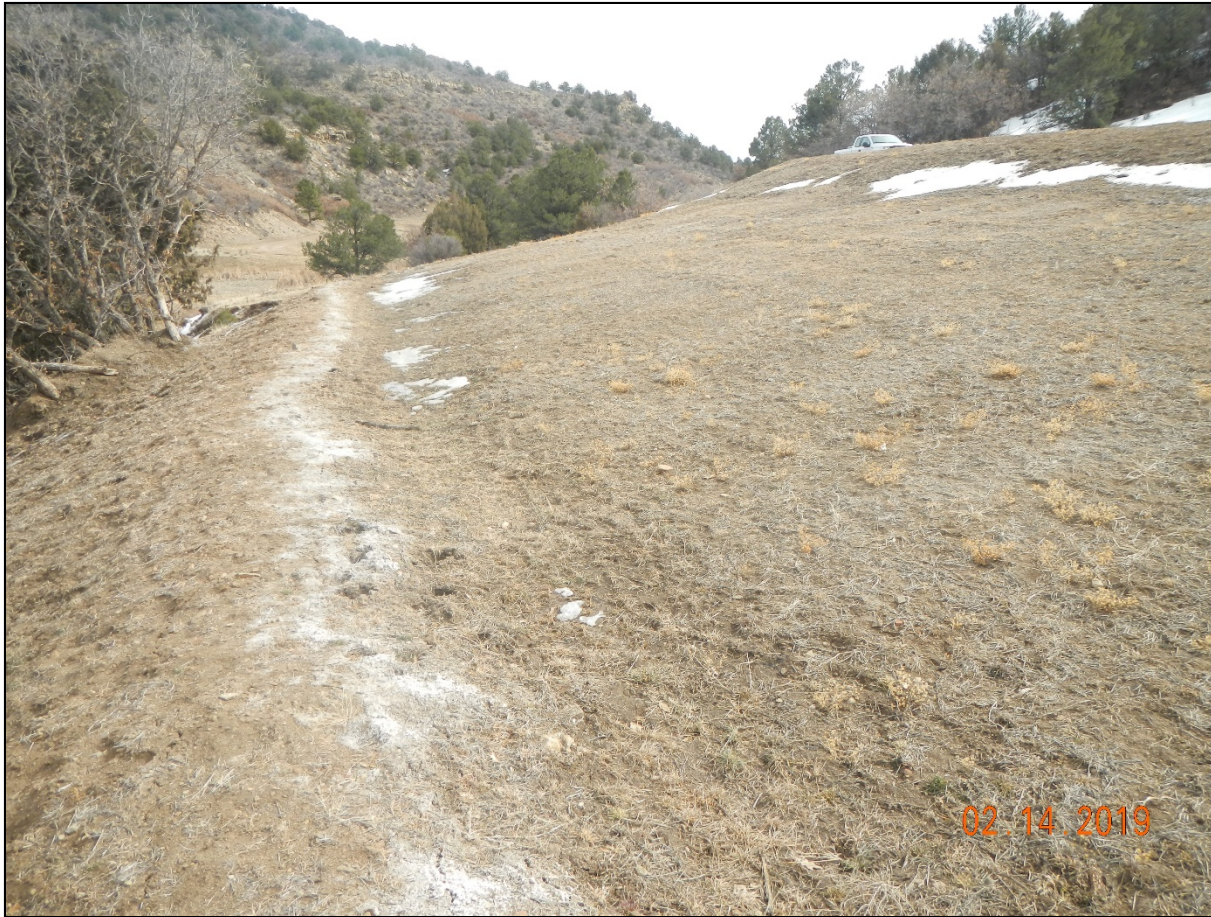
Photo 6. Facing southeast toward the fillslope.

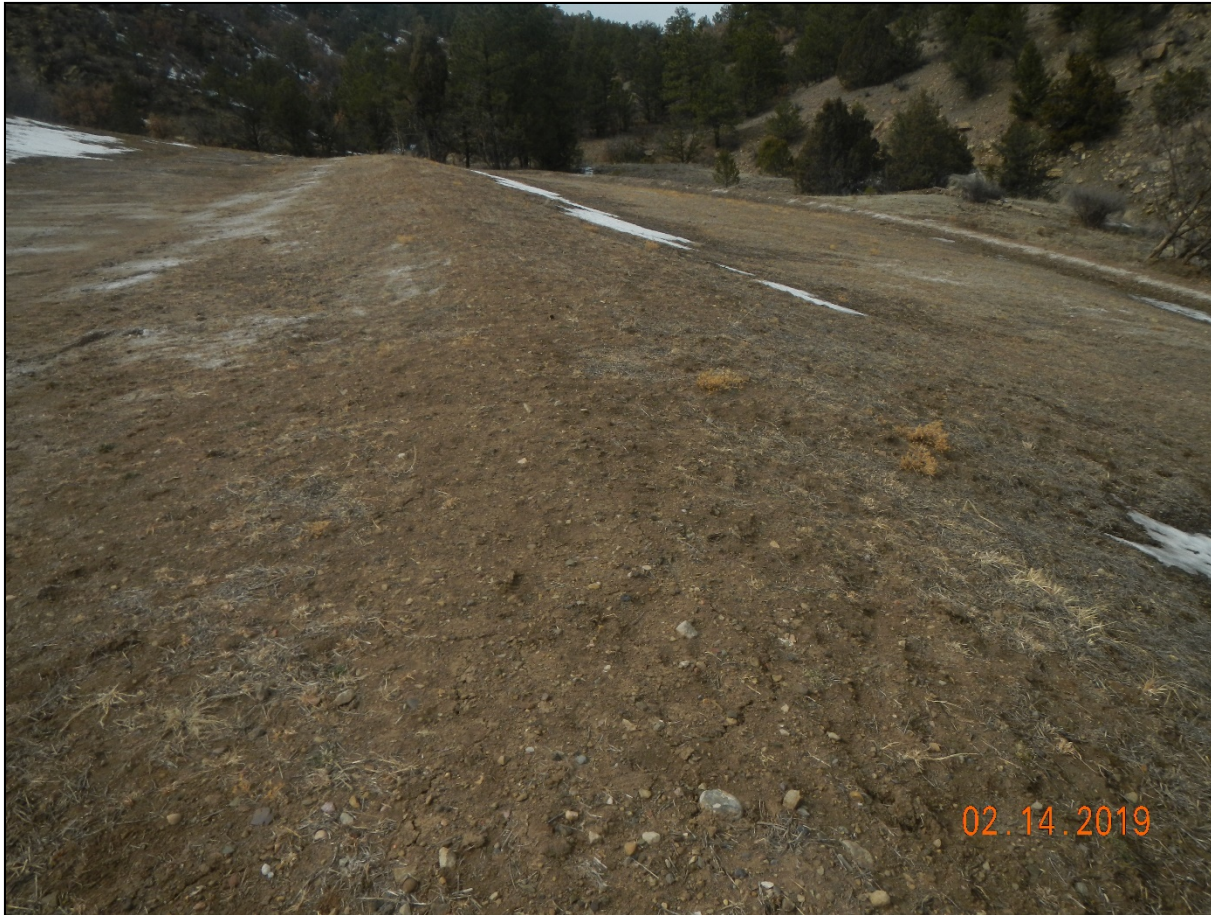
Photo 7. Facing northwest toward the recontoured fill slope.
