Inspection Photos

API: 05-071-09411

Operator: PIONEER NATURAL RESOURCES

Inspection Date: 2/14/2019

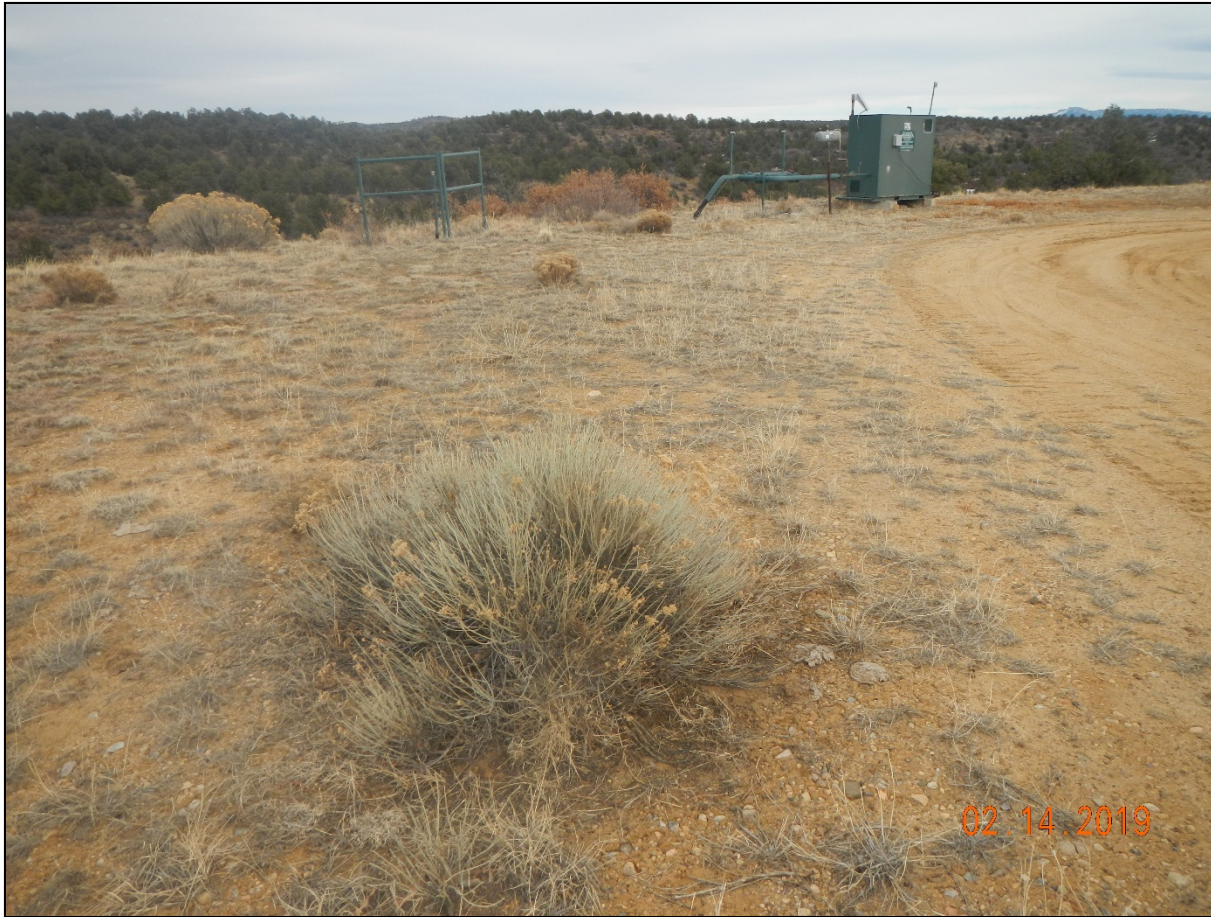
Photo 1. Facing east at the location. Interim vegetation appears to be established.

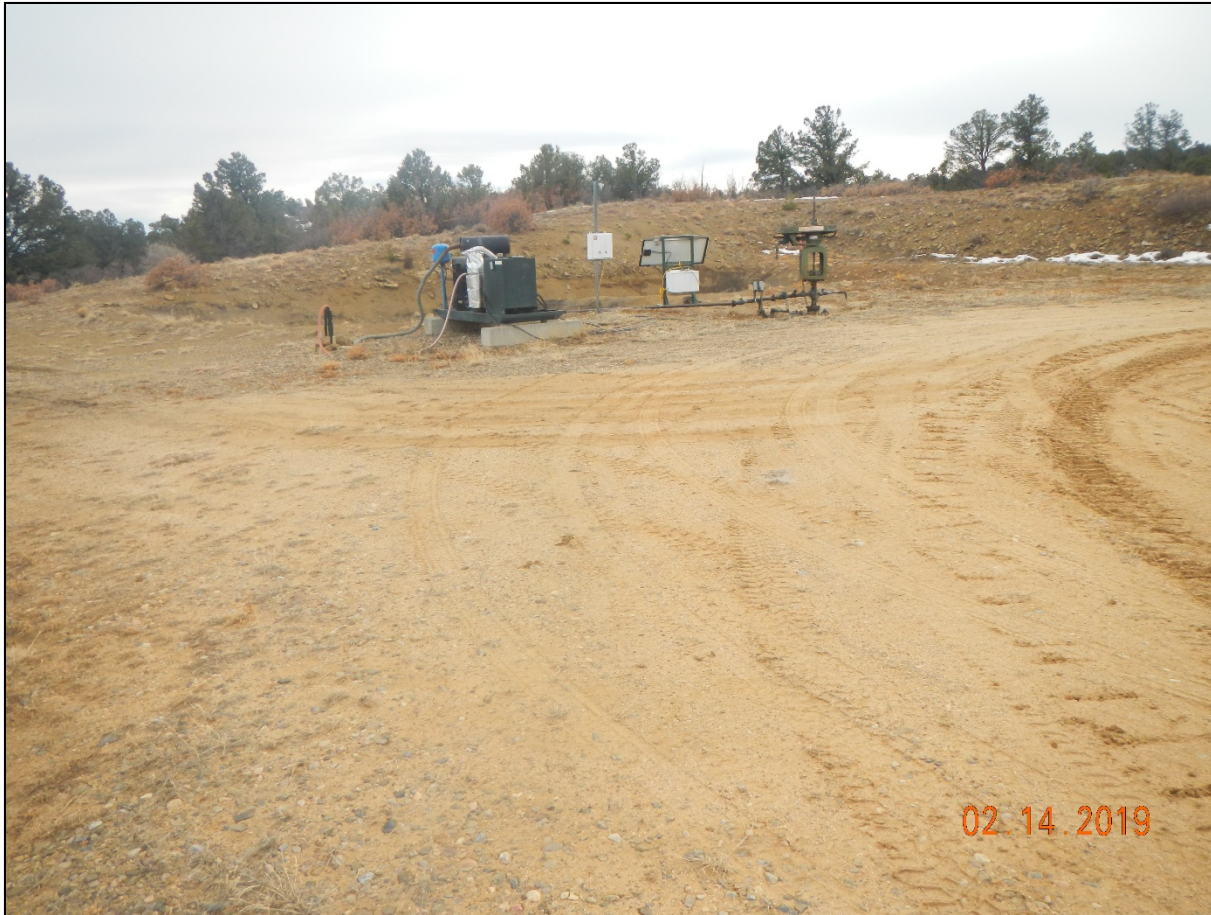
Photo 2. Facing south toward the well.

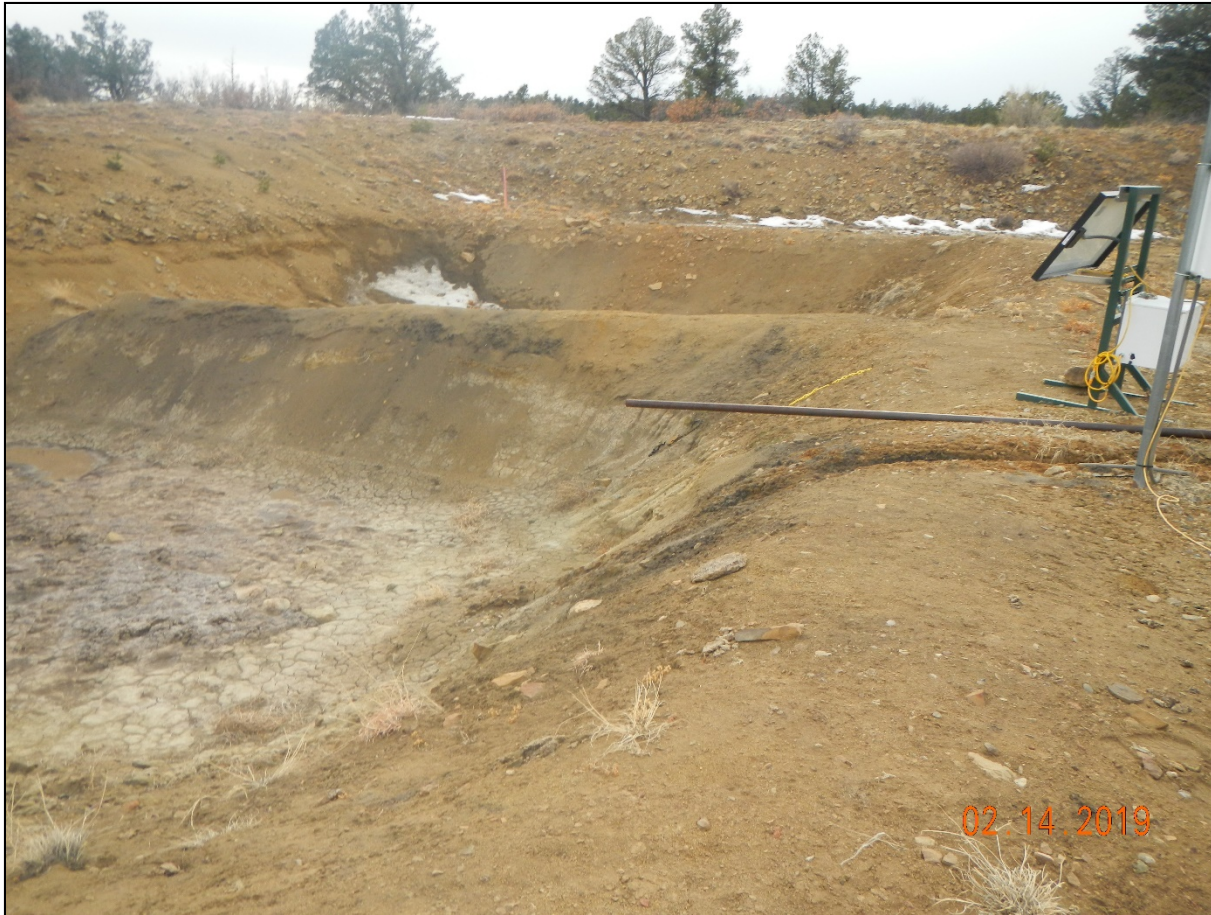
Photo 3. Facing toward the pit. The 2ft. Freeboard marker is present.
