Inspection Photos

Location Name: MFS Federal 29-2

Location ID: 05-103-08849

Inspection: 679703058

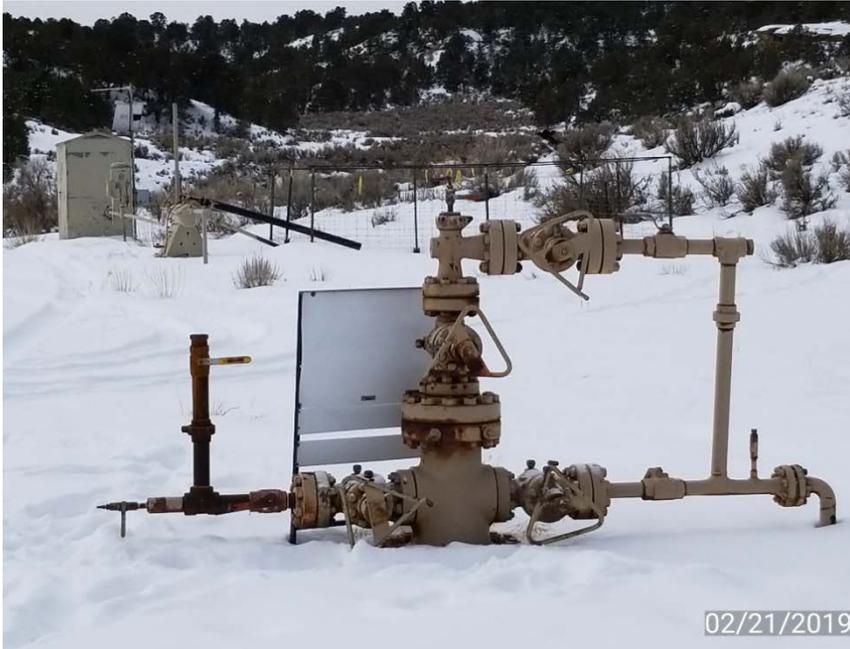
Photo 1. Location looking south.

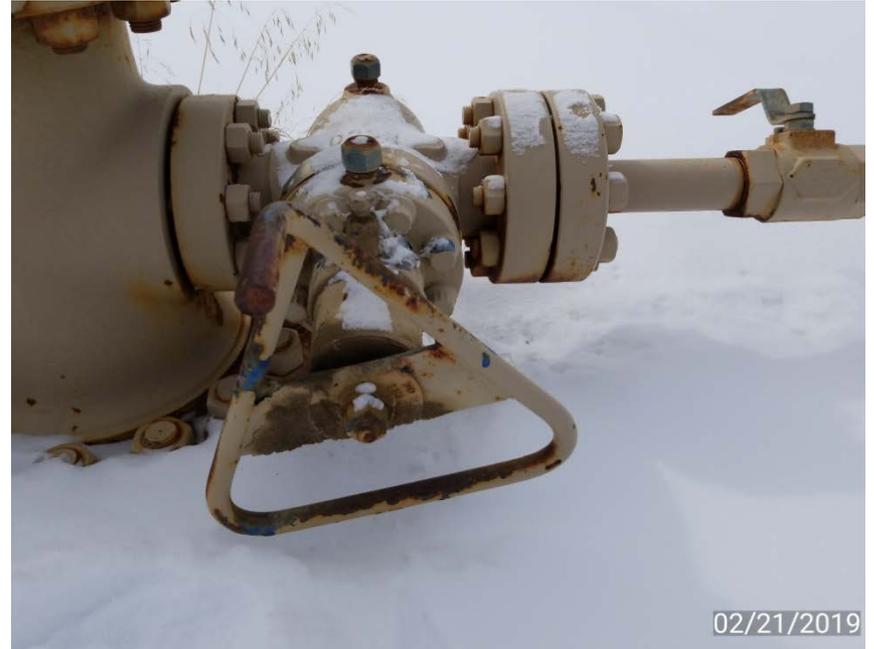
Photo 2. Casing well head valve leaking gas.
