# Construction and Storm Water Inspection

Operator: CRESTONE PEAK RESOURCES OPERATING LLC – 10633

Location ID: 451044

Inspection Document #: 674902526

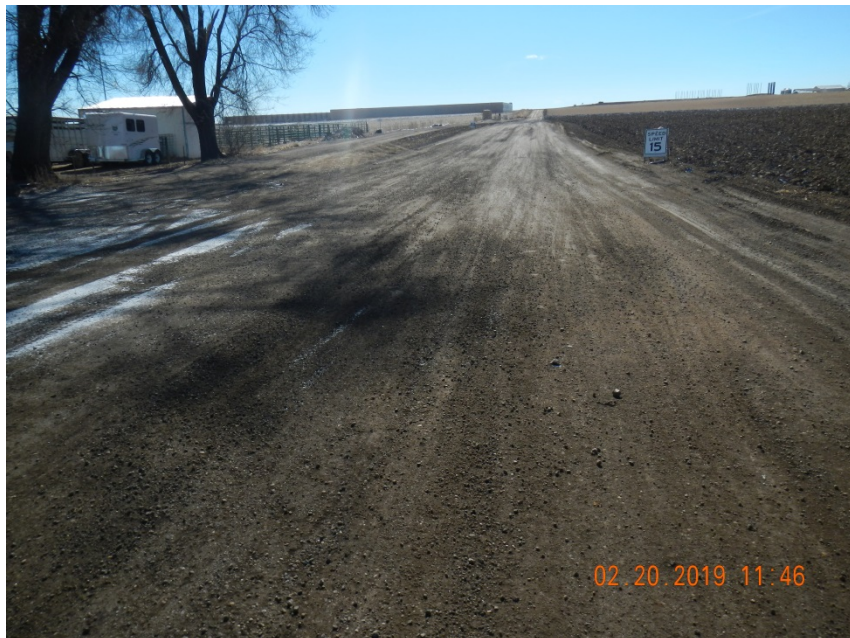
**Photo 1.** Photo taken from the access road near the entrance of the location off CR 20.5, facing South. Operator has installed a track pad and gravel potentially to limit tracking onto the county road.

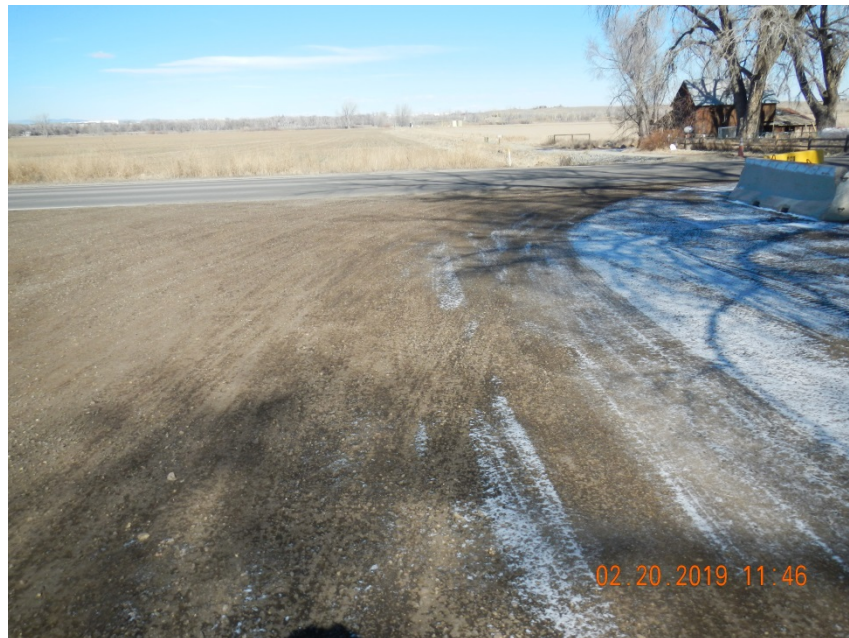
**Photo 2.** Photo taken from the entrance of the location off CR 20.5, facing North. See comments from Photo 1.

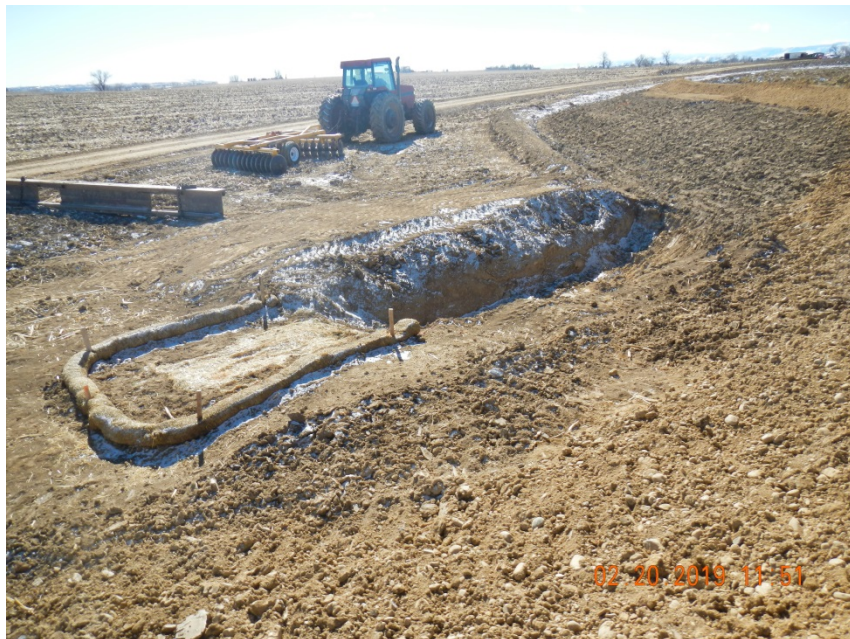
**Photo 3.** Photo taken from eastern perimeter of the location, facing Southeast. Appears the Operator is installing sediment traps with stabilized outlets around the original permitted location.

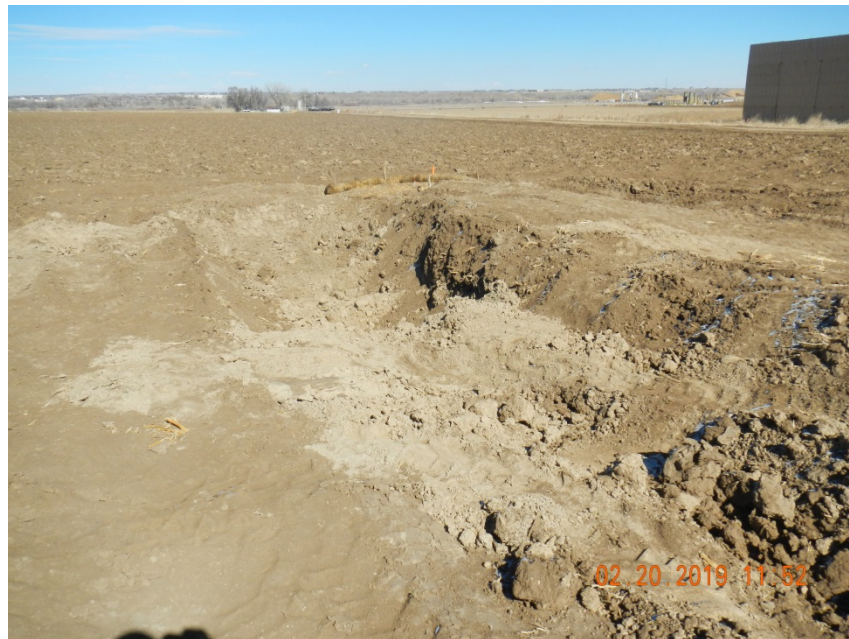
**Photo 4.** Photo taken from northeastern perimeter of the location, facing South. Photo illustrates the ditch and berm BMP that has been installed around the perimeter of the location.

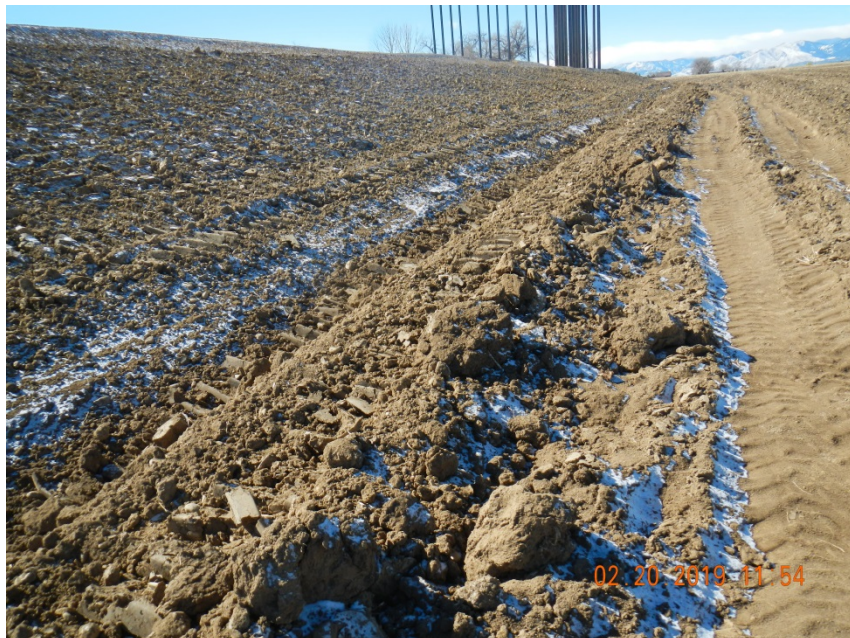
**Photo 5.** Photo taken from northeastern perimeter of the location, facing South. Photo illustrates the ditch and berm BMP that has been installed around the perimeter of the location. Parts of the BMP remain unconsolidated.

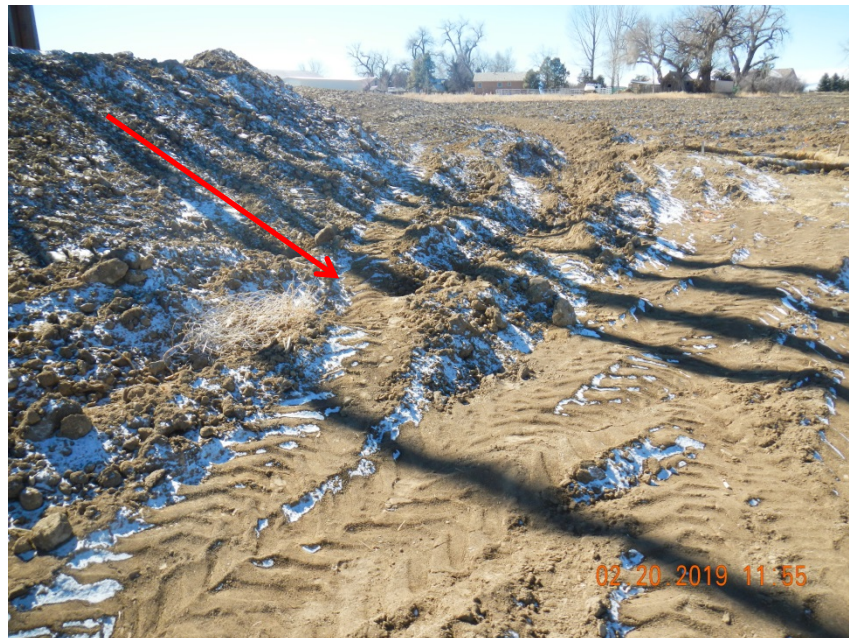
**Photo 6.** Photo taken from northwestern perimeter of the unpermitted disturbance area, facing South. Photo illustrates the ditch and berm BMP that has been installed around the perimeter of the location has been tracked through by equipment and opens to adjacent field with no stormwater BMP perimeter.

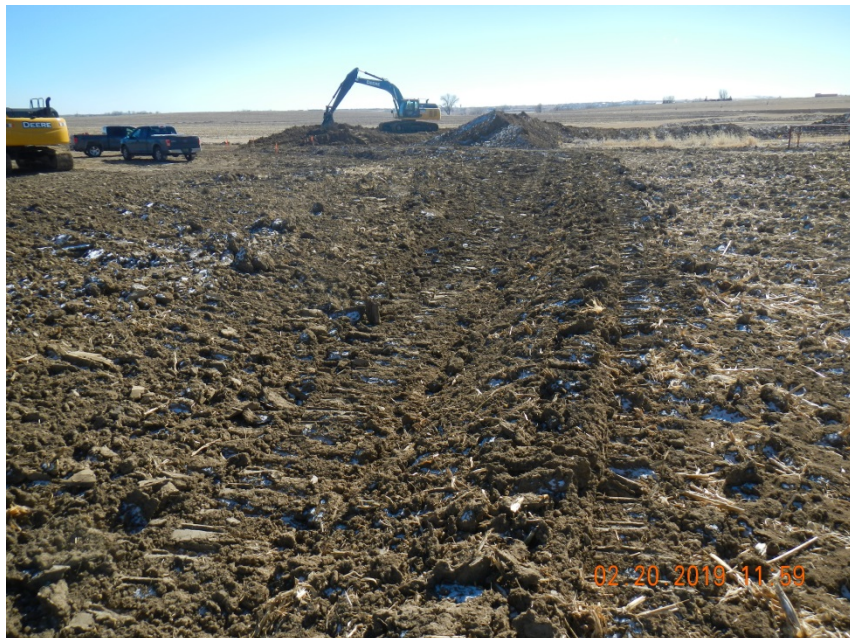
**Photo 7.** Photo taken from western perimeter of the location, facing South. Appears flowline ROW construction is underway. Parts of the ditch and berm BMP remain unconsolidated.

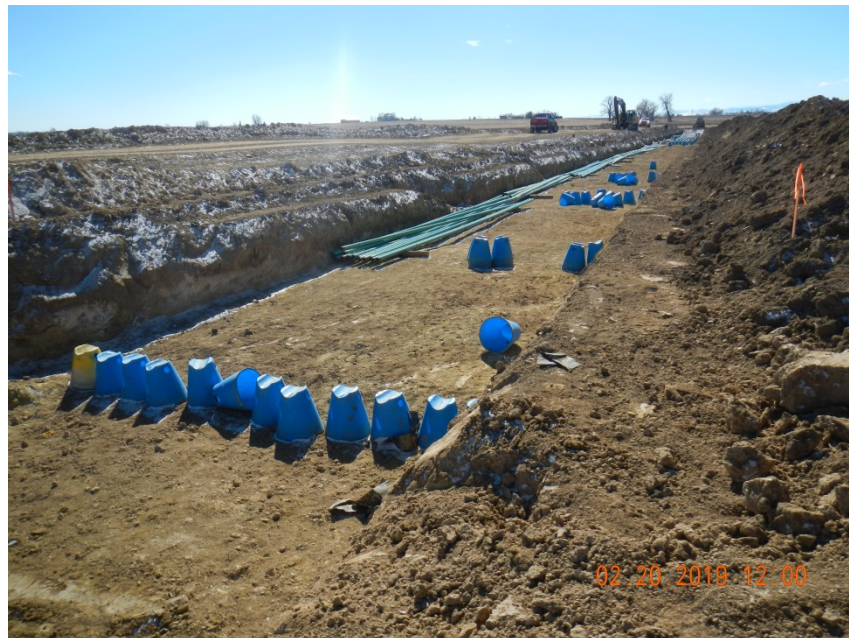
**Photo 8.** Photo taken from western perimeter of the flowline ROW, facing Southwest. See comments from Photo 7.

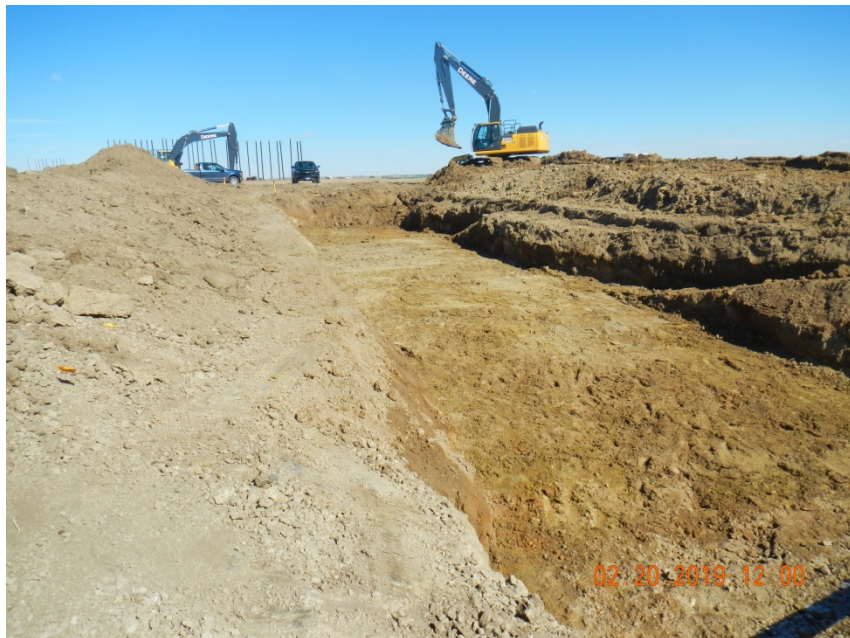
**Photo 9.** Photo taken from western perimeter of the flowline ROW, facing Northeast. See comments from Photo 7.

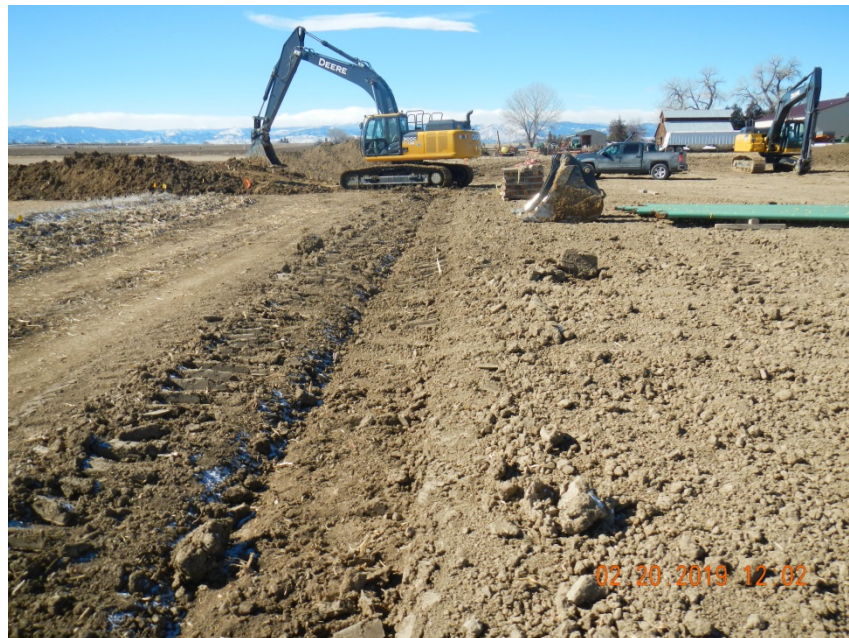
**Photo 10.** Photo taken from southern perimeter of the location looking towards the flowline ROW, facing West.
