Inspection Photos

Operator: H & M PETROLEUM CORPORATION #
10032

Location ID: 458288

Inspection Doc. Number: 682504523
Logan County, CO

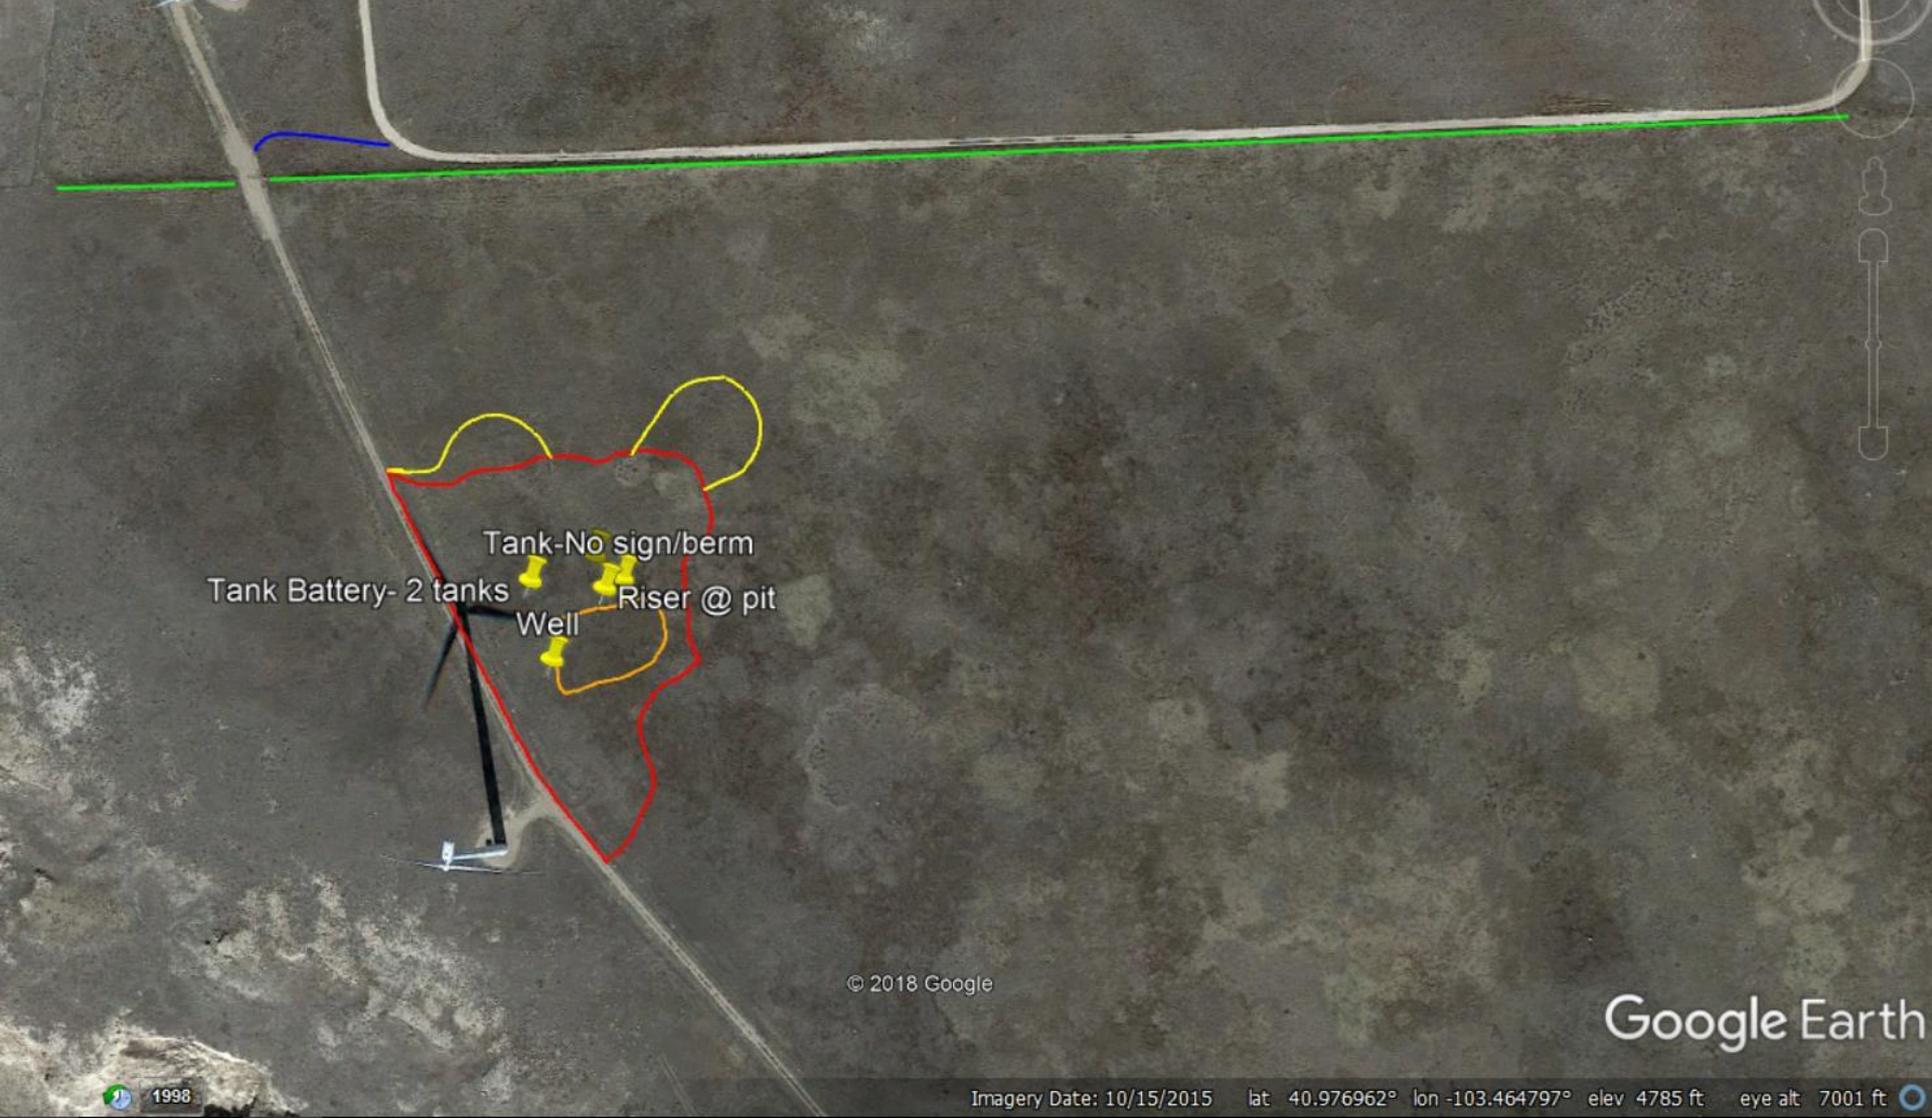
Photo 1: 2013 Google Earth aerial image. Photo shows location disturbance (red), areas where vehicles traveled onto adjacent lands (yellow), area of the pit (orange), additional access road created for location (blue), and the additional disturbance areas parallel to access road during construction (where soil was removed for pad, green).

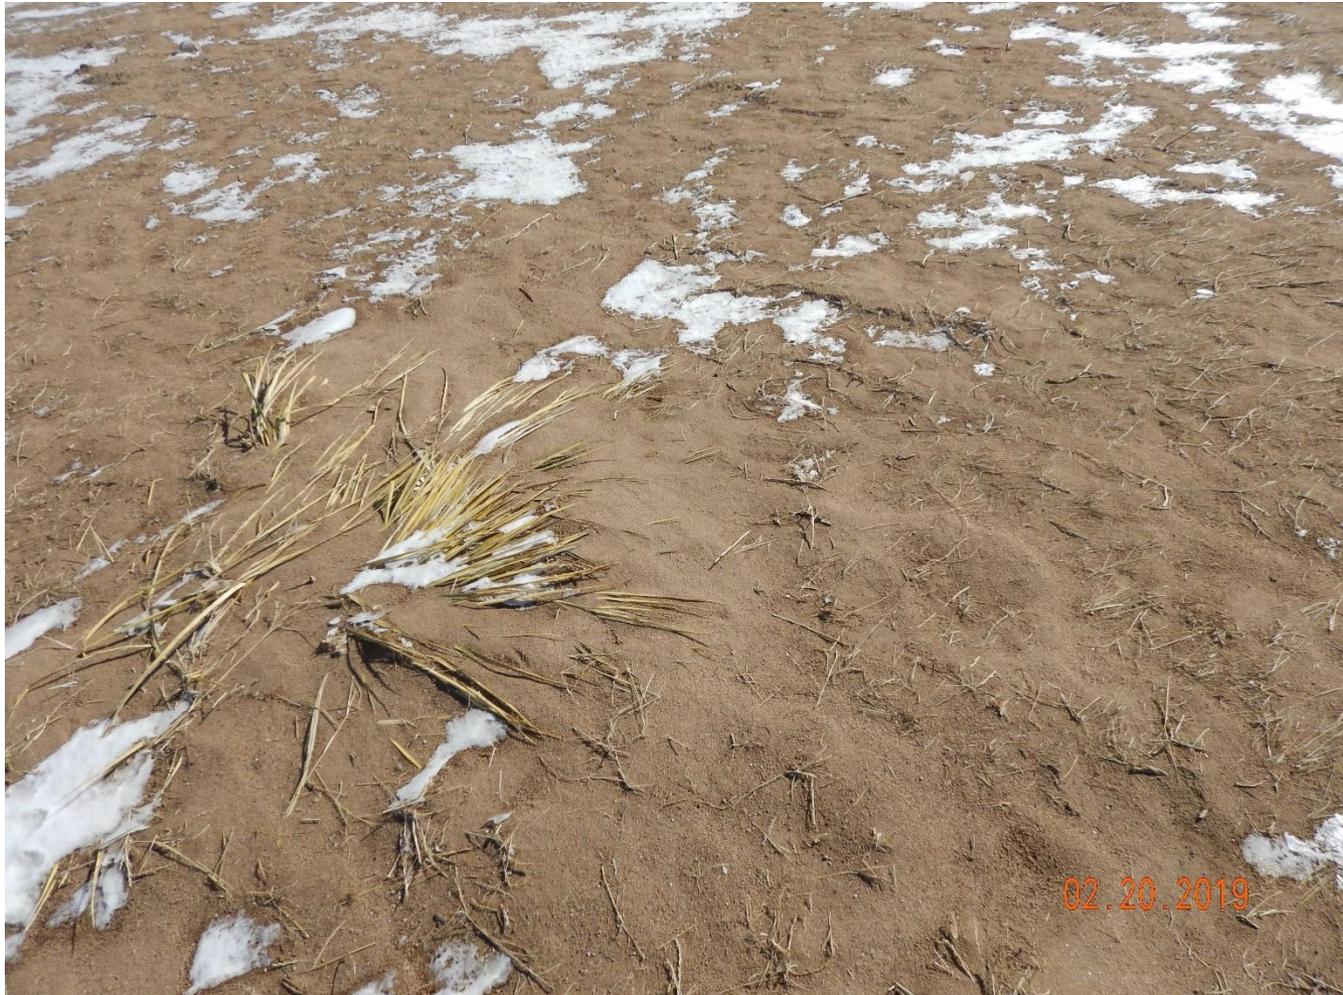
Photo 4: Photo taken from the south end of the location. Photo shows area where operator had brought soil to “build up” the pad. Operator previously stated that “~3 feet of soil will be placed on the location to build up the pad”. Photo shows vegetation (yucca, grass) is visible within the material brought on location suggestion either 1) Operator failed to stabilize the soils brought onto the pad and wind erosion has removed the material, or 2) Operator failed to import a sufficient amount of material to build to pad and protect the topsoil below. Regardless, operator has failed to take appropriate measures to protect the topsoil and the natural features.

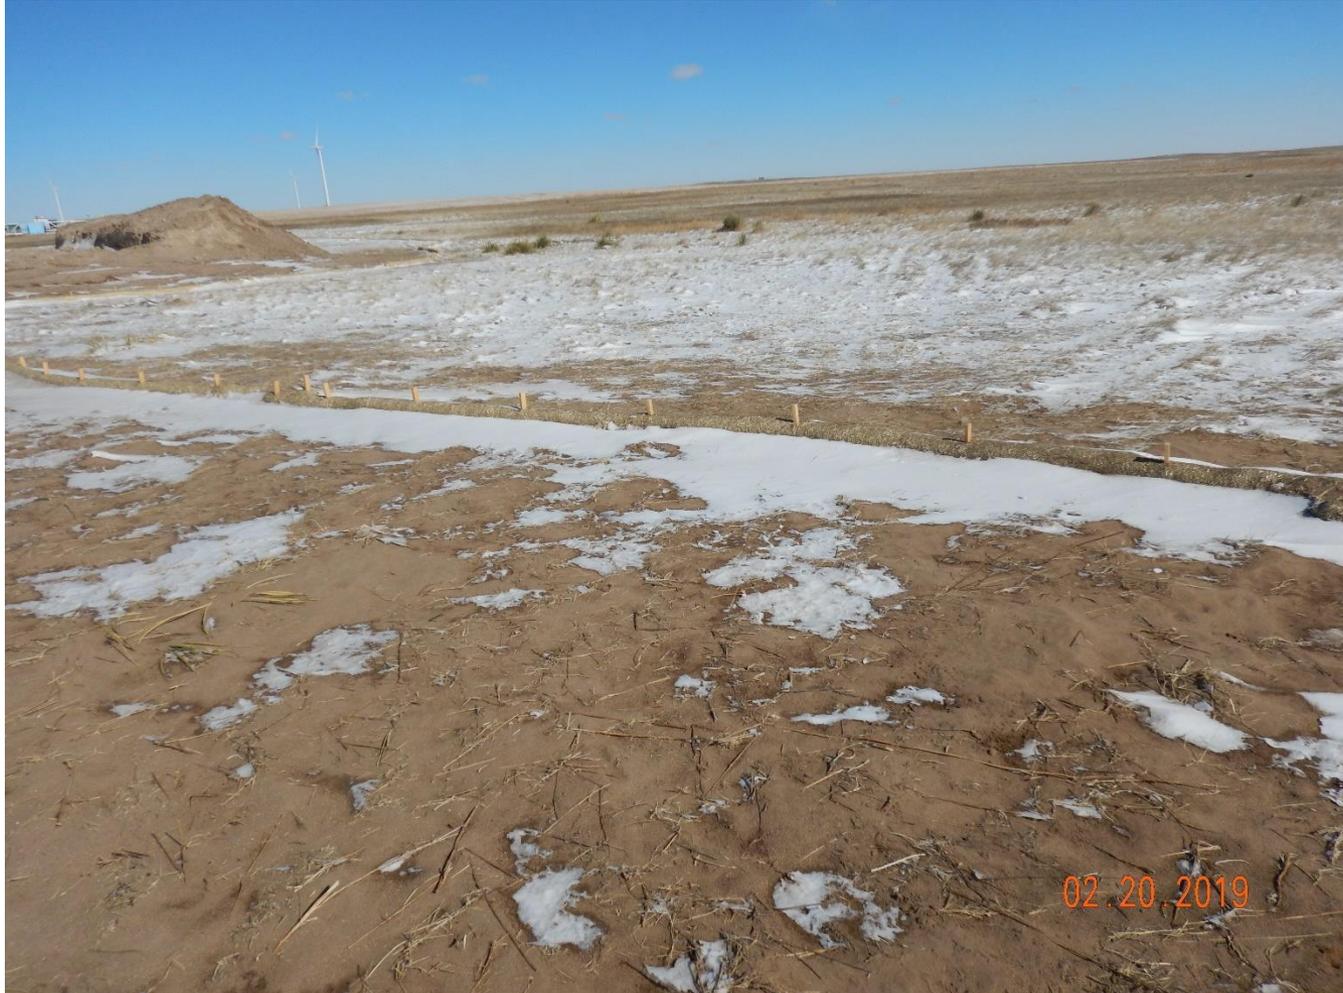
Photo 5: Photo taken from the northeast end of the location, facing east. Photo shows operator has implemented wattles/erosion logs on the eastern, and portions of the northern perimeter of the location. Erosion logs are temporary sediment control barriers and ponding BMPs that intercept sheet flow runoff from disturbed areas, and are required to be trenched and back-filled in order to be in proper functioning condition.

Photo shows Operator only placed/staked the erosion logs upon the surface of the soil; BMPs have not been trenched and back-filled in accordance with good engineering practices and are not in proper functioning condition.

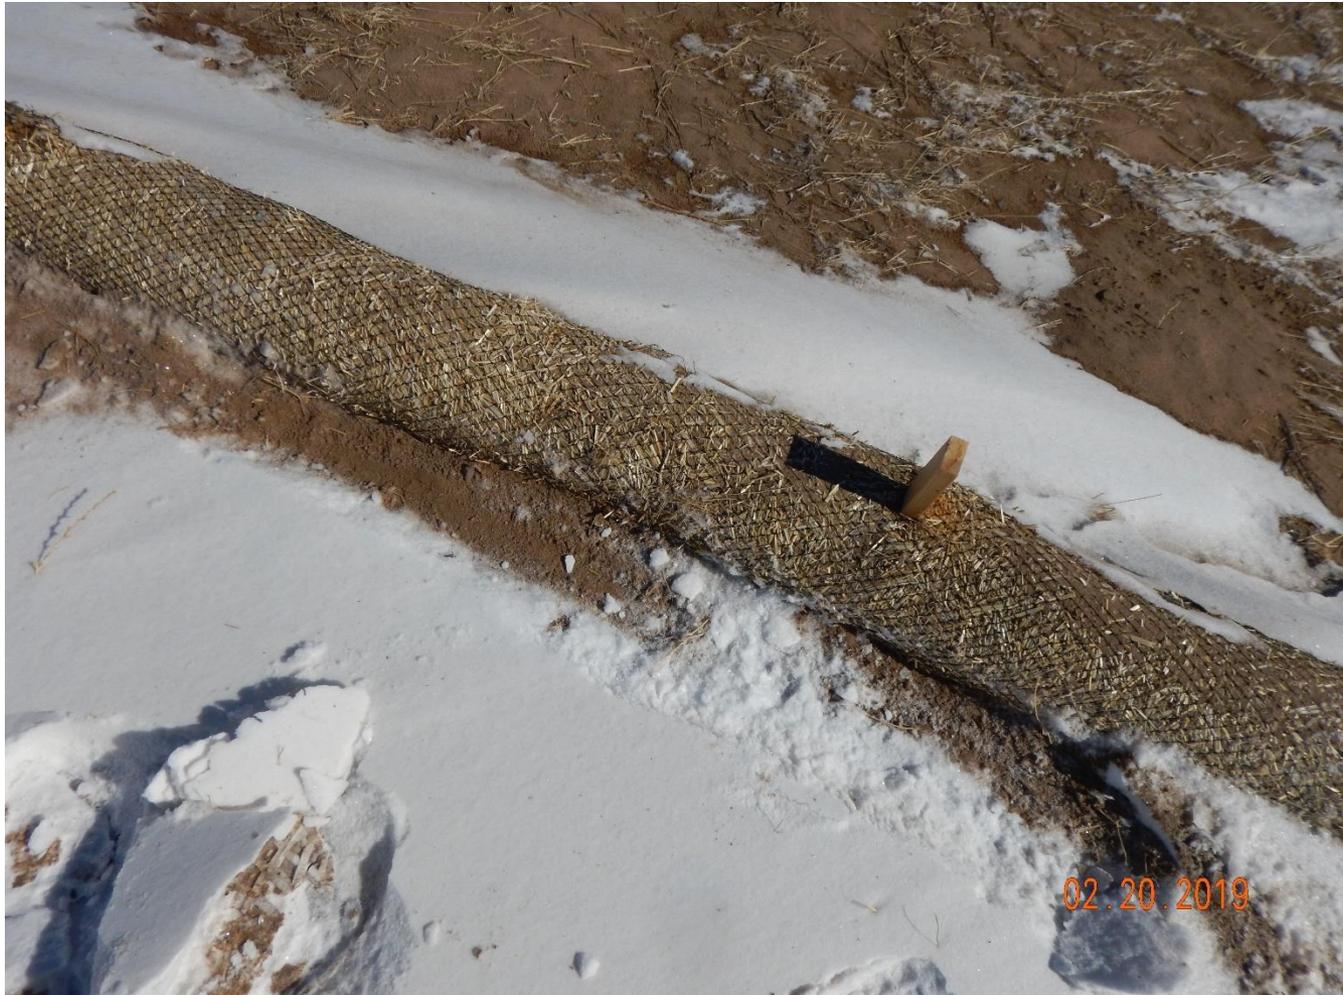
Photo 6: Continued from photo 5. Photo shows Operator only placed/staked the erosion logs upon the surface of the soil; BMPs have not been trenched and back-filled in accordance with good engineering practices and are not in proper functioning condition.

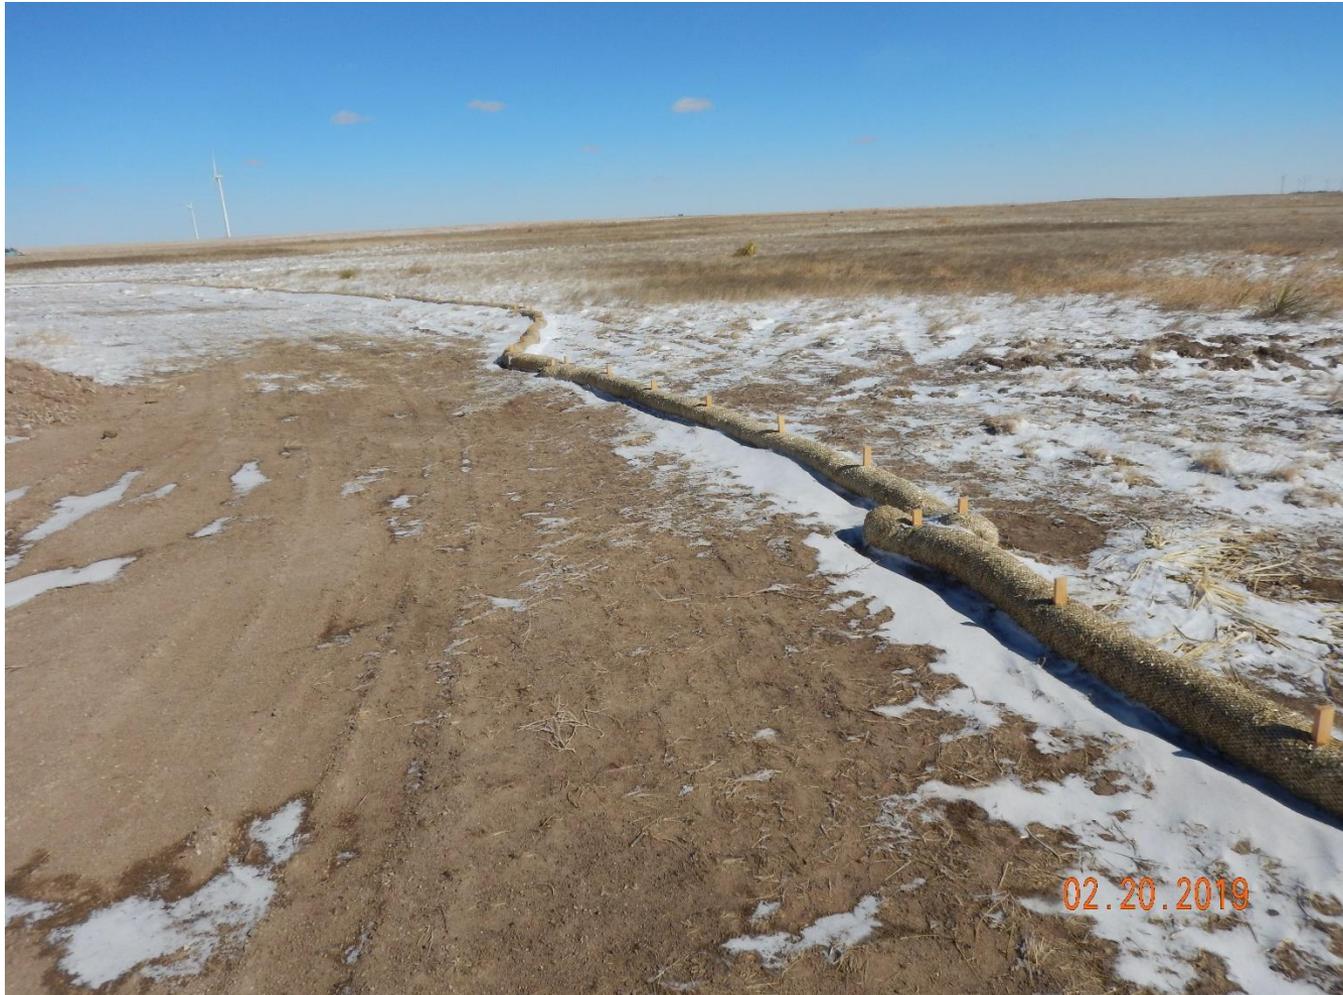
Photo 7: Continued from photo 5. Photo shows Operator improperly installed erosion logs. See comments under photo 6.

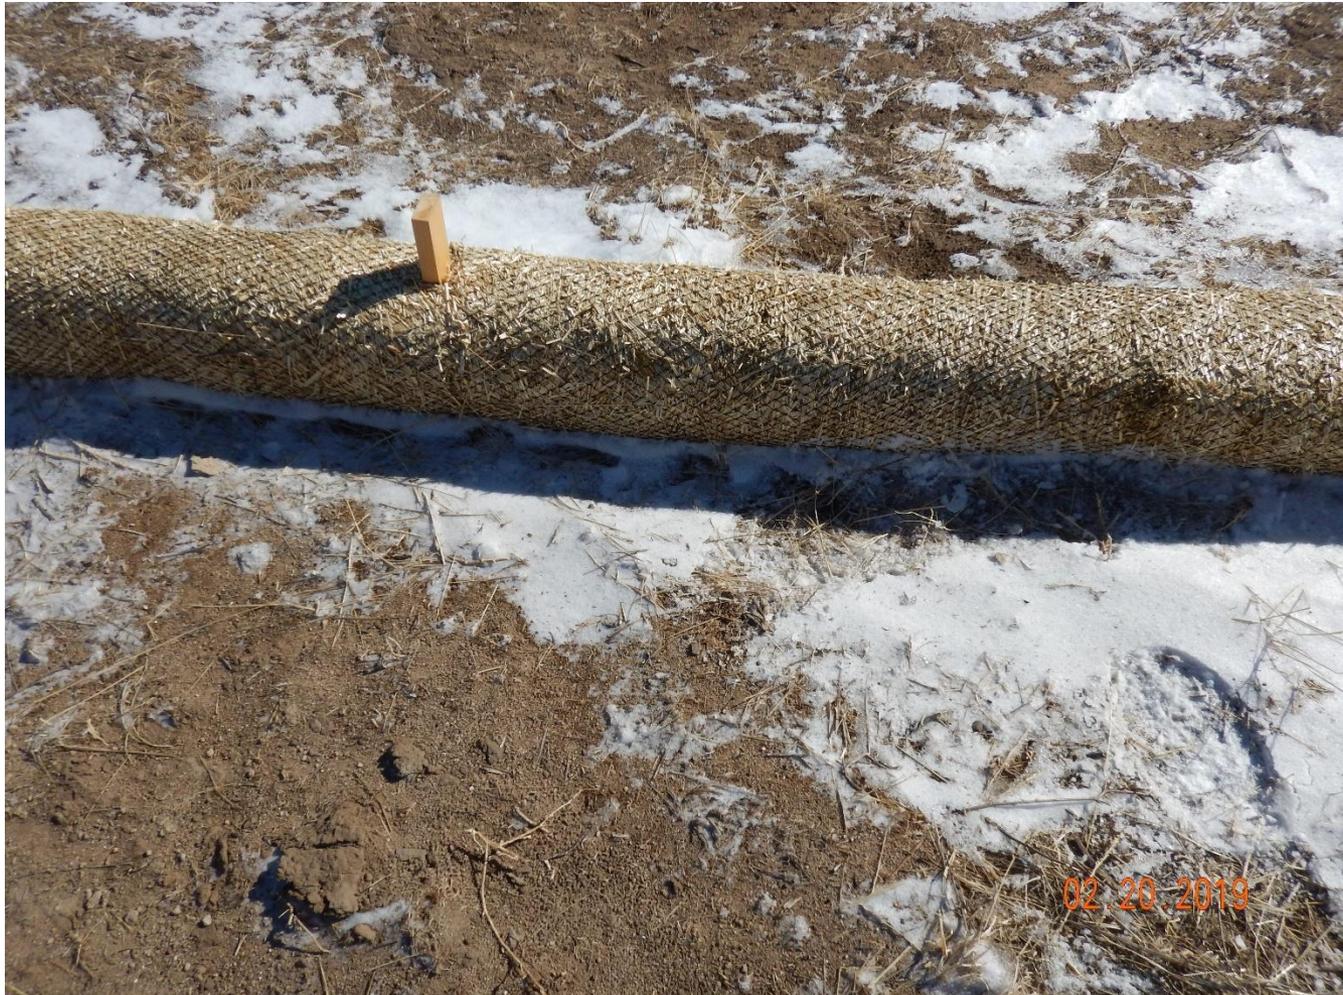
Photo 8: Continued from photo 7. See comments under photo 6.

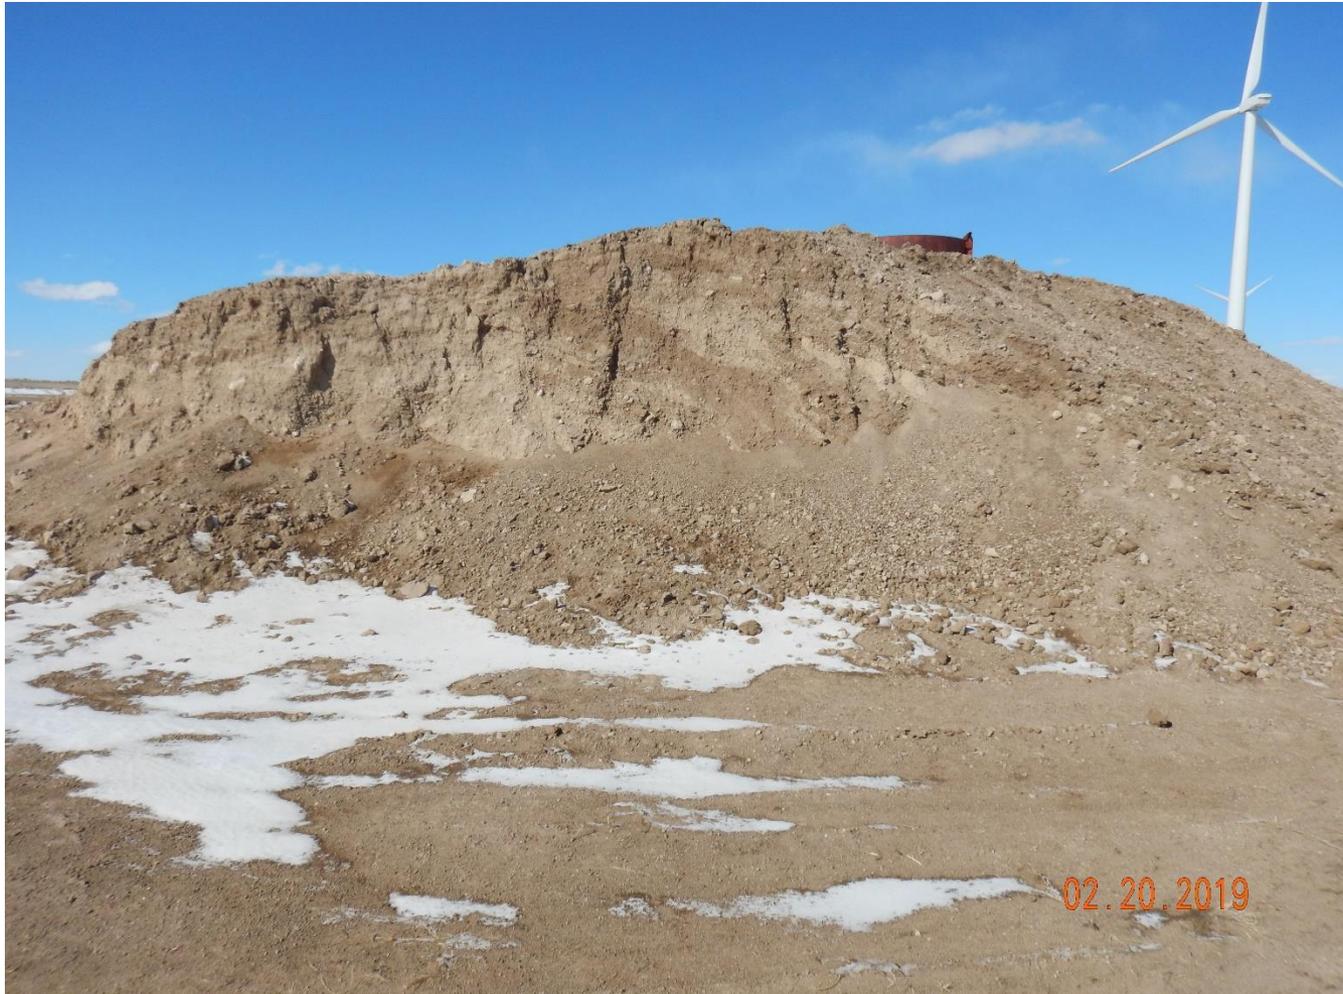
Photo 9: Photo taken from the south end of the pit soil stockpile, facing north. The previous inspection documented that the topsoil and subsoil horizons from the pit was not separated and stored in accordance with 1002.b. This photo continues that documentation. Additionally, rule 1002.c requires that “All stockpiled soils shall be protected from degradation due to contamination, compaction and, to the extent practicable, from wind and water erosion during drilling and production operations”. Photo shows soil stockpile remains loose, unstabilized material at risk to wind and water erosion. Operator has failed to sufficiently stabilize the soil stockpile in accordance with 1002.c

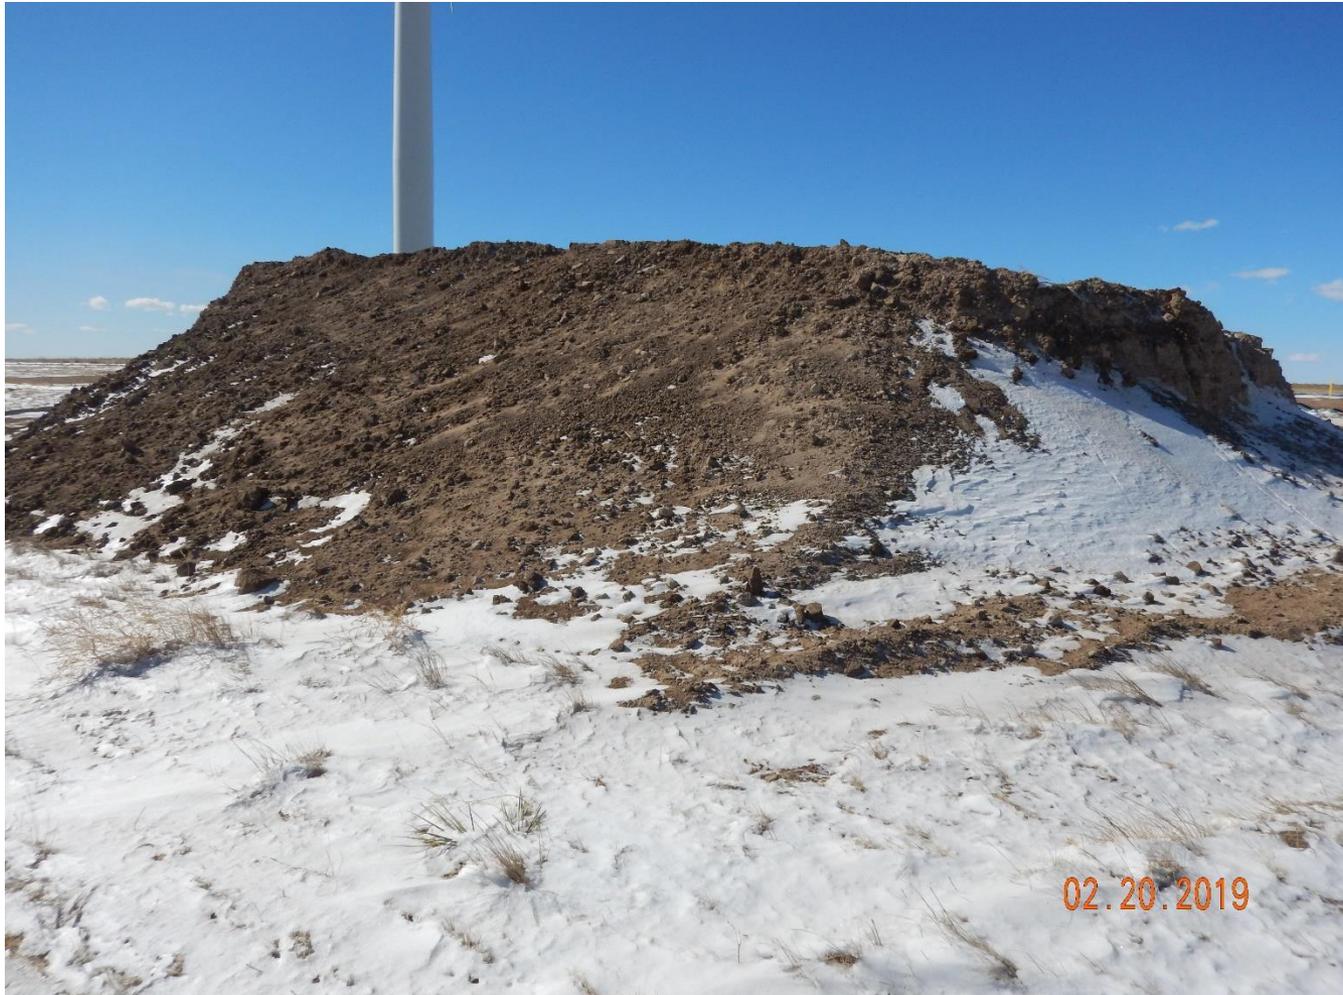
Photo 10: Photo taken from the east end of the pit soil stockpile, facing west. See comments under photo 9.

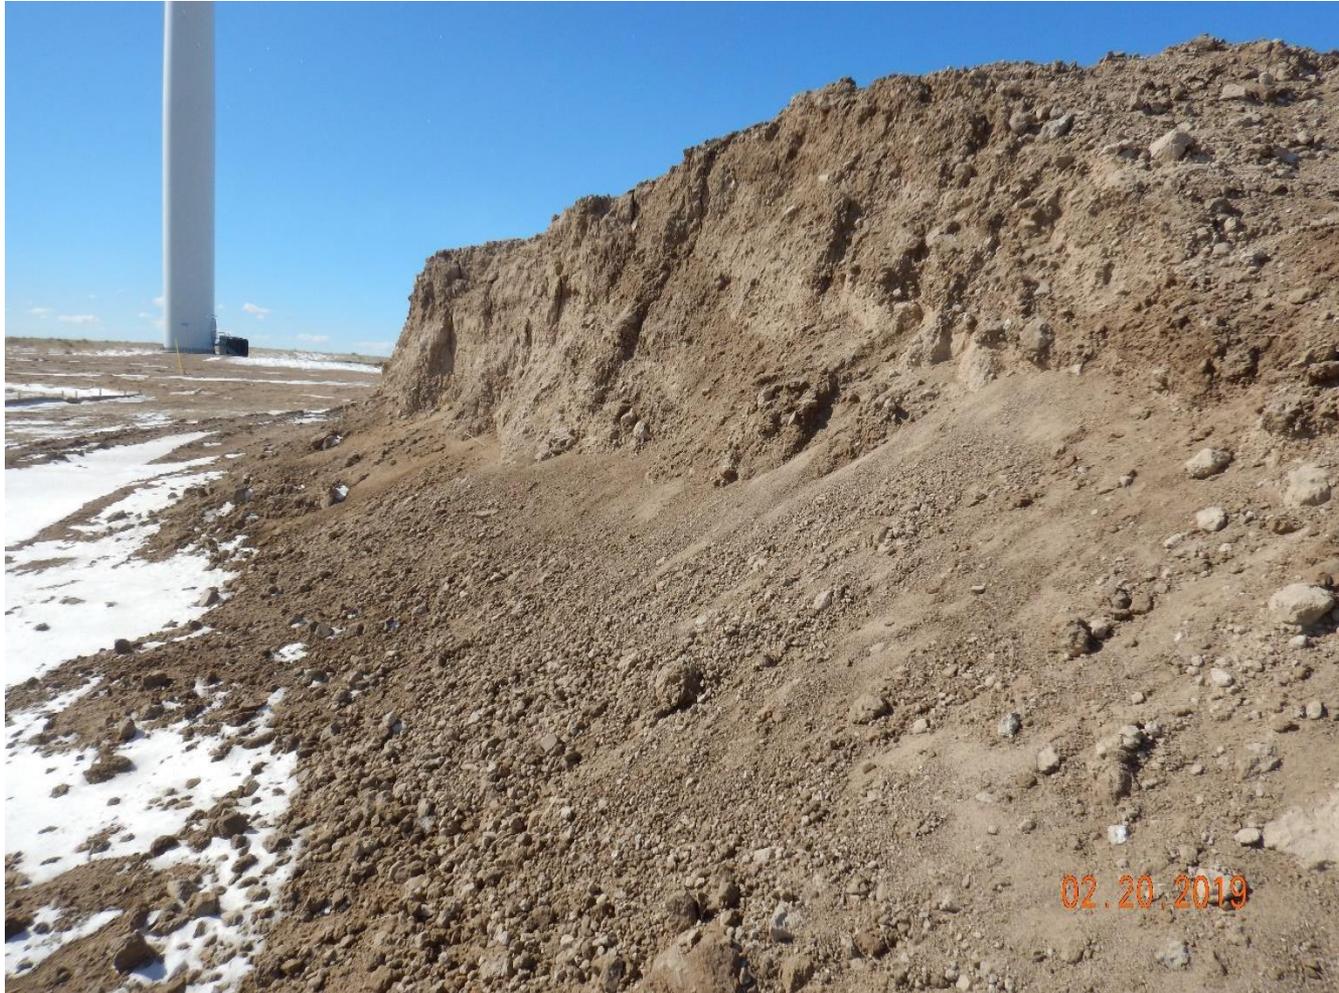
Photo 11: Photo taken from the south end of the pit soil stockpile, facing west. See comments under photo 9.

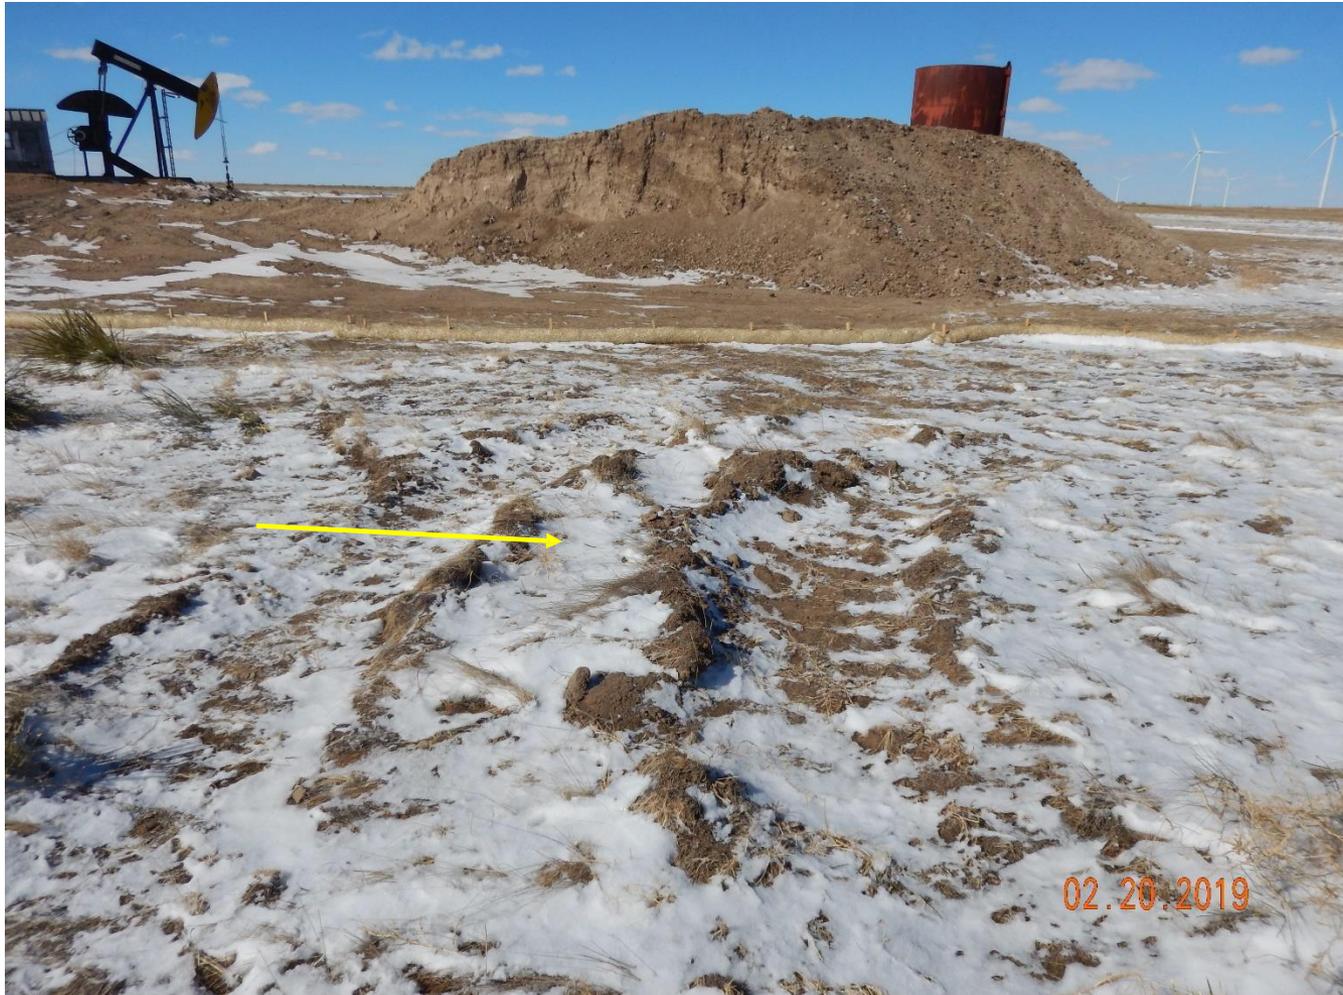
Photo 12: Photo taken from the southeast of the pit soil stockpile, facing northwest. See comments under photo 9. Photo also shows additional disturbances beyond location.

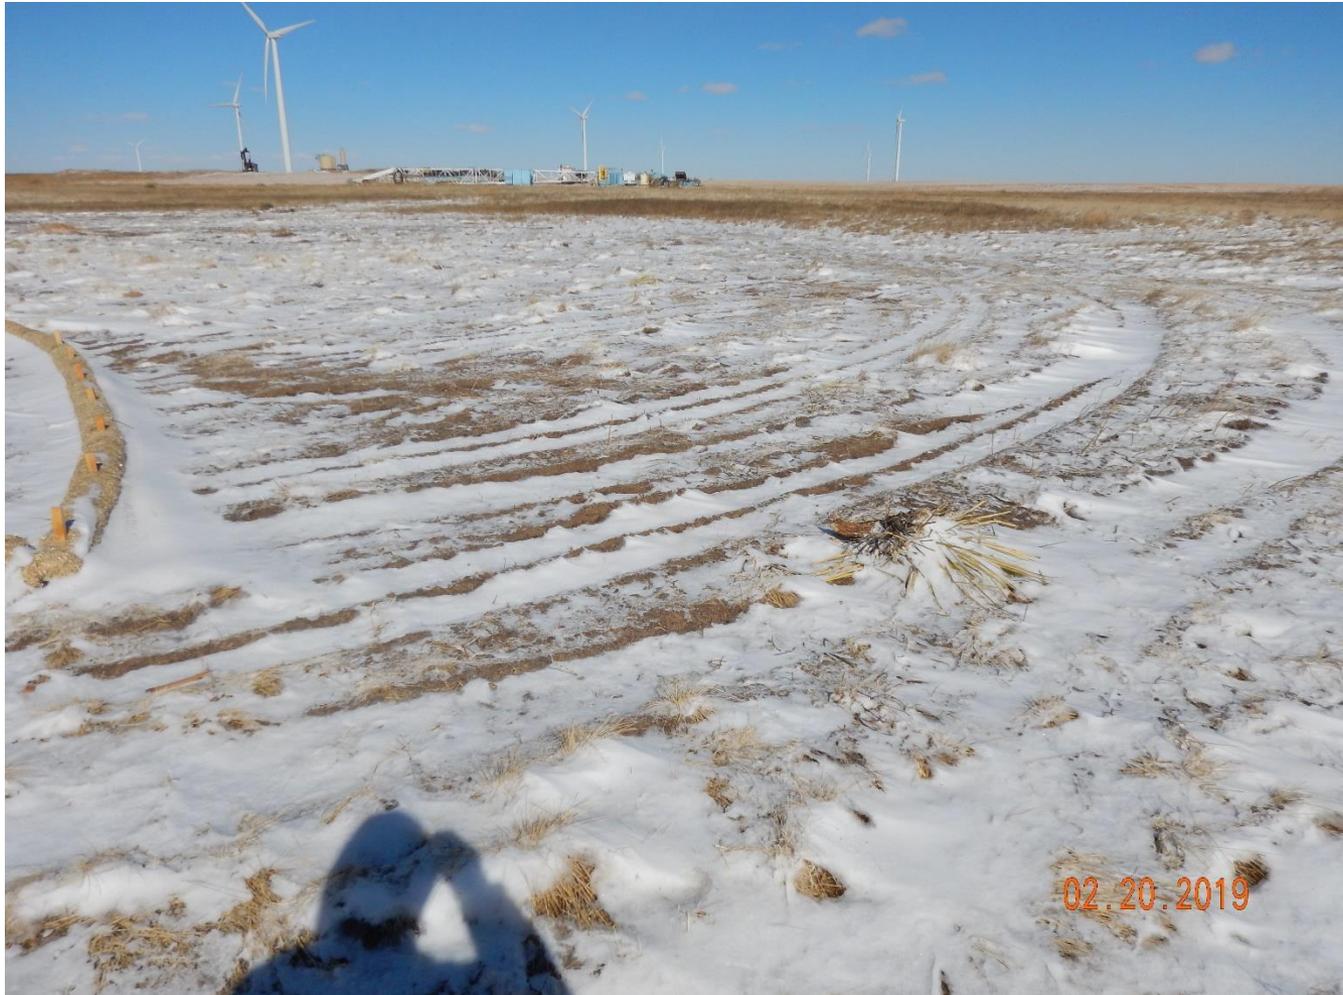
Photo 13: Photo taken from the northeast of the location. Previous inspection documented that operator drove equipment/vehicles on areas off of the location.. Photos 13, and 17 through 25 continue to document the additional disturbance. Ruts due to compaction observed in photos as deep as 6 inches.

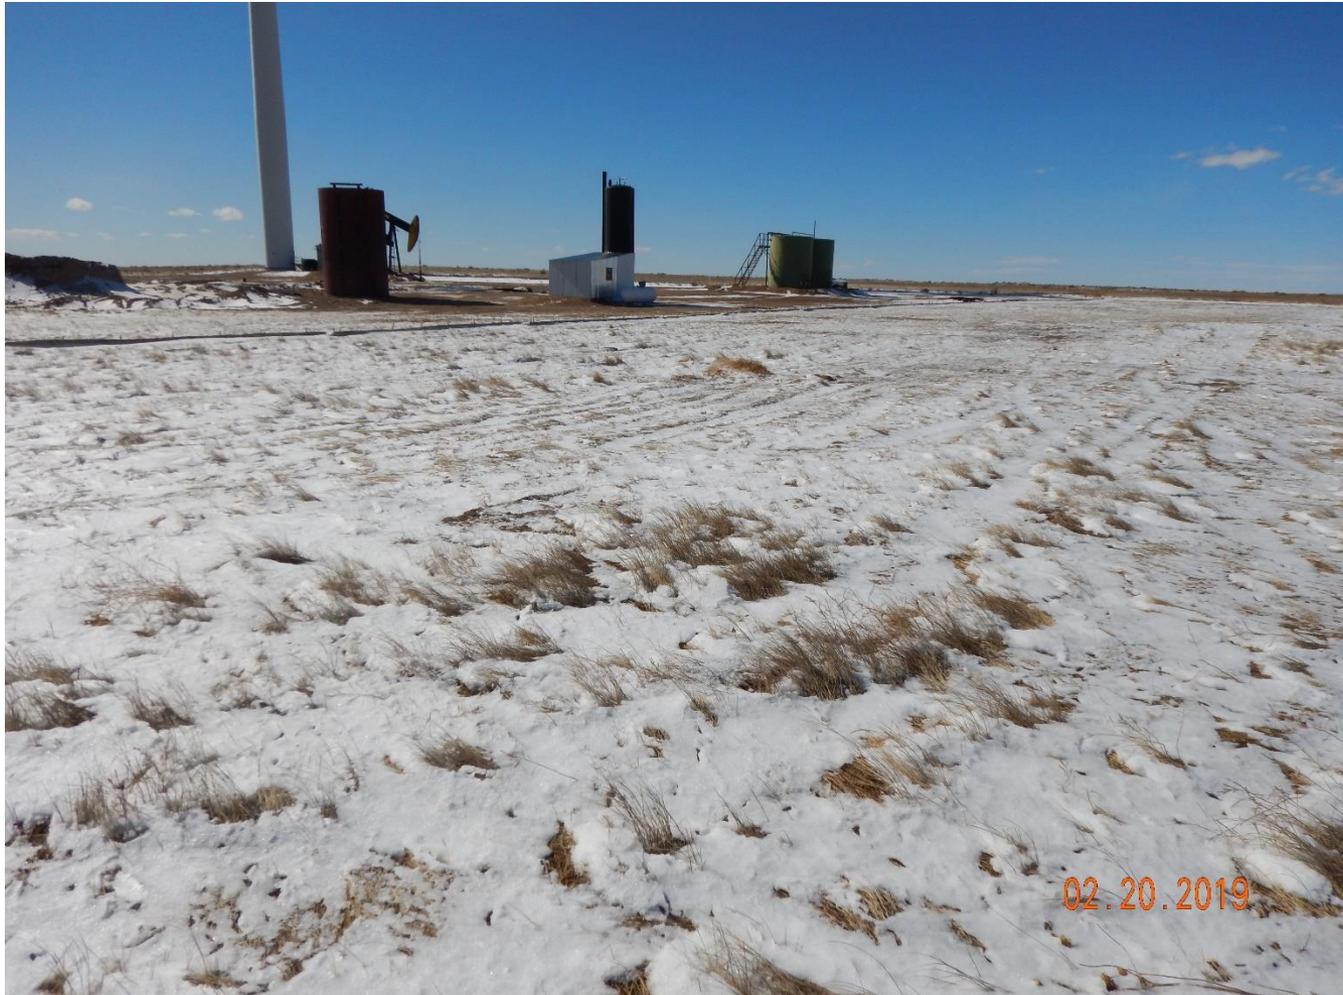
Photo 15: Photo taken from the northeast end of the location, facing west. Photo provides an overview of the location. Photo also shows areas where operator stored equipment/vehicles. No pad construction/topsoil salvage was conducted, nor was the topsoil protected.

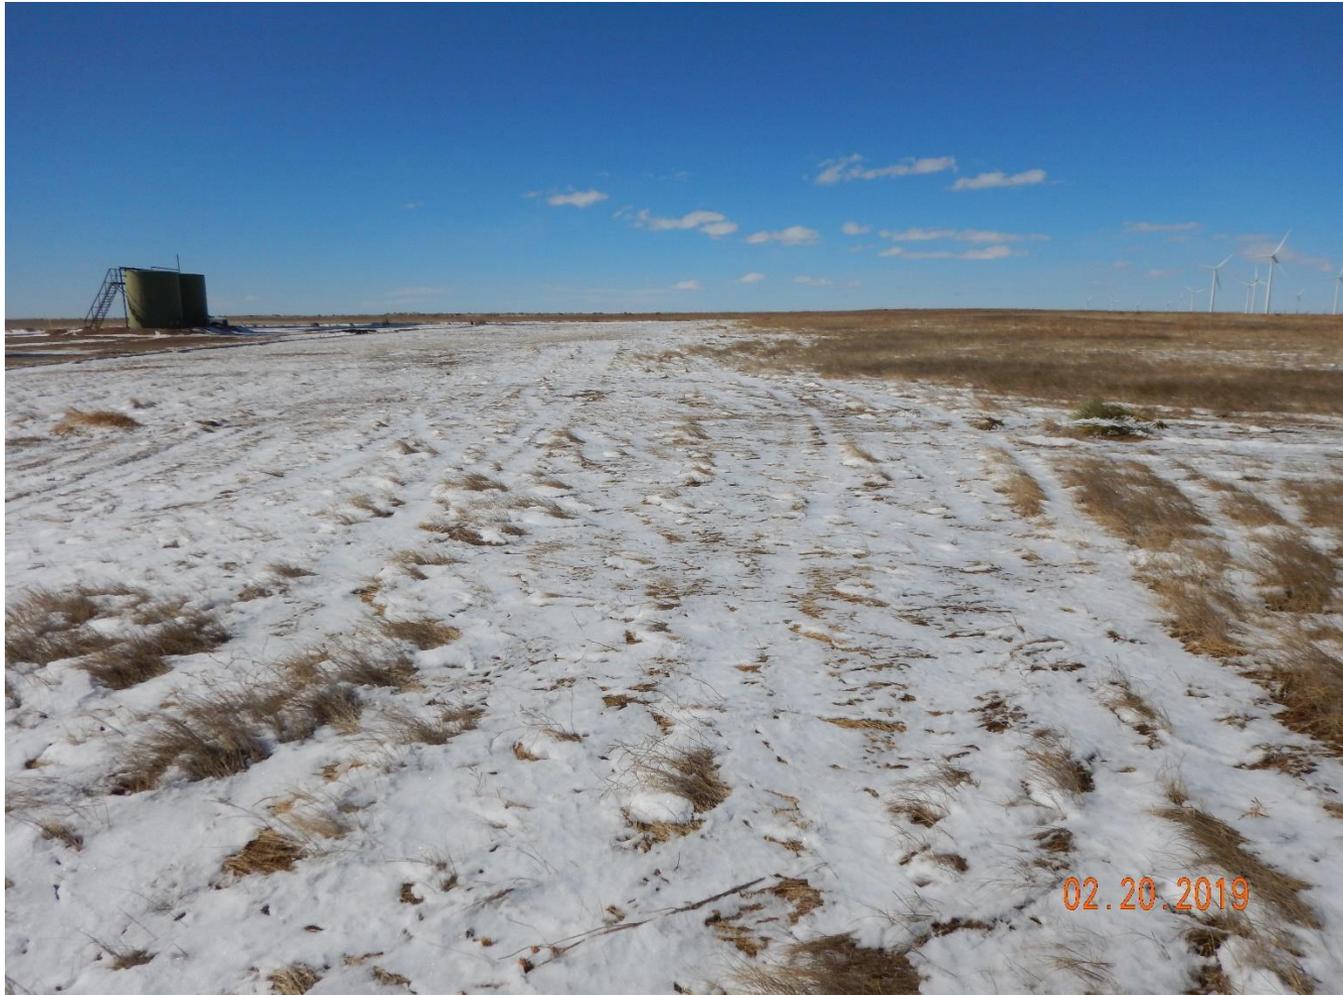
Photo 16: Photo taken from the northeast end of the location, facing west. Photo provides an overview of the location. See comments under photo 15.
