Inspection Photos

Operator: H & M PETROLEUM CORPORATION #
10032

Location ID: 458288

Inspection Doc. Number: 682504523
Logan County, CO

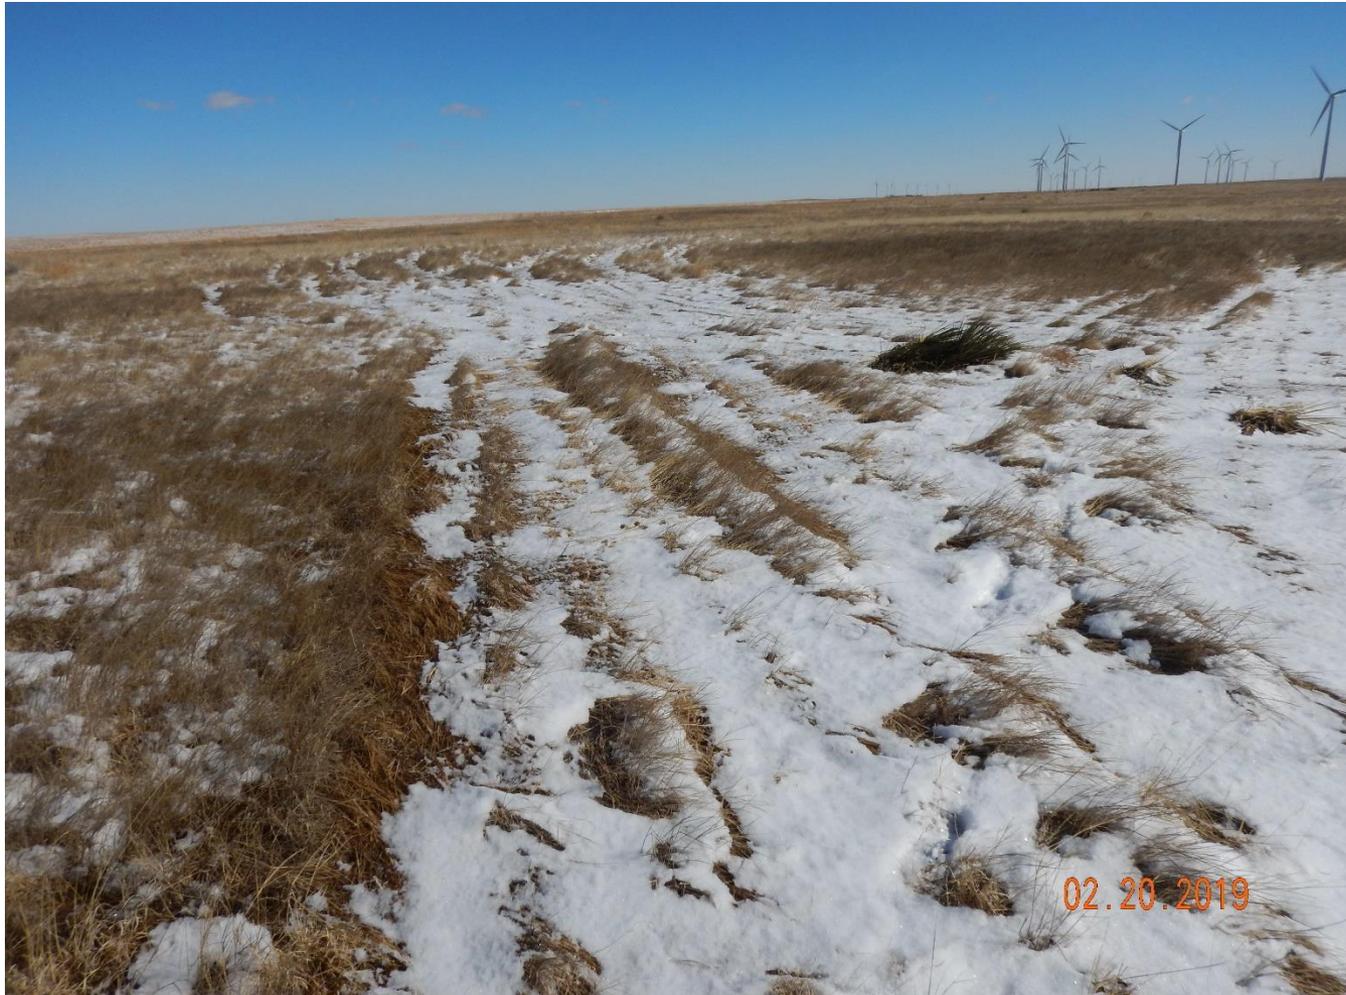
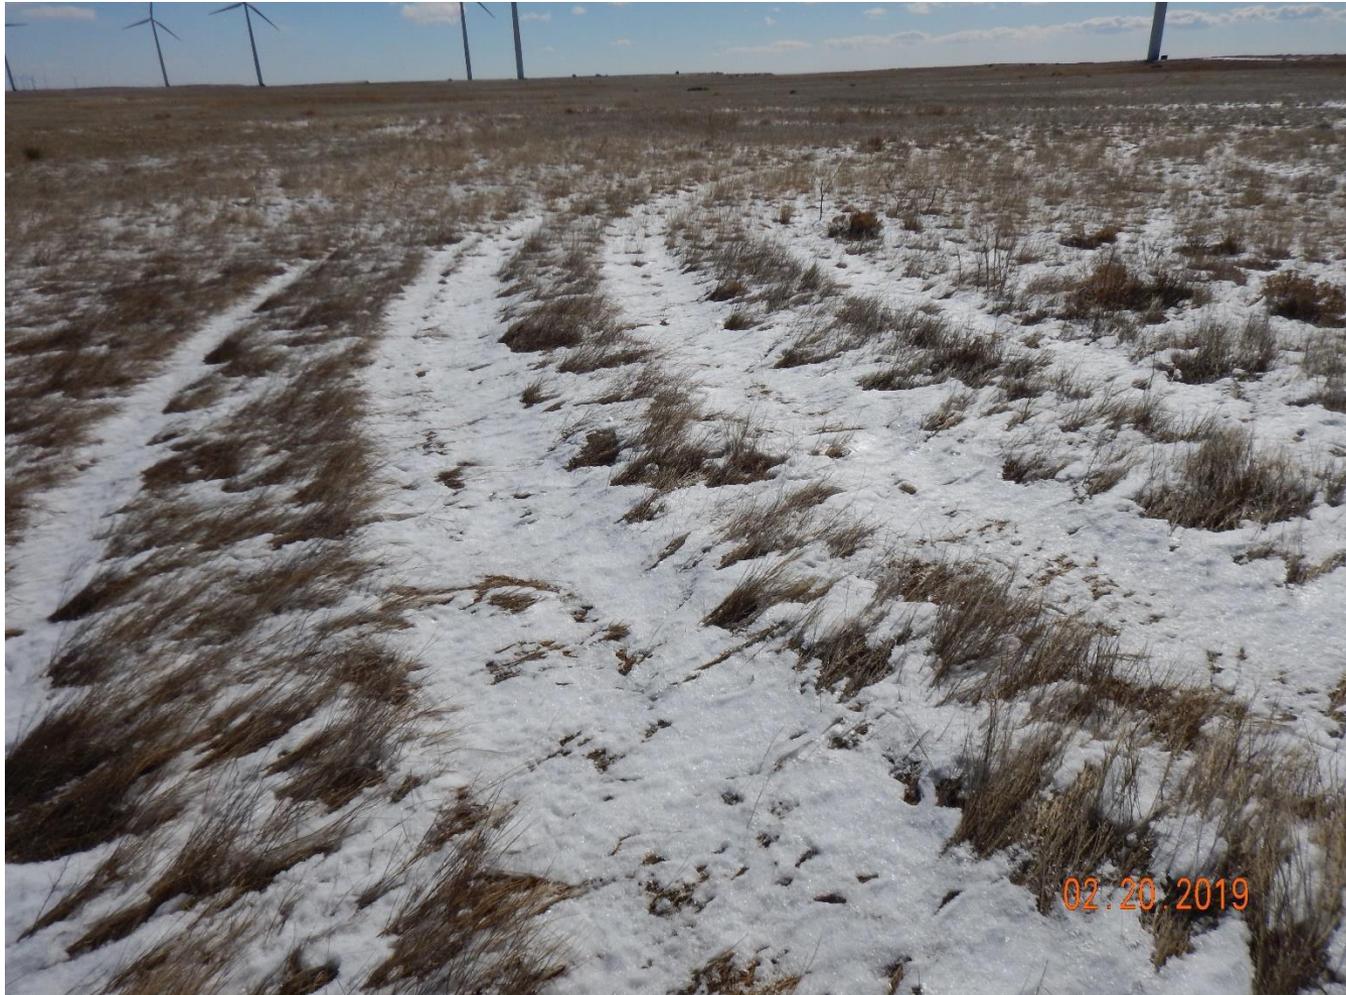
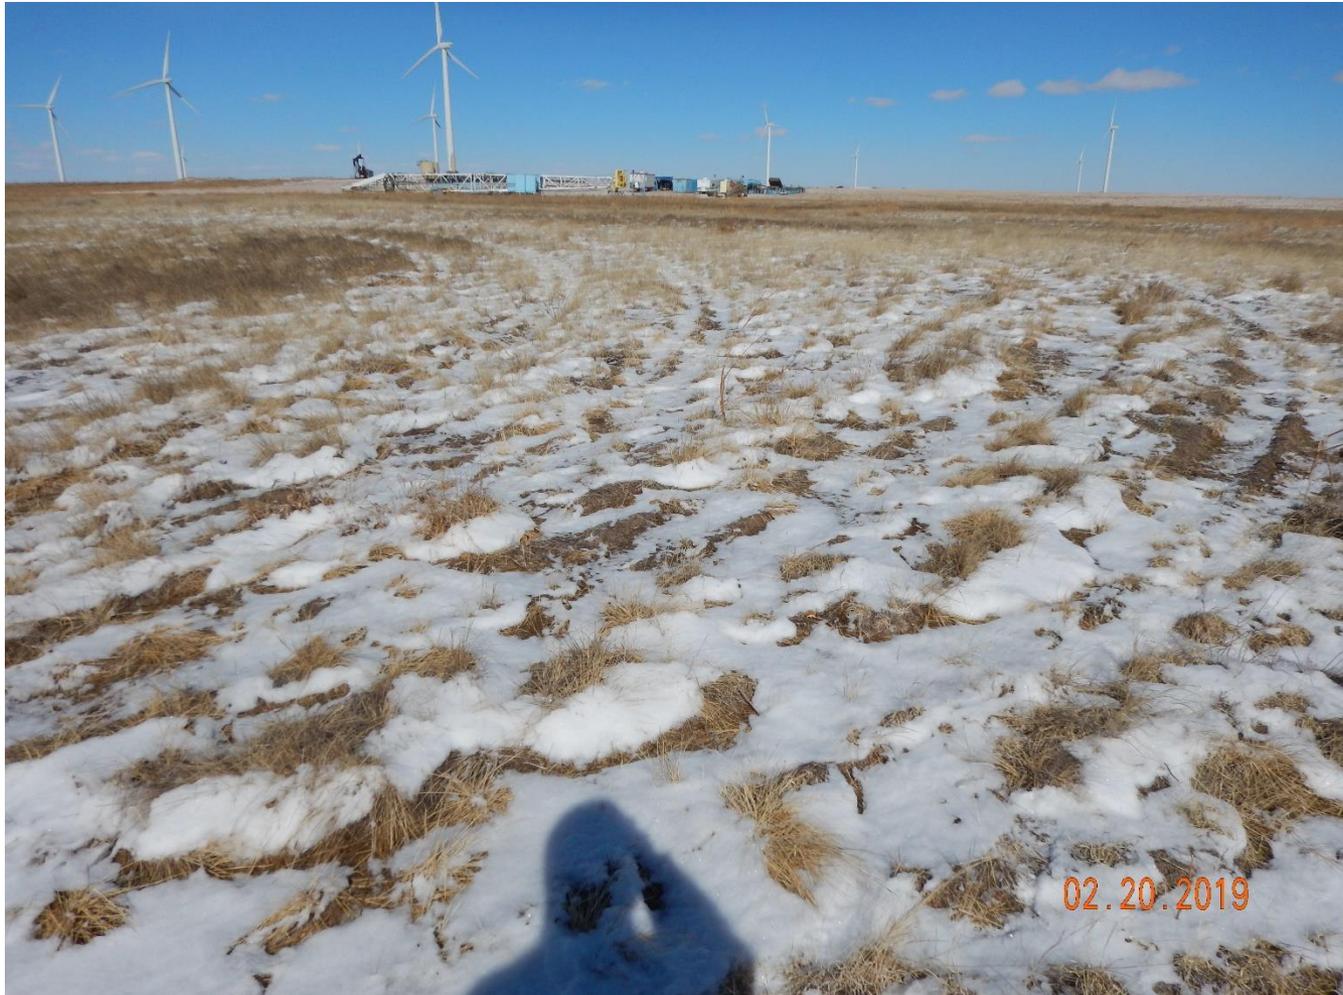
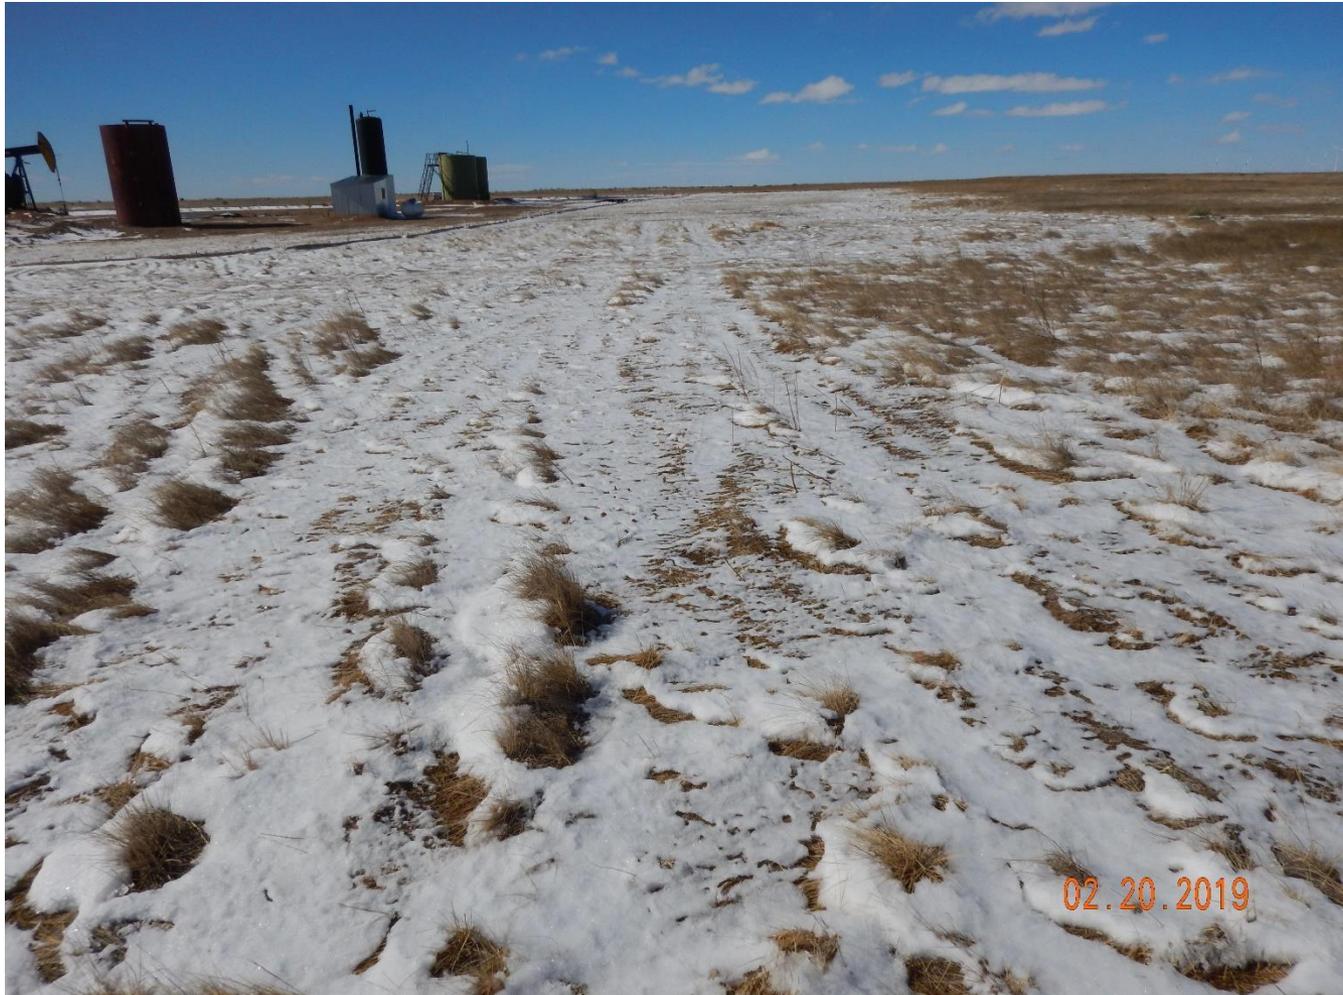
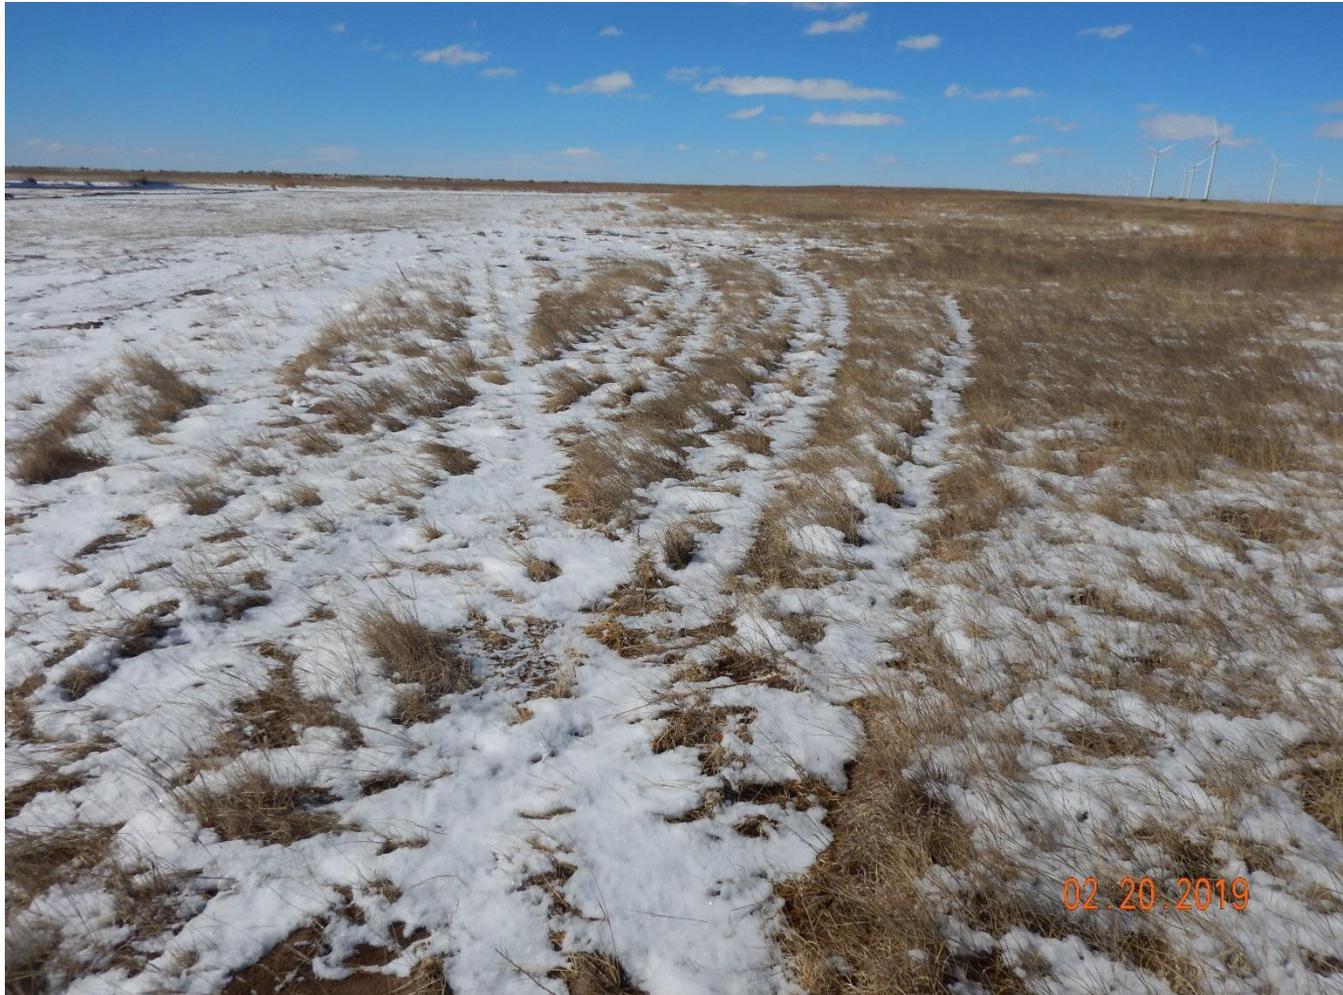
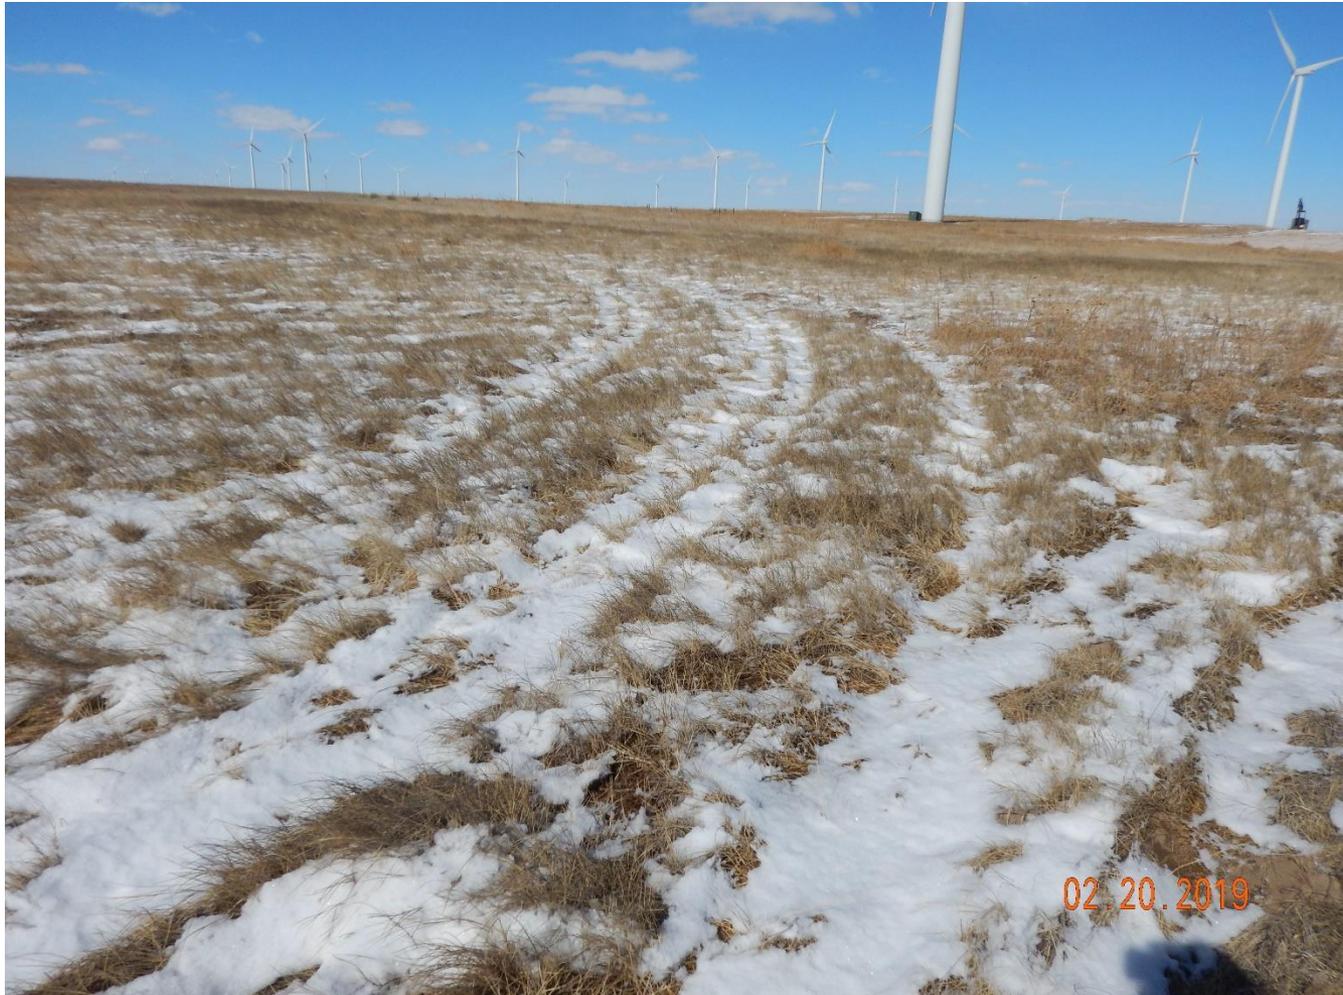
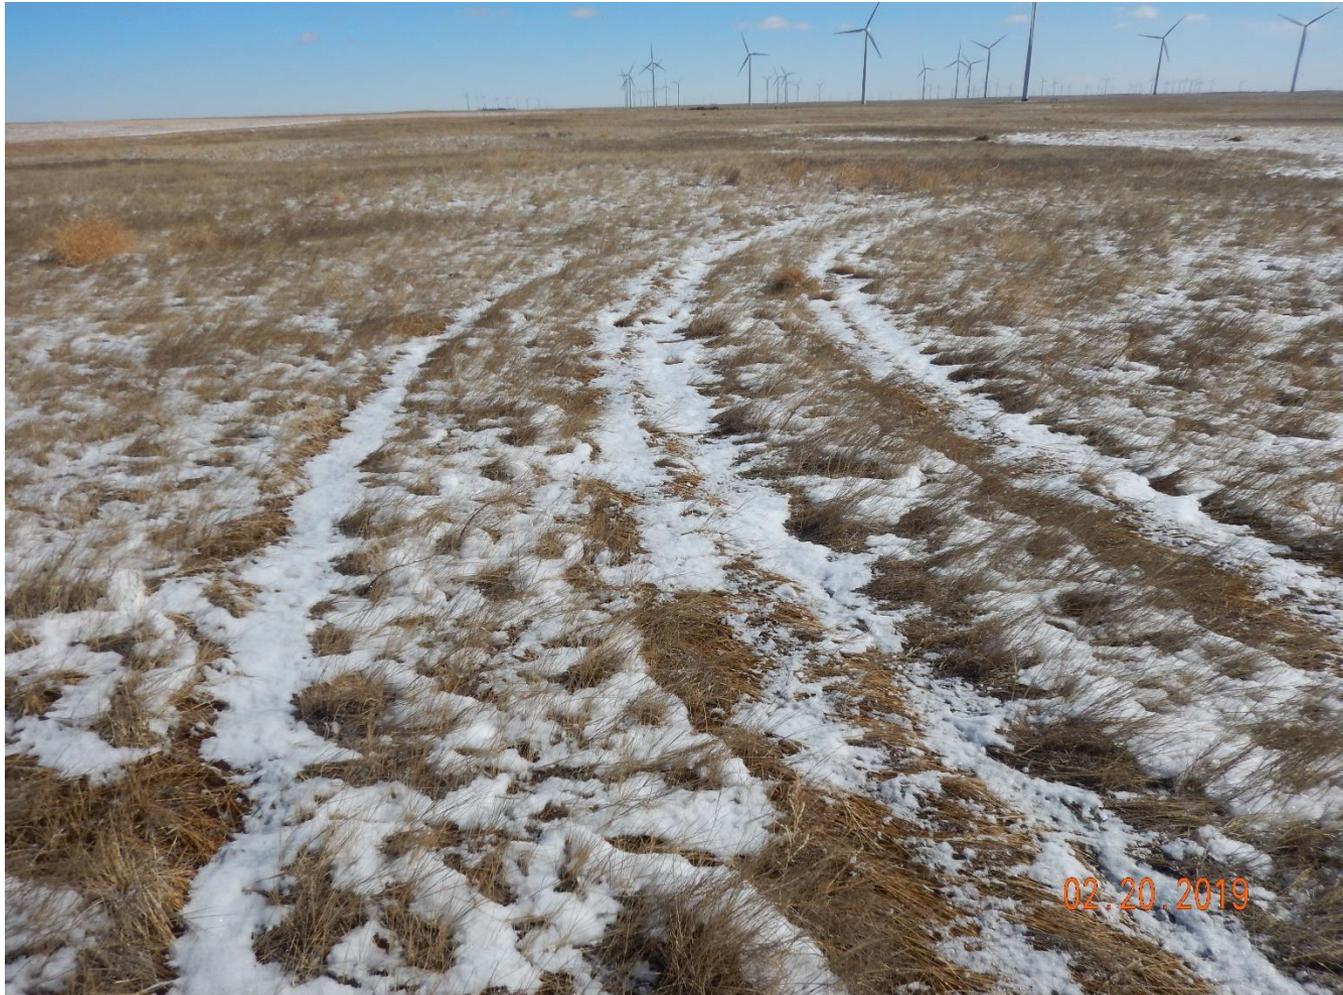
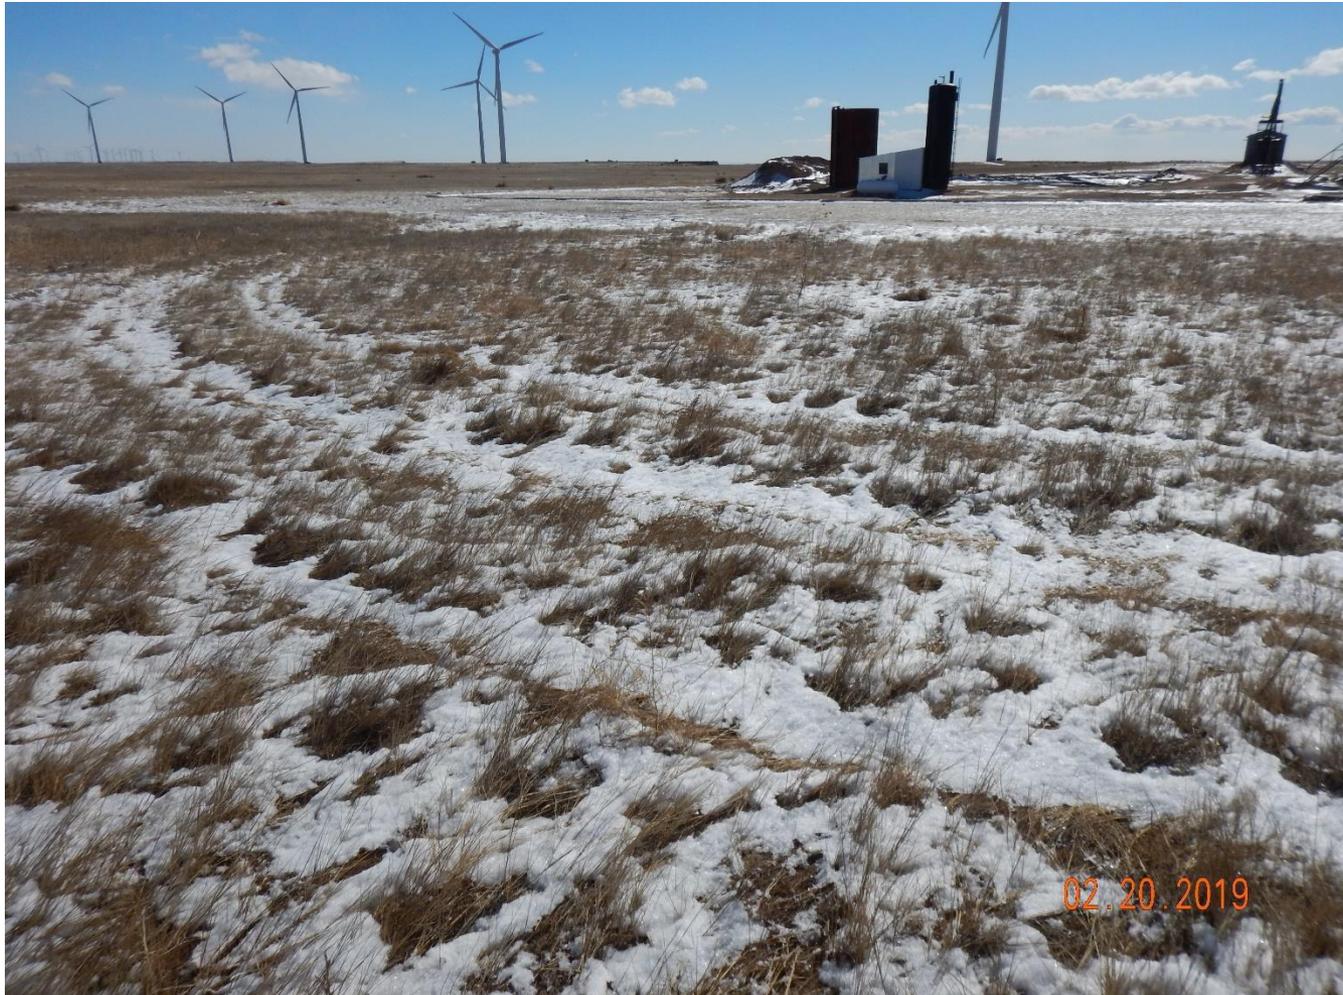
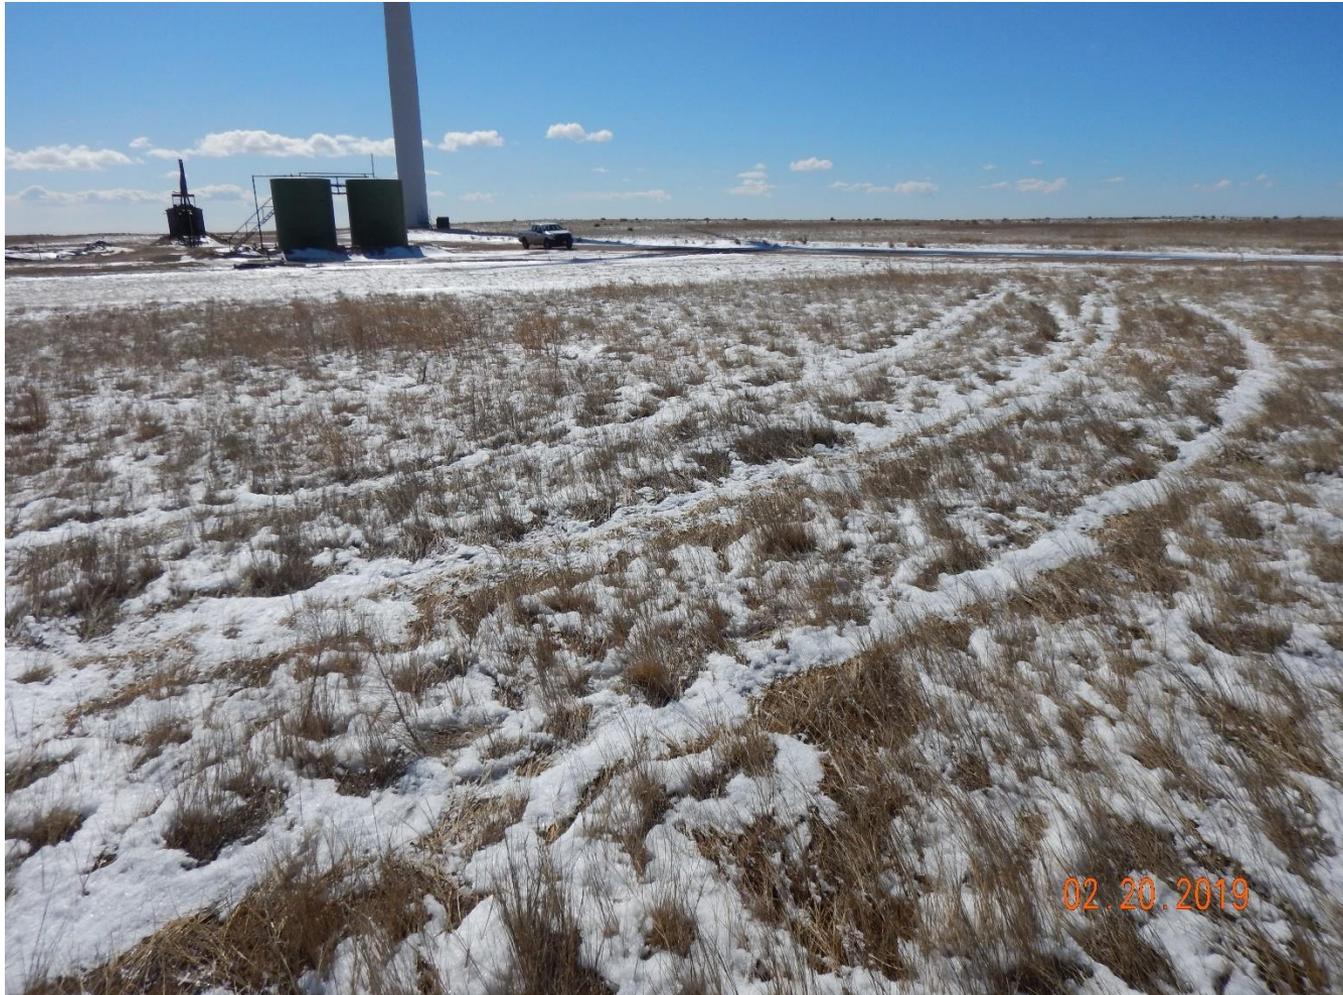
Photo 13: Photo taken from the northeast of the location. Previous inspection documented that operator drove equipment/vehicles on areas off of the location.. Photos 13, and 17 through 25 continue to document the additional disturbance. Ruts due to compaction observed in photos as deep as 6 inches.

Photo 17: Photo taken from the northeast end of the location, facing east. See comments under photo 13.

Photo 18: Photo taken from the northeast end of the location, facing south. See comments under photo 13.

Photo 19: Photo taken from the northeast end of the location, facing north. See comments under photo 13.

Photo 20: Photo taken from the northeast end of the location, facing west. See comments under photo 13.

Photo 21: Photo taken from the north end of the location, facing west. See comments under photo 13.

Photo 22: Photo taken from the north end of the location, facing northwest. See comments under photo 13.

Photo 23: Photo taken from the north end of the location, facing southeast. See comments under photo 13.

Photo 24: Photo taken from the north end of the location, facing south. See comments under photo 13.

Photo 25: Photo taken from the north end of the location, facing southwest. See comments under photo 13.

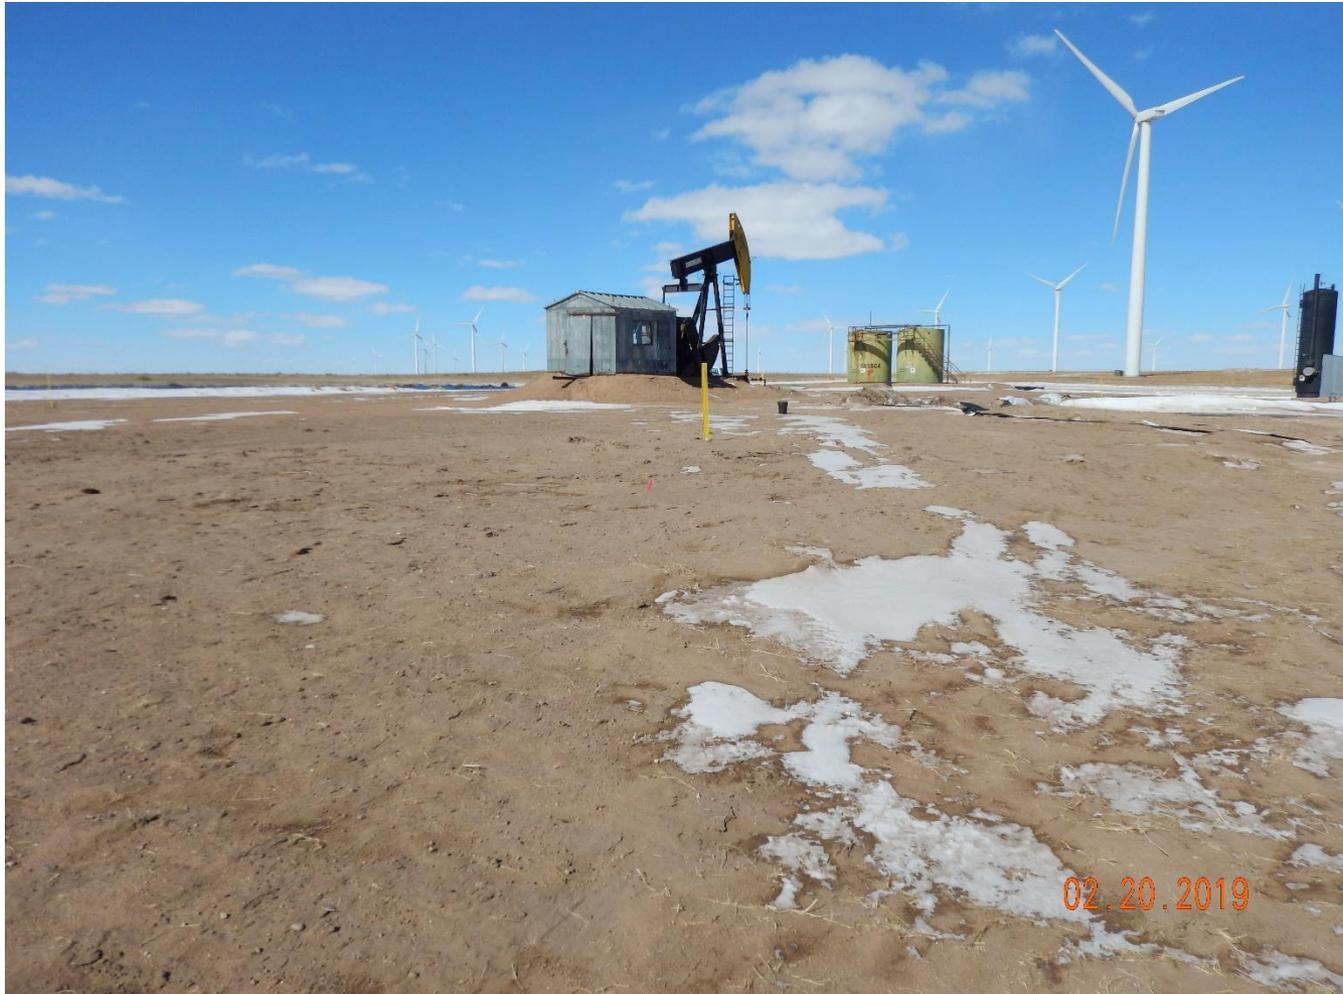
Photo 26: Photo taken from the south end of the location, facing north. Photo shows pumpjack/well. Photo also shows unstabilized soils.

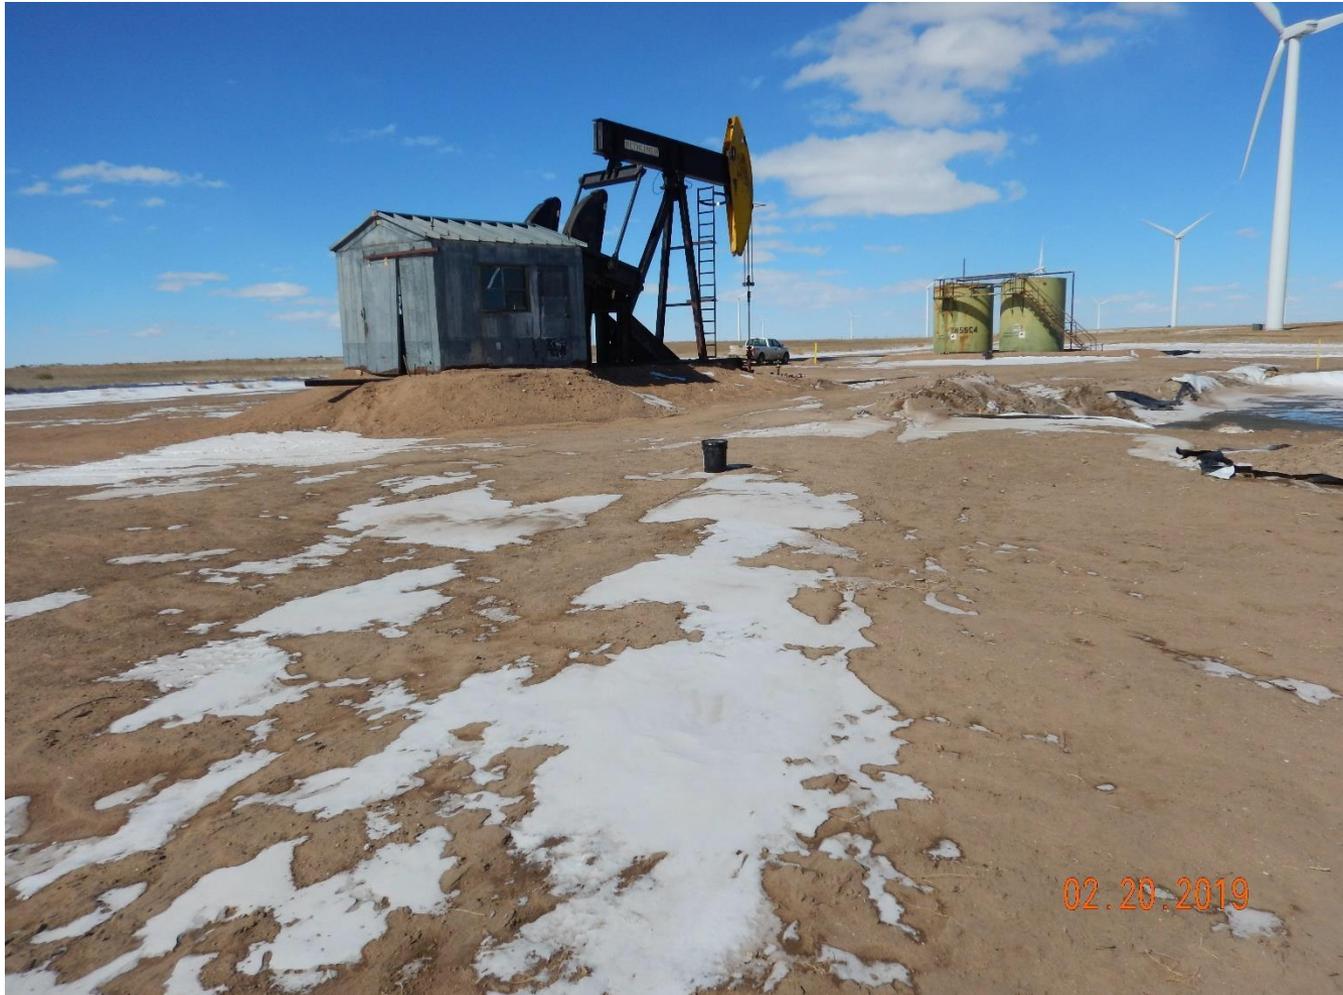
Photo 27: Photo taken from the south end of the location, facing north. Photo shows pumpjack/well and unstabilized soils. Photo also shows a 5 gallon oil bucket being improperly stored on the soil surface of the location.

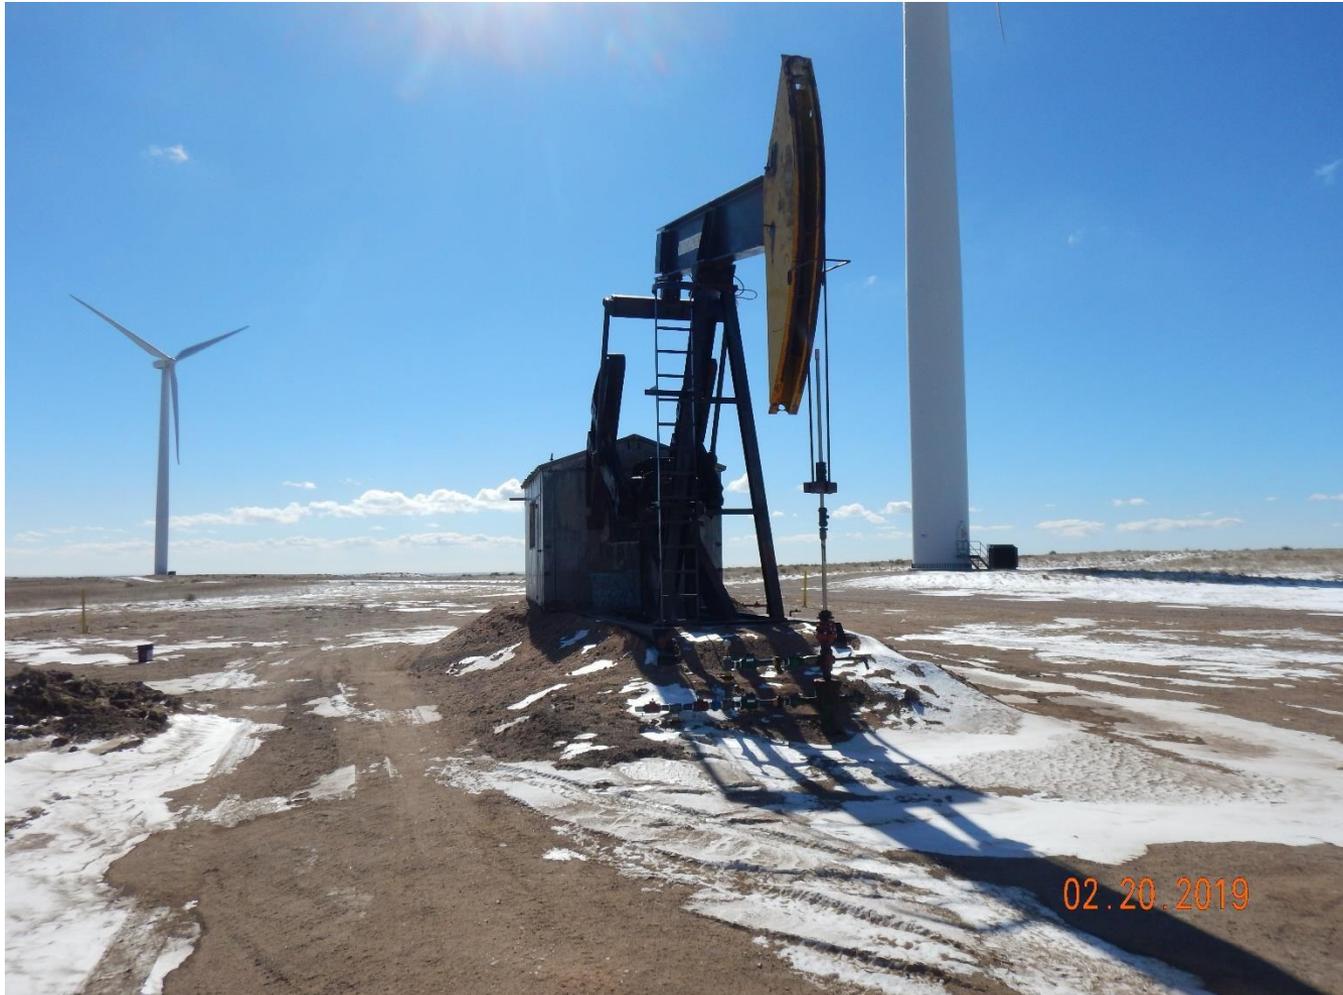
Photo 29: Photo taken from the north end of the well, facing south. Photo shows sign is missing from wellhead in accordance with 210.b(1).

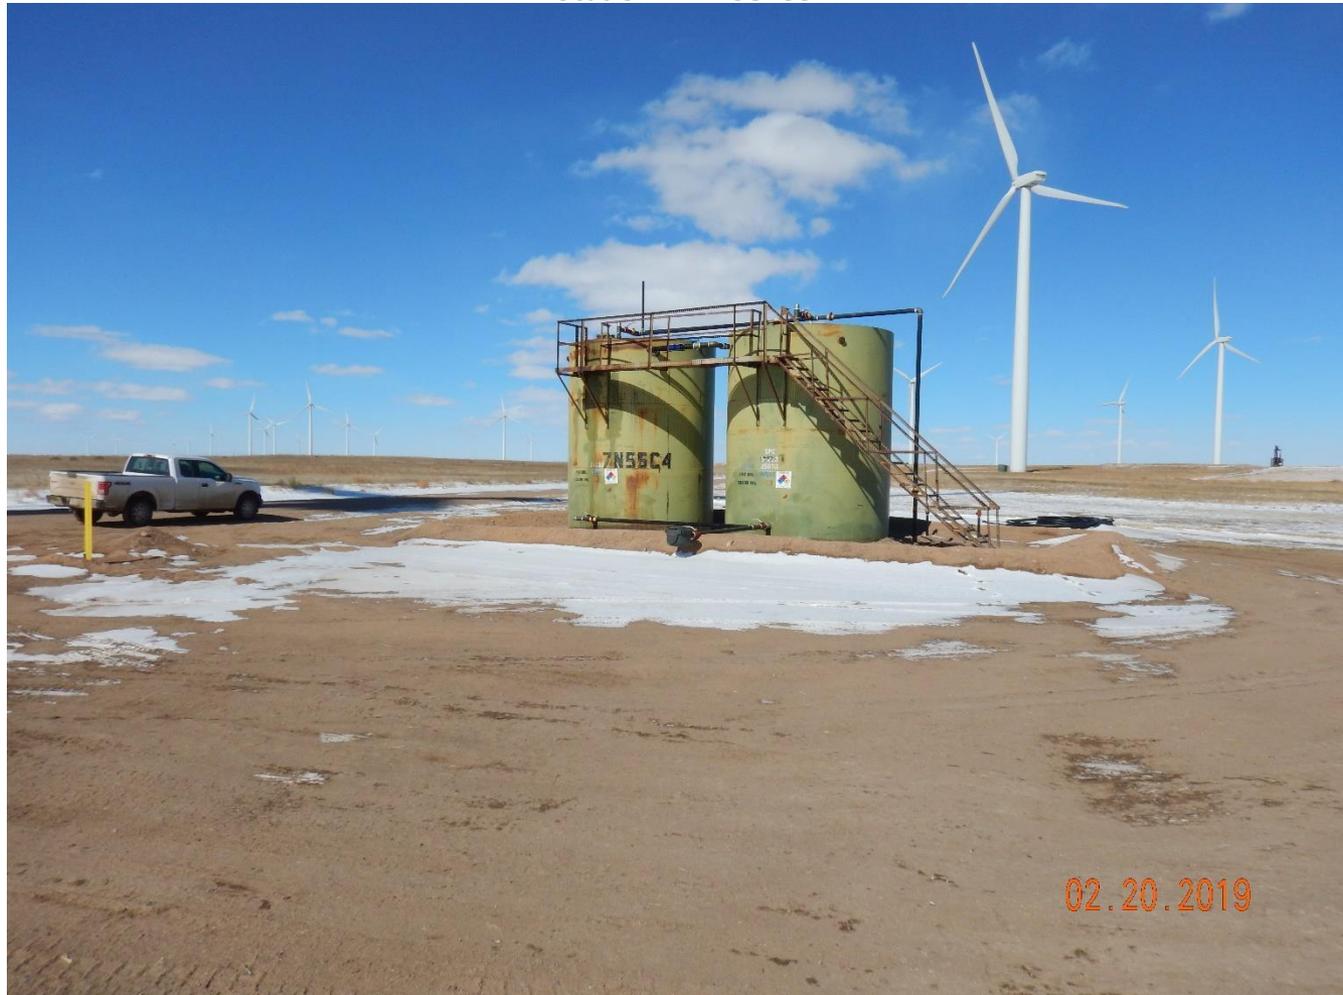
Photo 31: Photo taken from the north end of the location, facing north. Photo shows two (2) 300 bbl AST of “crude oil”. Photo also shows tanks/battery is missing the operator information/signage in accordance with 210.b(2). Berm around battery does not appear to be sufficient in size.

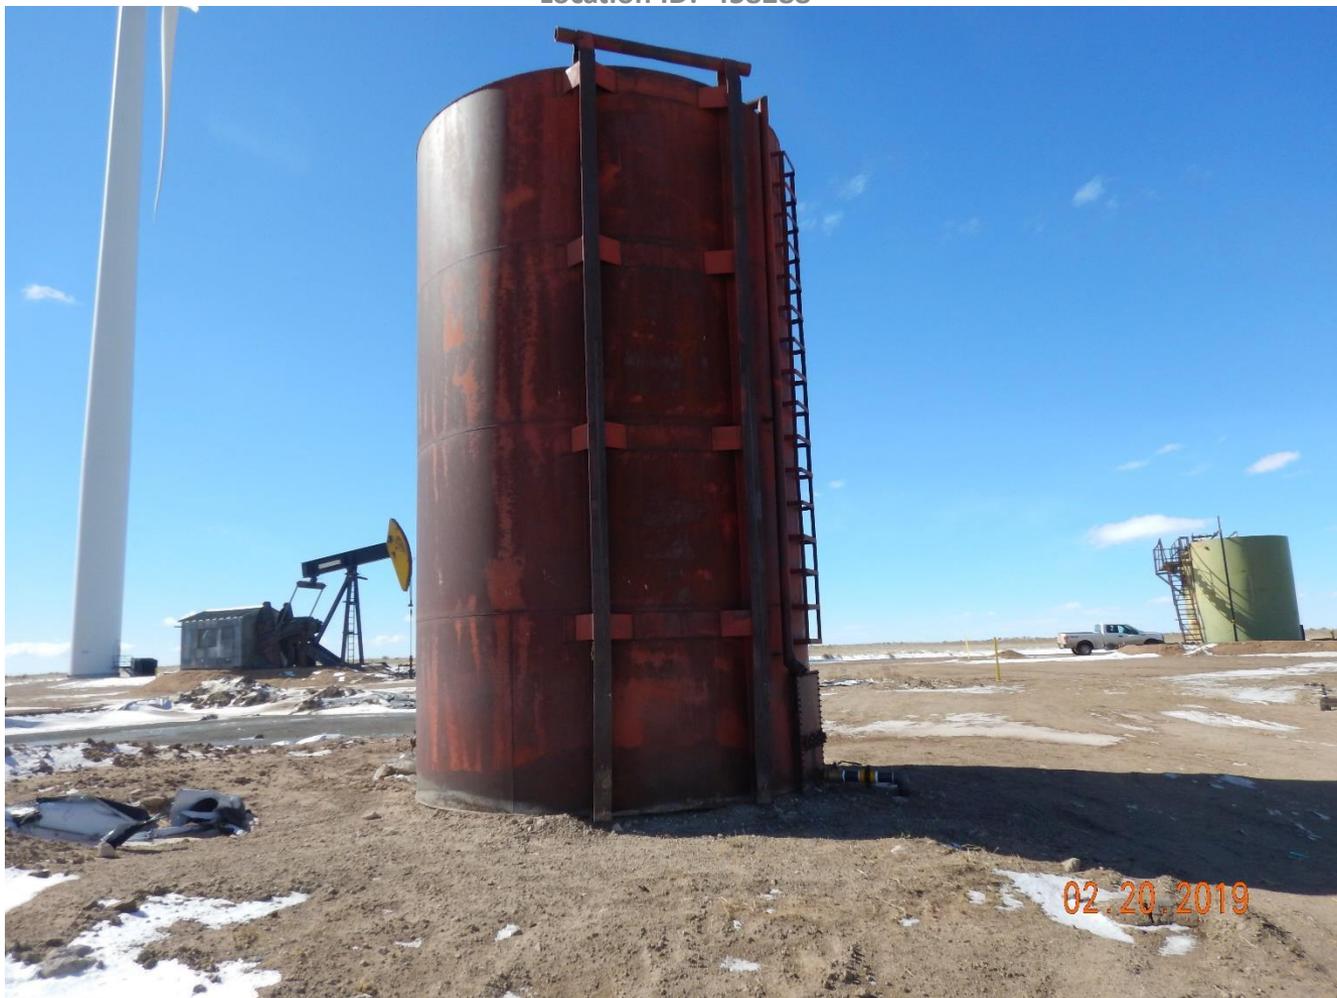
Photo 33: Photo taken from the east end of the location, facing west. Photo shows what appears to be a 300 bbl AST. Tank is missing required signage/labeling in accordance with 210.d. Photo also shows tank is missing required secondary containment in accordance with 906.d(1).

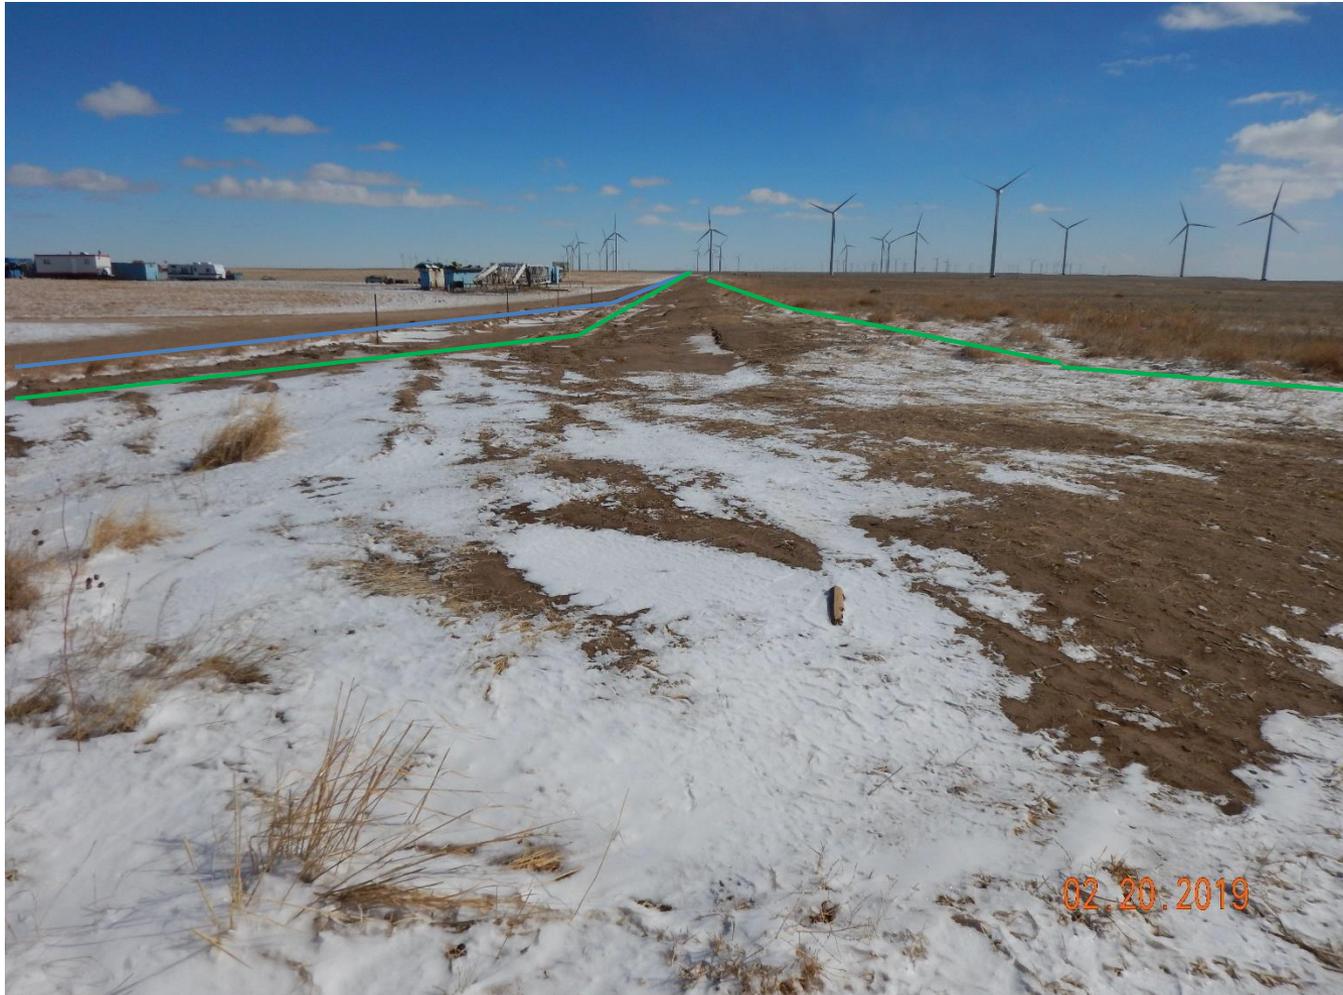
Photo 34: Photo taken from the access road north of the location, facing east. Photo shows areas of disturbance (green) parallel to the access road (blue) where operator had removed soil to be brought onto the pad

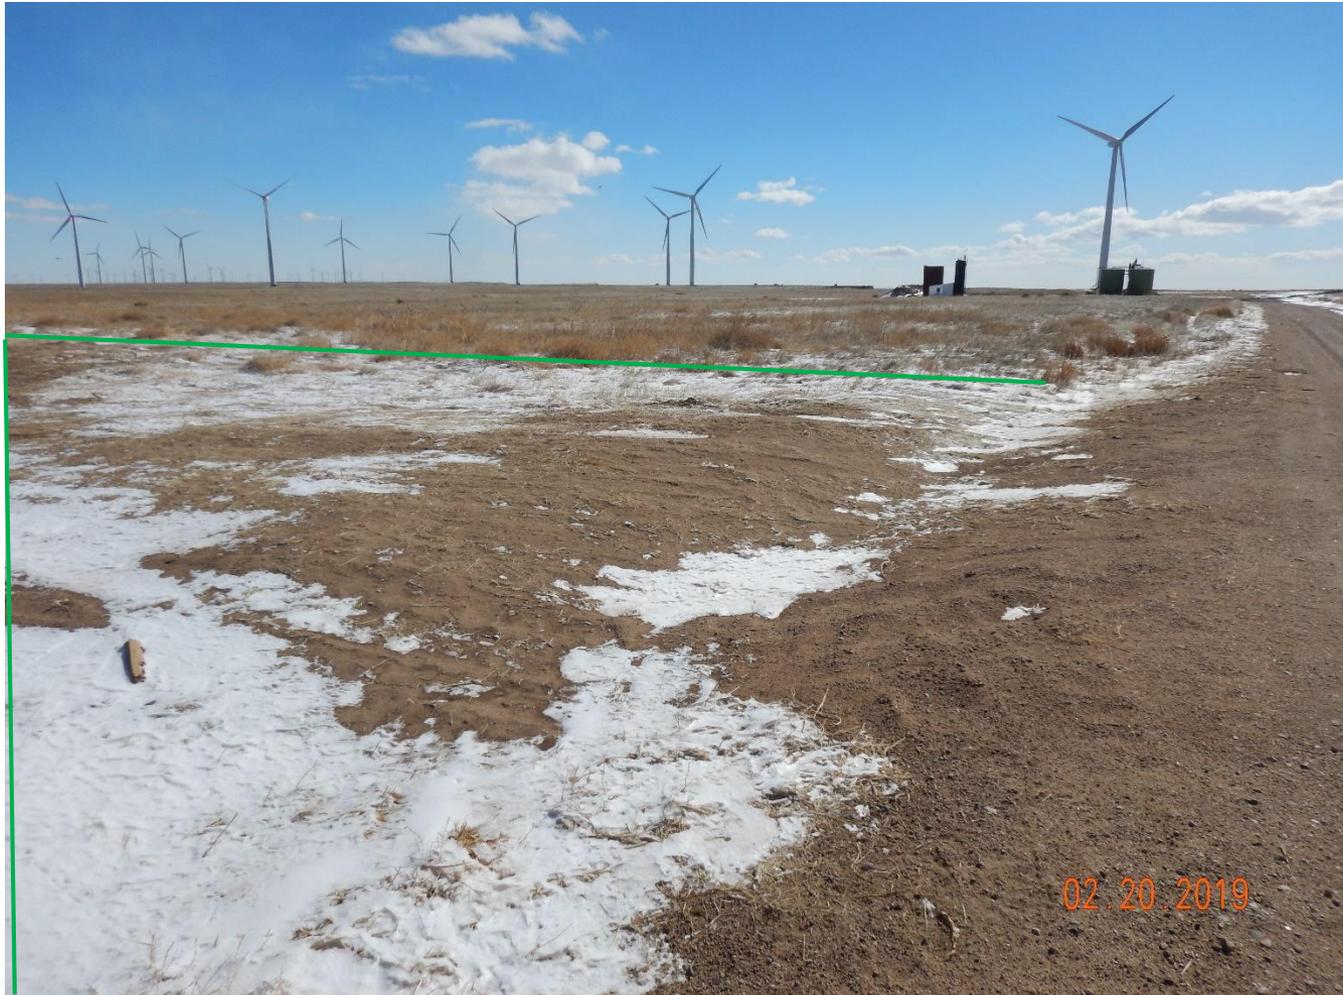
Photo 35: Photo taken from the access road north of the location, facing south towards the location. Photo shows area show areas of disturbance (green) parallel to the access road where operator had removed soil to be brought onto the pad
