Inspection Photos

Operator: H & M PETROLEUM CORPORATION #
10032

Location ID: 458288

Inspection Doc. Number: 682504523
Logan County, CO

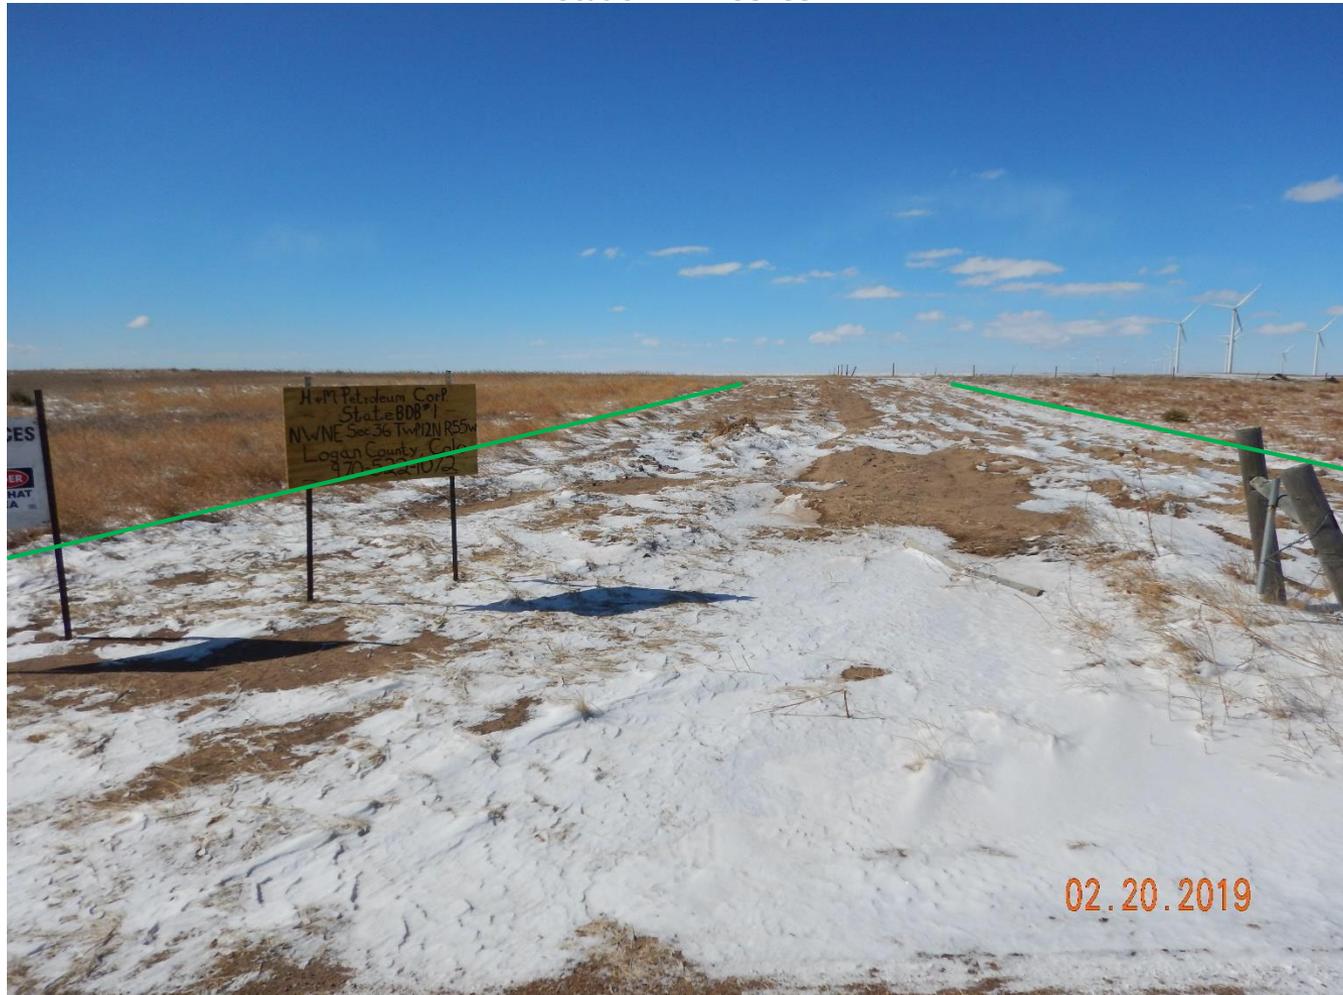
Photo 36: Photo taken from the access road north of the location, facing west. Photo shows areas of disturbance (green) where operator had removed soil to be brought onto the pad

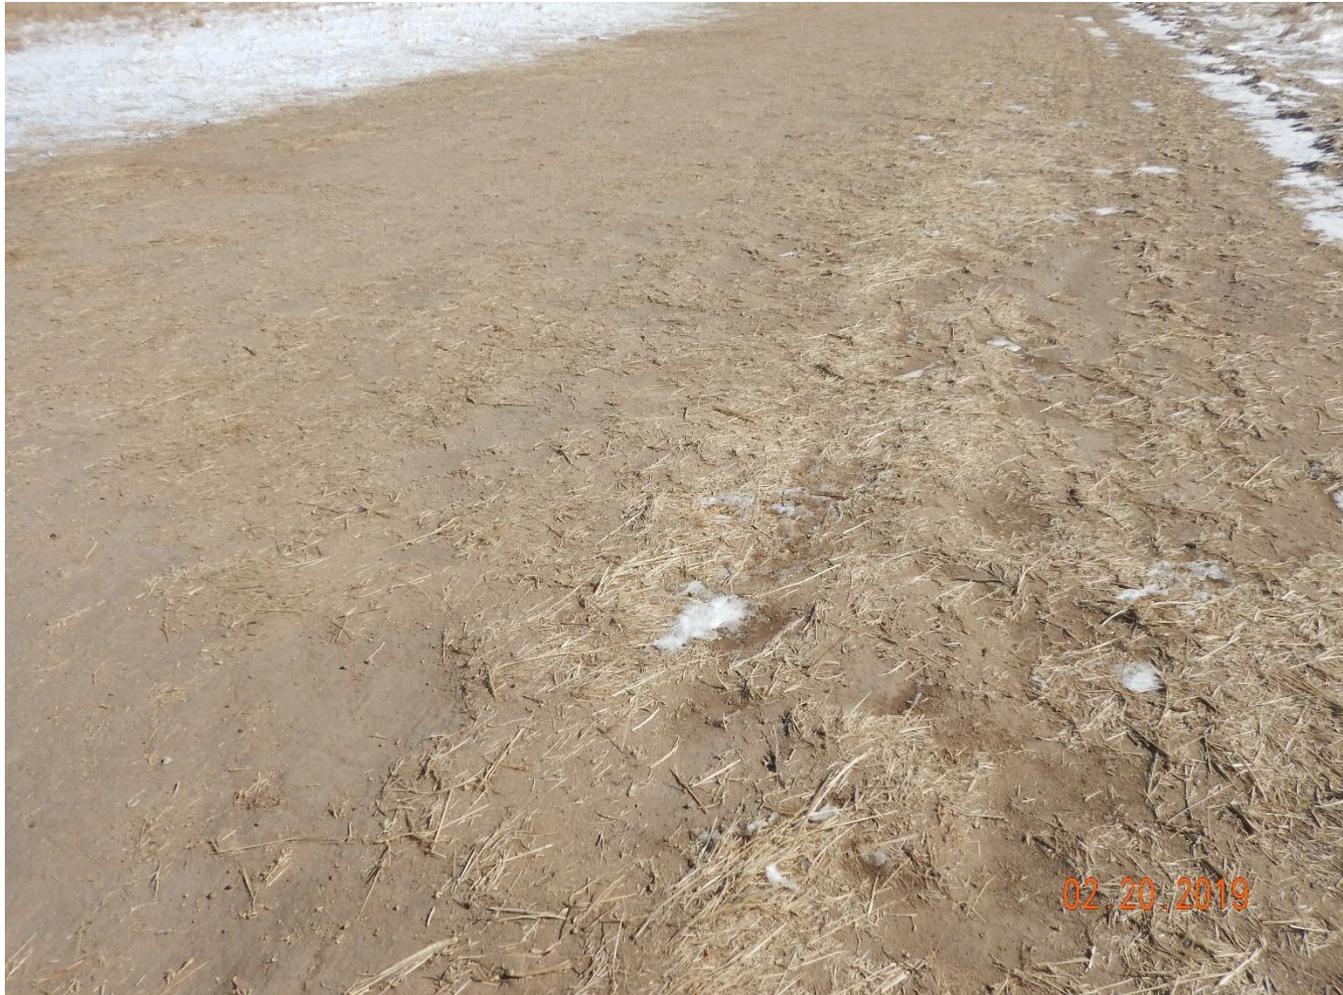
Photo 38: Continued from photo 37. Photo shows vegetation on the area of the new section of access road. Operator does not appear to have constructed the road (salvaged topsoil, imported road base) but rather traveled over the surface until a road was created. This is not protective of topsoil.

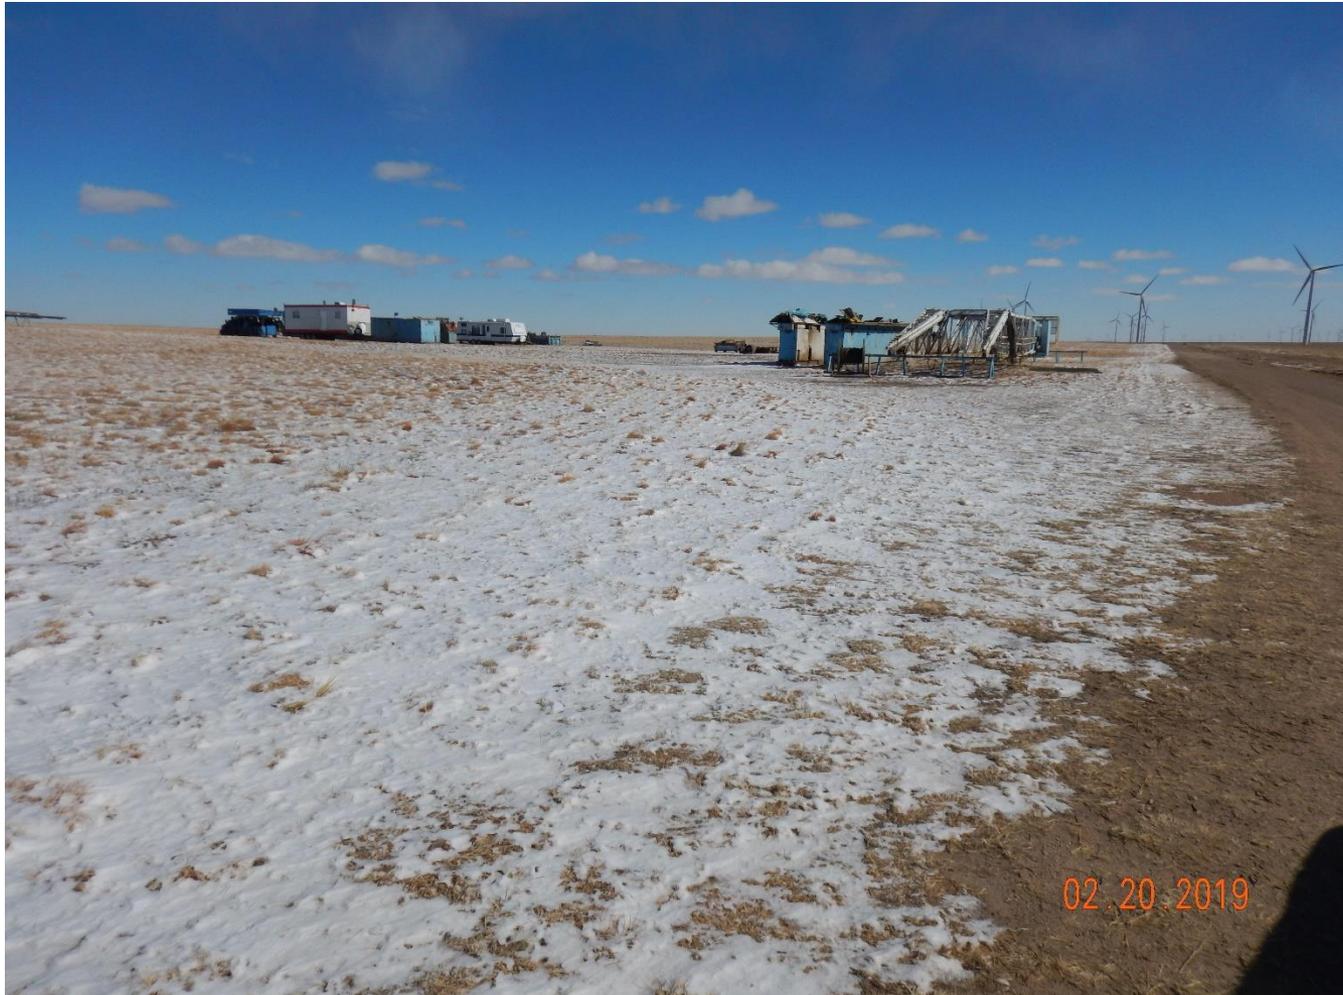
Photo 39: Photo taken from the access road north of the location, facing east. Photo shows operator storing oil and gas equipment on the crop field to the north.

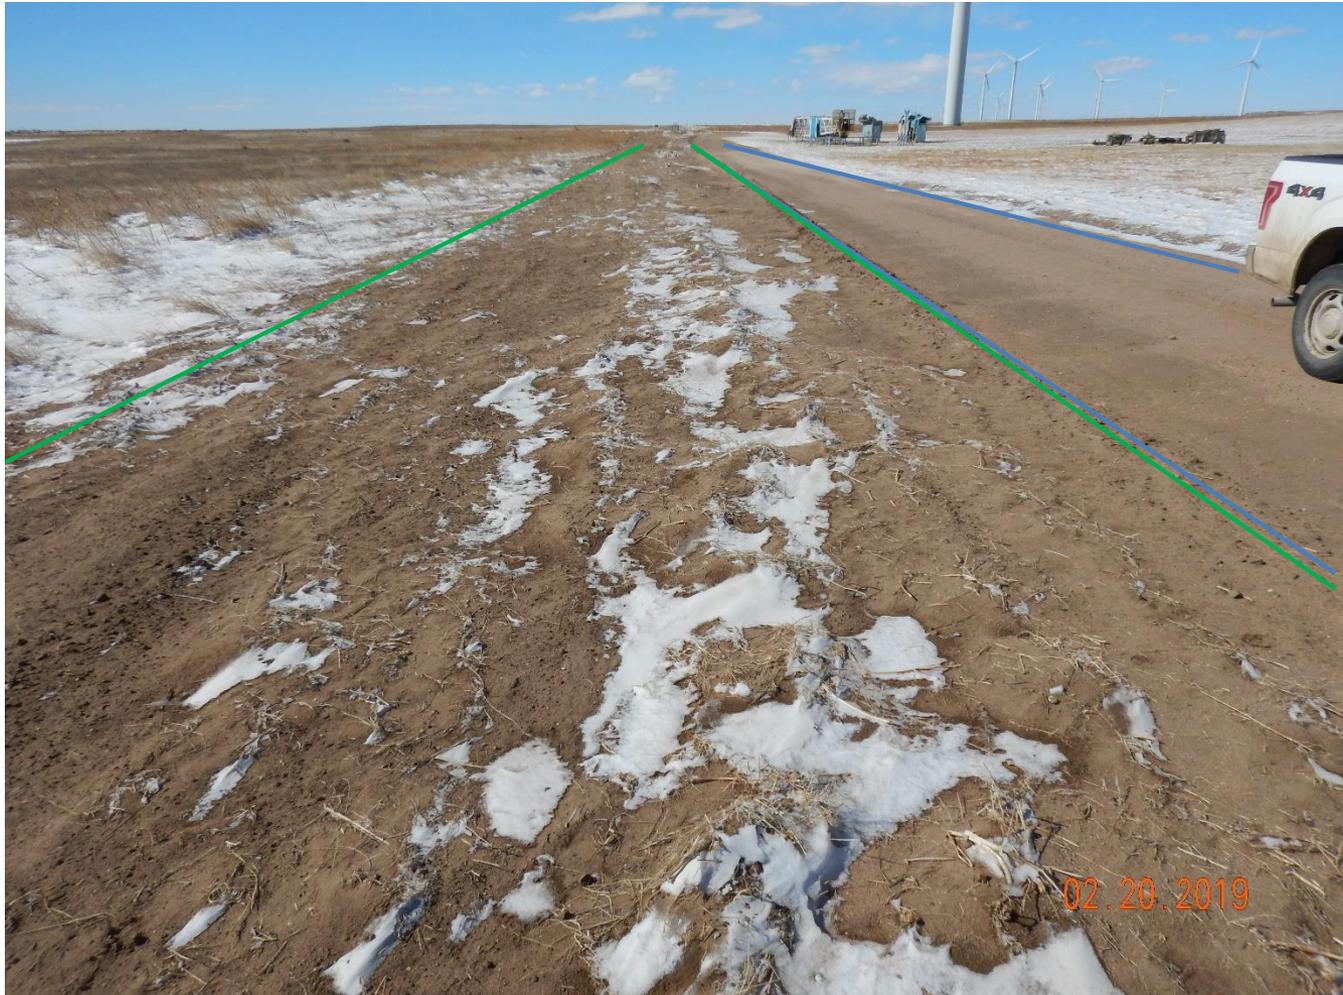
Photo 40: Photo taken from the access road north of the location, facing west. Photo shows areas of disturbance (green) parallel to the access road (blue) where operator had removed soil to be brought onto the pad

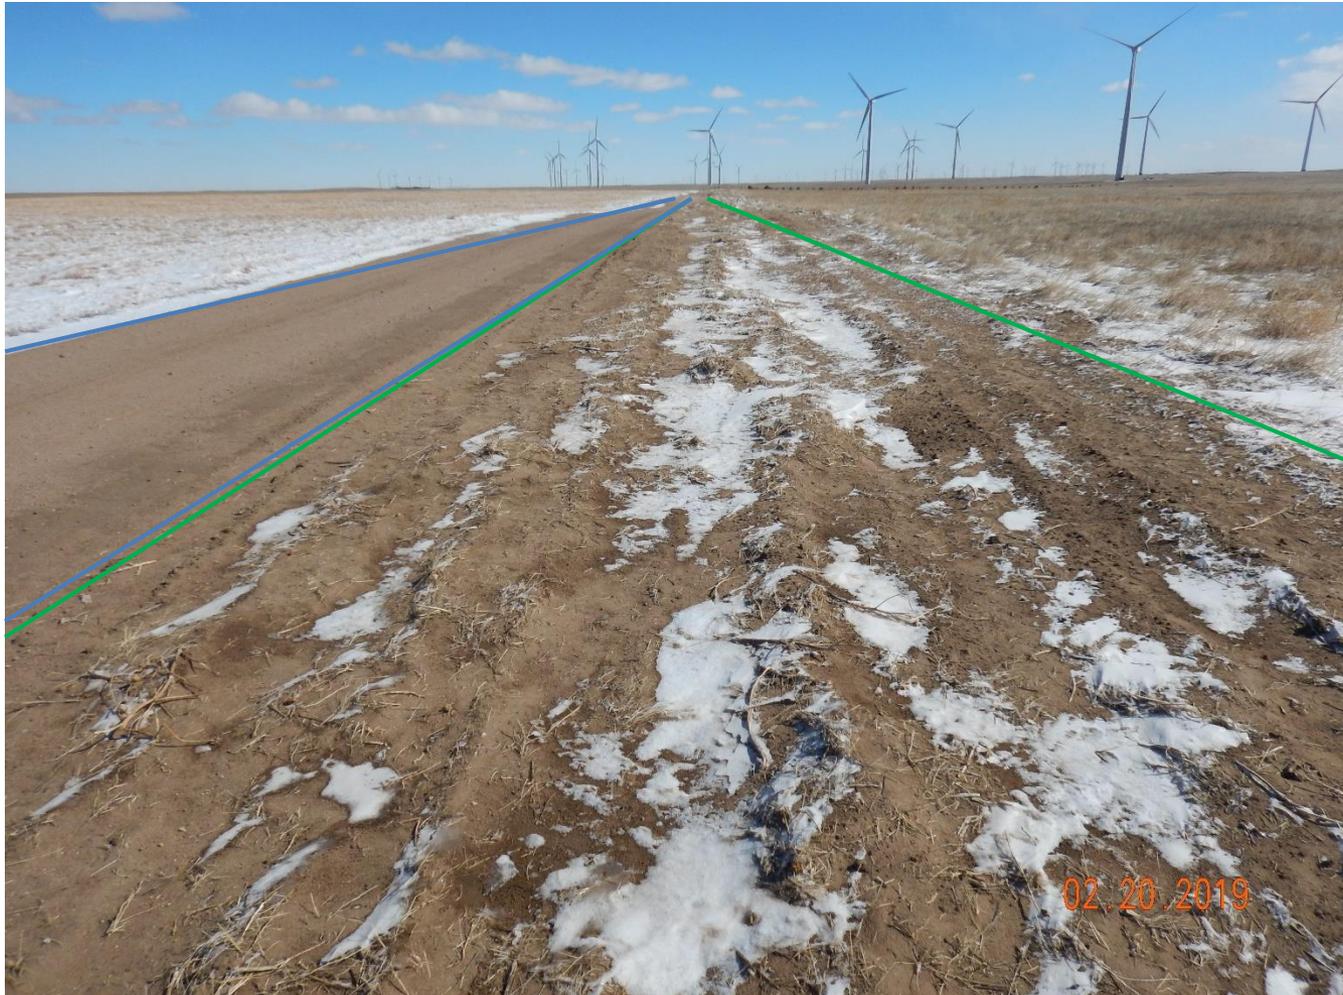
Photo 41: Photo taken from the access road north of the location, facing east. Photo shows areas of disturbance (green) parallel to the access road (blue) where operator had removed soil to be brought onto the pad
