Inspection Photos
Location Name: LOEHR Larry R #1
Location ID: 322864

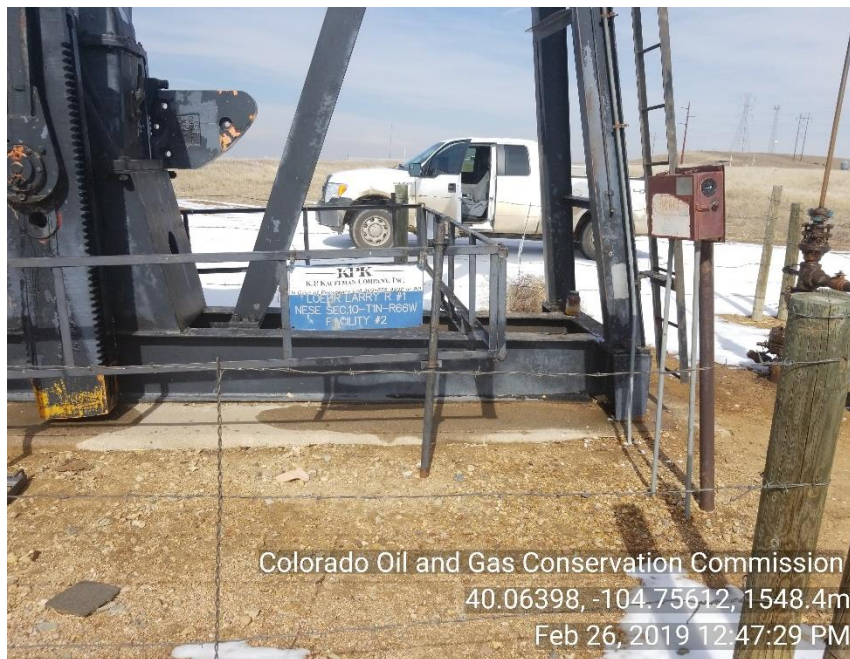
Photo 1 WH sign

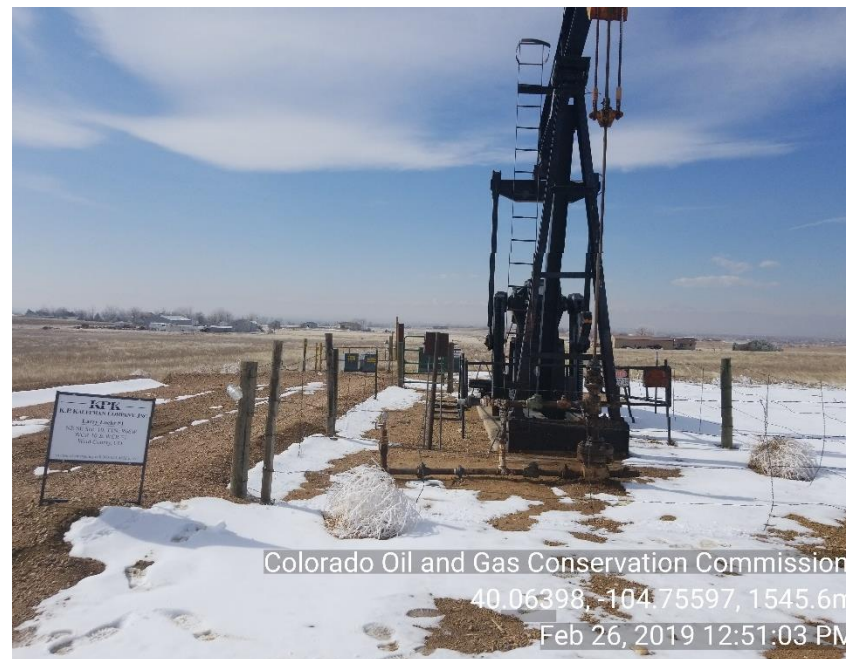
Photo 2 PU

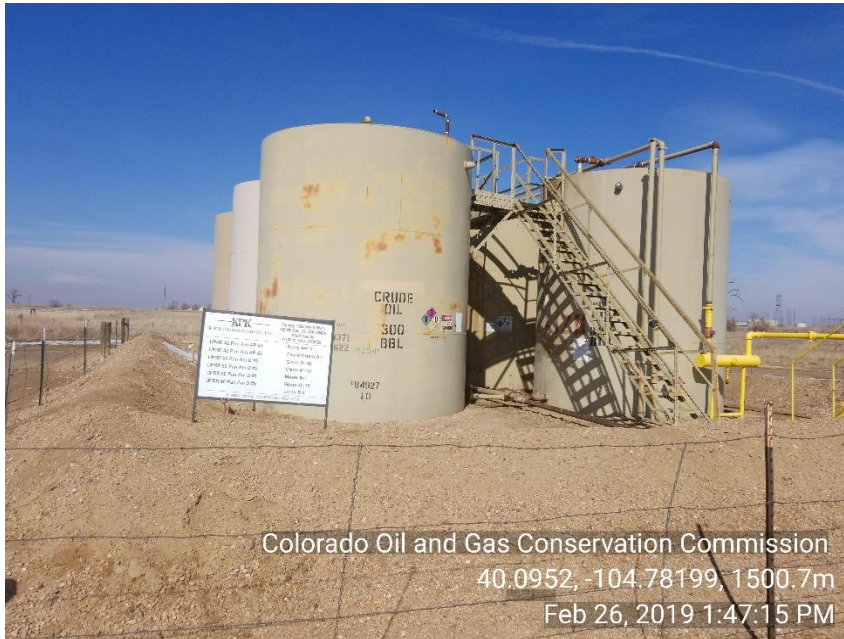
Photo 3 TNK BTRY

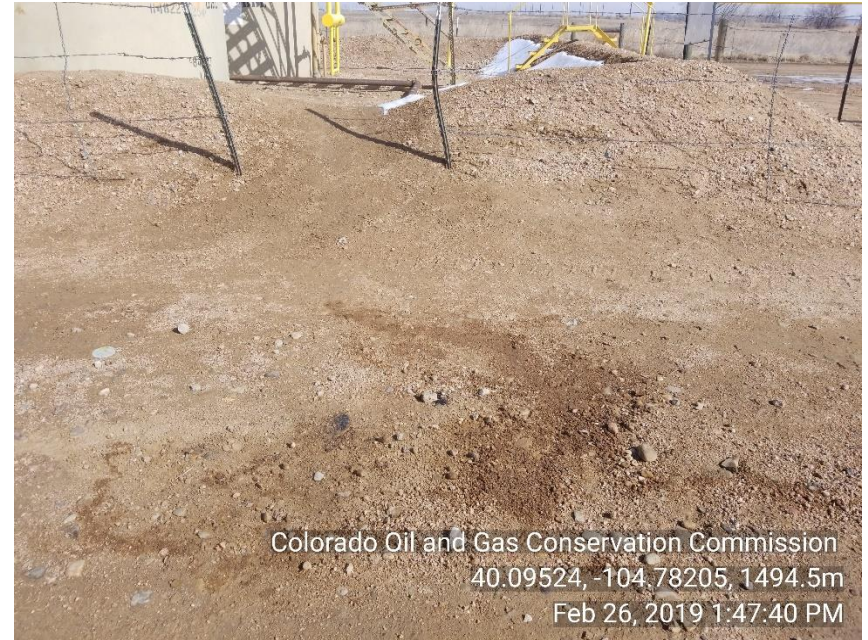
Photo 4 Stained soil appears to be from trucks off loading tanks

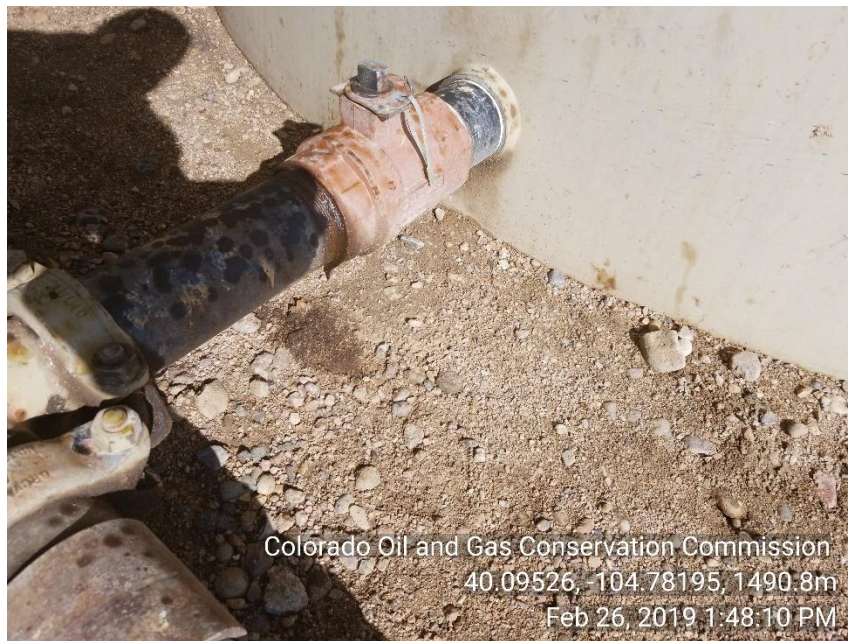
Photo 5 stained soil under load line to crude oil tank

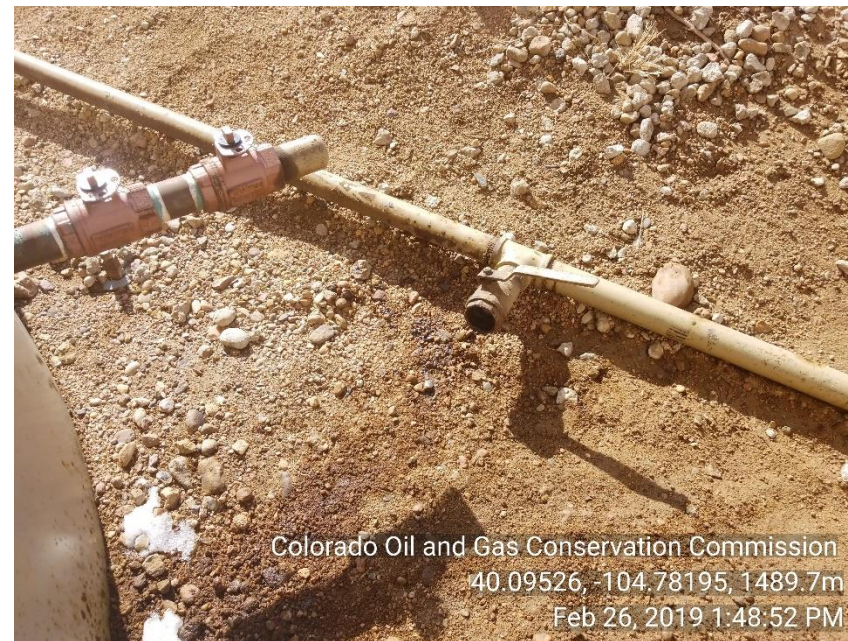
**Photo 6 Stained soil under disconnected crude oil load line
and no bull plug on 2" VLV**

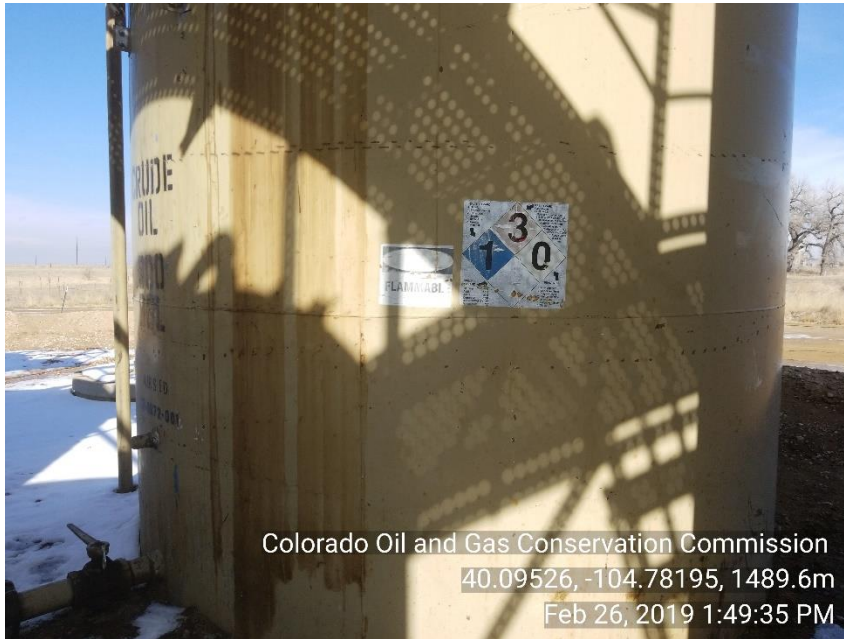
Photo 7 faded NPPA placard

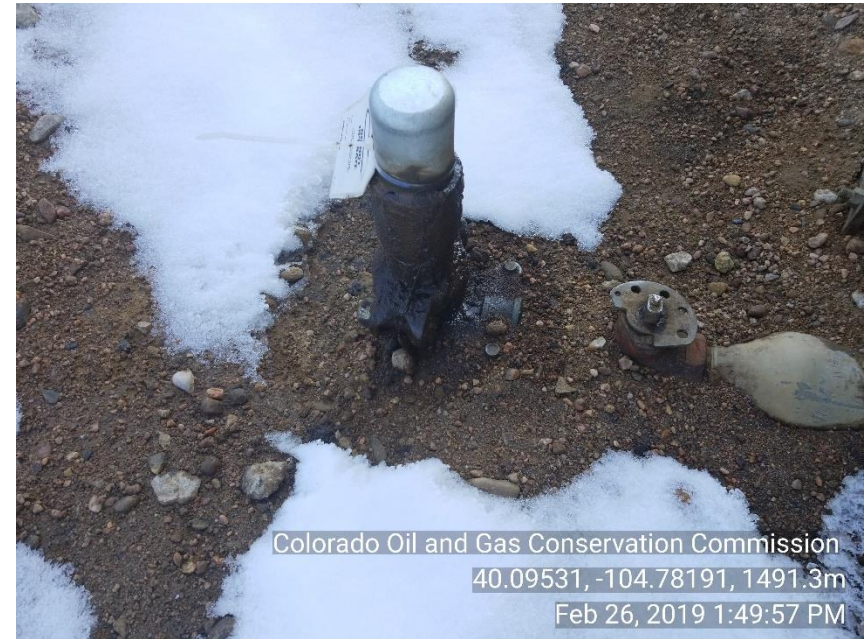
Photo 8 stained soil 2" bull plug on crude oil load line to tank

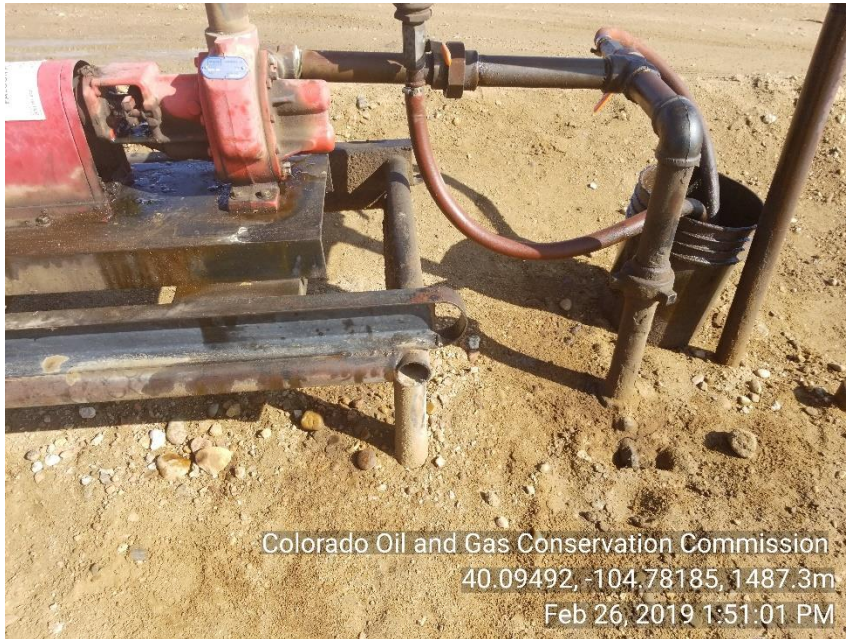
Photo 9 stained soil around recirc pump

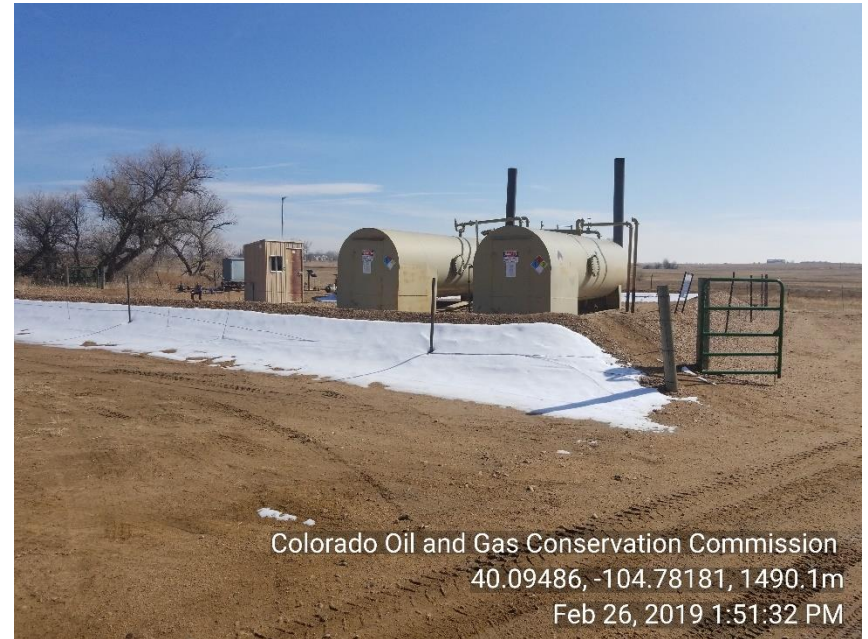
Photo 10 Separators and meter house

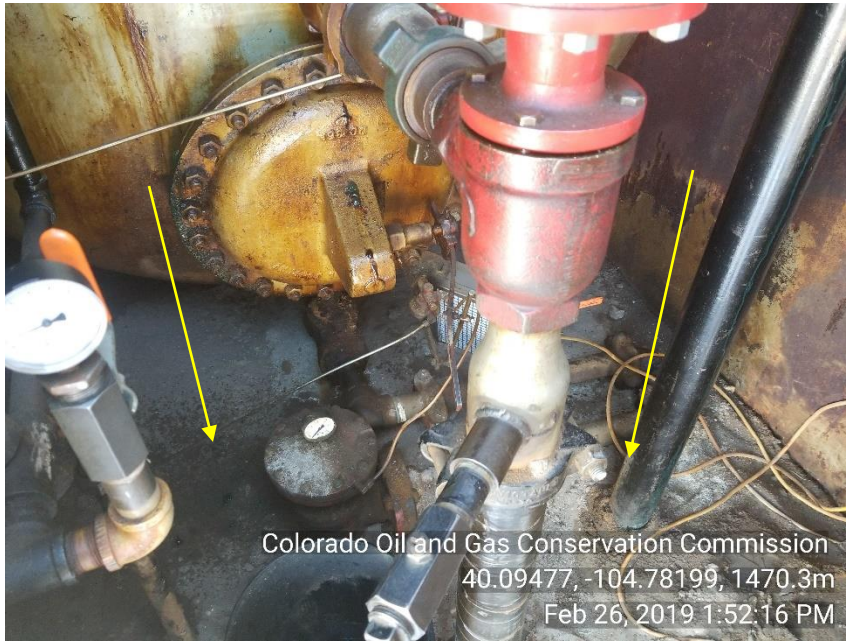
Photo 11 Stained soil inside separator house

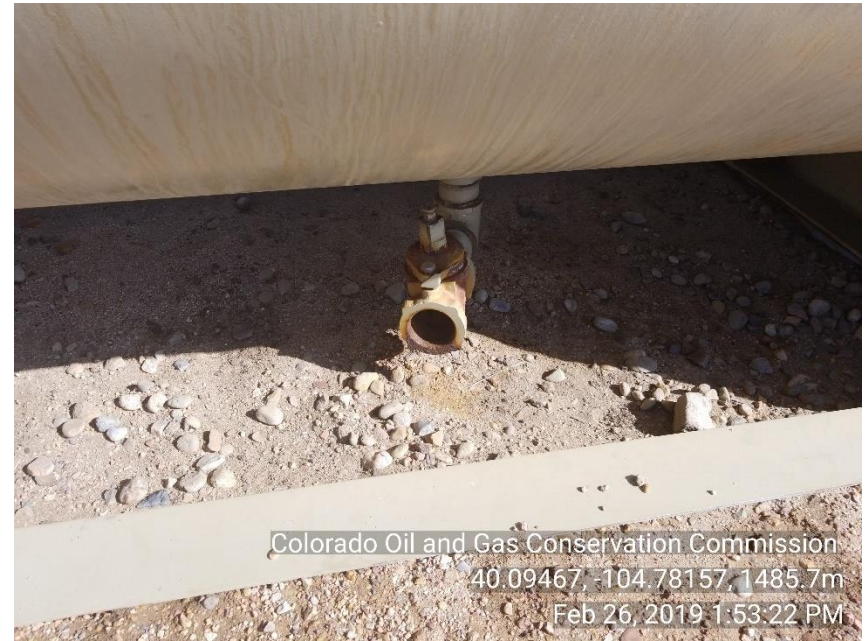
Photo 12 no bull plug on drain line of separator

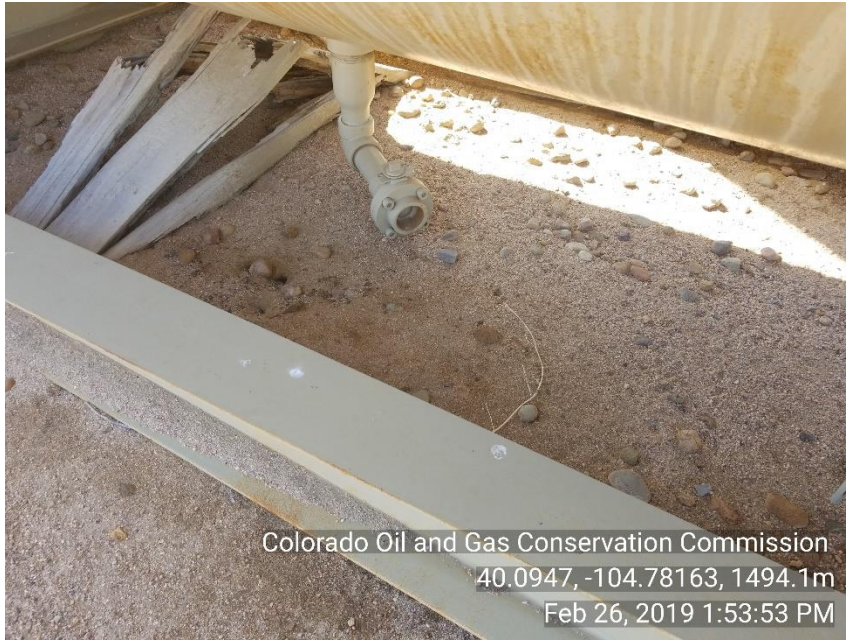
Photo 13 no bull plug on drain line of separator

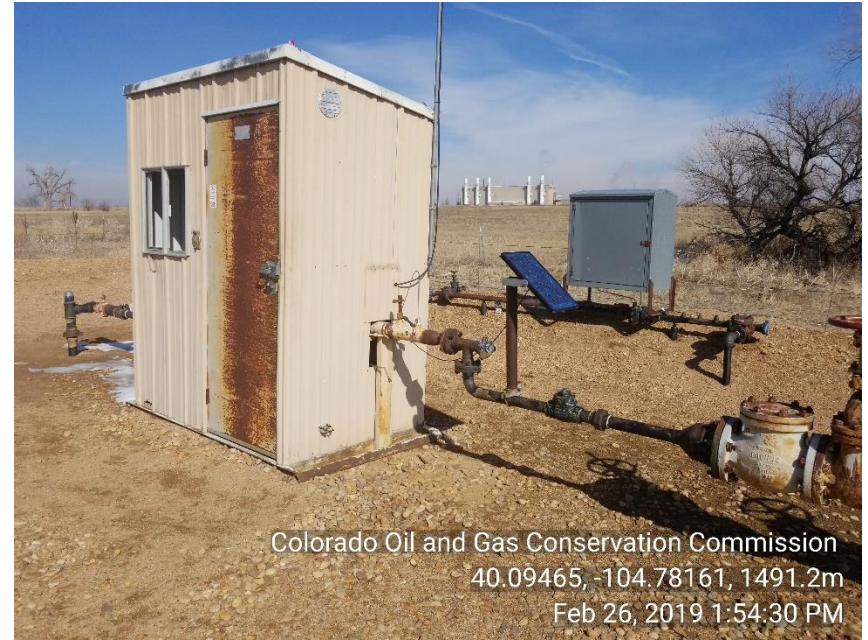
Photo 14 Meter run
