Inspection Photos
Location Name: LORENCITO 1-17
API #: 05-071-06642
Insp. Doc. # 695100225

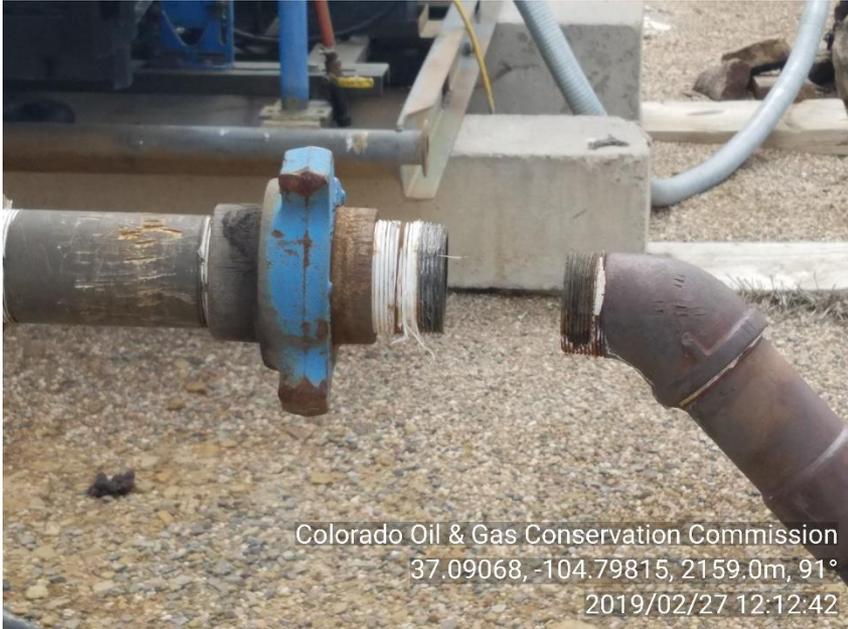
PHOTO 3: VALVE MISSING.

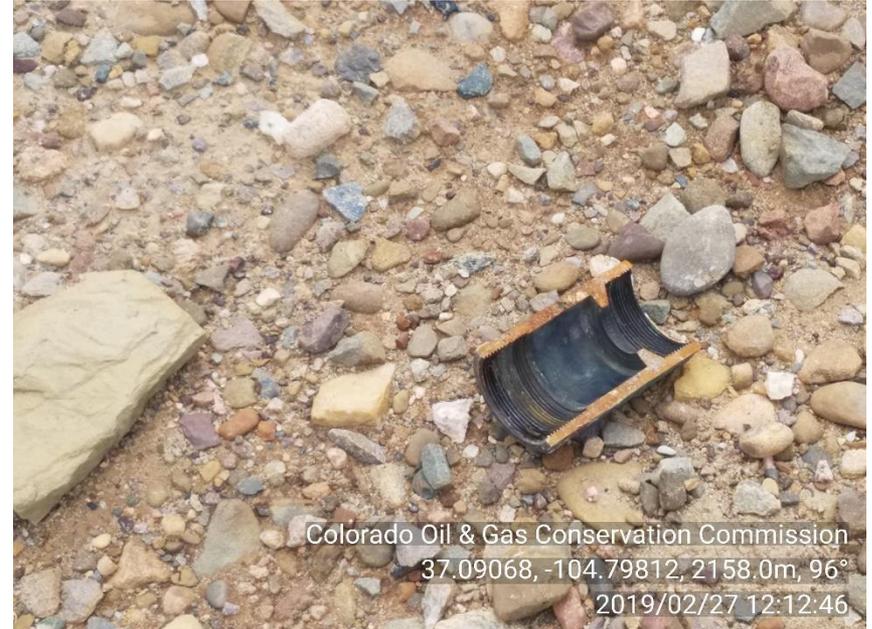
PHOTO 4: HALF OF VALVE ON GROUND UNDER TBG LINE SEPARATION.

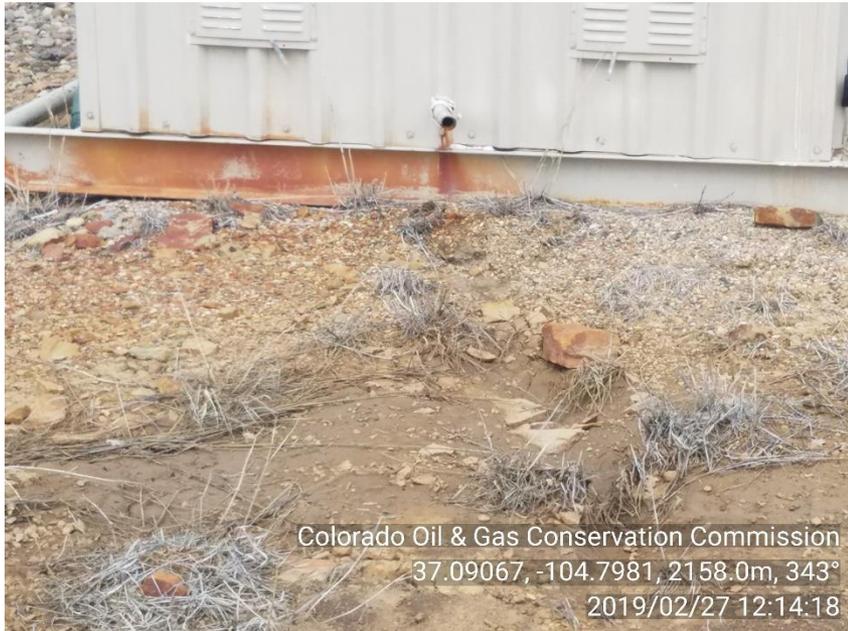
PHOTO 5: WET SOIL OUTSIDE METER HOUSE. IT APPEARS THAT FLUID FROM SEPARATOR IS BEING DRAINED ON THE GROUND.

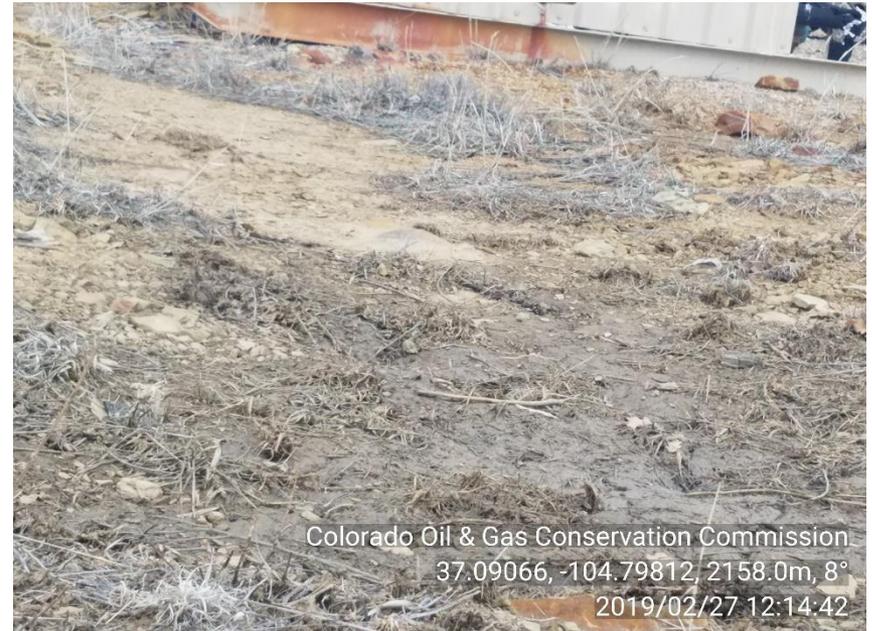
PHOTO 6: MORE WET SOIL OUTSIDE METER HOUSE. IT APPEARS THAT FLUID FROM SEPARATOR IS BEING DRAINED ON THE GROUND.
