# Inspection Photos

API: 05-071-08776

Operator: XTO ENERGY INC

Inspection Date: 2/8/2019

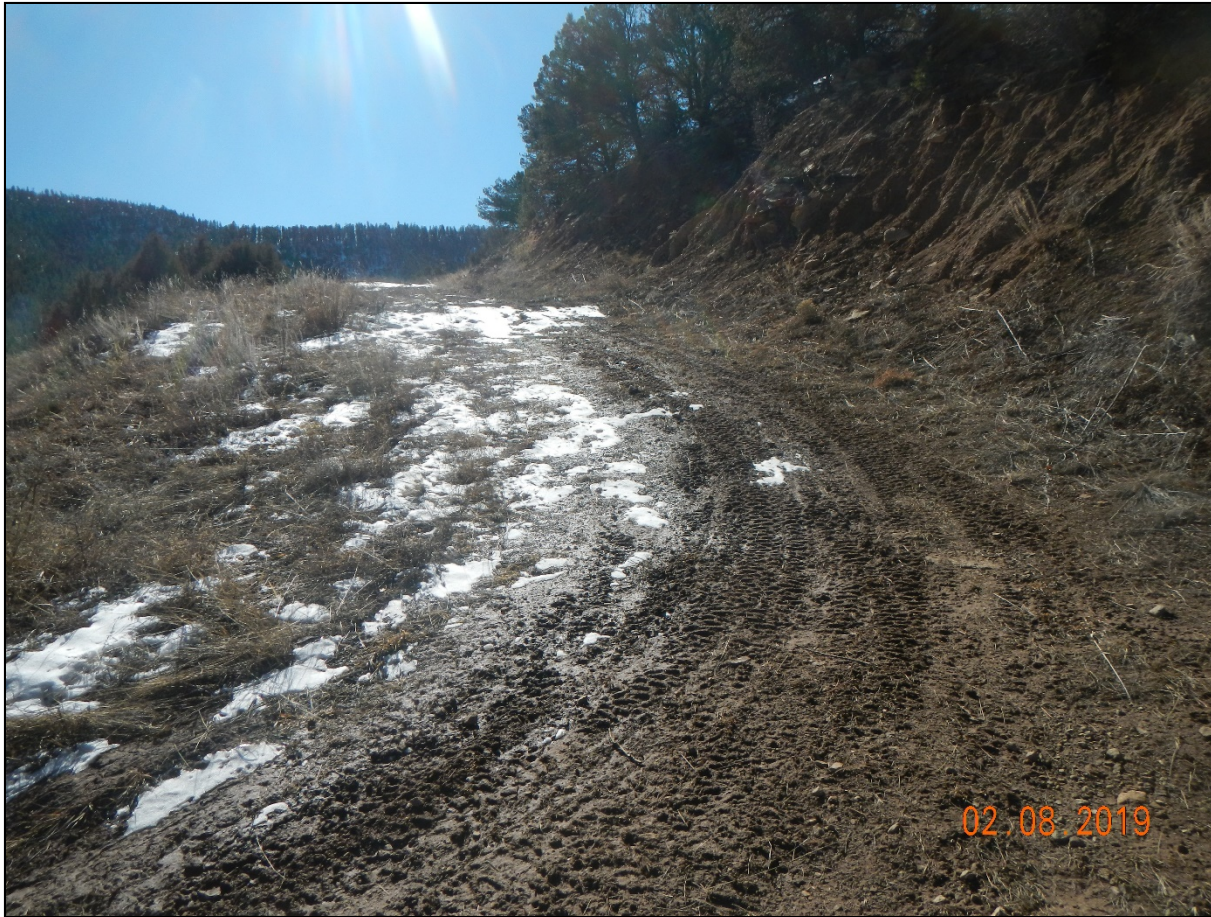
**Photo 1.** Access road remains to the location.

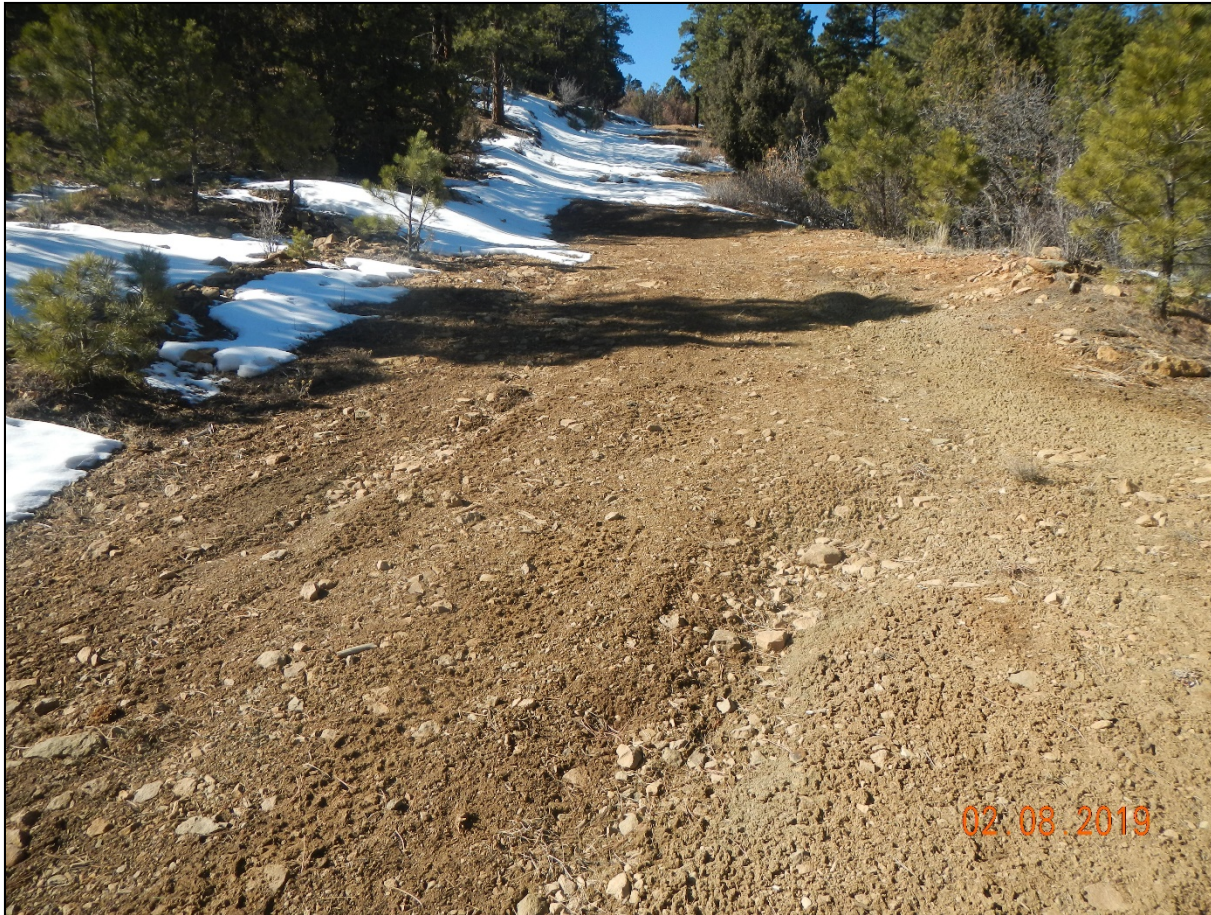
**Photo 2.** Facing northwest along the access road.

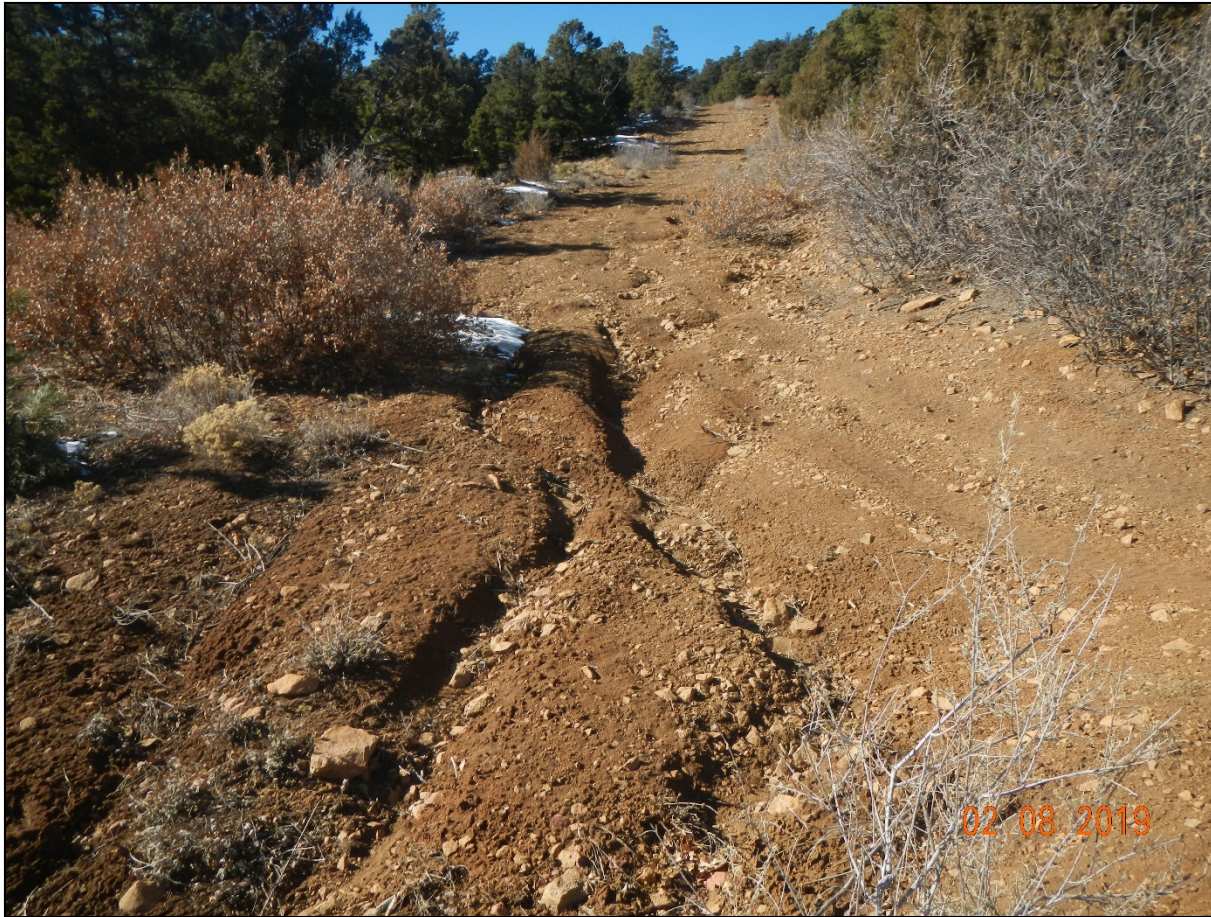
**Photo 3.** There are signs of erosion occurring along areas of the access road.

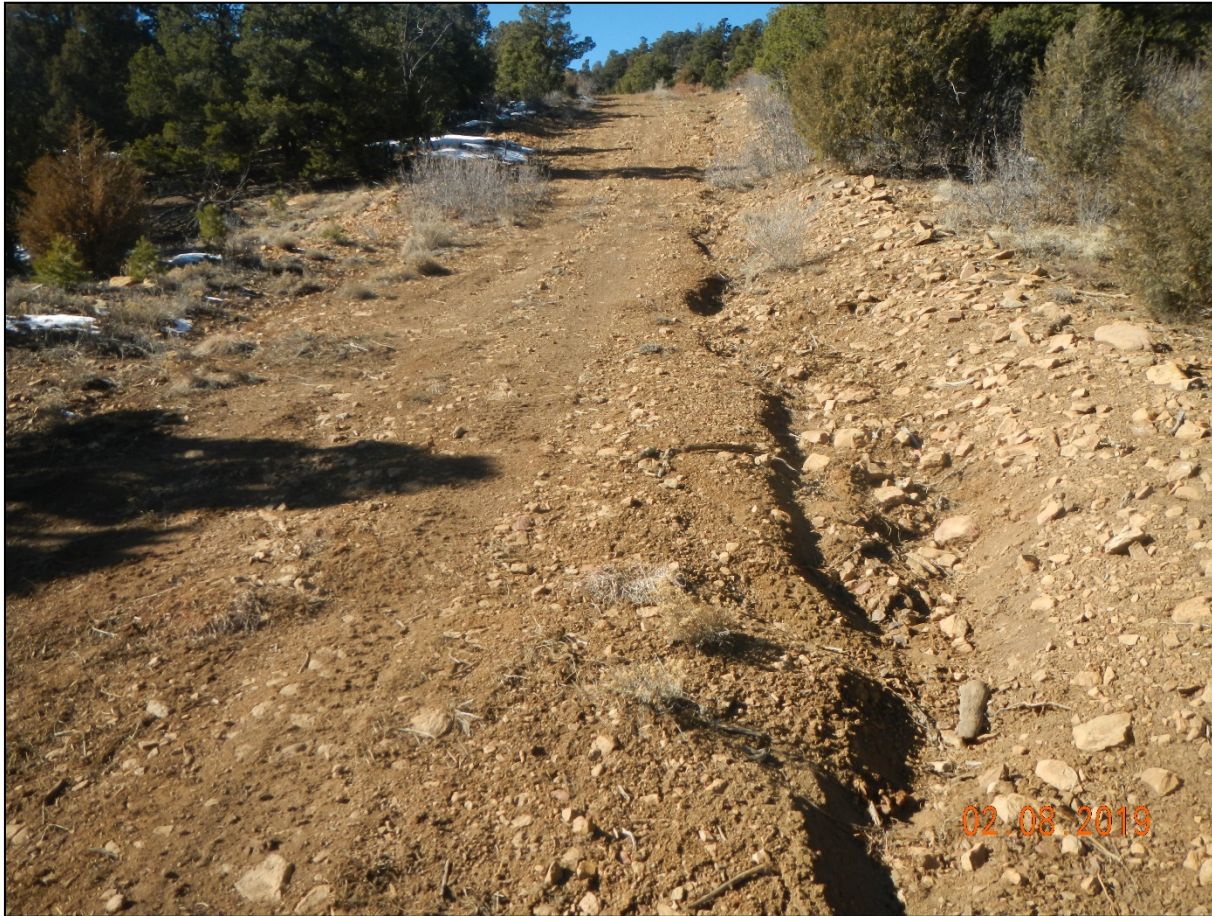
**Photo 4.** Erosion is occurring on the side of the road and there are no BMP's.

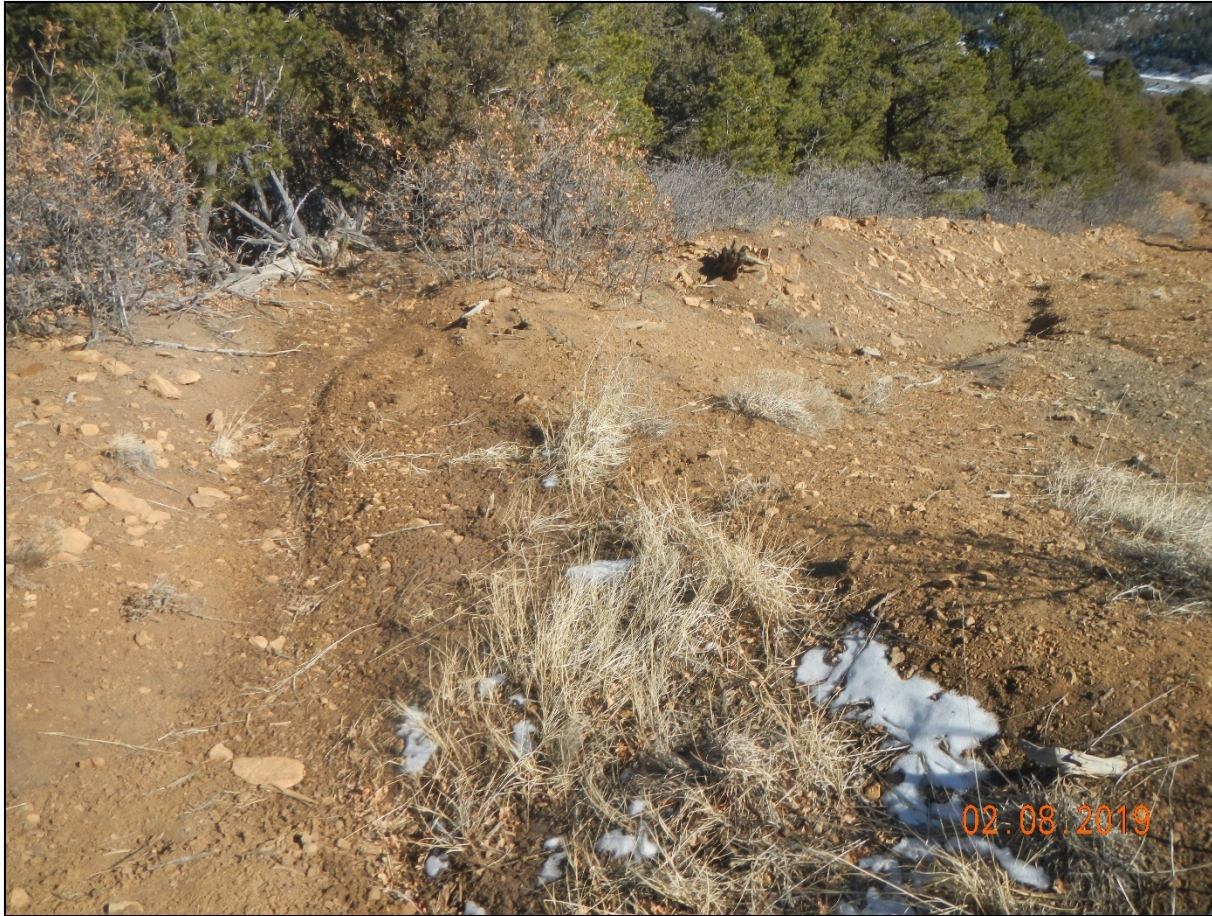
**Photo 5.** This water bar is filled in with sediment and stormwater is directed back toward the road.

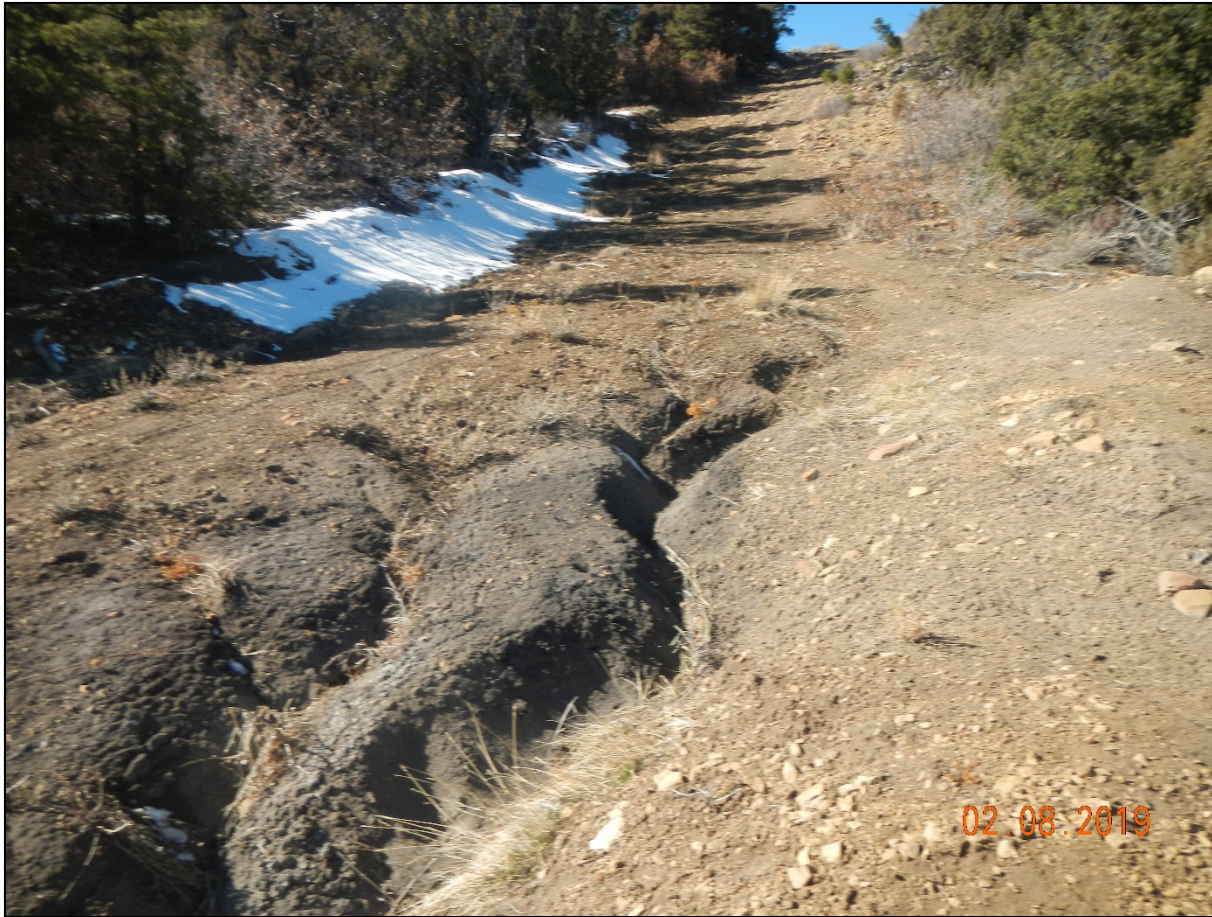
**Photo 6.** Further along the road near the location. There is erosion rills developed along the road.

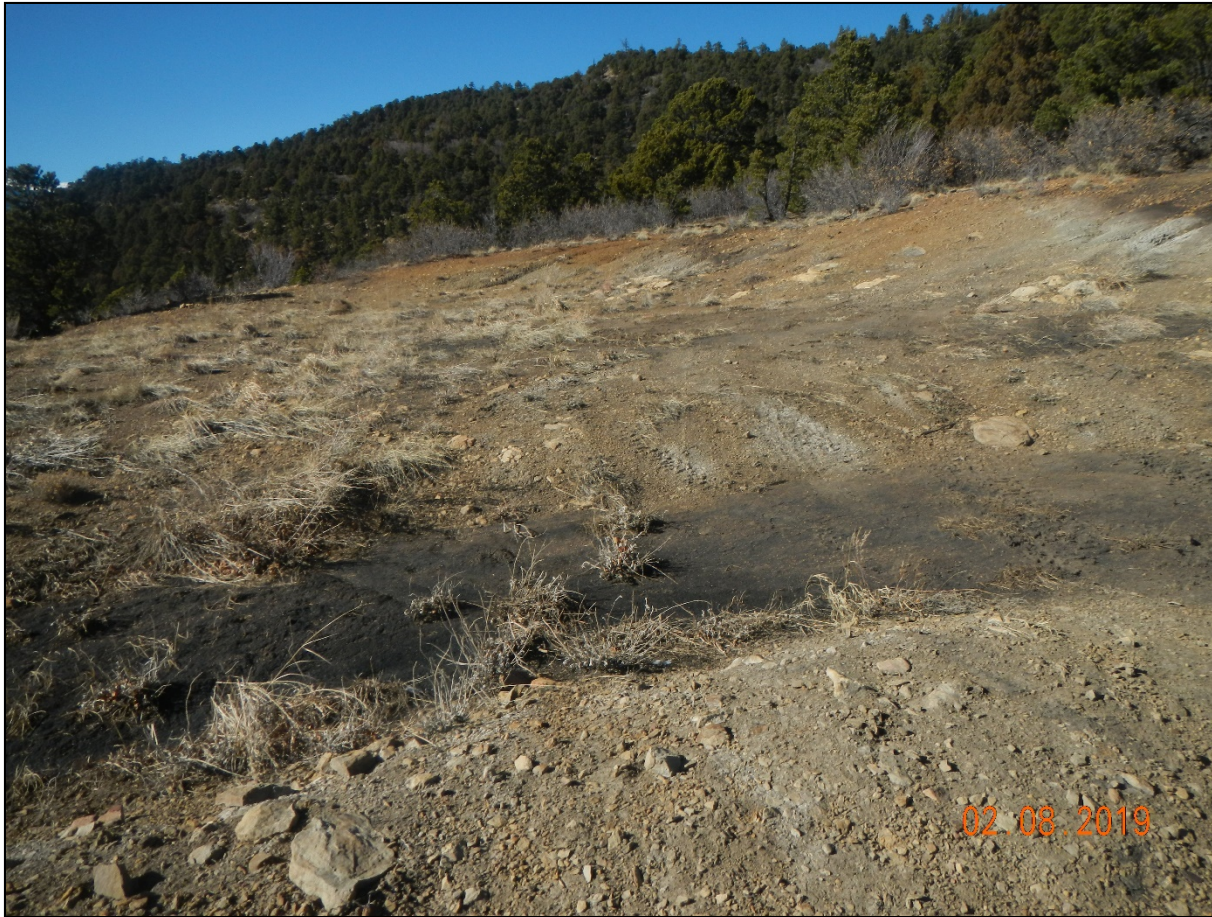
**Photo 7.** Facing northwest toward the location. Vegetation has not established the eastern side of the location.

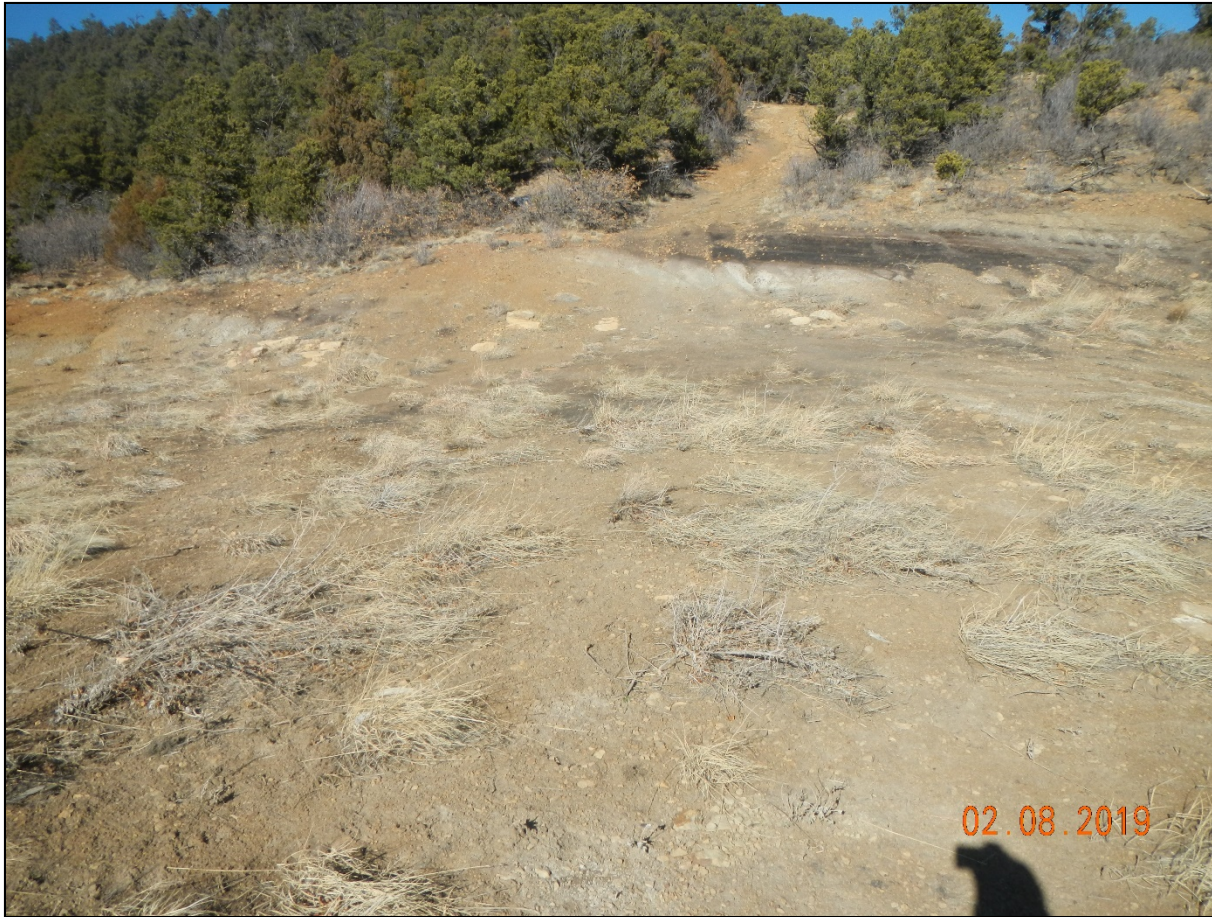
**Photo 8.** Facing northeast at the location. It appears there is a road that continues past the location.
