# Inspection Photos

Operator: NOBLE ENERGY INC - 100322

Location ID: 460414

Inspection Doc. Number: 682504527

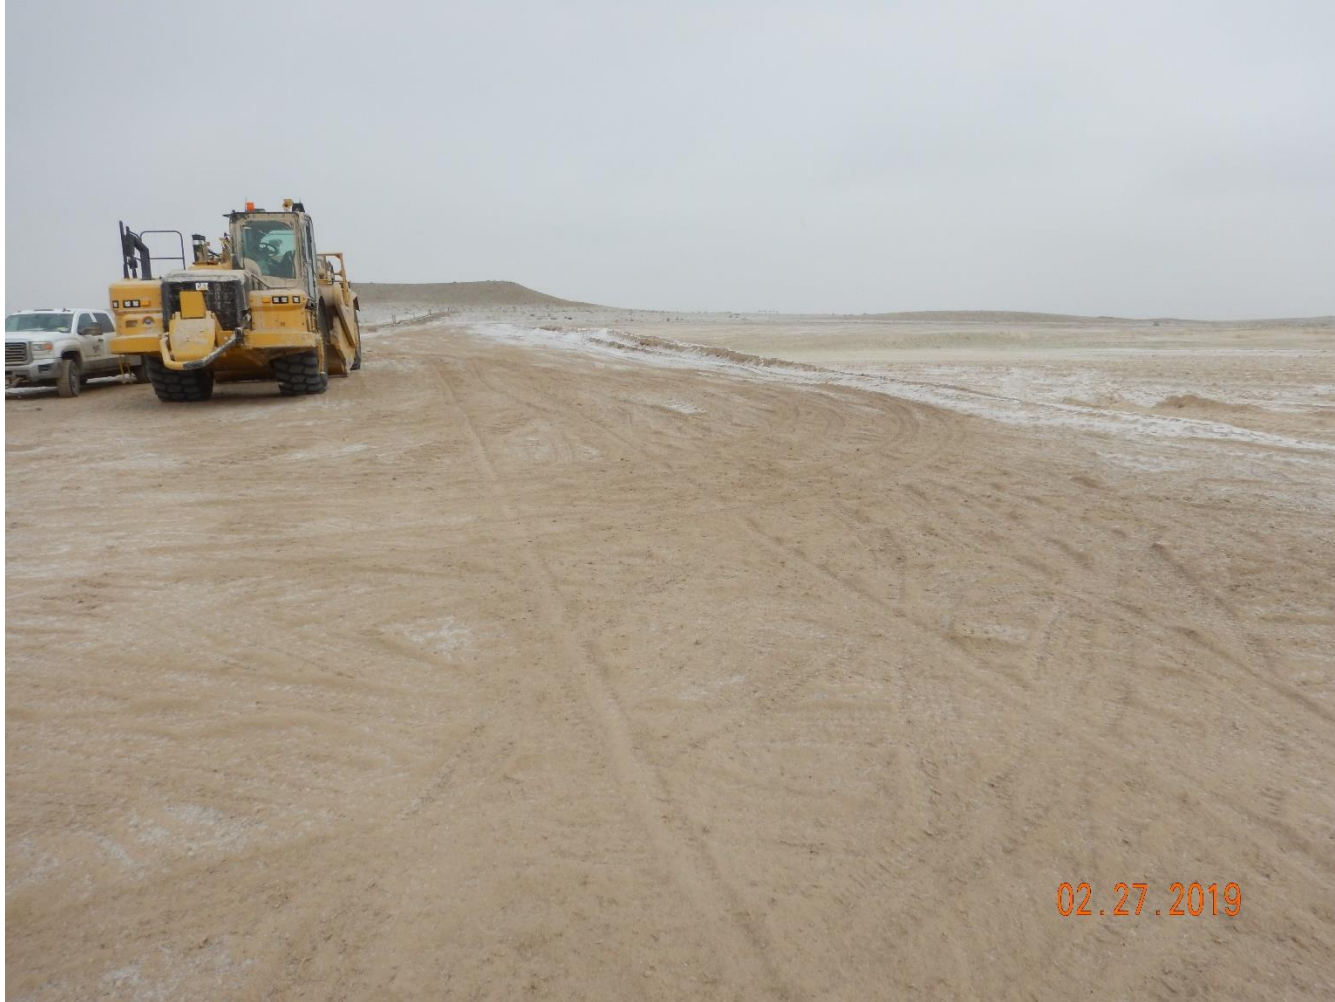
**Photo 1:** Photo taken from the southwest corner of the location, facing north. Photos 1-4 provide an overview of the location and construction in process from north, northeast, east to southeast.

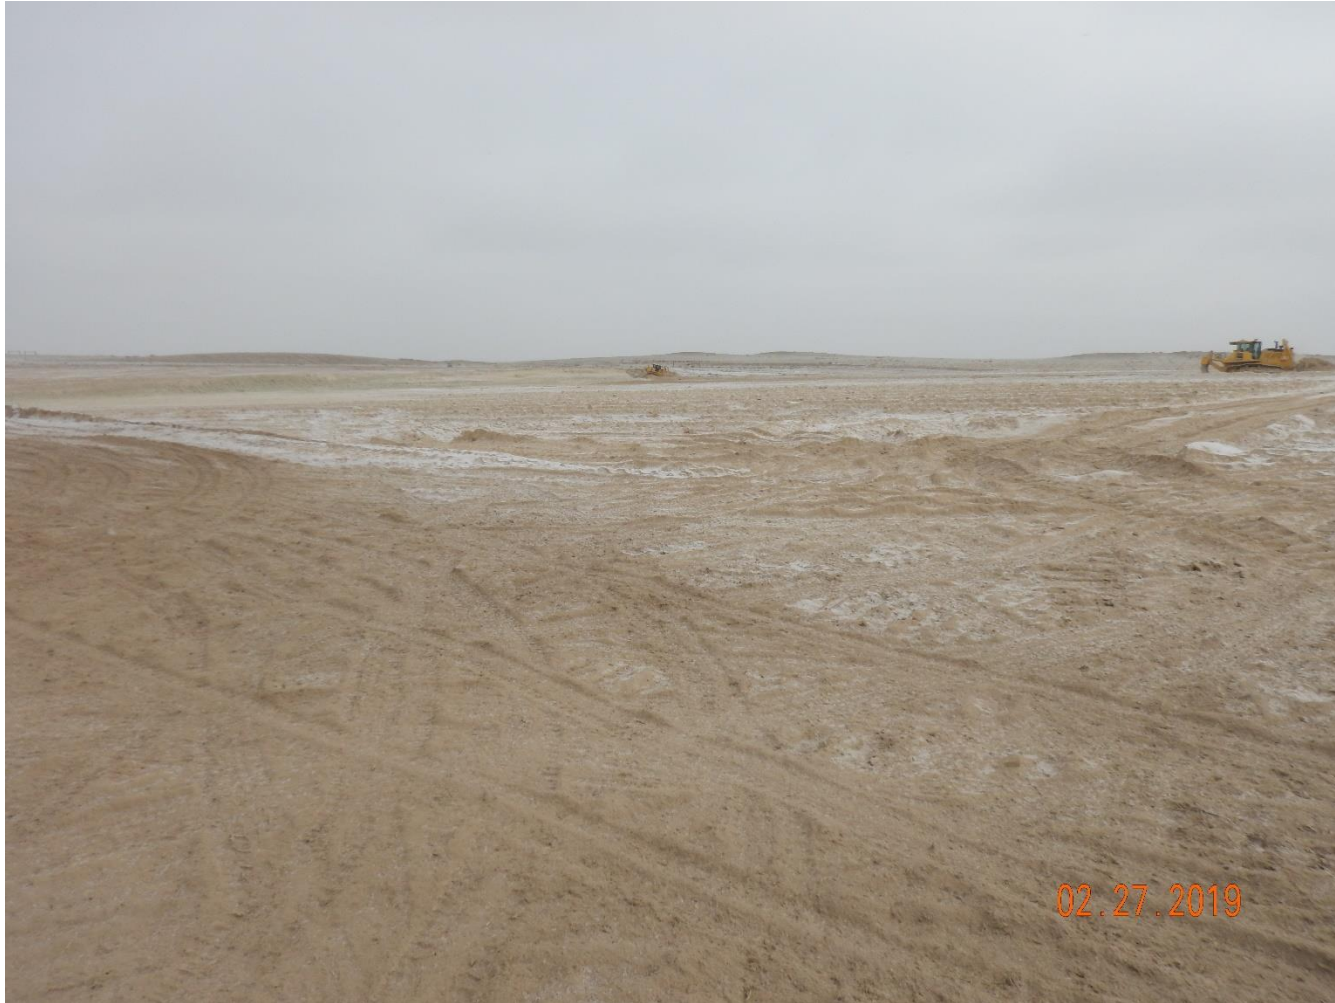
**Photo 2:** See comments under photo 1.

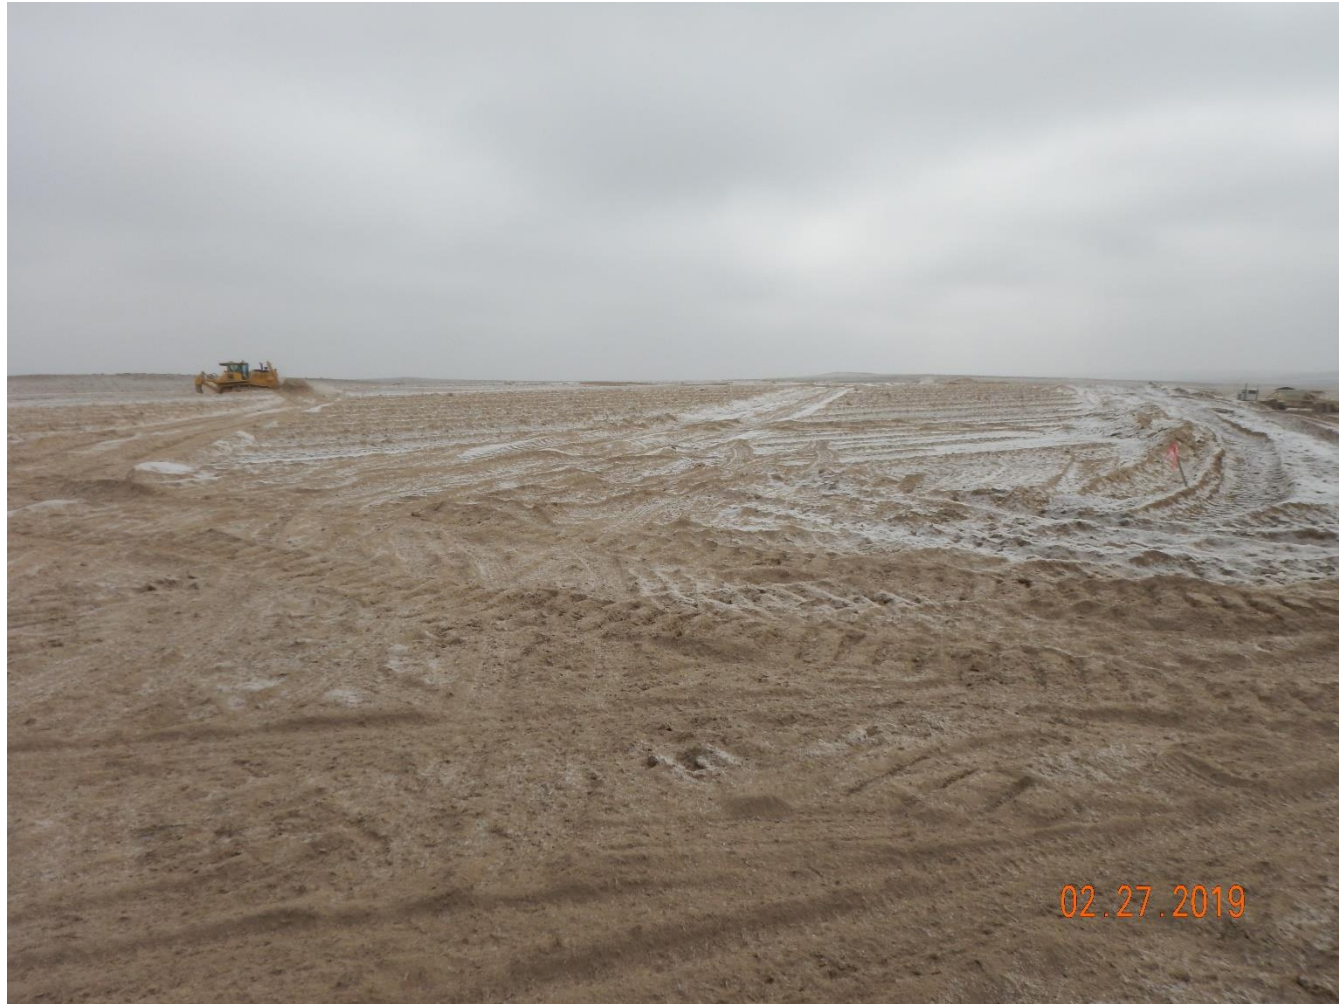
**Photo 3:** See comments under photo 1.

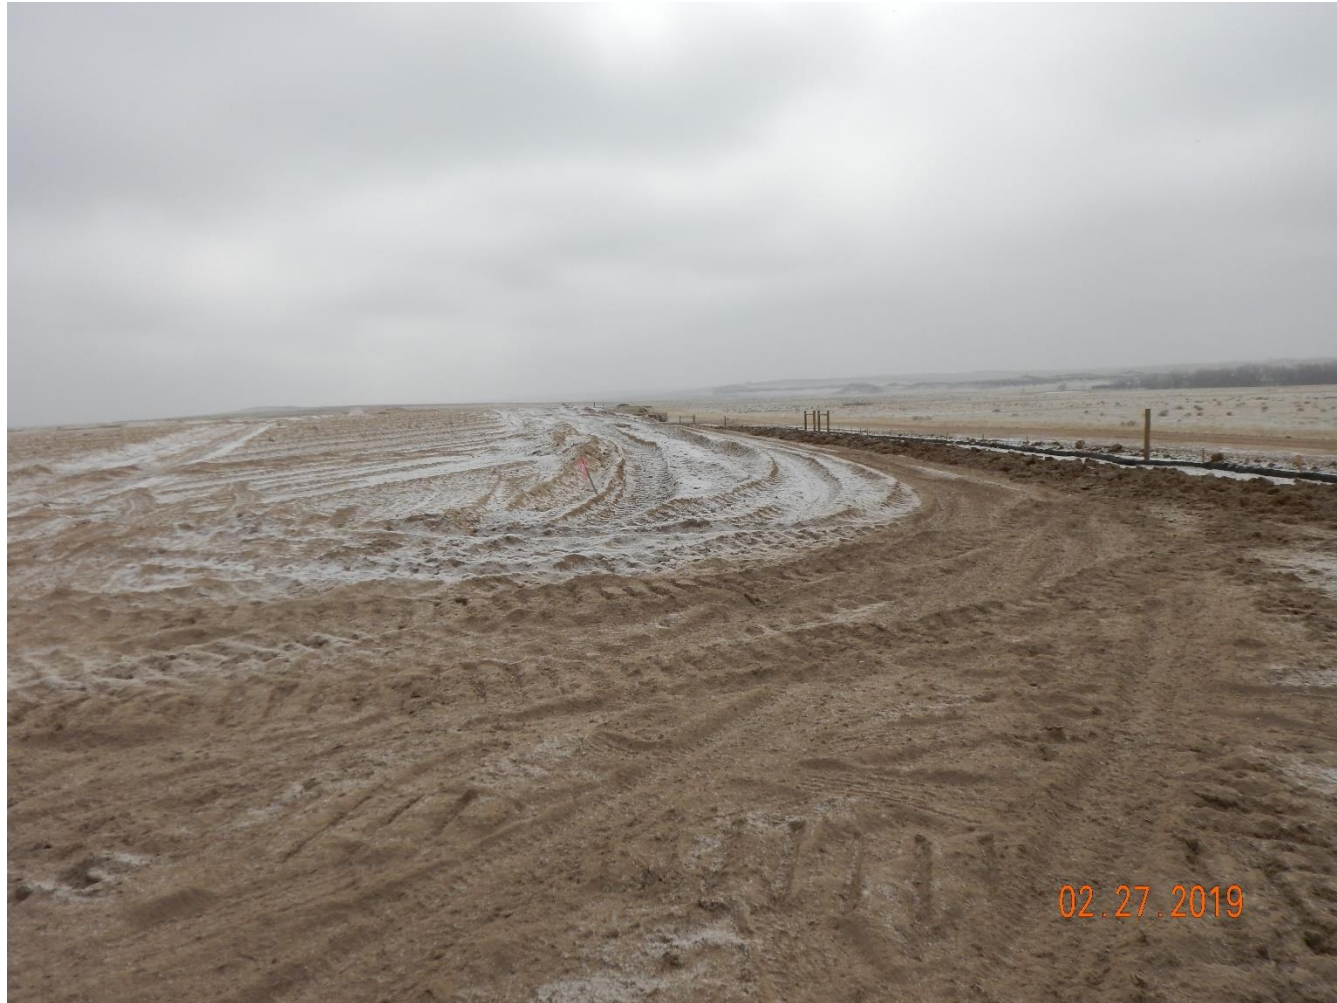
**Photo 4:** See comments under photo 1.

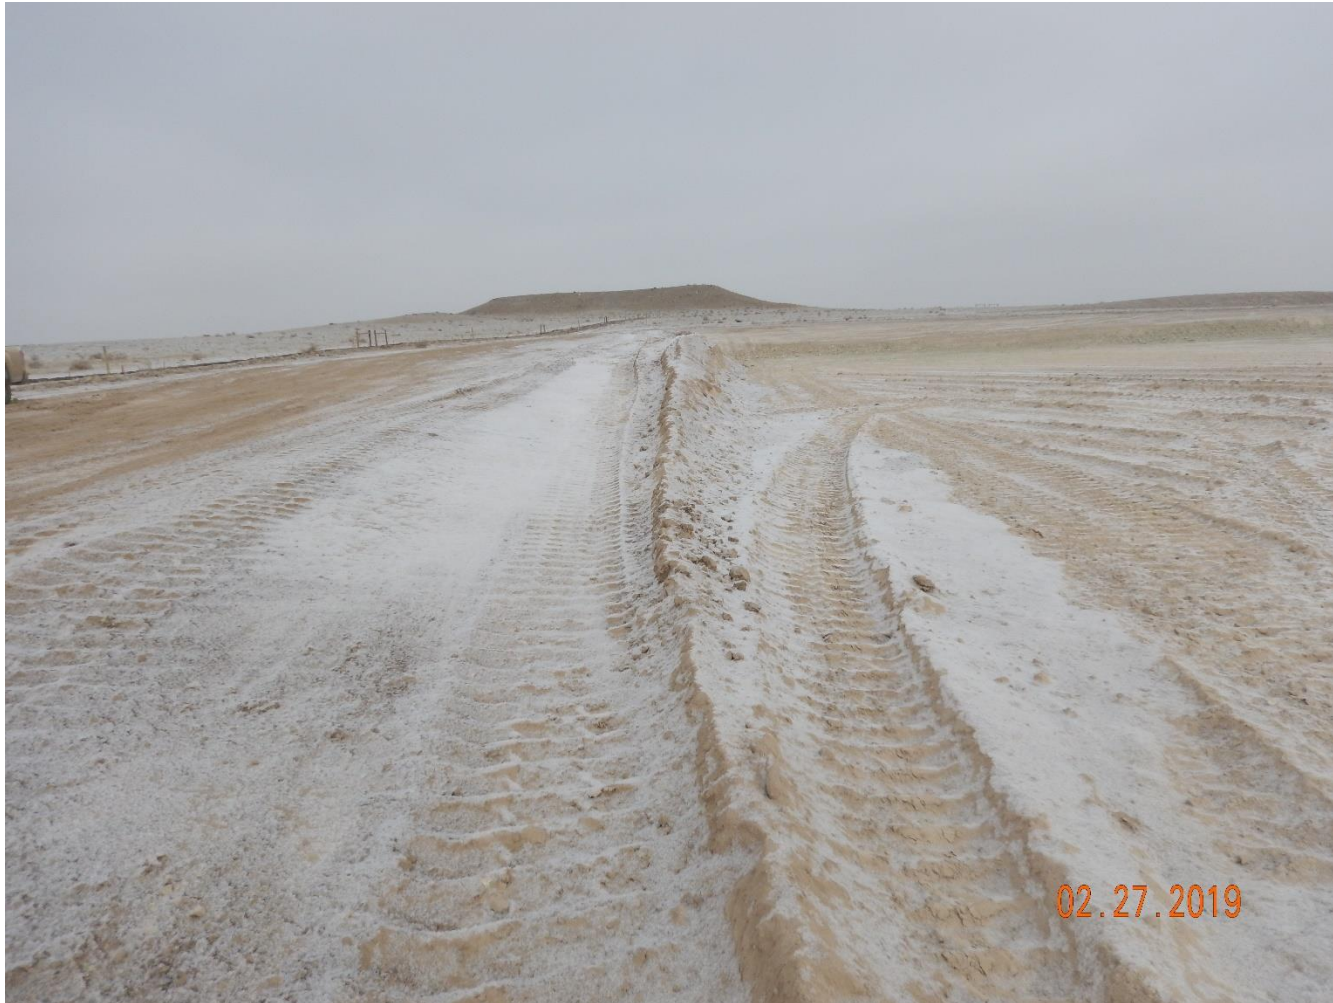
**Photo 5:** Photo taken from the west end of the location, facing north. Photo shows the slopes on the western end of the location.

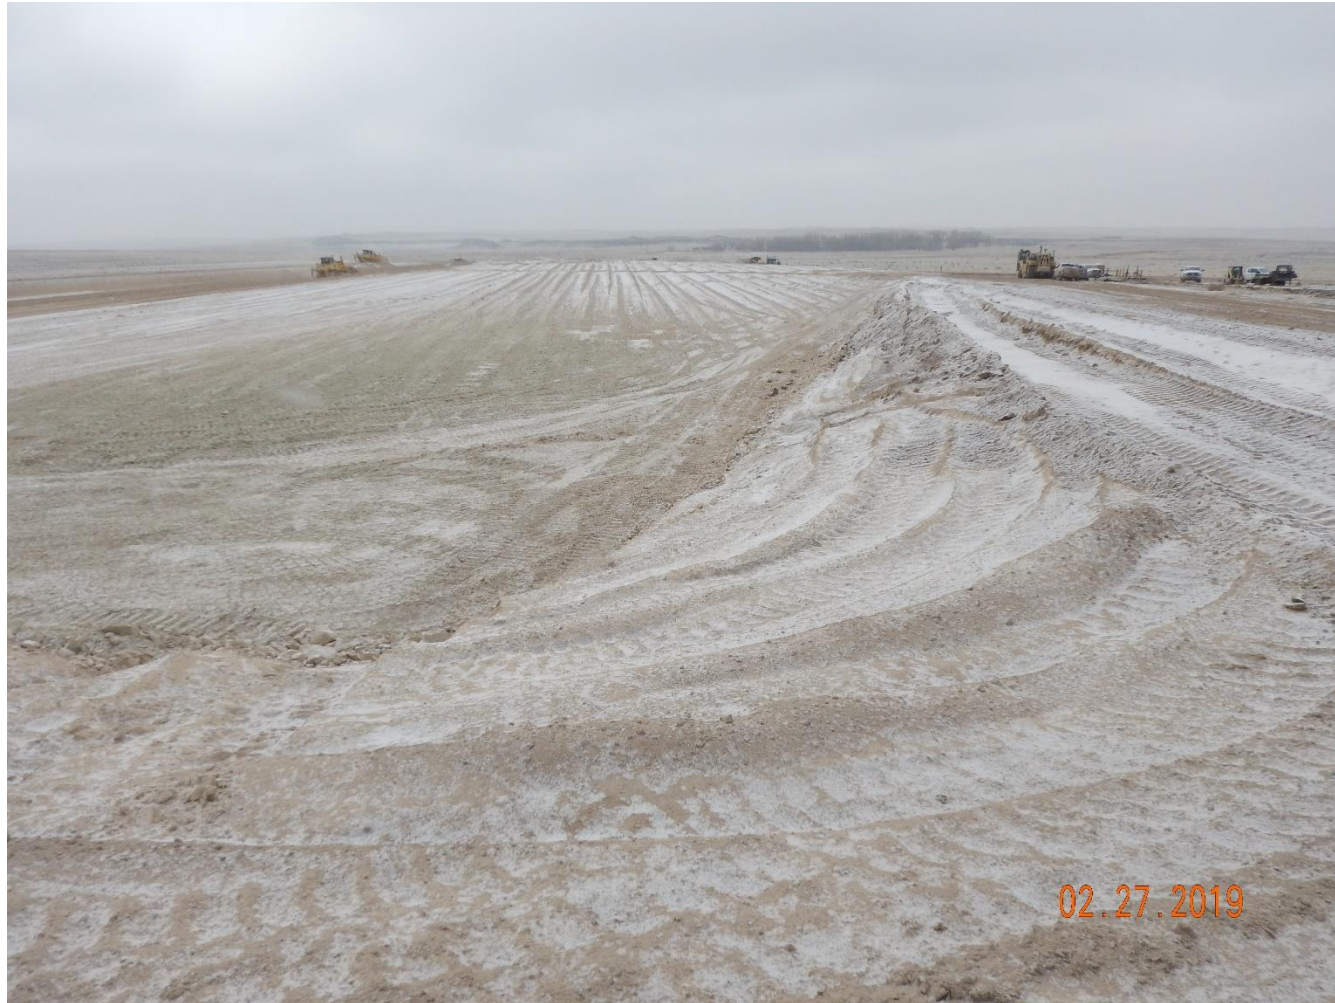
**Photo 6:** Photo taken from the northwest corner of the current disturbance area, facing south. Photos shows an overview of the location.

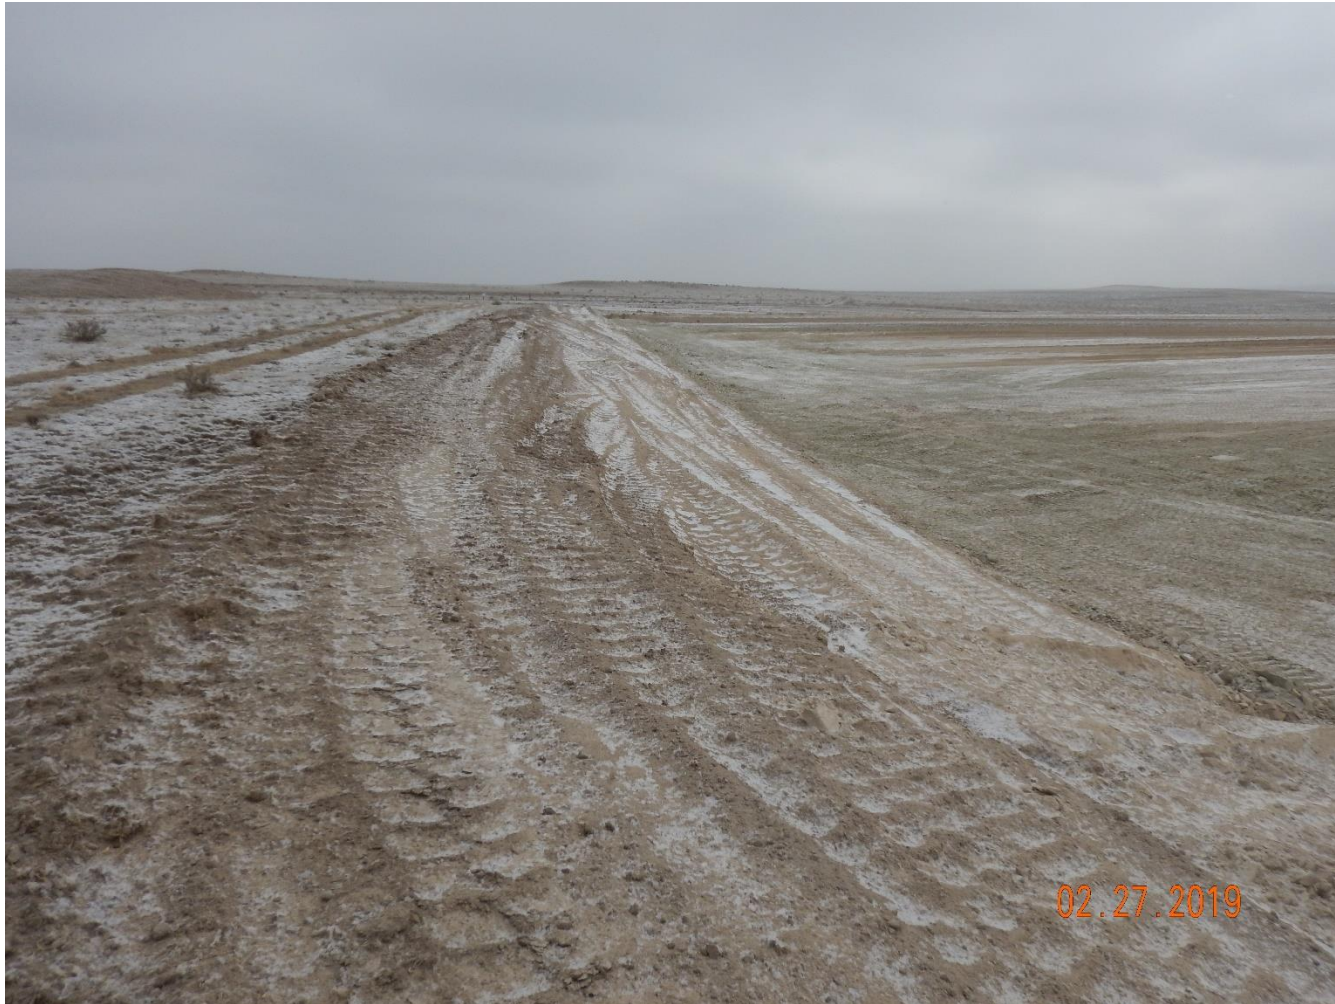
**Photo 7:** Photo taken from the northwest corner of the current disturbance area, facing east. Photos shows an overview of the location.

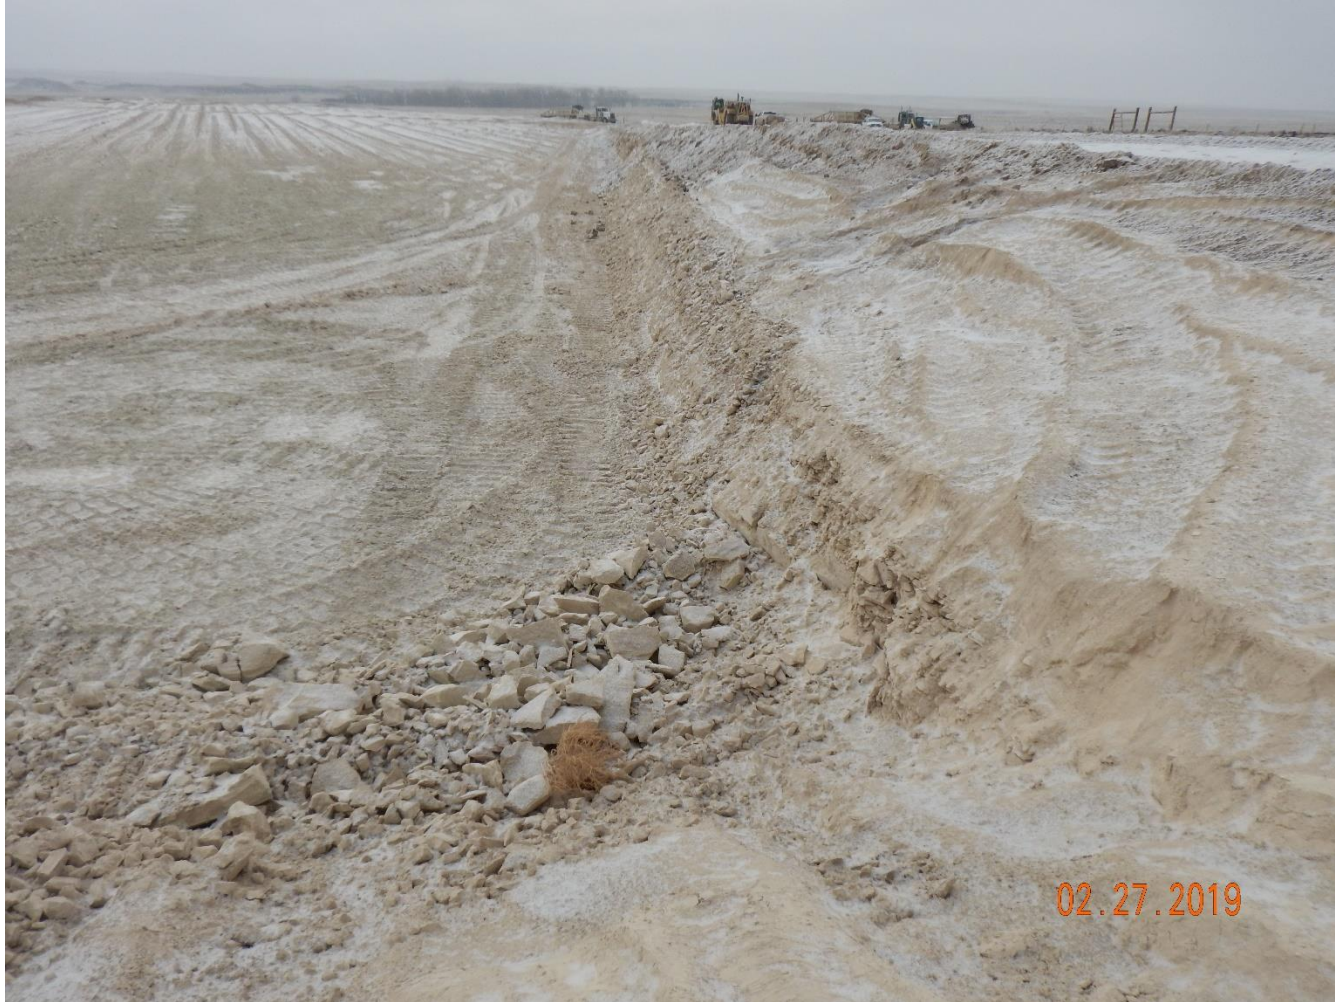
**Photo 8:** Photo taken from the northwest end of the location, facing south. Photo shows cut slopes of the location.

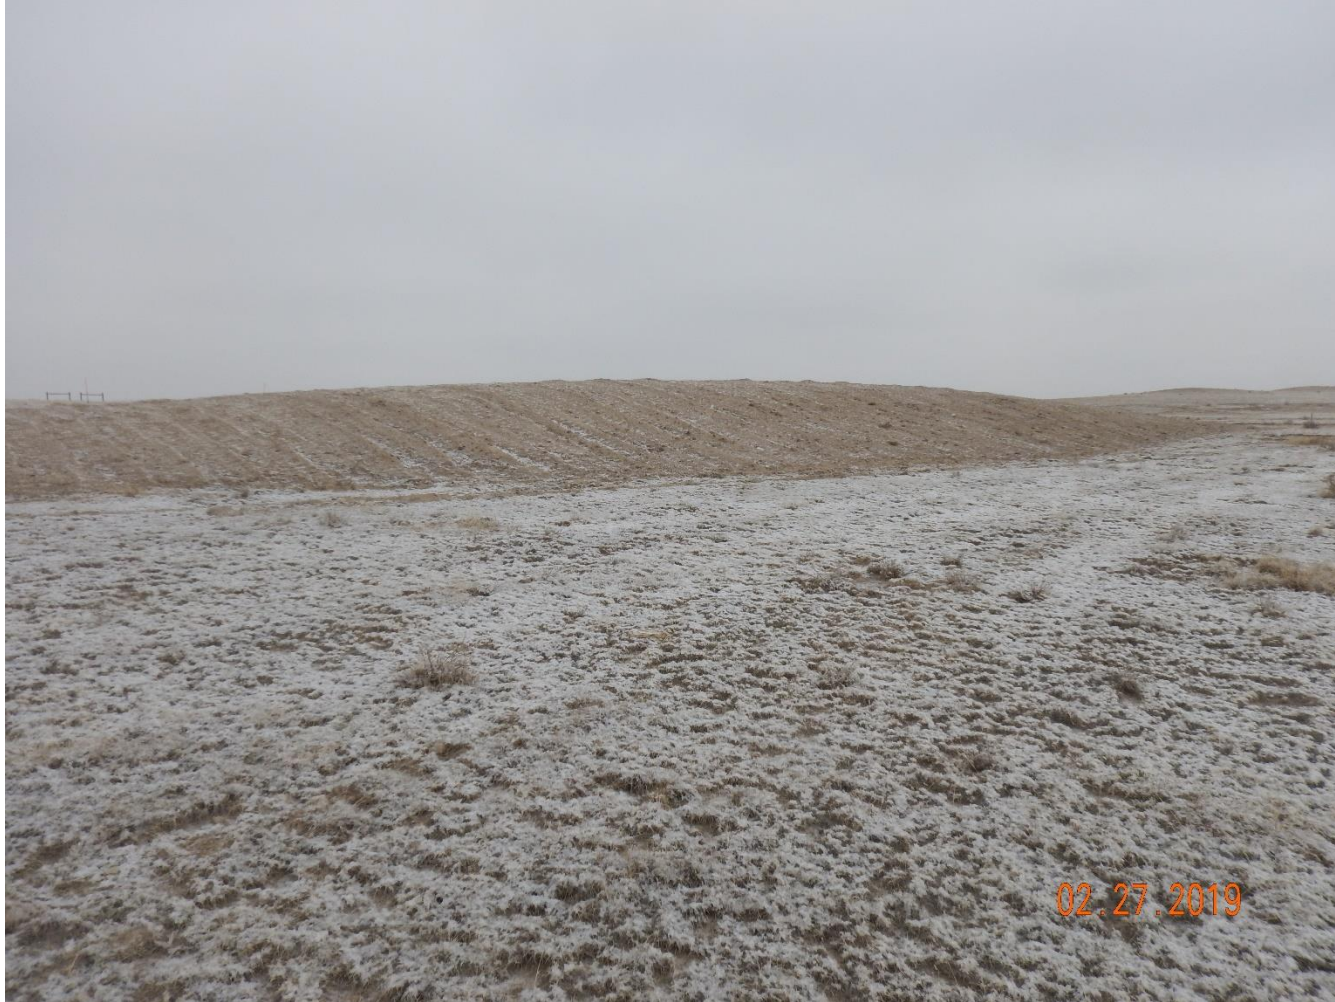
**Photo 9:** Photo taken from the north end of the disturbance area, facing northeast. Photo shows soil stockpile.

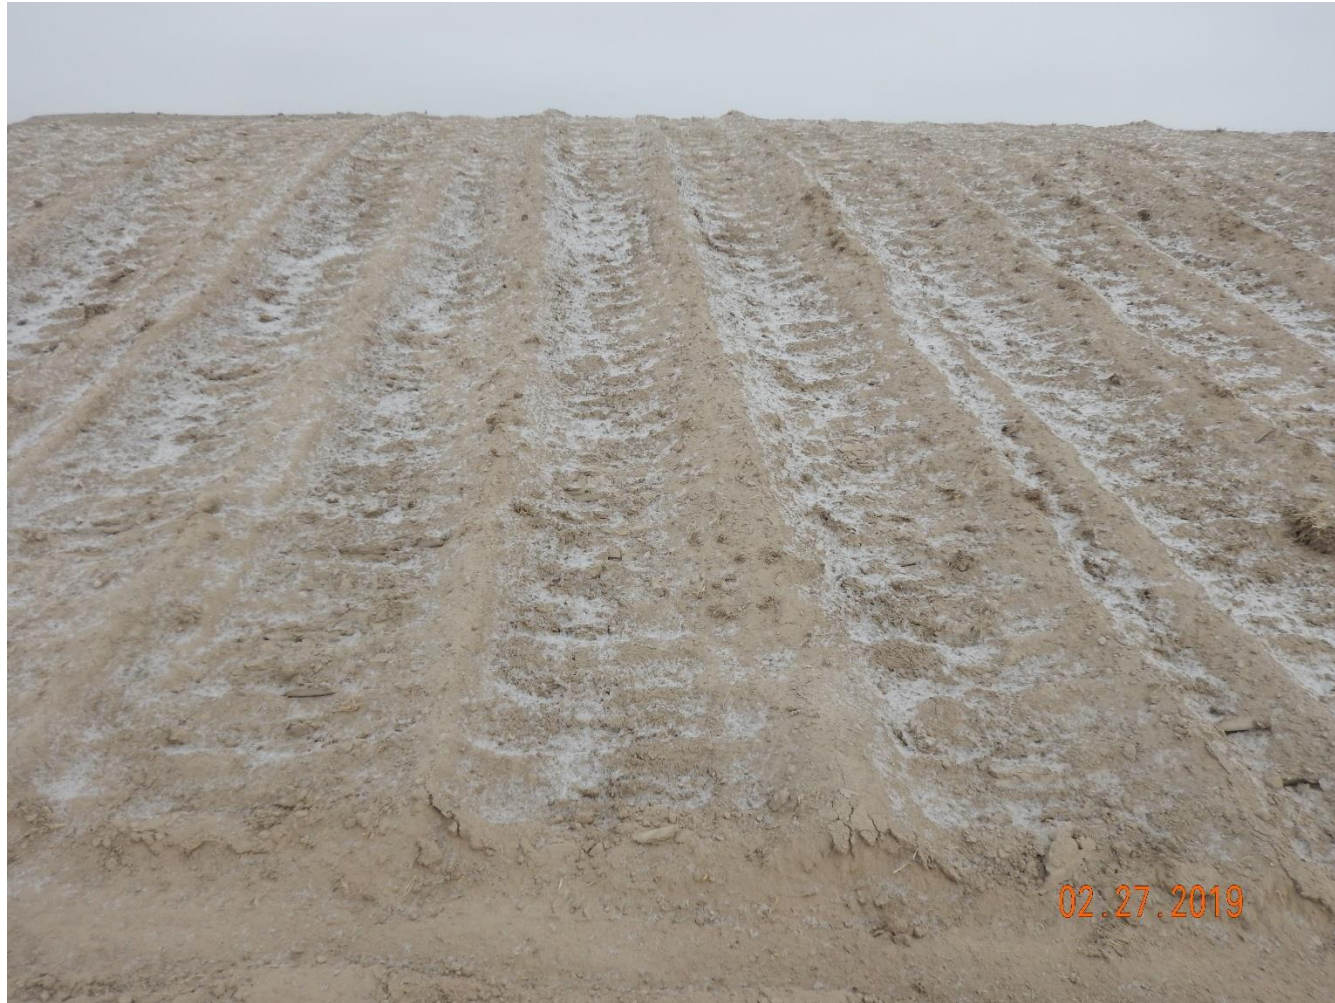
**Photo 10:** Continued from photo 9. Photo shows operator appears to have attempted to track the soil stockpile. Photo shows tracking does not appear to have been adequate as soils have not been sufficiently stabilized and remain loose material at risk to erosion degradation.

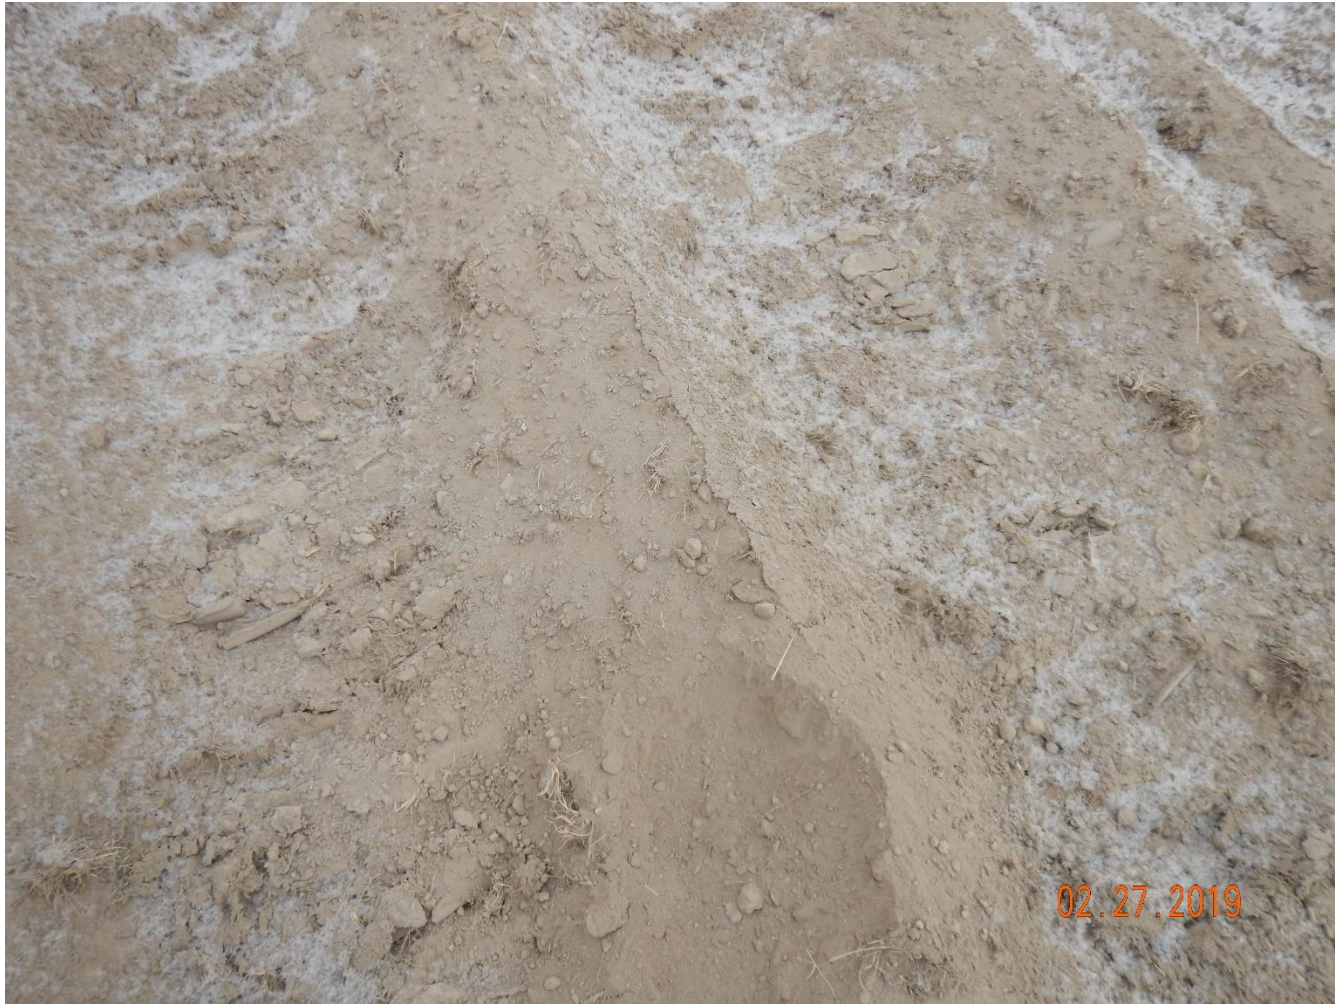
**Photo 11:** Continued from photo 11. Photo shows tracking does not appear to have been adequate as soils have not been sufficiently stabilized and remain loose material at risk to erosion degradation.

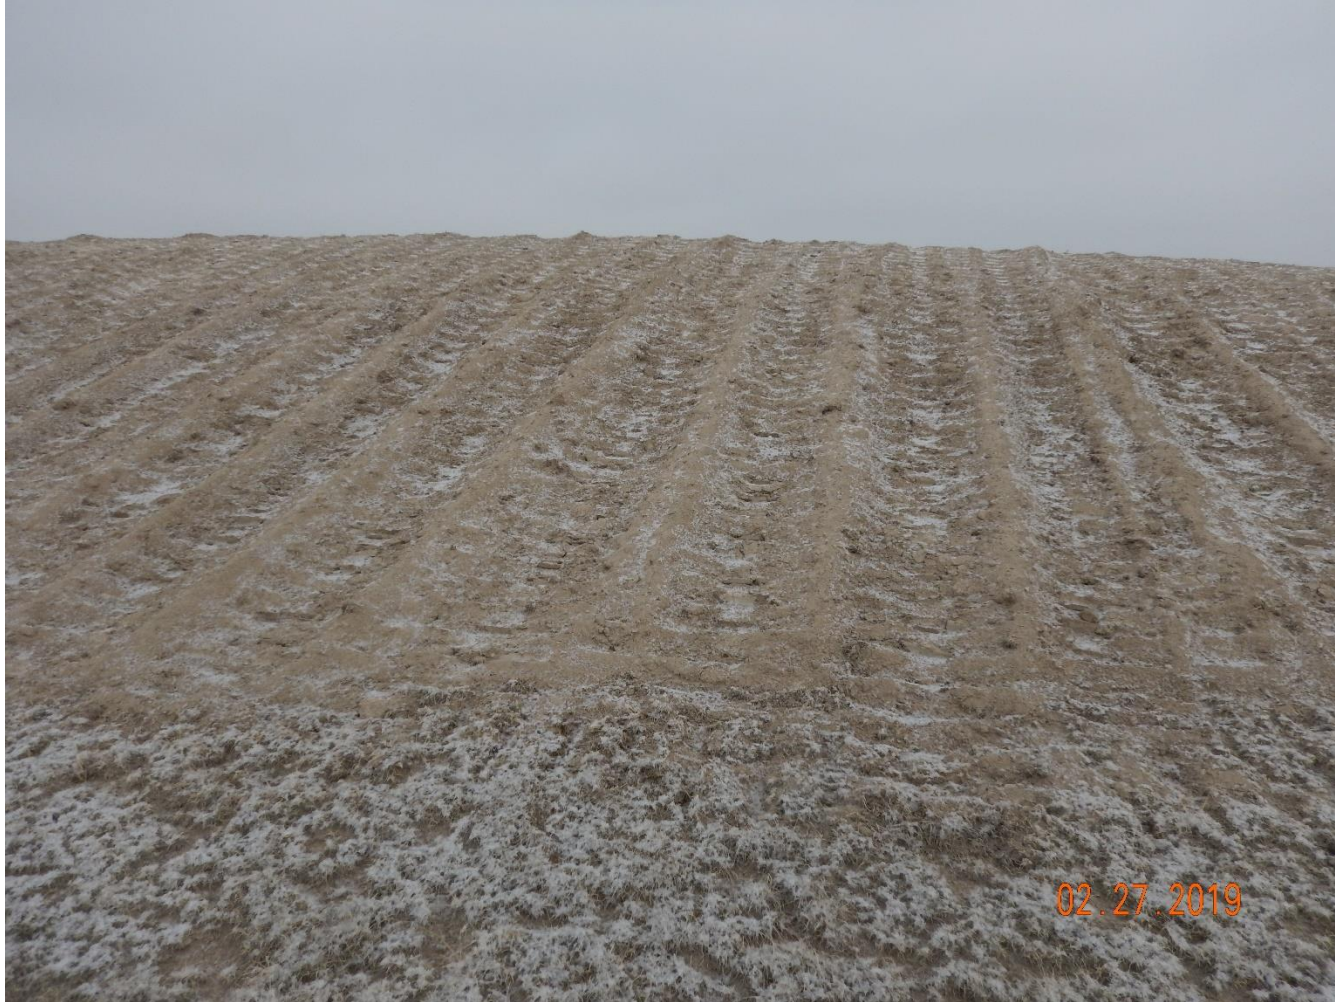
**Photo 12:** Continued from photo 10, see comments under photo 11.

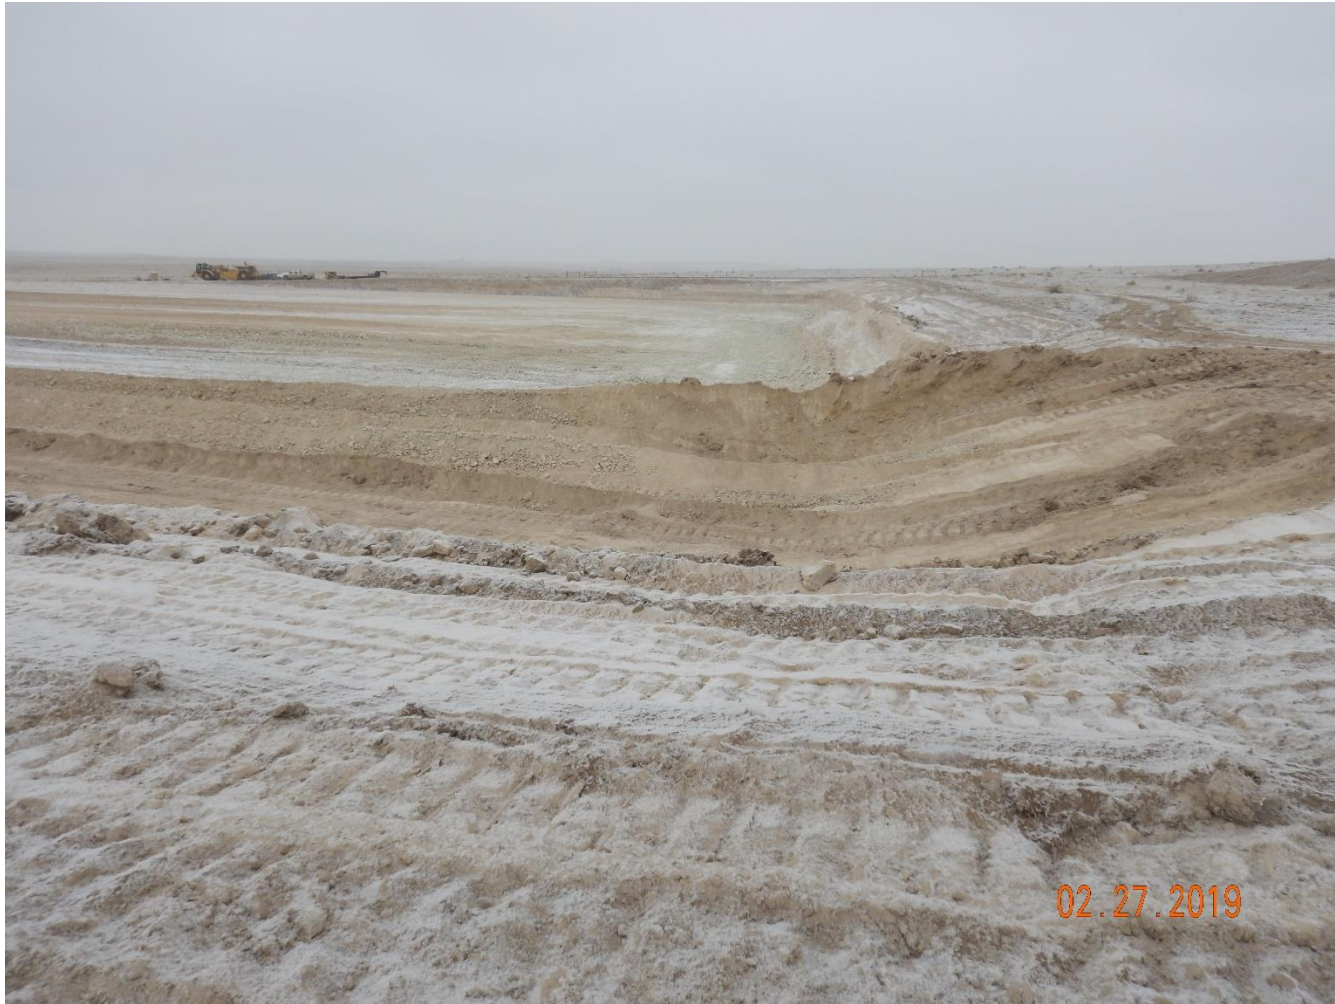
**Photo 13:** Photo taken from the north east corner of the location, facing west. Photo shows construction activities in process and an overview of the location.

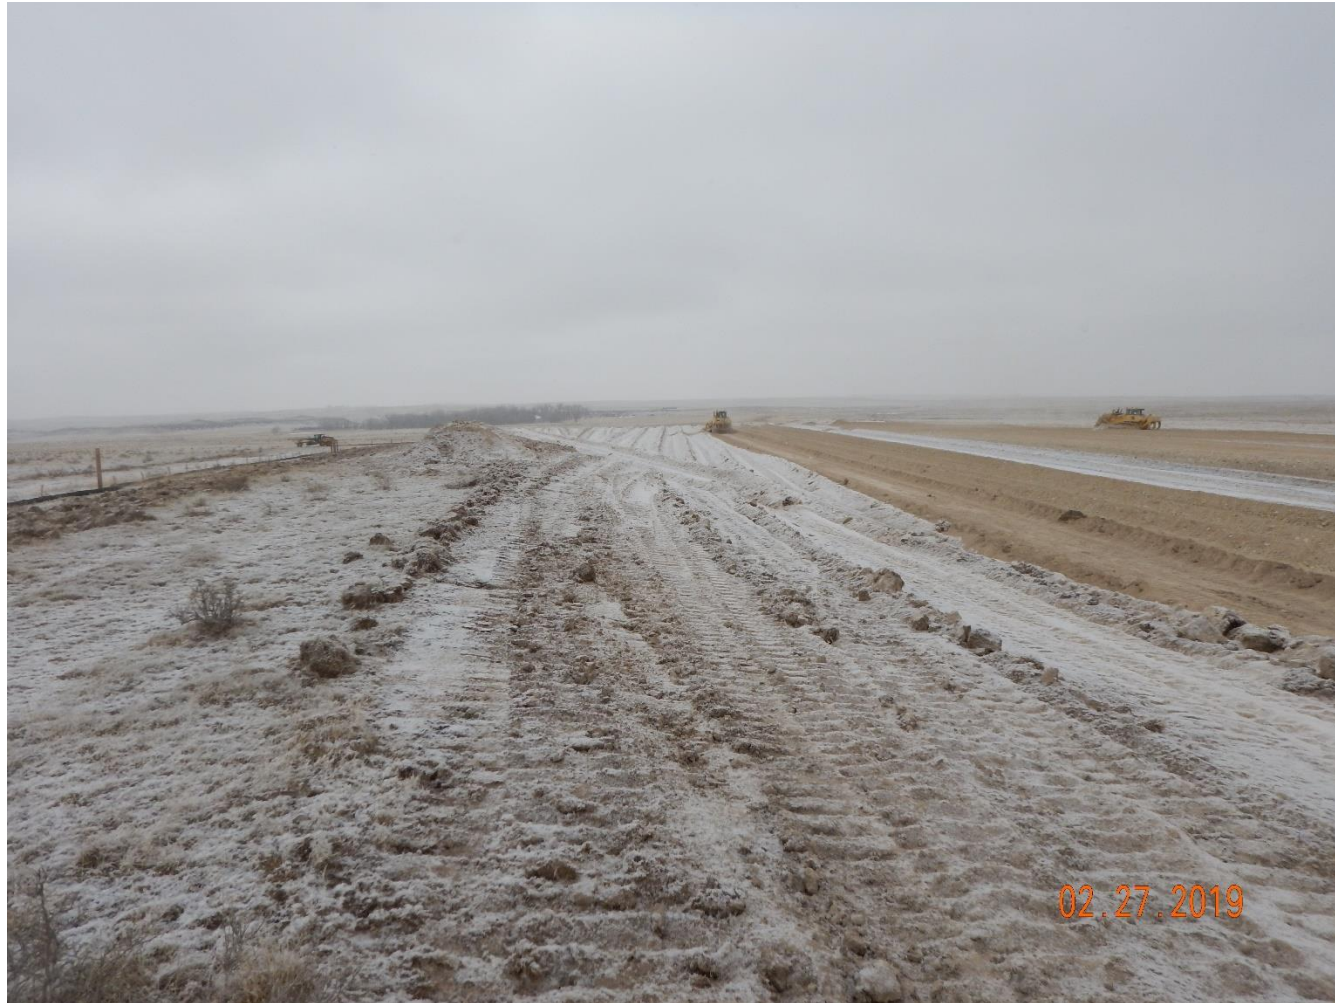
**Photo 14:** Photo taken from the north east corner of the location, facing south. Photo shows construction activities in process and an overview of the location.

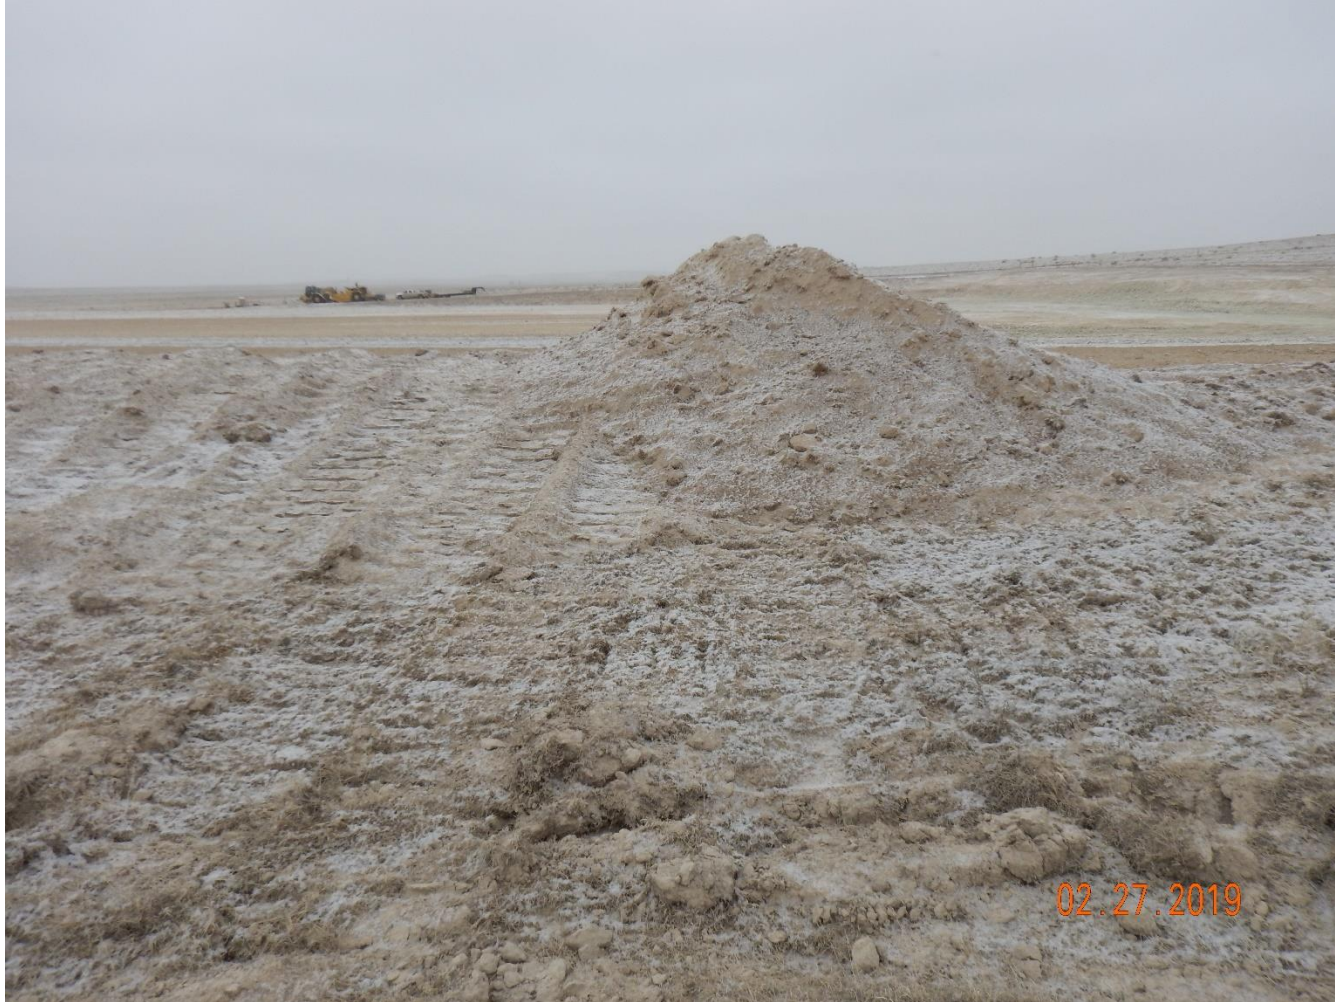
**Photo 15:** Photo taken from the soil stockpiles on the east end of the location. See comments under photo 10.

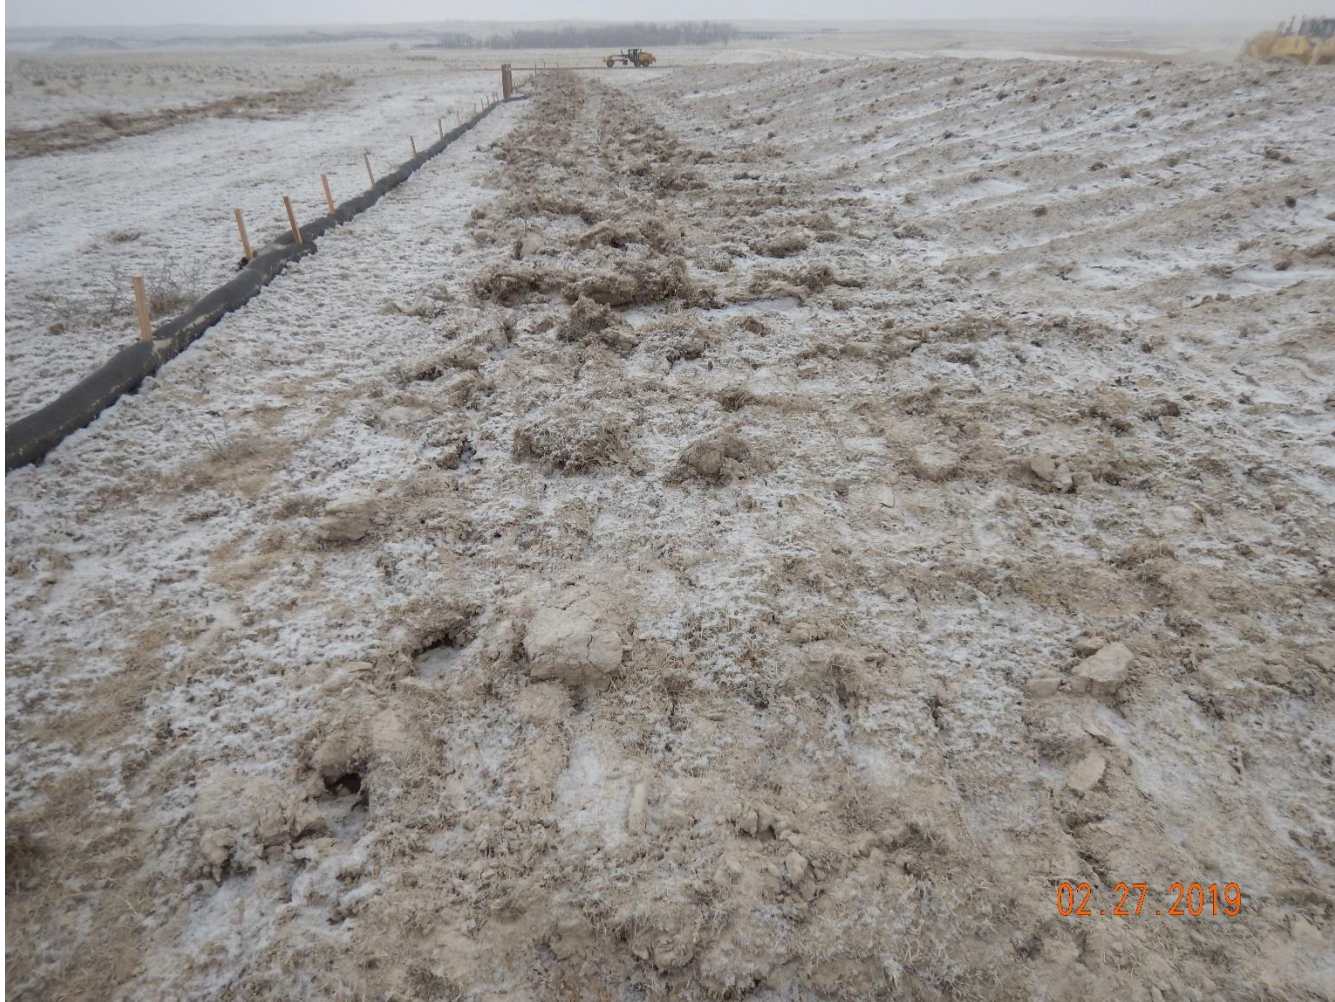
**Photo 16:** Photo taken from the east end of the location. Photo shows operator appears to have driven over the surface roughening BMP along the perimeter of the location. BMP is no longer in proper functioning condition and requires maintenance.
