# Inspection Photos

Operator: NOBLE ENERGY INC - 100322

Location ID: 460414

Inspection Doc. Number: 682504527

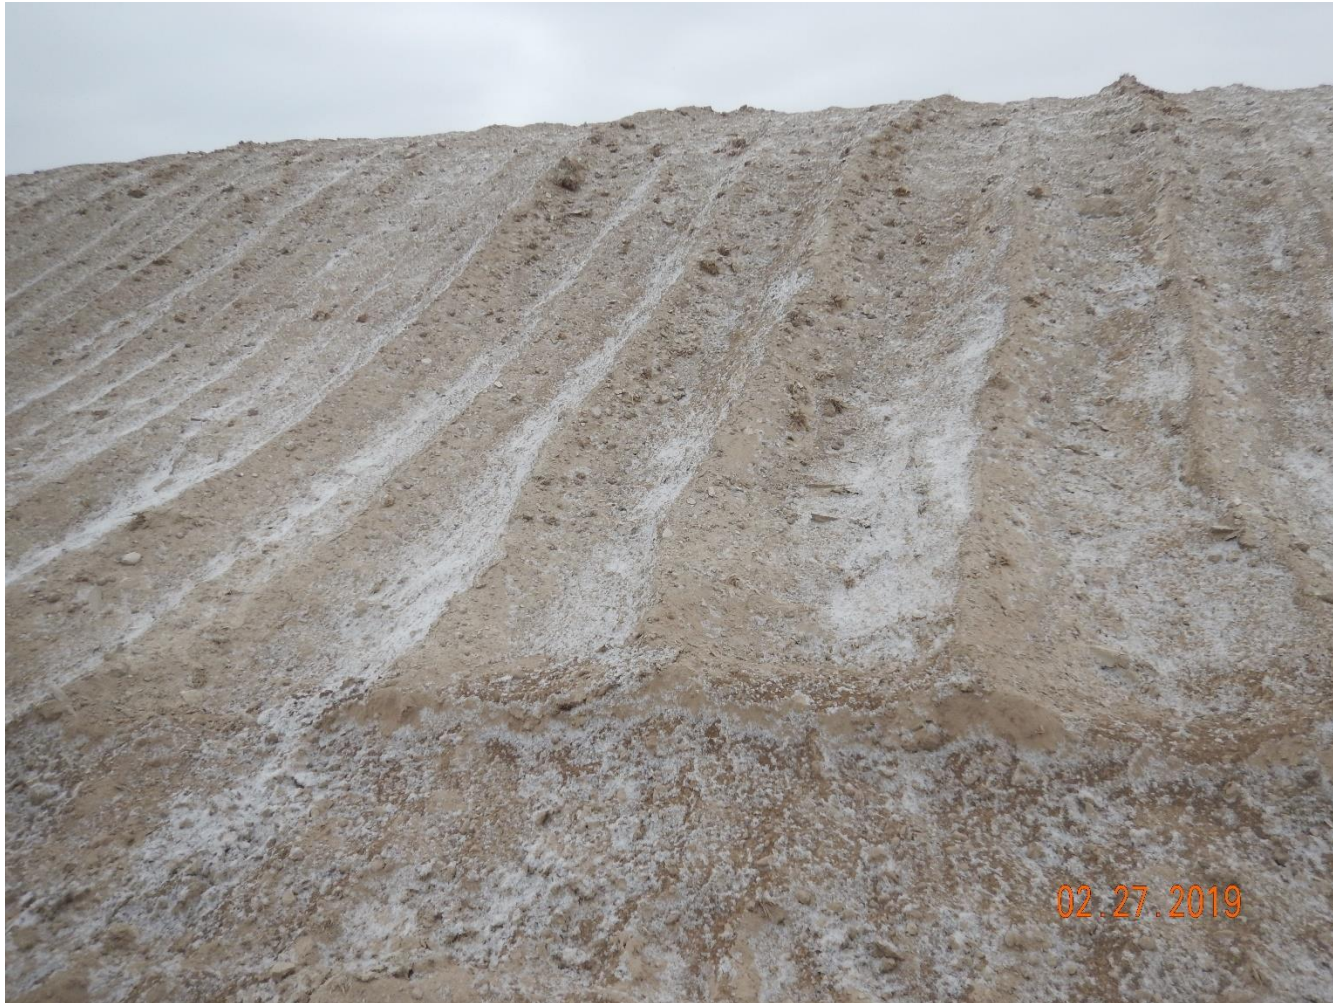
**Photo 10:** Continued from photo 9. Photo shows operator appears to have attempted to track the soil stockpile. Photo shows tracking does not appear to have been adequate as soils have not been sufficiently stabilized and remain loose material at risk to erosion degradation.

**Photo 17:** Photo taken from the soil stockpiles on the south end of the location. See comments under photo 10.

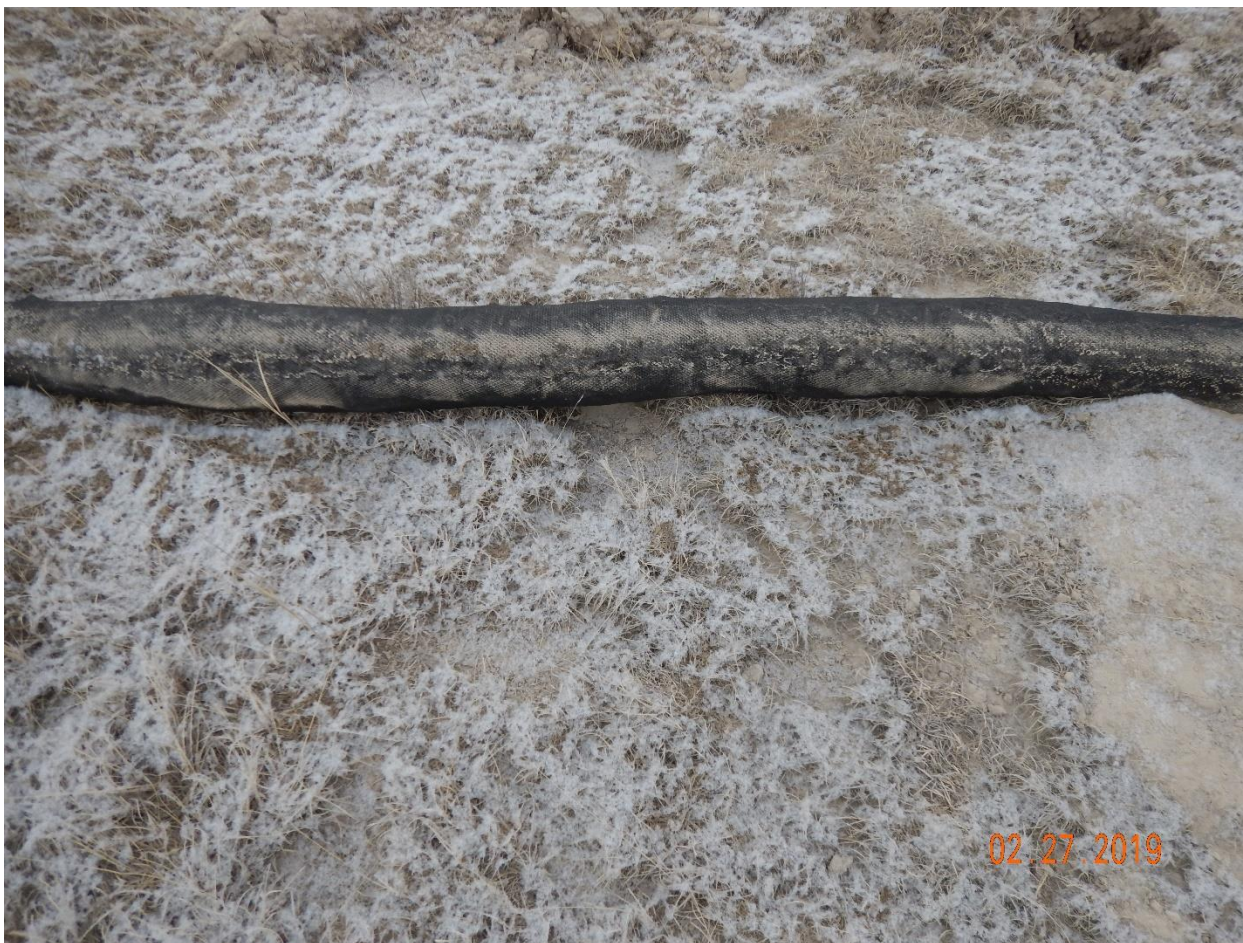
**Photo 18:** Photo shows Operator has installed an 8 inch diam. "Filtrexx SiltSoxx" wattle as a perimeter control. Operator has installed BMP by placing wattle upon the surface of the soil and staking in place. The following photos are examples that show that due to site conditions found commonly within rangeland (bumpy, rocky, changes in elevation affecting ground surface contact), this "lay on surface" installation practice is not appropriate or sufficient to allow this perimeter control to mitigate stormwater runoff on rangeland; BMP does not achieve a 100% ground surface contact to interrupt and mitigate stormwater runoff.

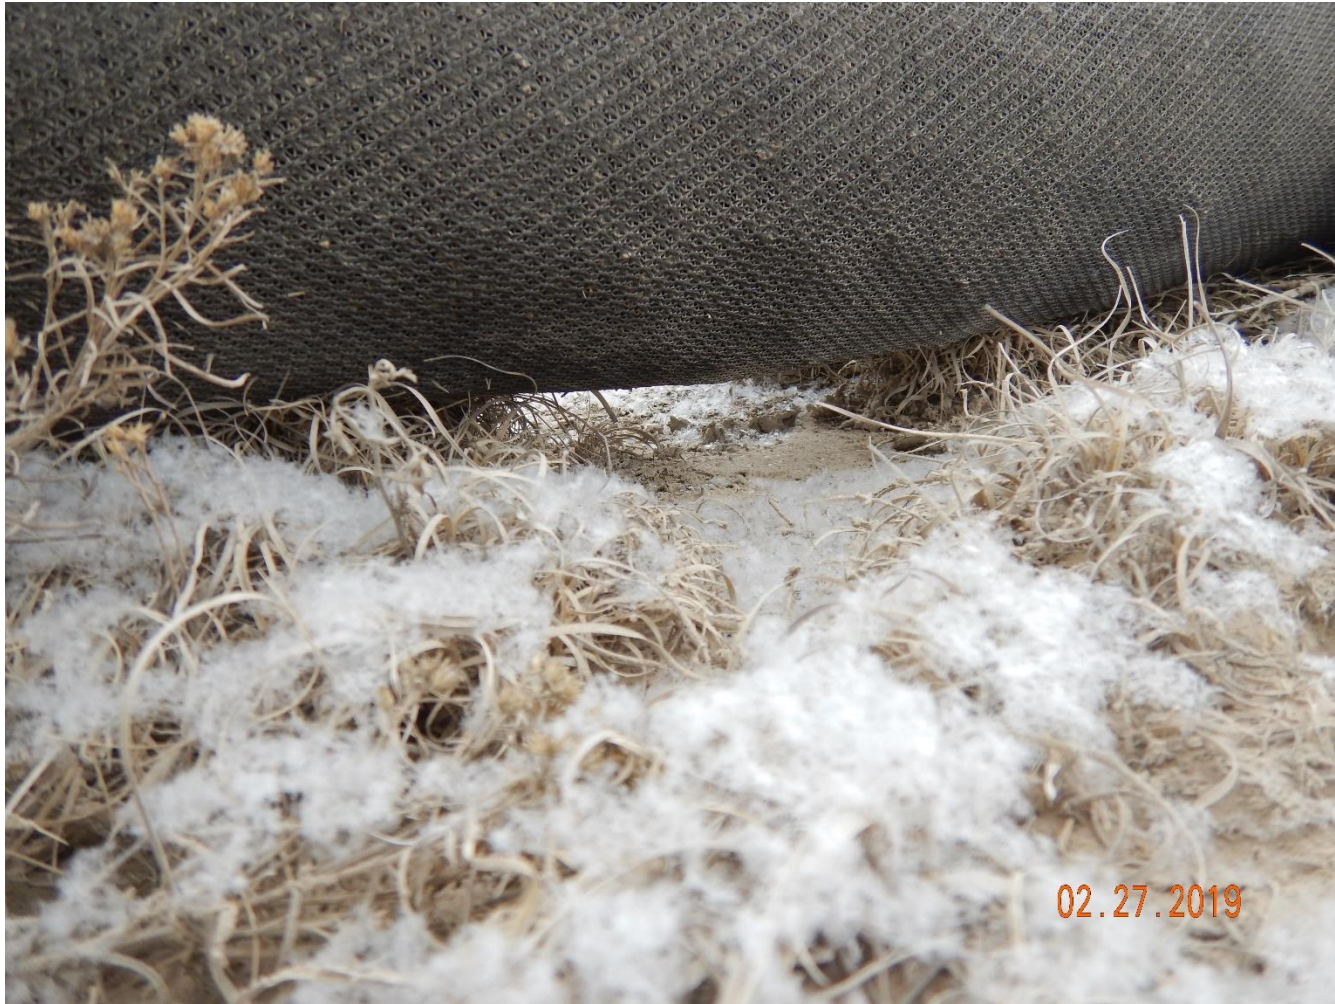
**Photo 19:** See comments under photo 18.

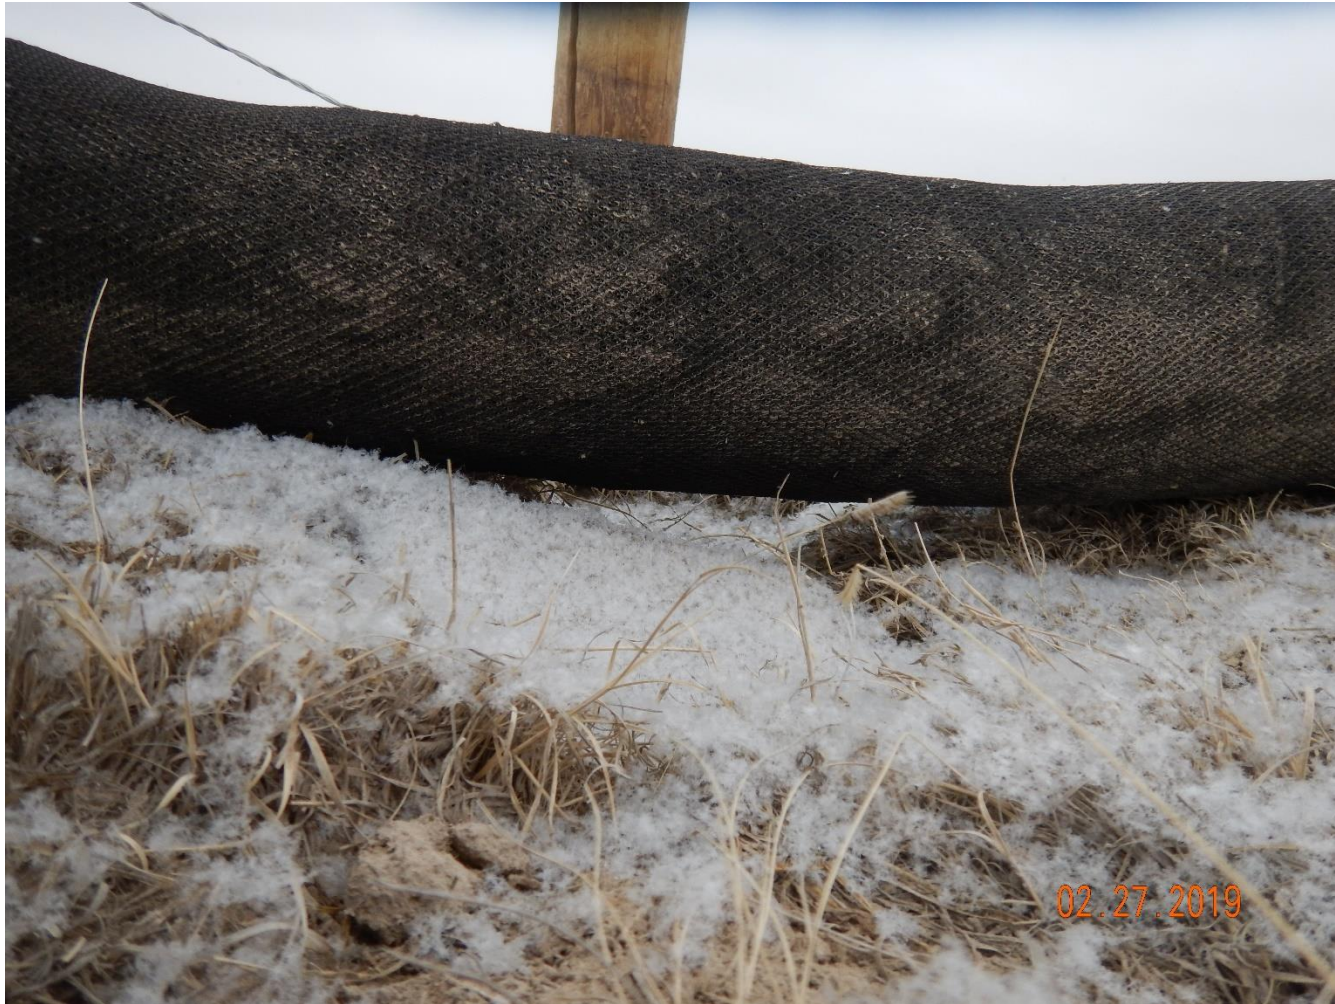
**Photo 20:** See comments under photo 18.

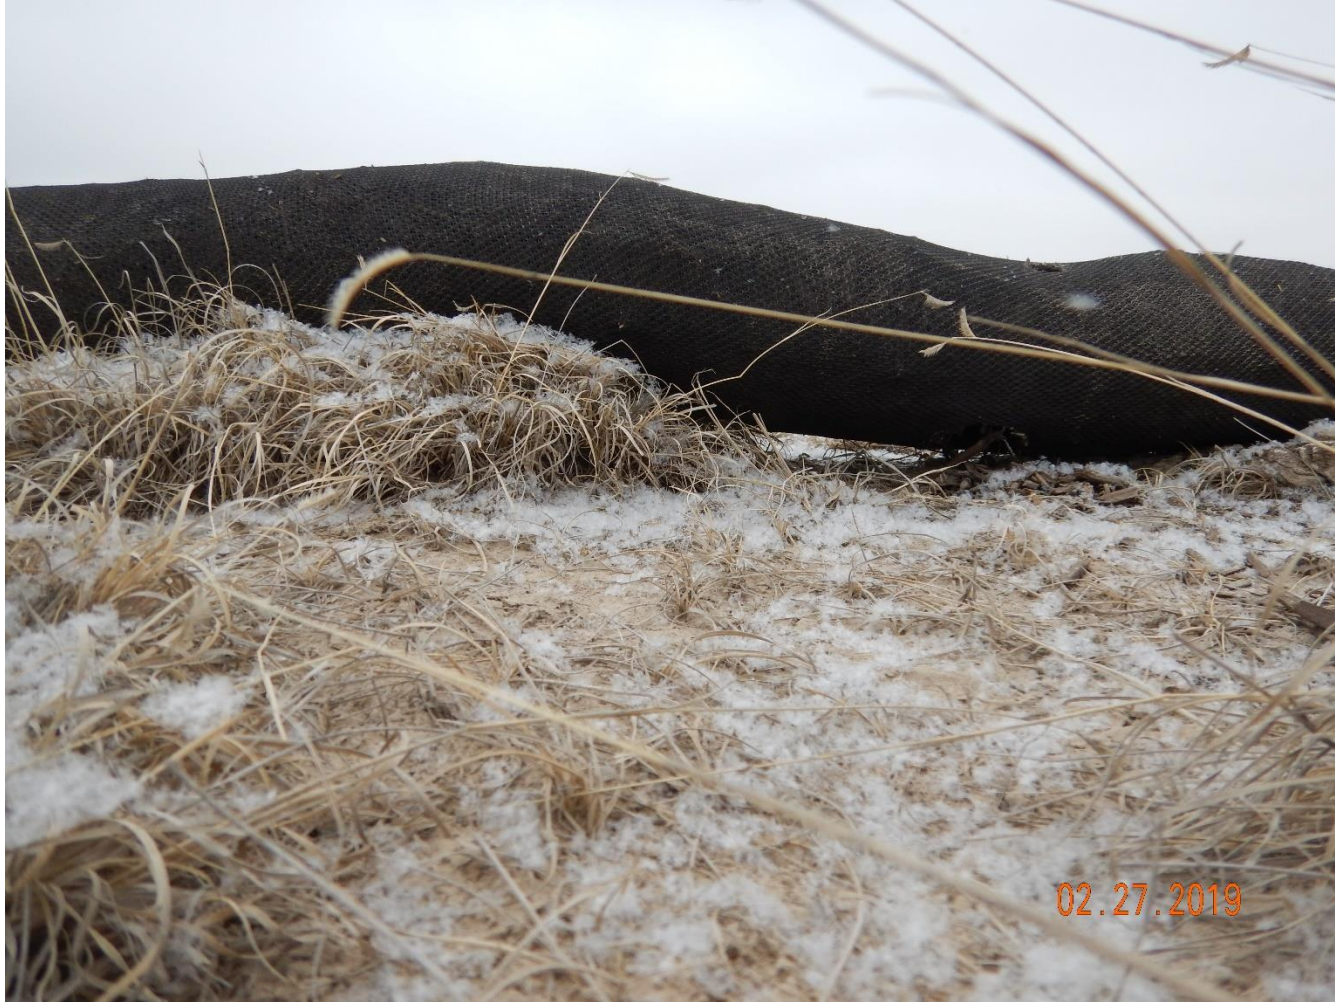
**Photo 21:** See comments under photo 18.
