Construction and Storm Water Inspection

February 20, 2019

Operator: EXTRACTION OIL & GAS INC – 10459

Location ID: 455317

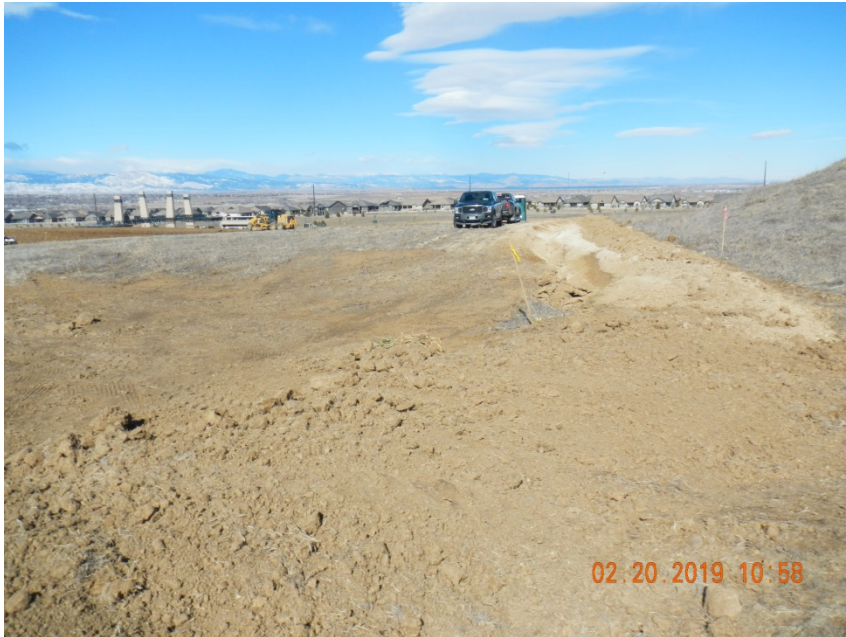
Photo 1. Photo taken from the eastern perimeter of the location, facing North. Photo illustrates a ditch and berm BMP that is being installed around the perimeter of the location. However this should have been complete at the time of inspection because major dirt work activities were occurring at the center of the location.

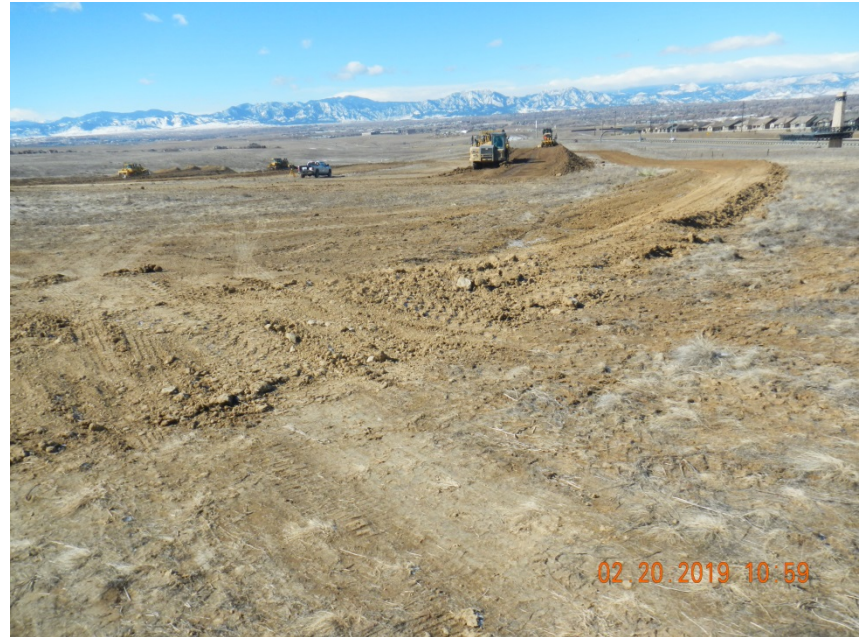
Photo 2. Photo taken from the northeastern perimeter of the location, facing West. See comments from Photo 1.

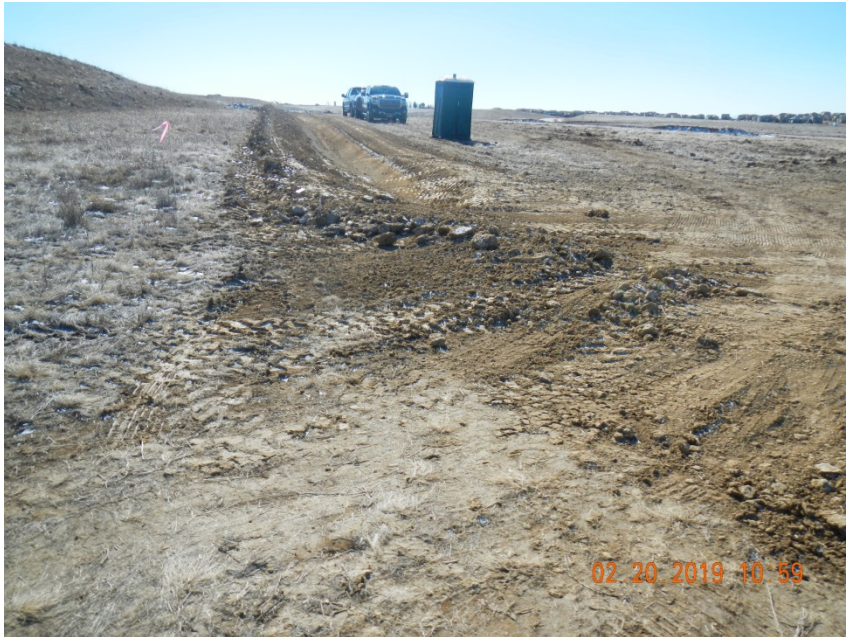
Photo 3. Photo taken from the northeastern perimeter of the location, facing South. See comments from Photo 1.

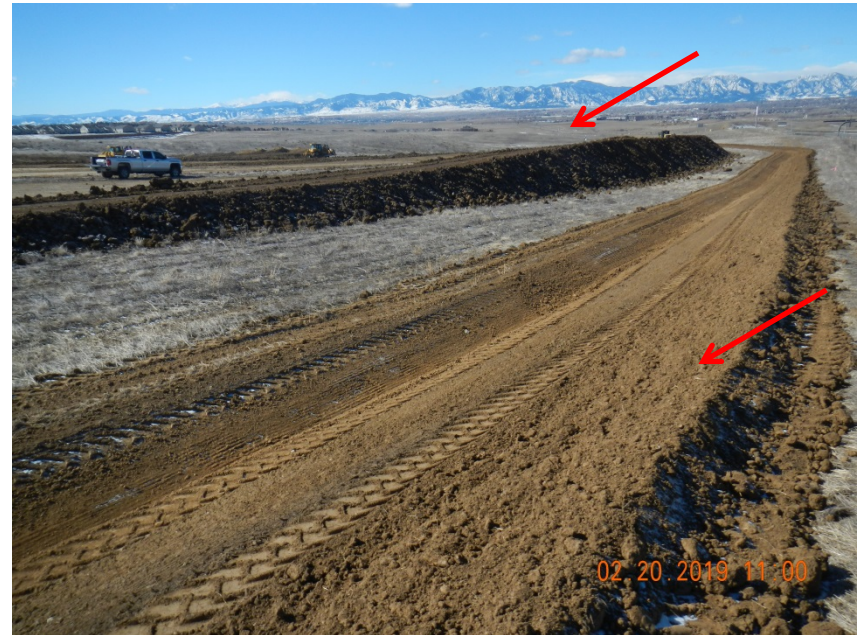
Photo 4. Photo taken from the northeastern perimeter of the location, facing West. The topsoil stockpile being stored along the northern area in the background of the Photo. The perimeter BMPs in the foreground of the Photo have not been completed due to lack of compaction and has not been installed with best engineering practices. However this should have been complete at the time of inspection because major dirt work activities were occurring at the center of the location.

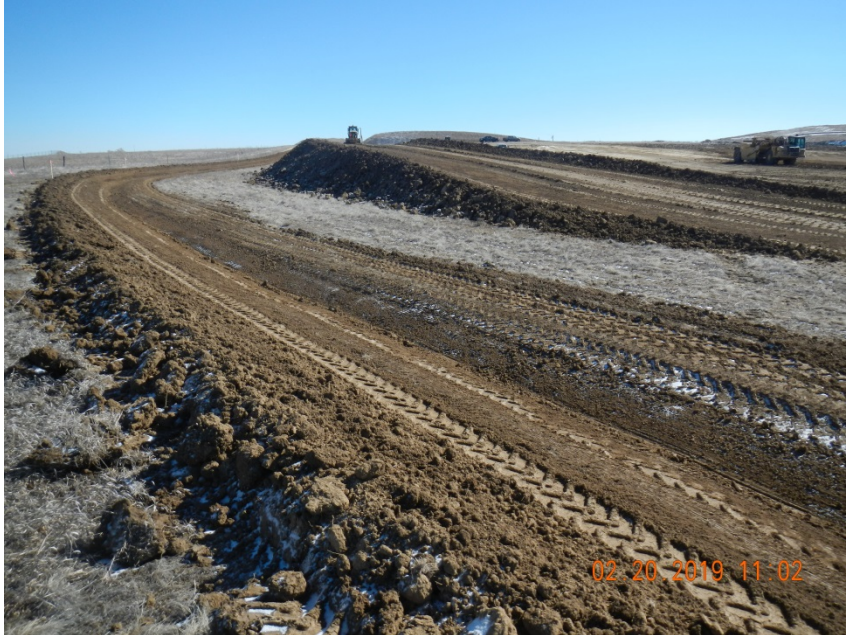
Photo 5. Photo taken from the northwestern perimeter of the location, facing East. See comments from Photo 4.

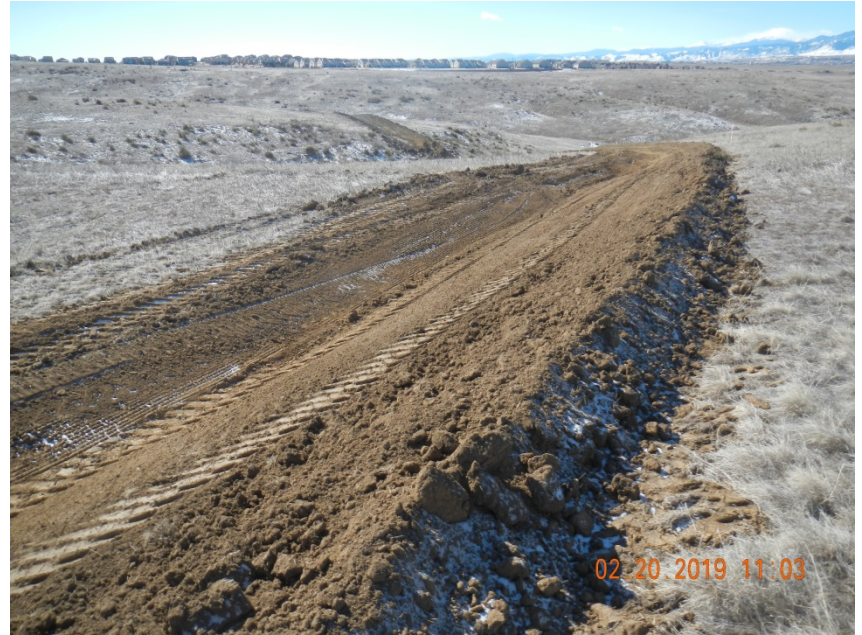
Photo 6. Photo taken from the western perimeter of the location, facing South. See comments from Photo 4.

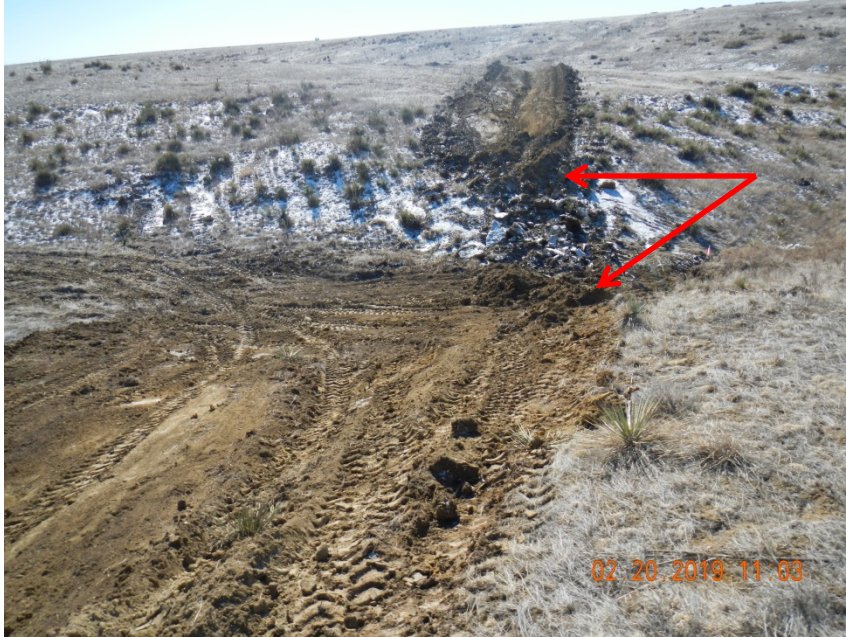
Photo 7. Photo taken from the western perimeter of the location, facing South. Photo illustrates the ditch and berm BMP was not completed at the time of inspection. Note there is a potential wetland downslope within the drainage where the break in the ditch and berm BMP is located.

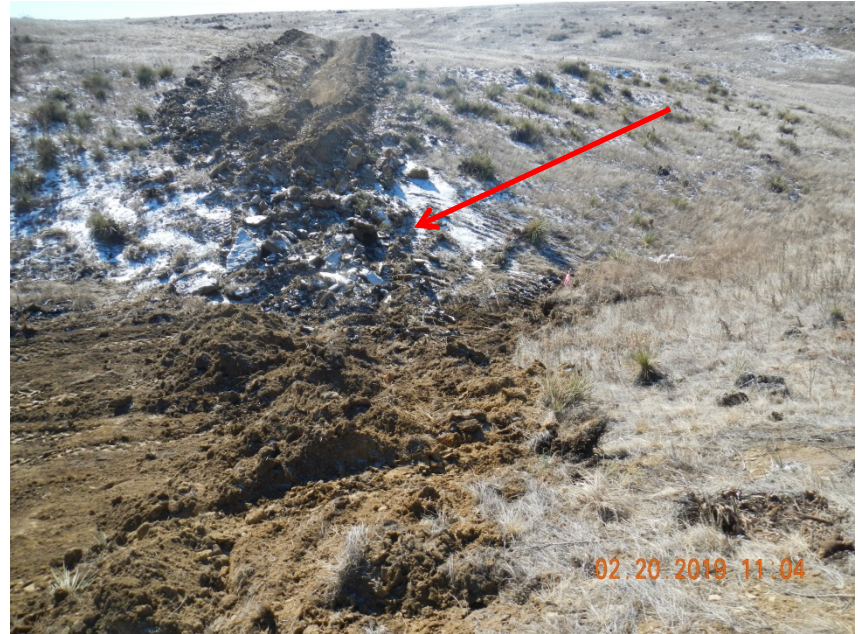
Photo 8. Photo taken from the western perimeter of the location, facing South. See comments from Photo 7.

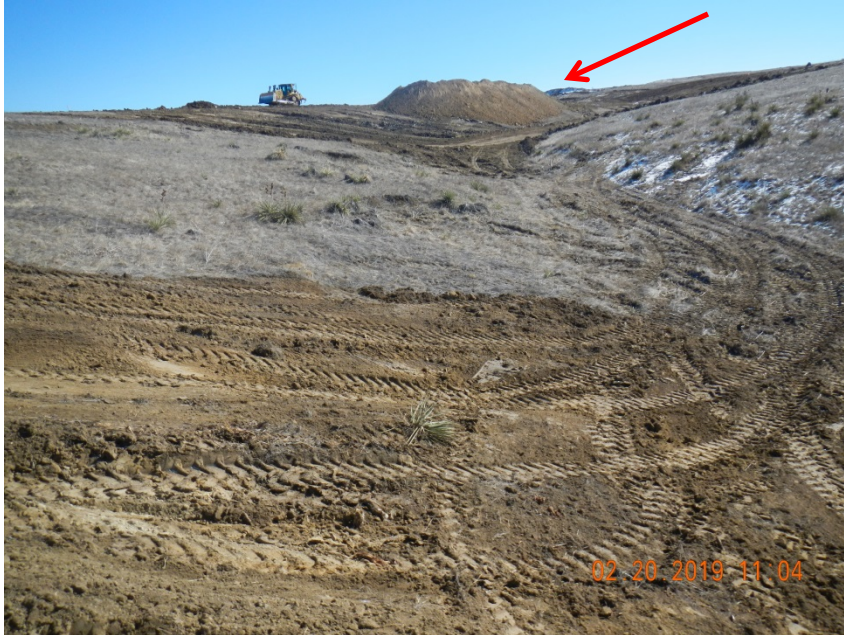
Photo 9. Photo taken from the western perimeter of the location from where the break in the ditch and berm BMP is located, facing East. Note the upslope work being conducted at the time of the inspection there were no BMPs downslope of the construction.

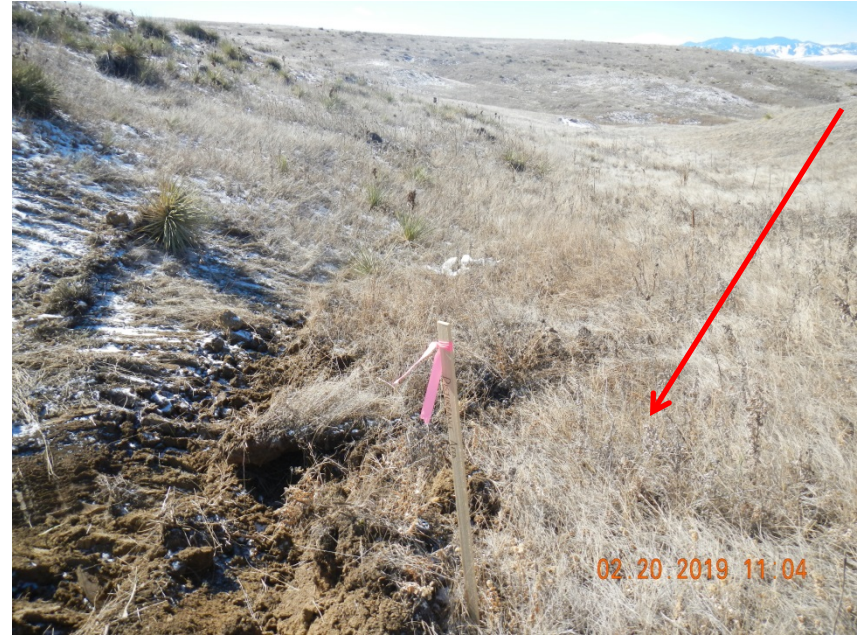
Photo 10. Photo taken from the western perimeter of the location from where the break in the ditch and berm BMP is located, facing West. Note the mapped Riverine System (R4SBC) wetland adjacent to the disturbance with plant species encountered included but was not limited to common threesquare (*Schoenoplectus pungens*). The Operators Form 2A stated that an Army Corps of Engineers Section 404 permit was not filed.

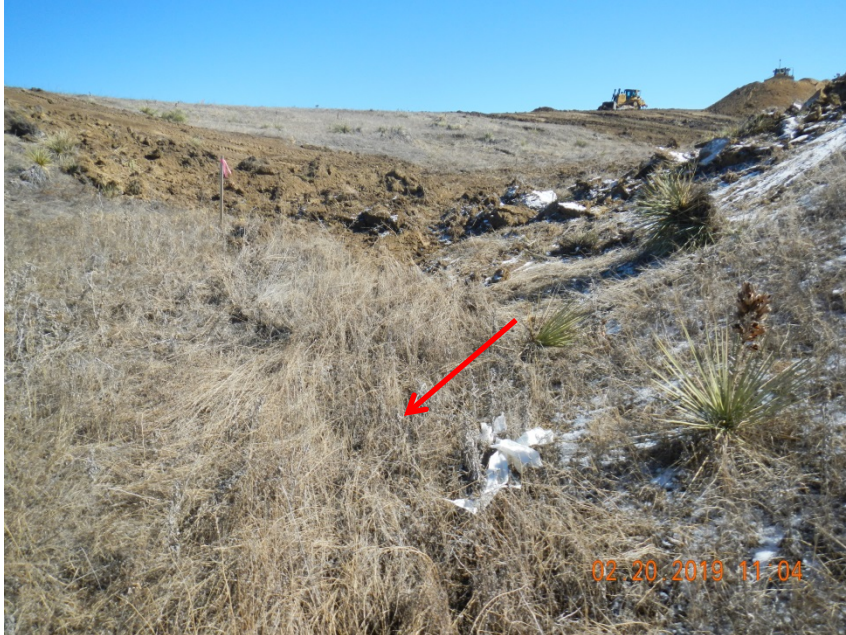
Photo 11. Photo taken from west of the location, facing East. Note the potential wetland adjacent to the disturbance with plant species encountered included but was not limited to common threesquare (*Schoenoplectus pungens*). See comments from Photo 7.

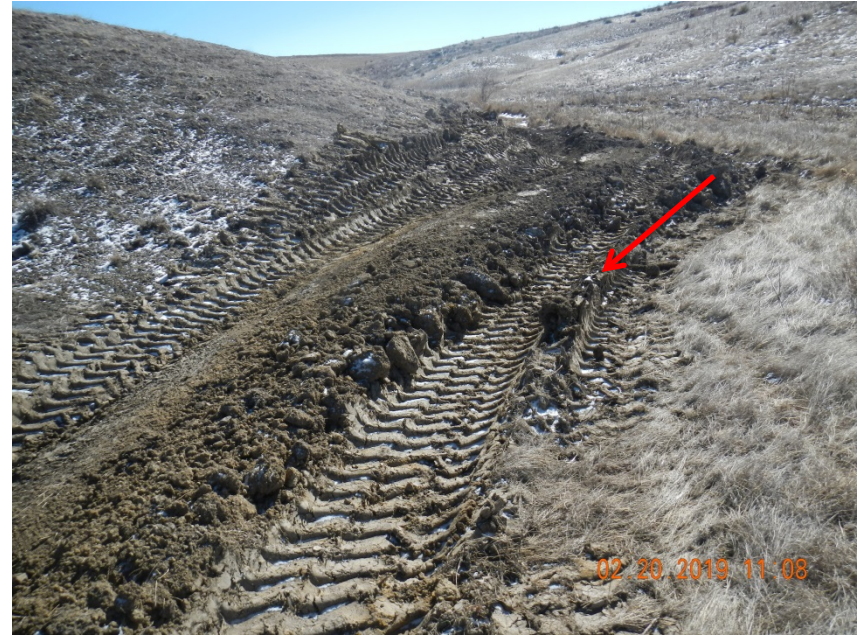
Photo 12. Photo taken from the southwestern perimeter of the location, facing East. Photo illustrates the ditch and berm BMP that has been improperly installed, not compacted and has been disturbed due to equipment.

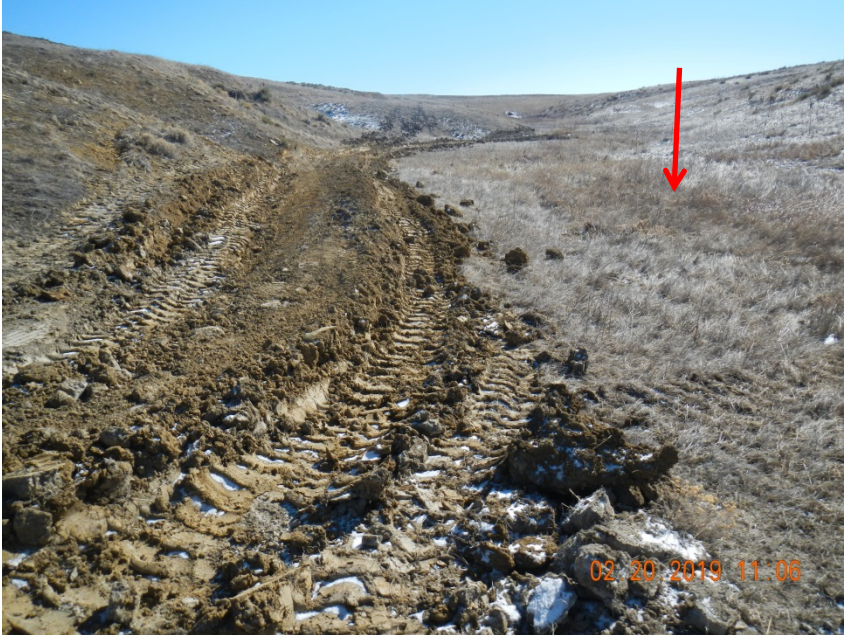
Photo 13. Photo taken from the southern perimeter of the location, facing East. This entire southern perimeter is a USFWS National Wetlands Inventory mapped Riverine System (R4SBC) wetland and has been disturbed due to the construction.

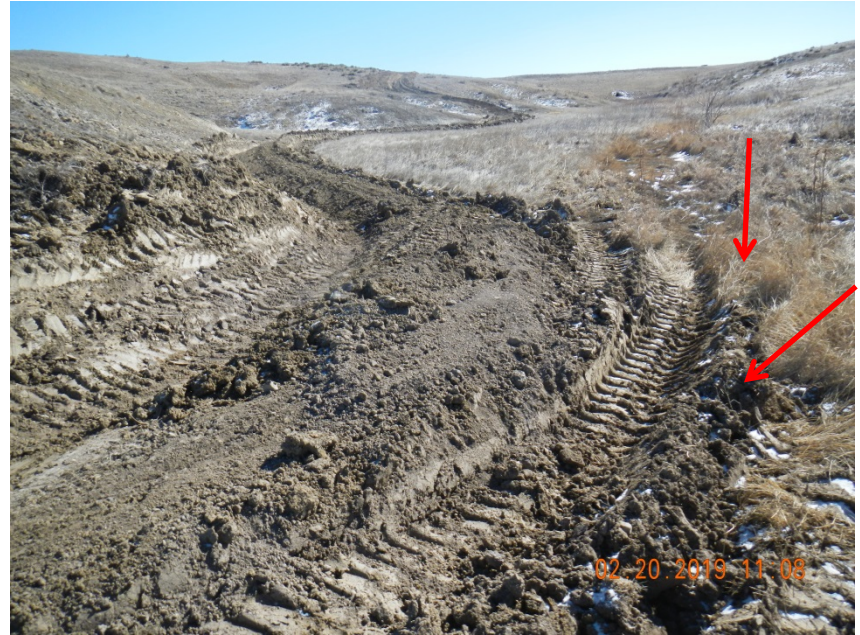
Photo 14. Photo taken from the southern perimeter of the location, facing East. See comments from Photos 13.

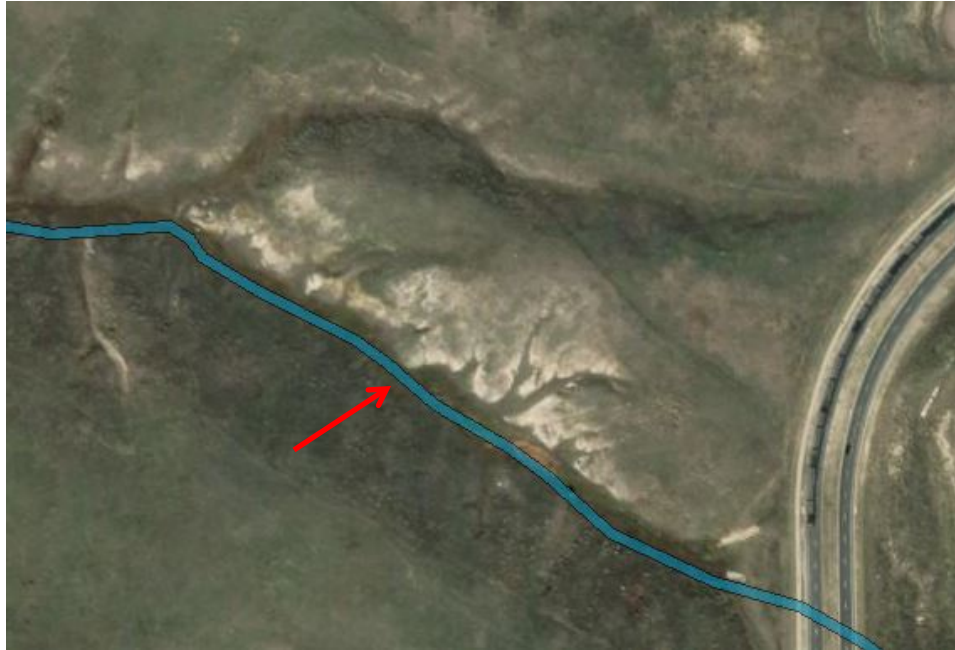
Photo 15. Aerial imagery showing the the USFWS National Wetlands Inventory mapped Riverine System (R4SBC) in the blue polygon
