**Inspection Photo (s)**  
**Epperly 14A**  
**API #05-045-10464**  
**FIR Inspection # 689303392**

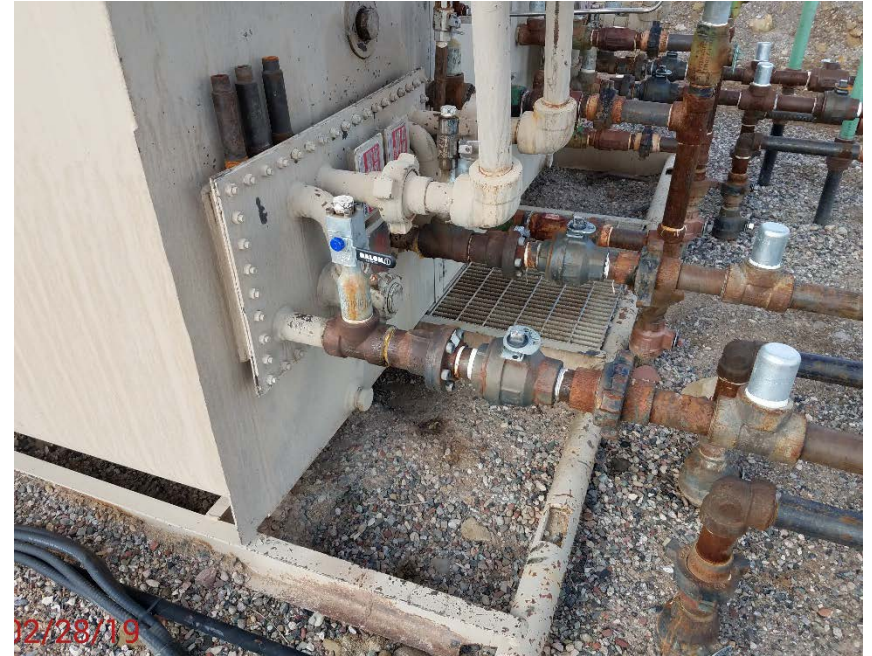
**Location Photo #4, 2 leaking fittings on inlets to separator.**

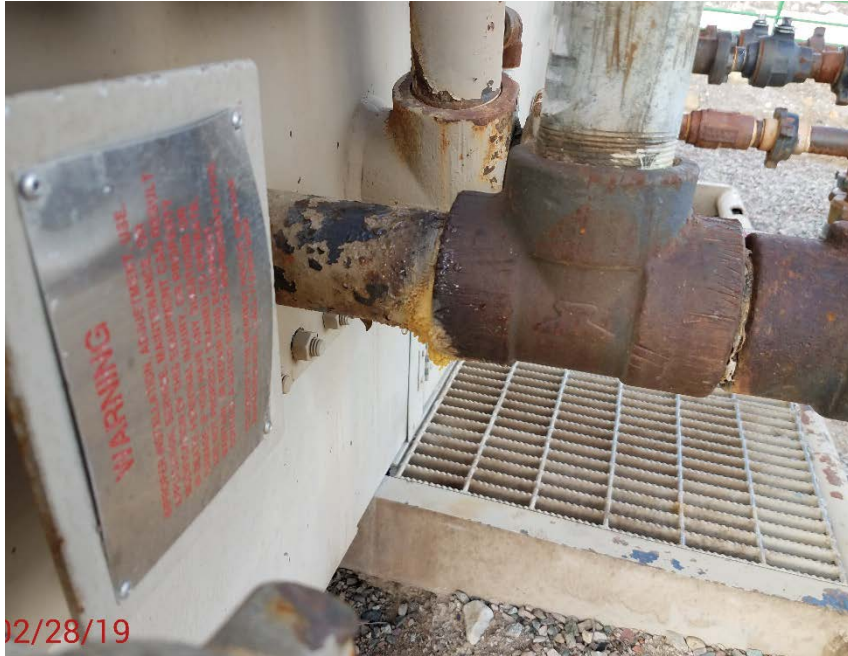
**Location Photo #5, leaking fitting on inlet flow line.**

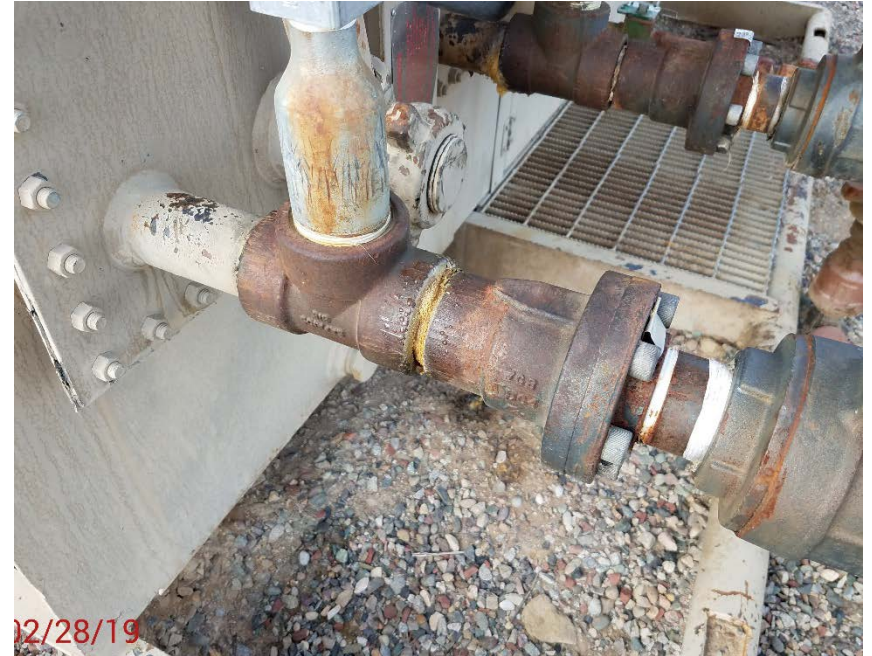
**Location Photo #6, leaking fitting on inlet flow line.**
