Inspection Photo (s)
Wilson 43A-23
API #05-045-10441
FIR Inspection # 689303400

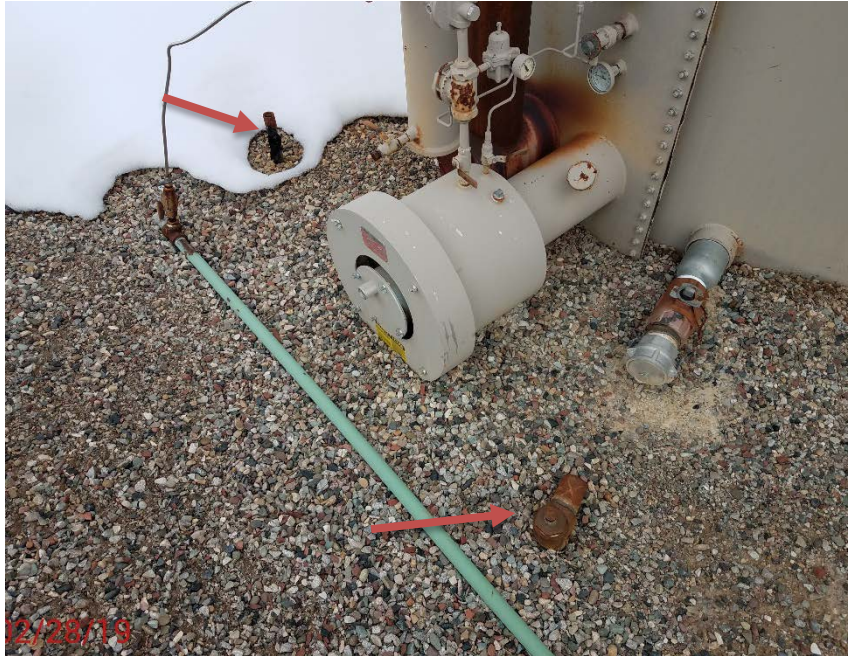
Location Photo #3, 2 unmarked/unused flowline risers in tank battery.

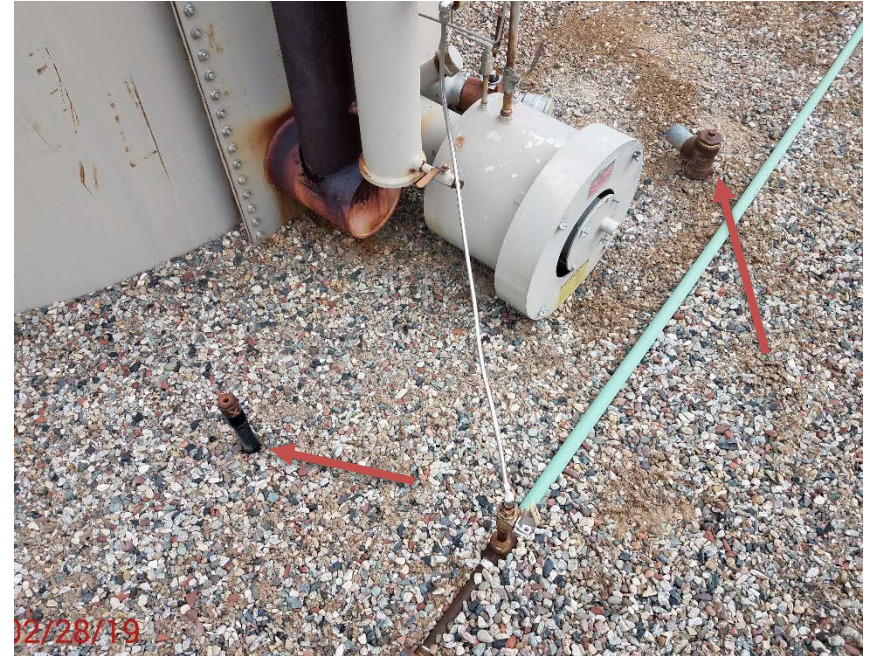
Location Photo #4, 2 unmarked/unused flowline risers in tank battery.

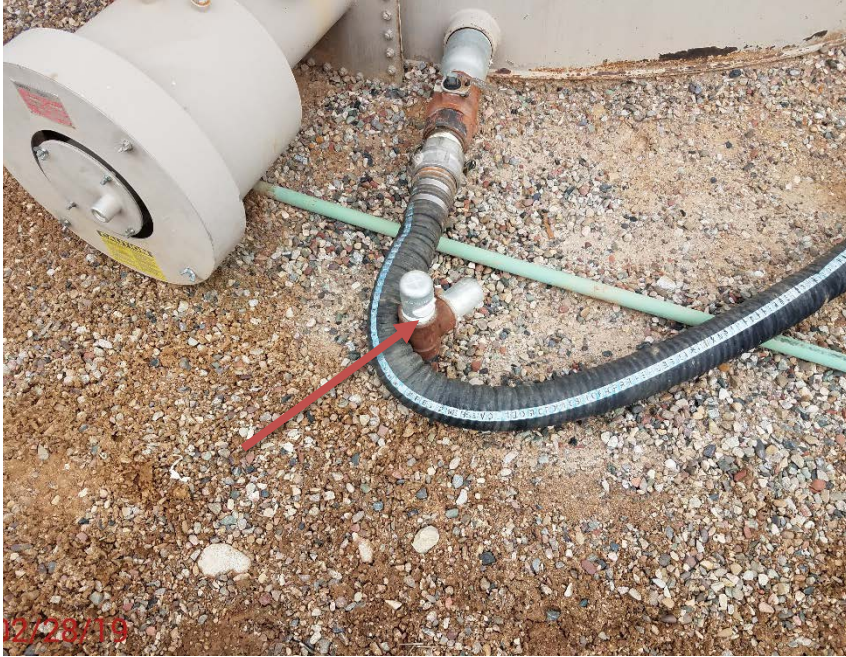
**Location Photo #5, 1 unmarked/unused
flowline risers in tank battery.**
