Inspection Photo (s)
Kaufman 23C-24
API #05-045-19649
FIR Inspection # 689303406

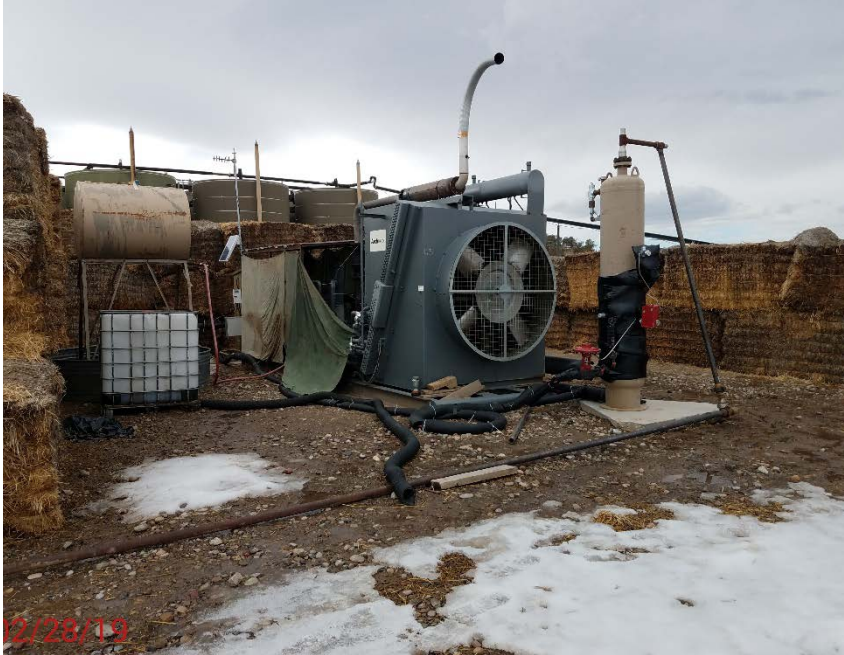
Location Photo #5, Temporary compressor for gas lift operation.

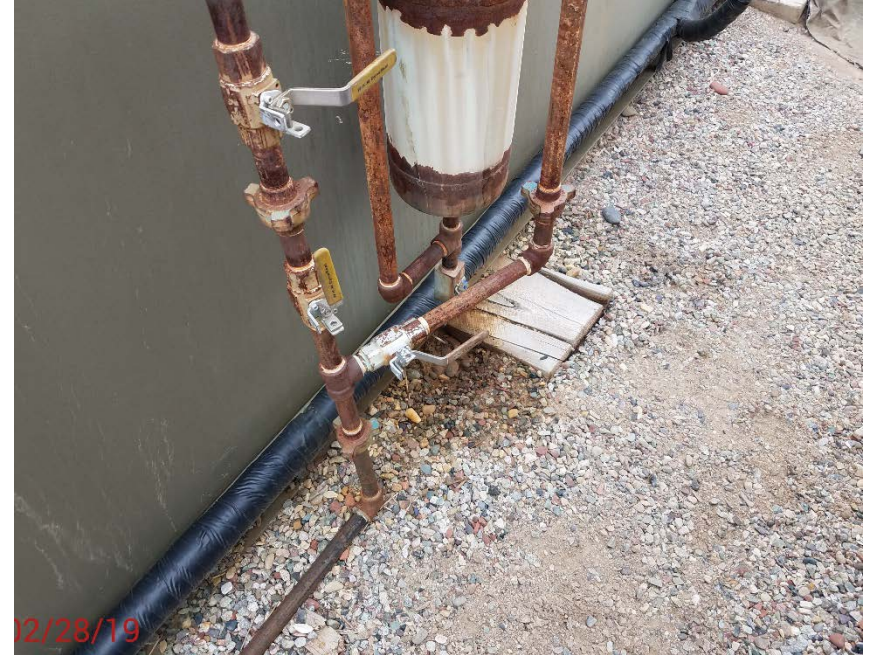
Location Photo #6, Stained ground underneath scrubber pot.

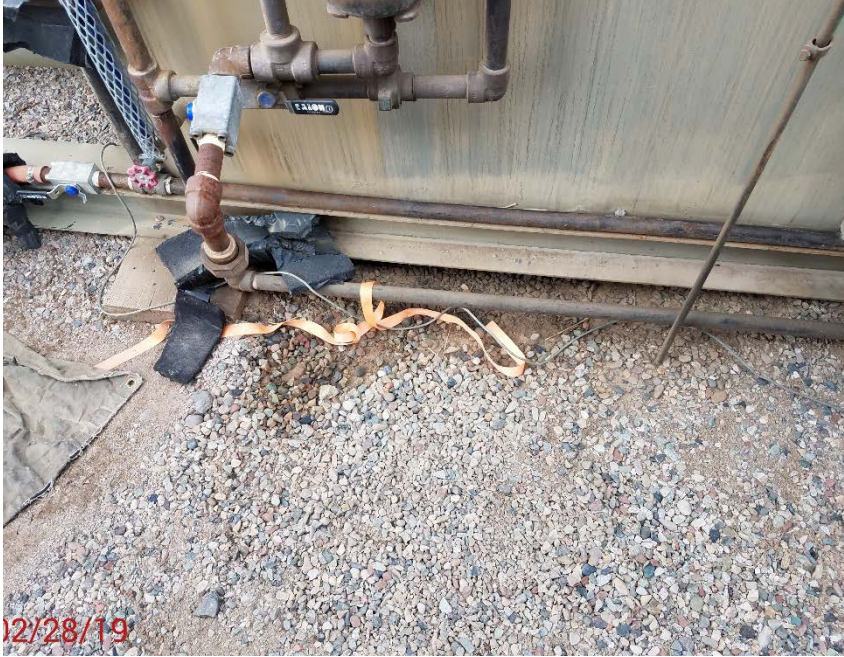
Location Photo #7, Stained ground underneath scrubber pot.

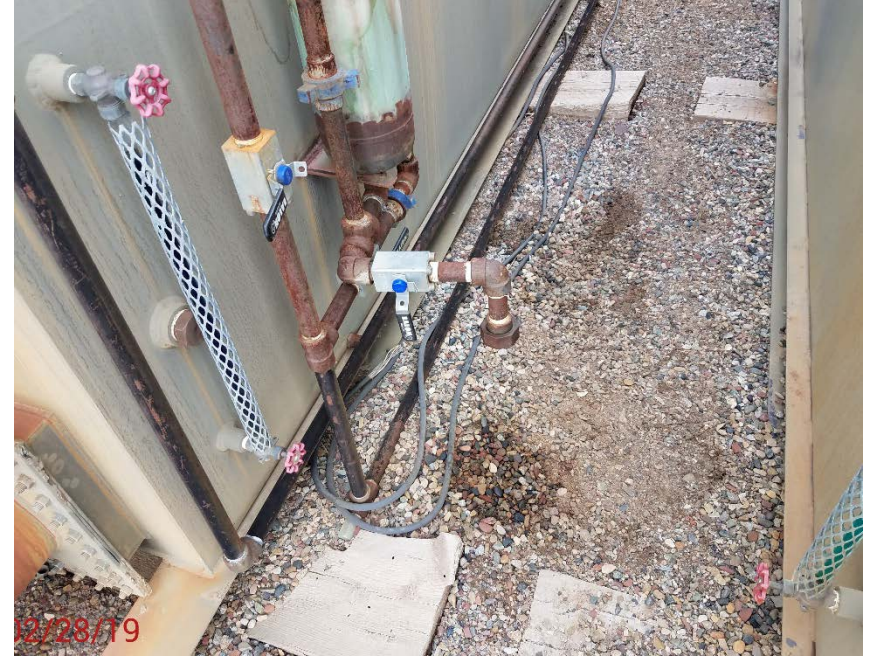
Location Photo #8, Stained ground underneath scrubber pot.

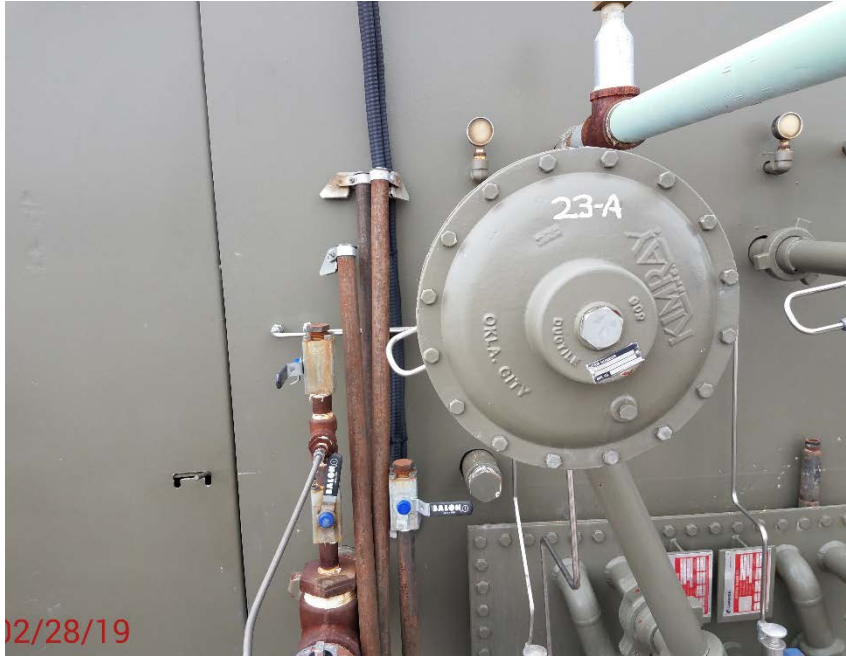
Location Photo #9, 2 Leaking fittings on unit 23A.

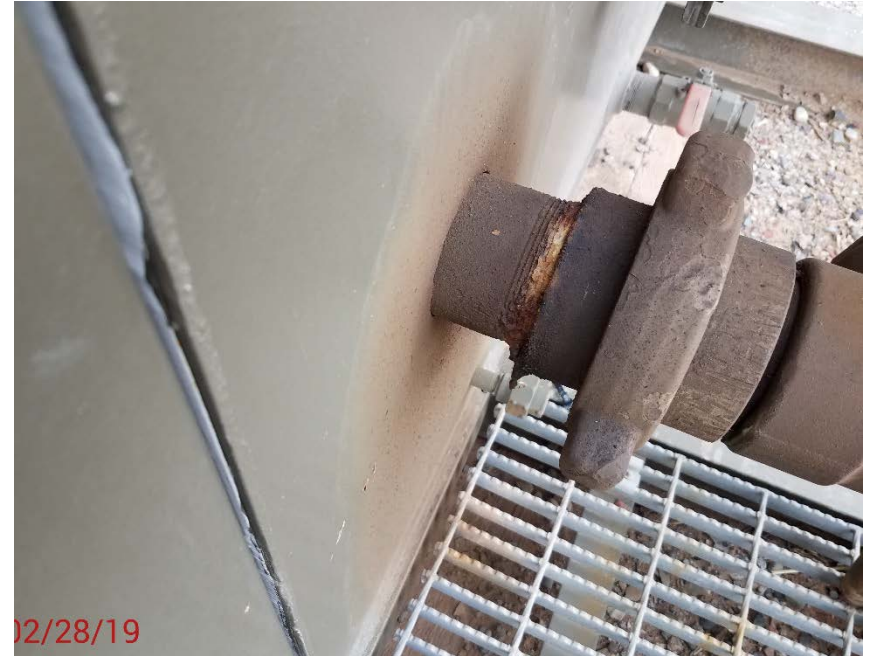
Location Photo #10, 1 of 2 Leaking fitting on unit 23A.

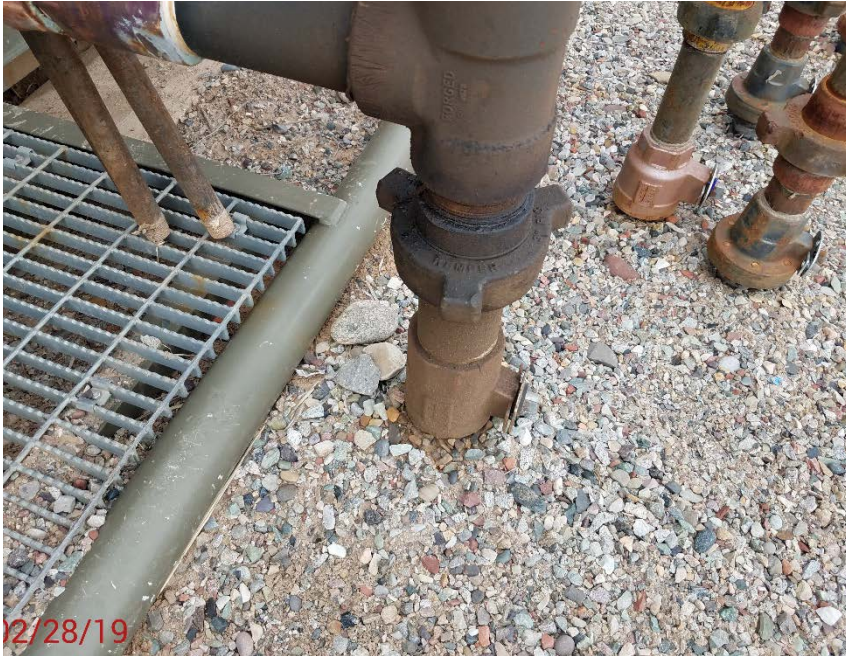
**Location Photo #11, 2 of 2 Leaking fitting on
unit 23A.**

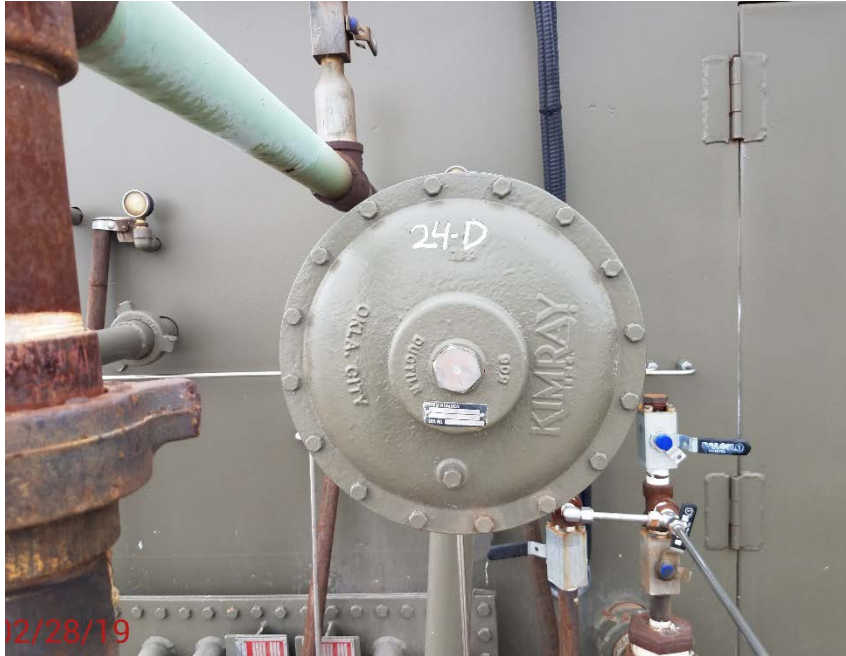
Location Photo #12, Leaking fitting on unit 24D.

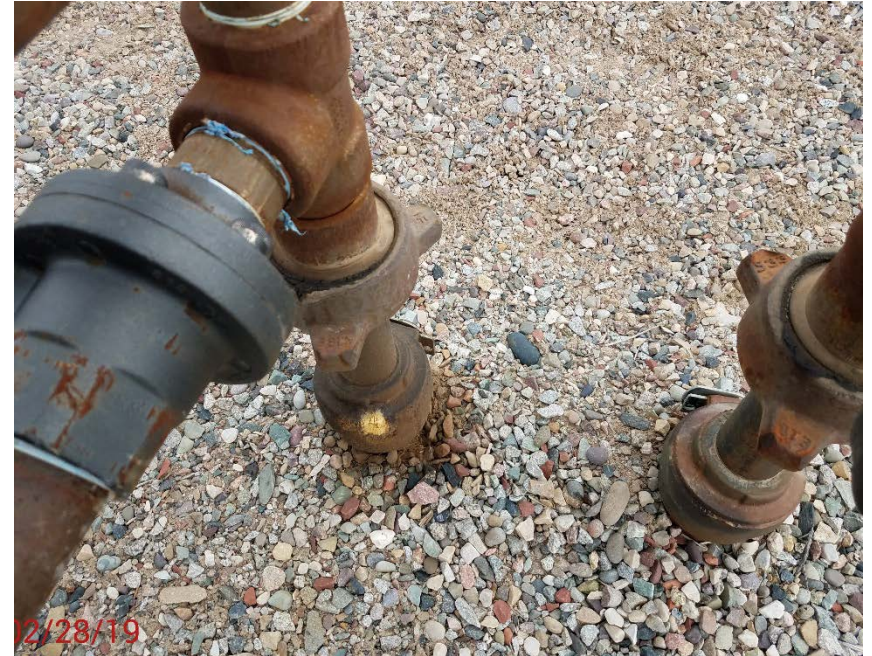
Location Photo #13, leaking fitting on 24D.
