**Inspection Photo (s)**  
**Kaufman 22D-24**  
**API #05-045-19909**  
**FIR Inspection # 689303408**

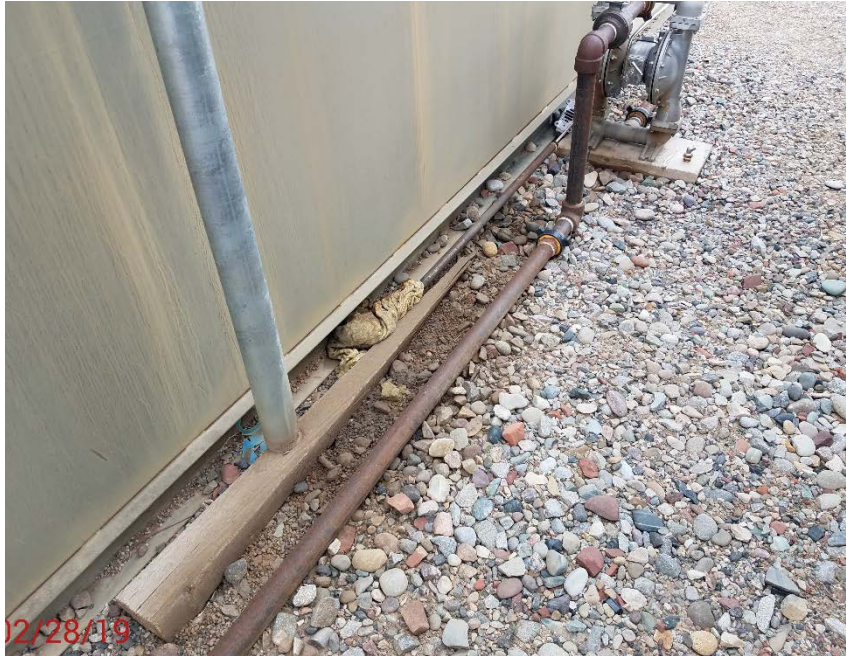
**Location Photo #4, stained ground at vent pipe for circulation pump.**

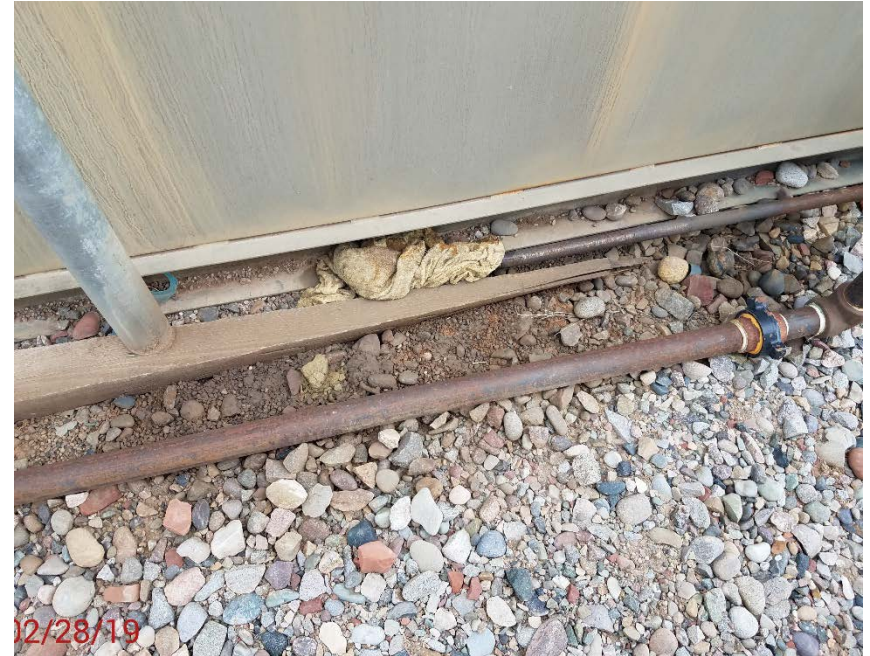
**Location Photo #5, stained ground at vent pipe for circulation pump.**

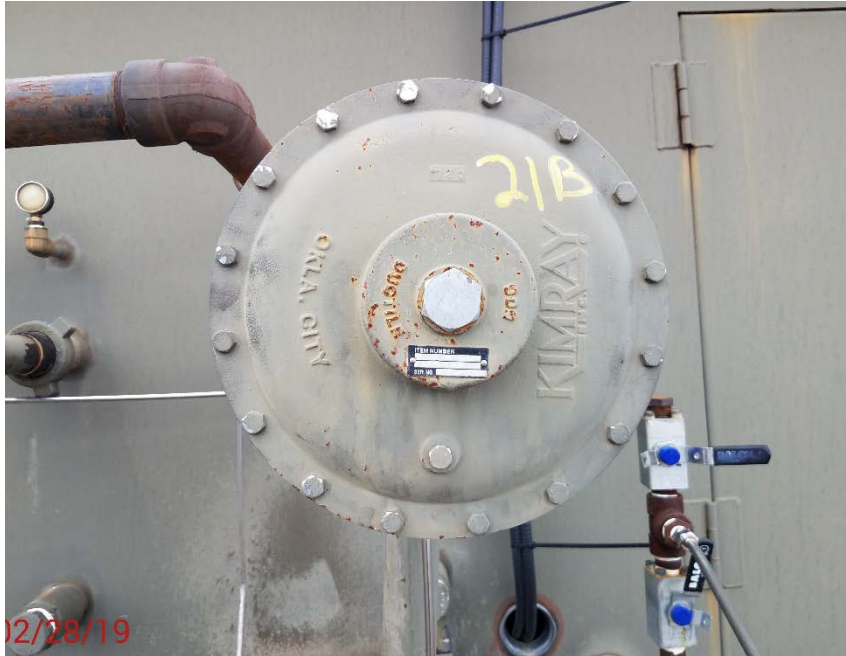
**Location Photo #6, Leaking fitting on unit 21B.**

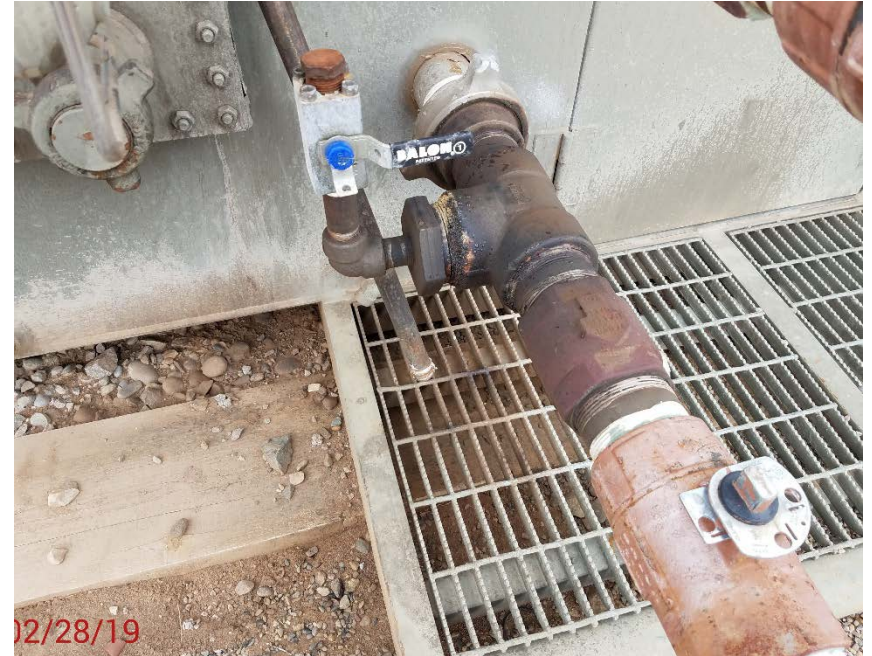
**Location Photo #7, Leaking fitting on unit 21B.**

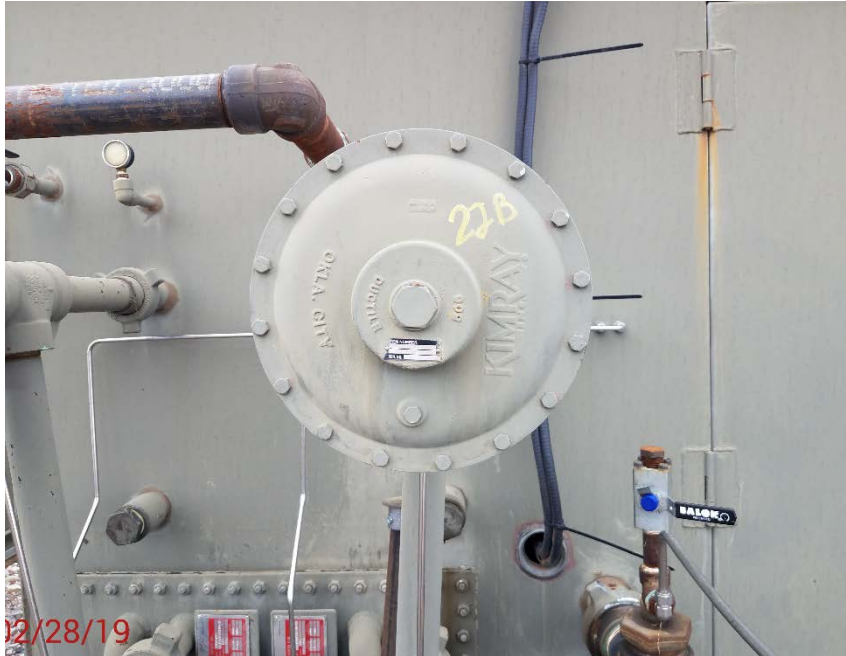
**Location Photo #8, Leaking fitting on unit 22B.**

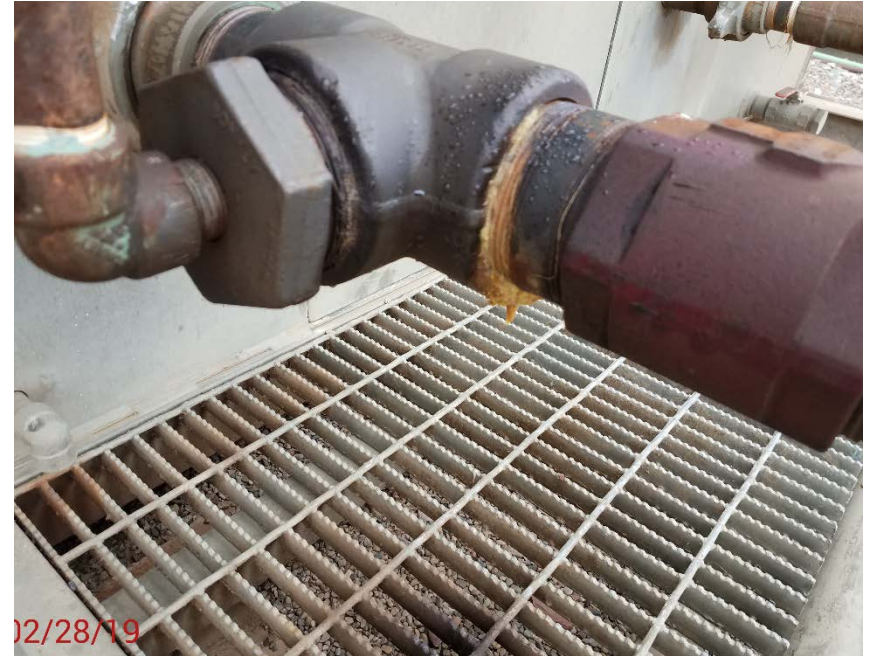
**Location Photo #9, Leaking fitting on unit 22B.**

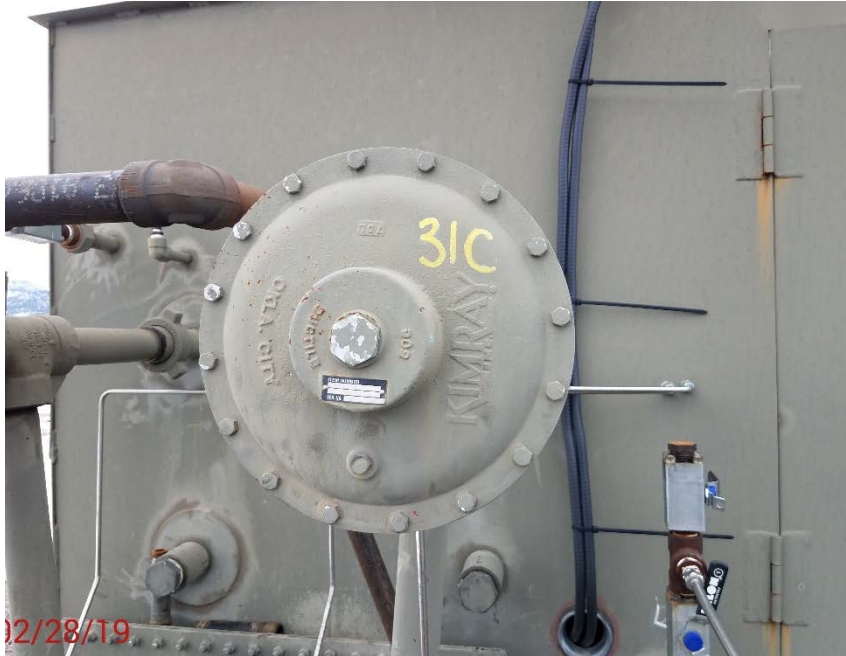
**Location Photo #10, Leaking fitting on unit 31C.**

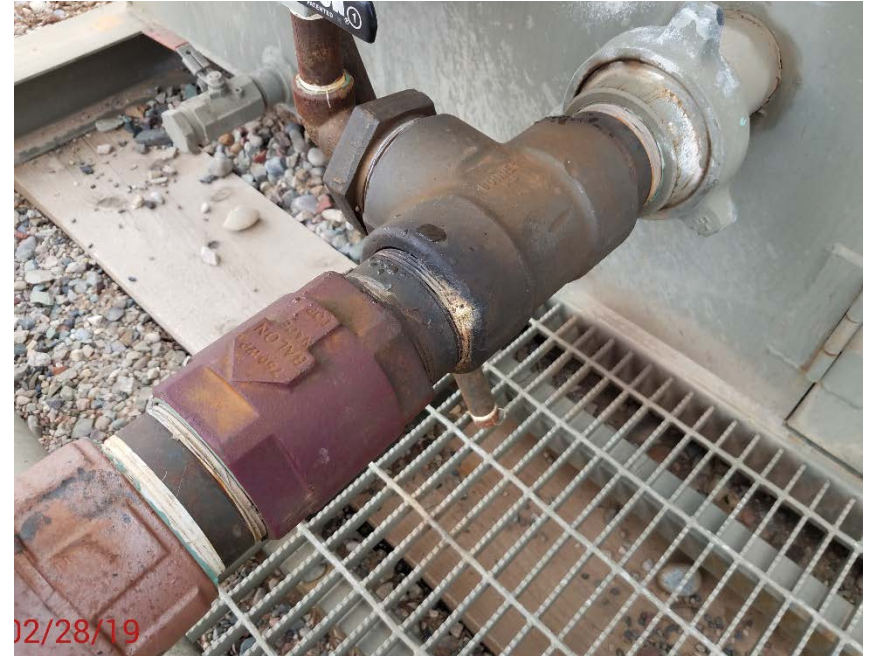
**Location Photo #11, Leaking fitting on unit 31C.**
