Inspection Photos

Operator: NOBLE ENERGY INC - 100322

Location ID: 460414

Weld County, CO

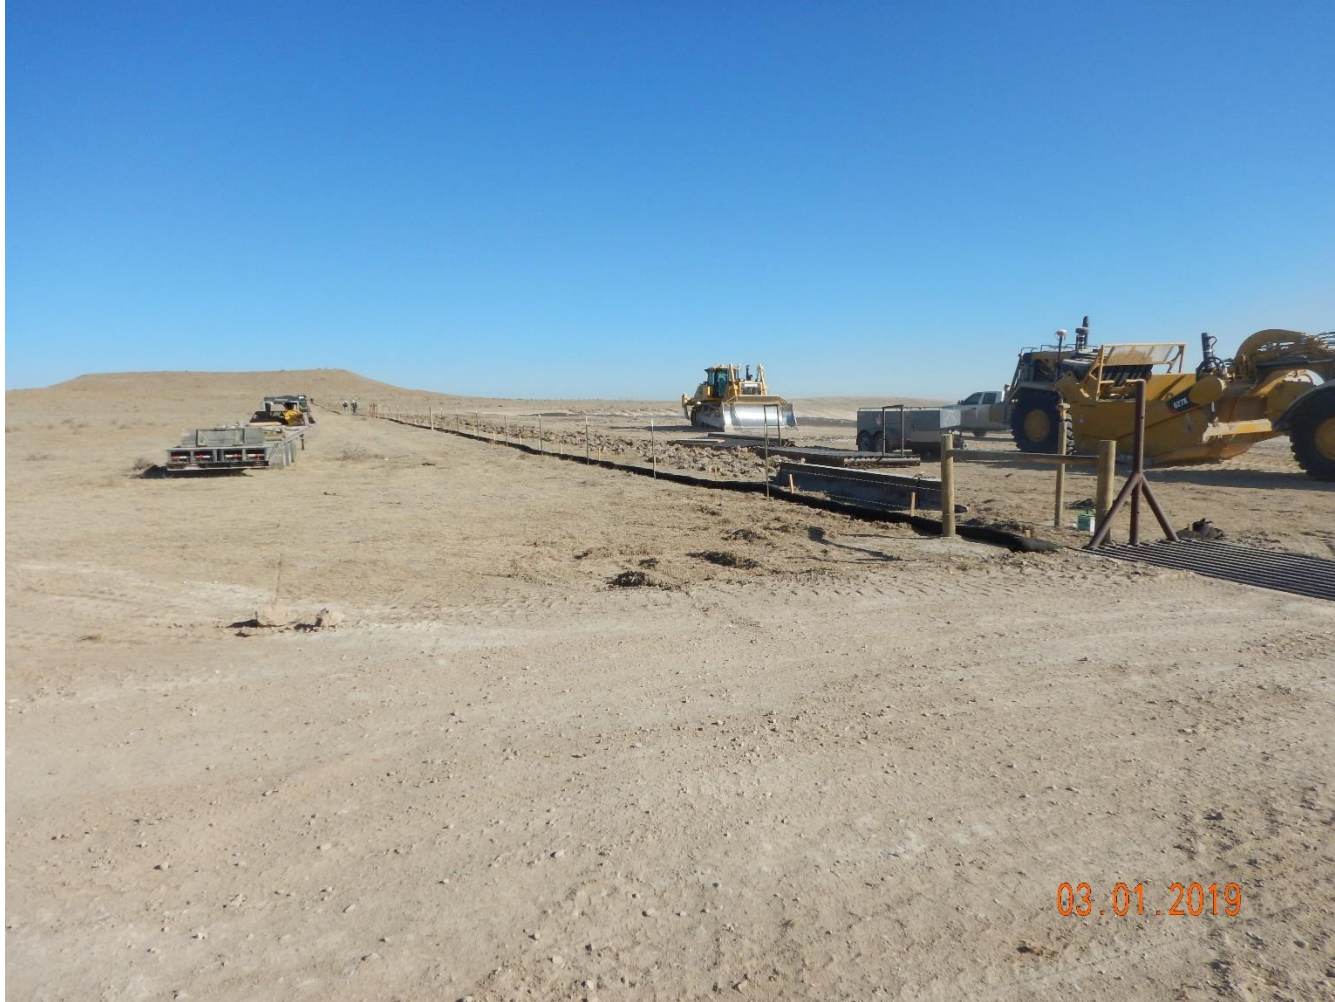
Photo 1: Photo taken from the southwest corner of the location, facing north. Photos 1-3 provide an overview of the location from north, east, to south.

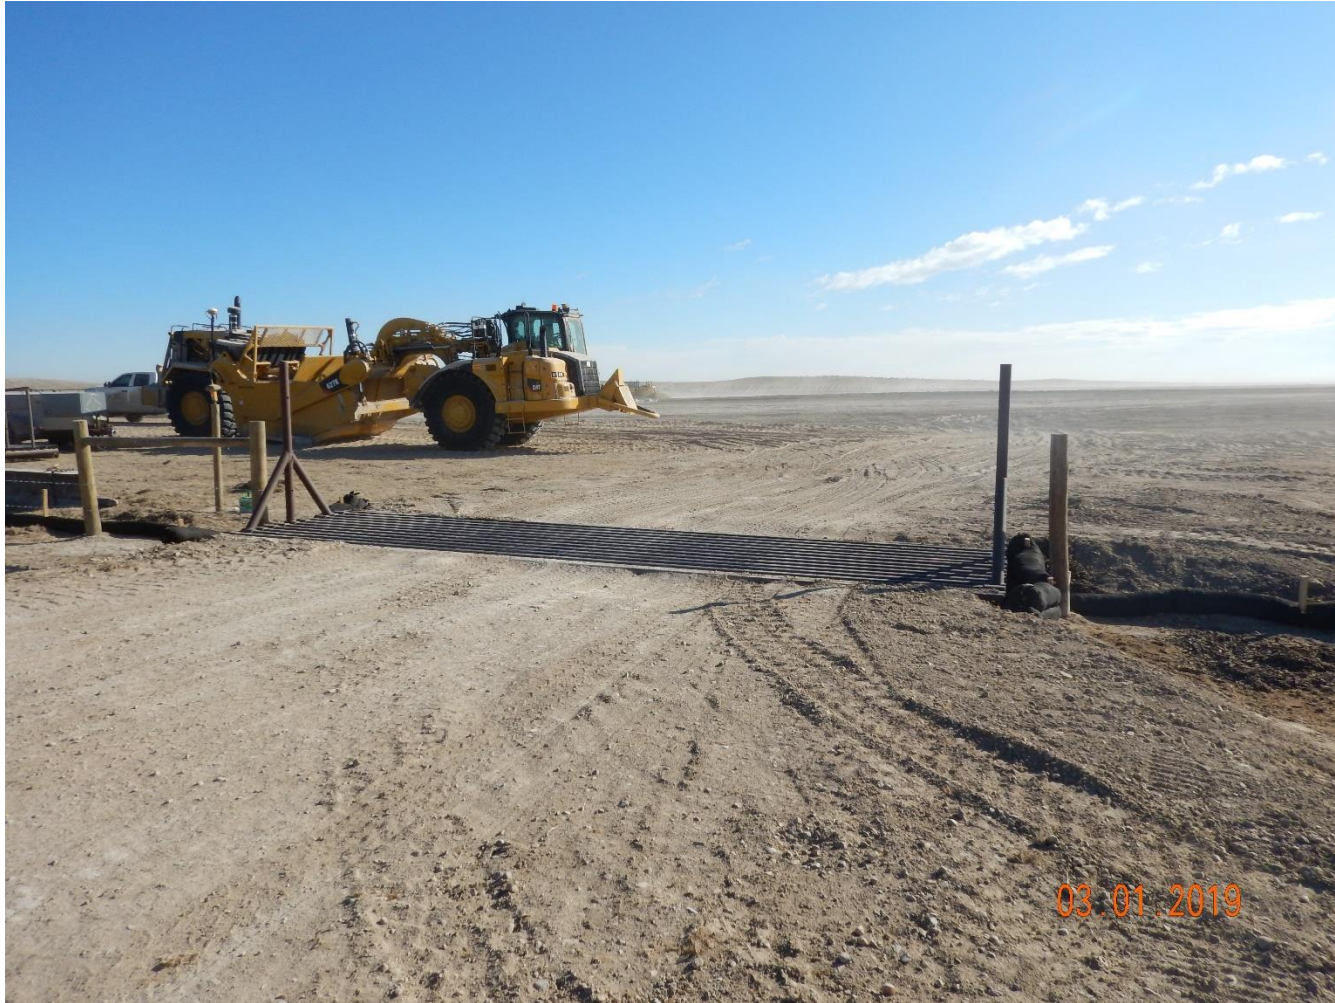
Photo 2: See comment under photo 1.

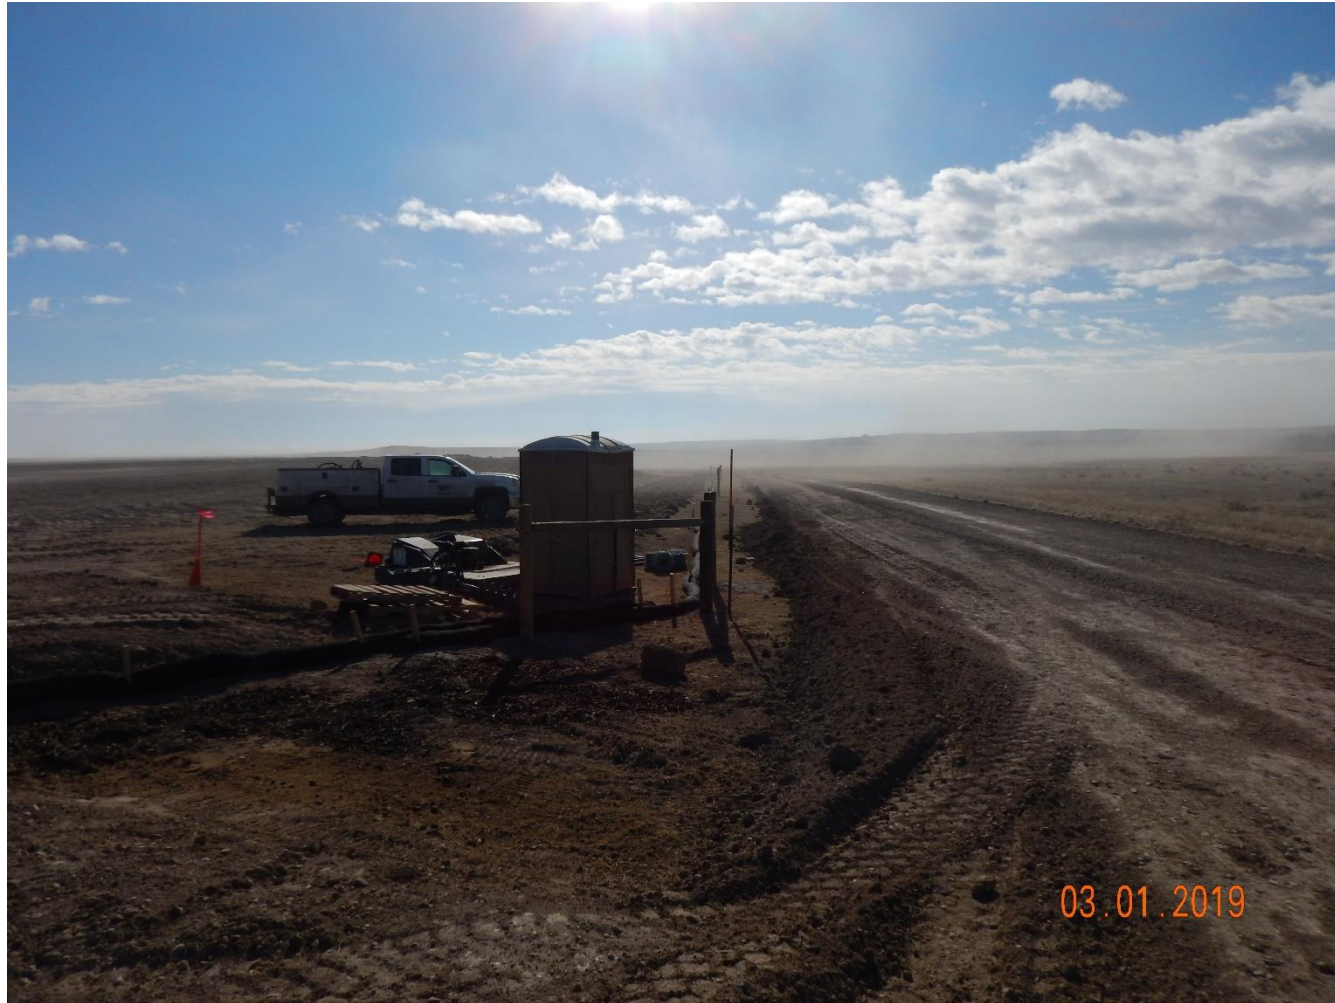
Photo 3: See comment under photo 1. Photo shows ongoing wind erosion degradation transporting sediment off of the location. Operator has failed to implement and maintain sufficient stabilization and erosion control BMPs to mitigate wind erosion and sediment transport on the location in accordance with 1002.f and 1002.e

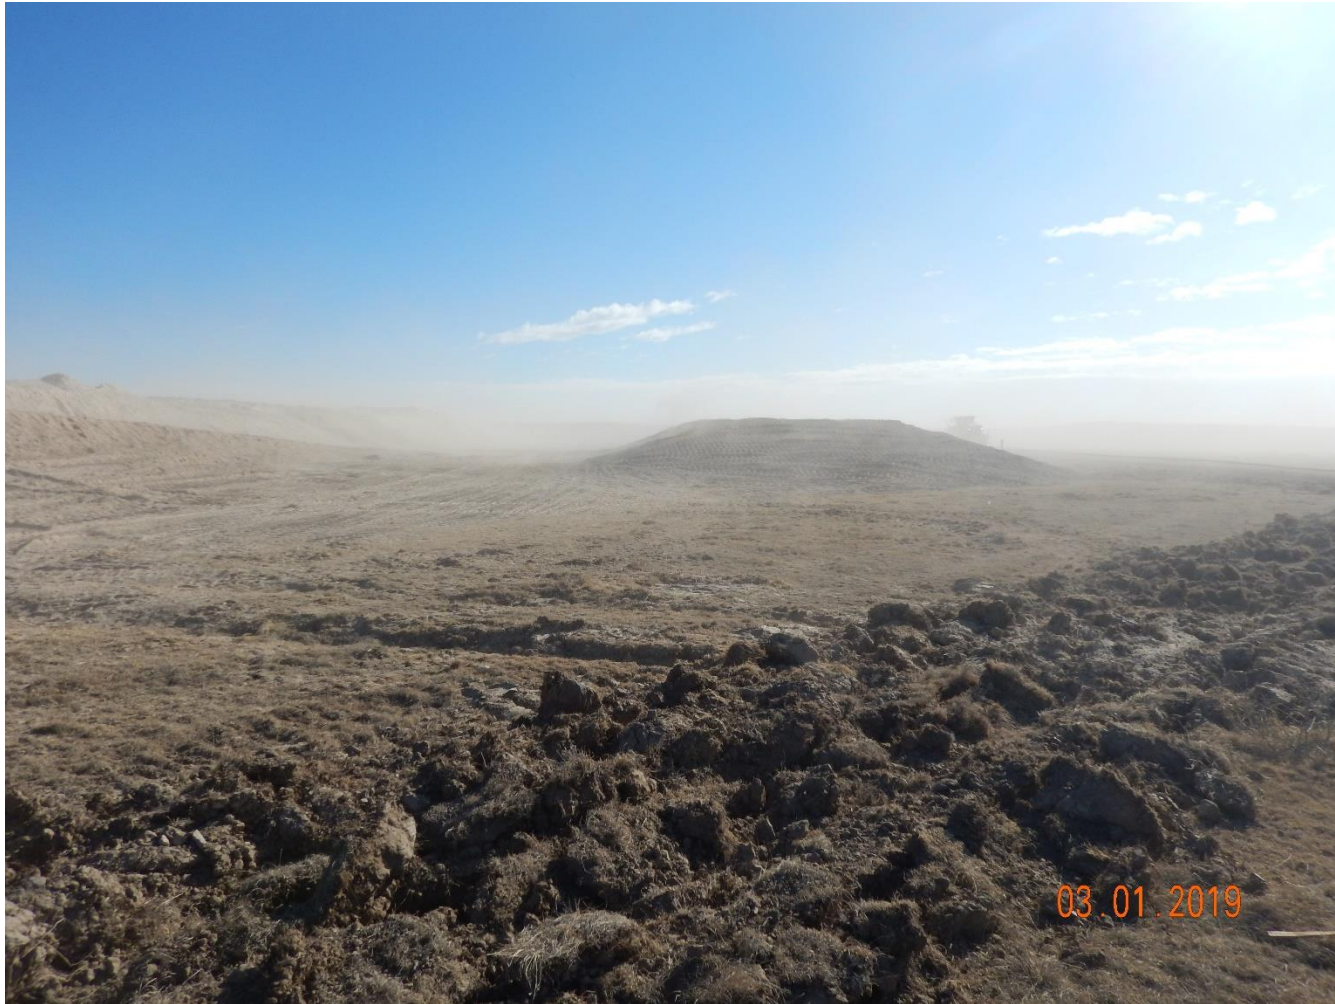
Photo 4: Photo taken from the south end of the location, facing east. Photo shows ongoing wind erosion degradation transporting sediment off of the location and soil stockpiles.

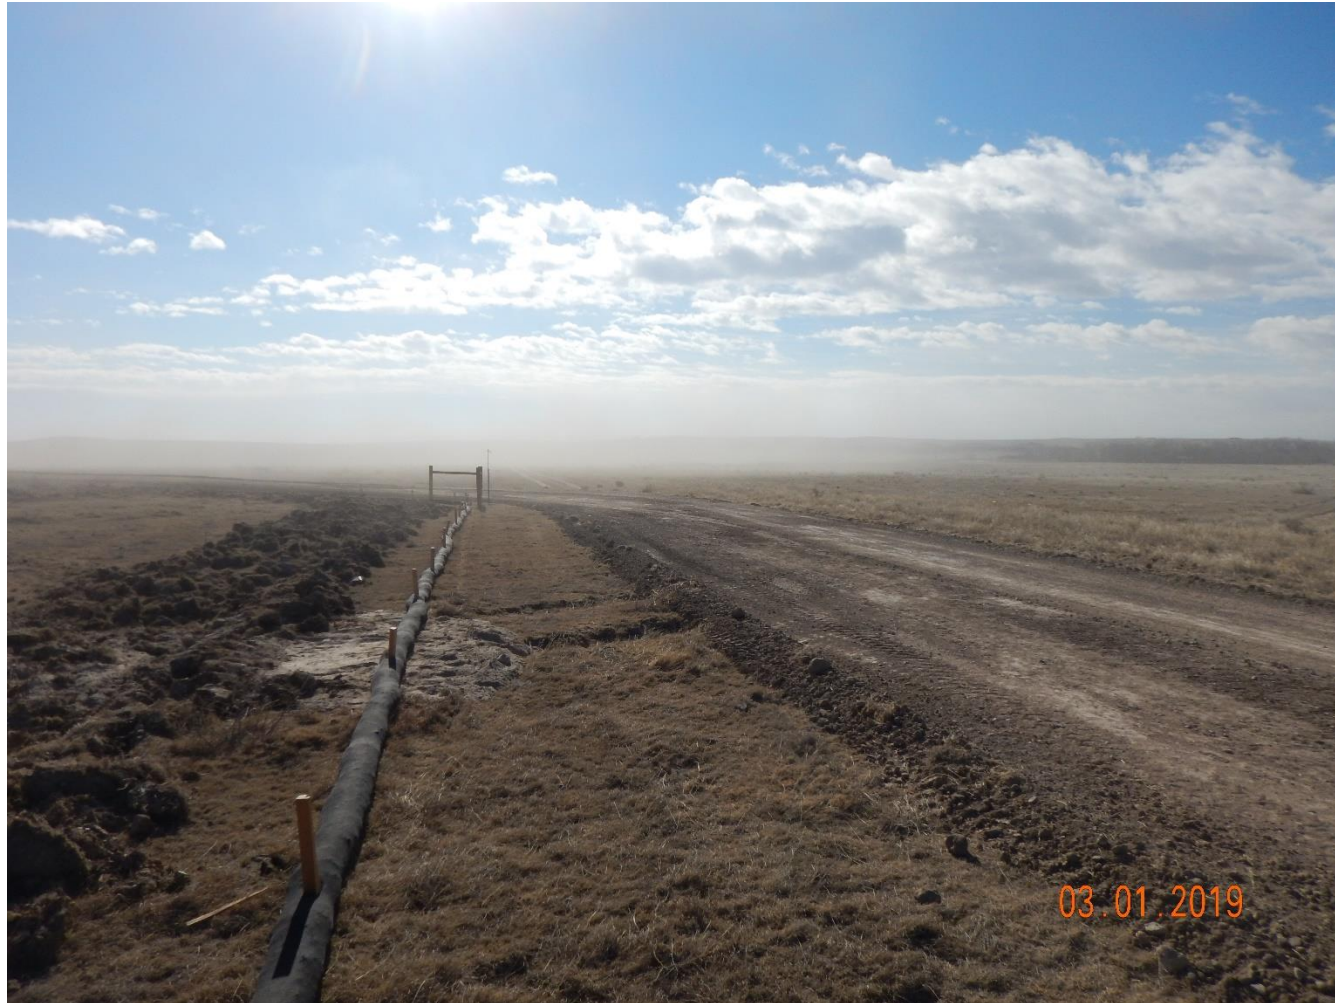
Photo 5: Photo taken from the south end of the location, facing southeast. Photo shows ongoing wind erosion degradation transporting sediment off of the location.

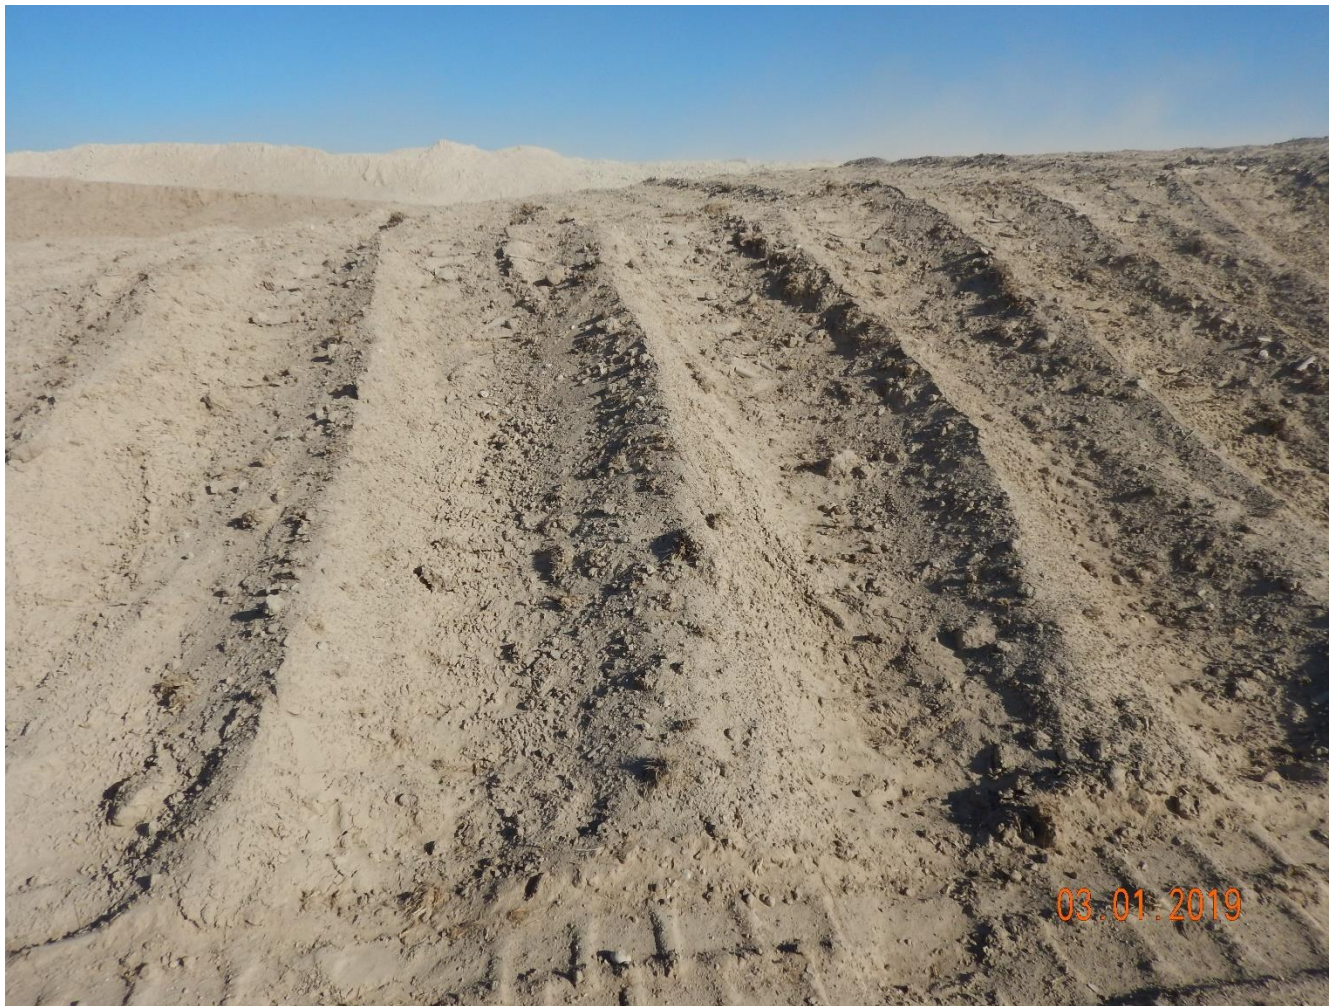
Photo 6: Photo taken from the soil stockpile on the south end of the location. Previous inspection required operator to install BMPs to stabilize the soil stockpiles on location in accordance with 1002.f and 1002.c. Photo shows soil stockpile remains insufficiently stabilized with loose material. Active wind erosion degradation and sediment transport off location occurring on location and soil stockpiles.

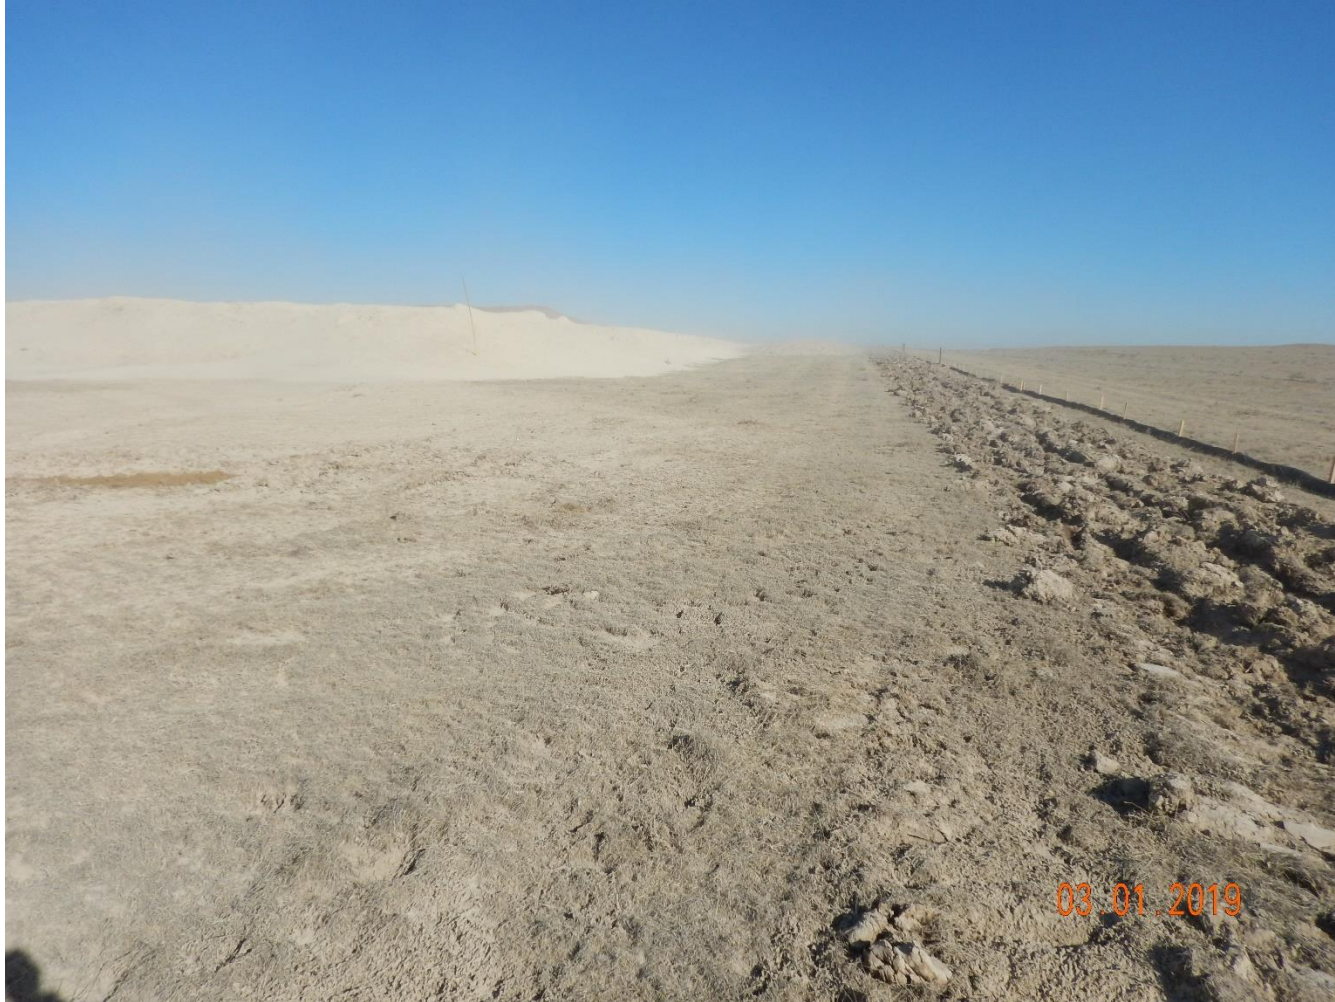
Photo 7: Photo taken from the southeast end of the location, facing north. Photo shows ongoing wind erosion degradation transporting sediment off of the location and soil stockpiles.

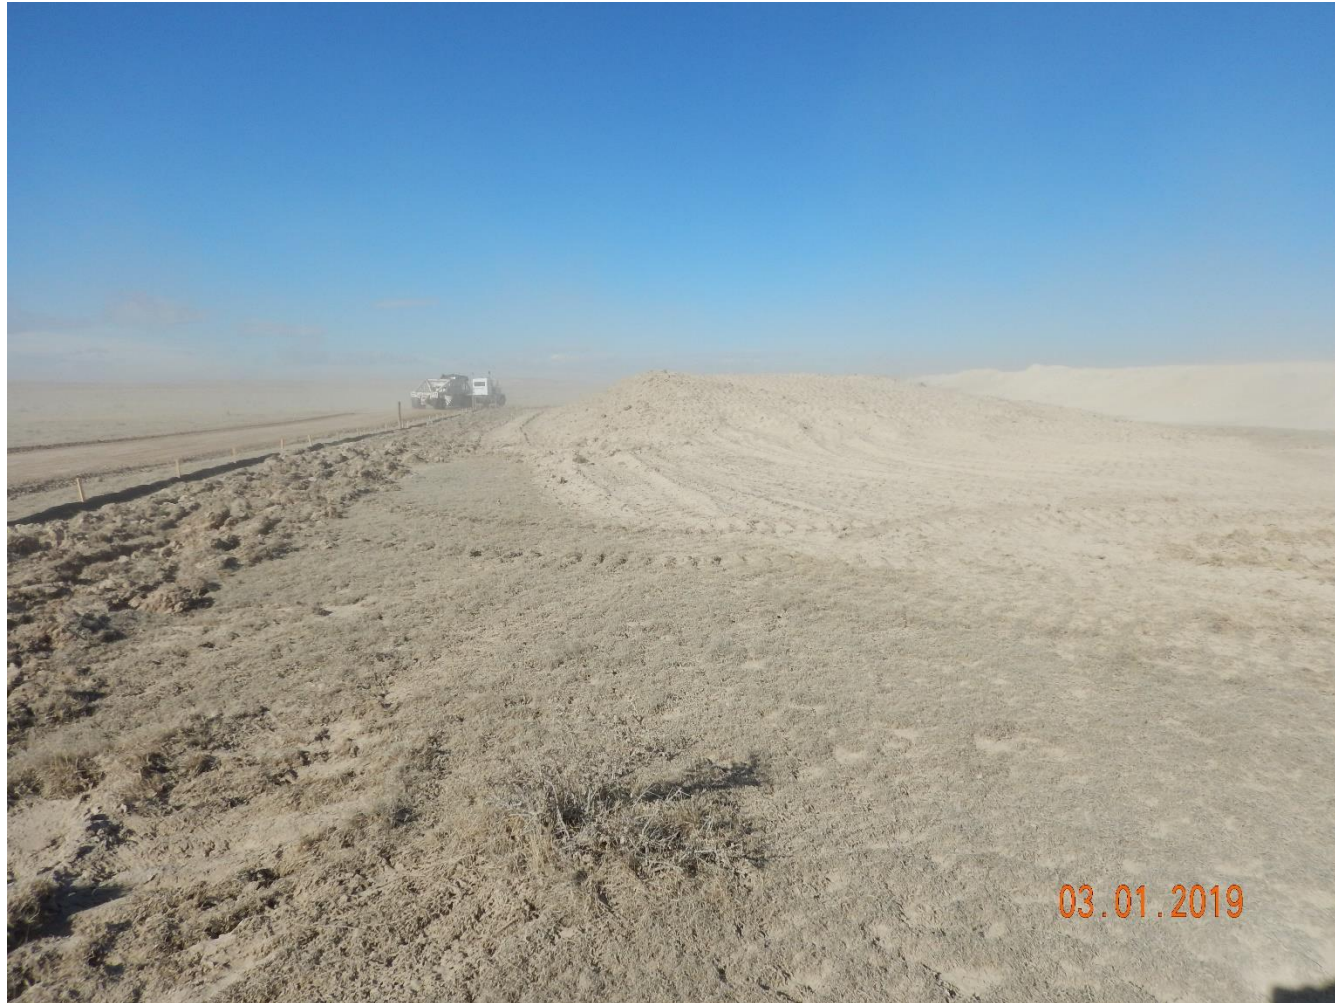
Photo 8: Photo taken from the southeast end of the location, facing west. Photo shows ongoing wind erosion degradation transporting sediment off of the location and soil stockpiles.

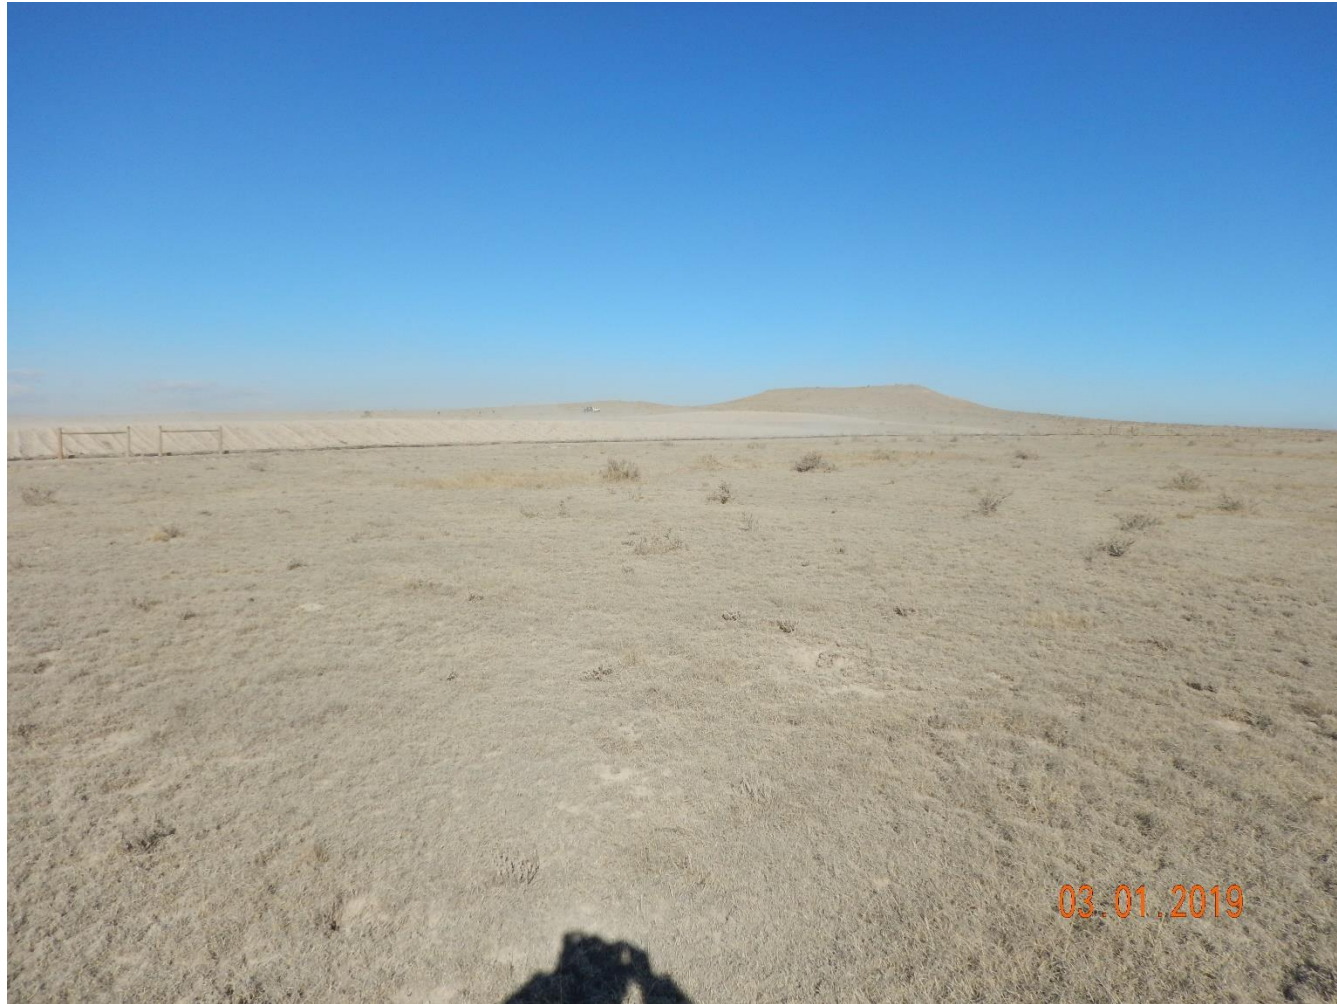
Photo 9: Photo taken from east of the location, facing northwest. Photo shows ongoing wind erosion degradation transporting sediment off of the location and soil stockpiles.

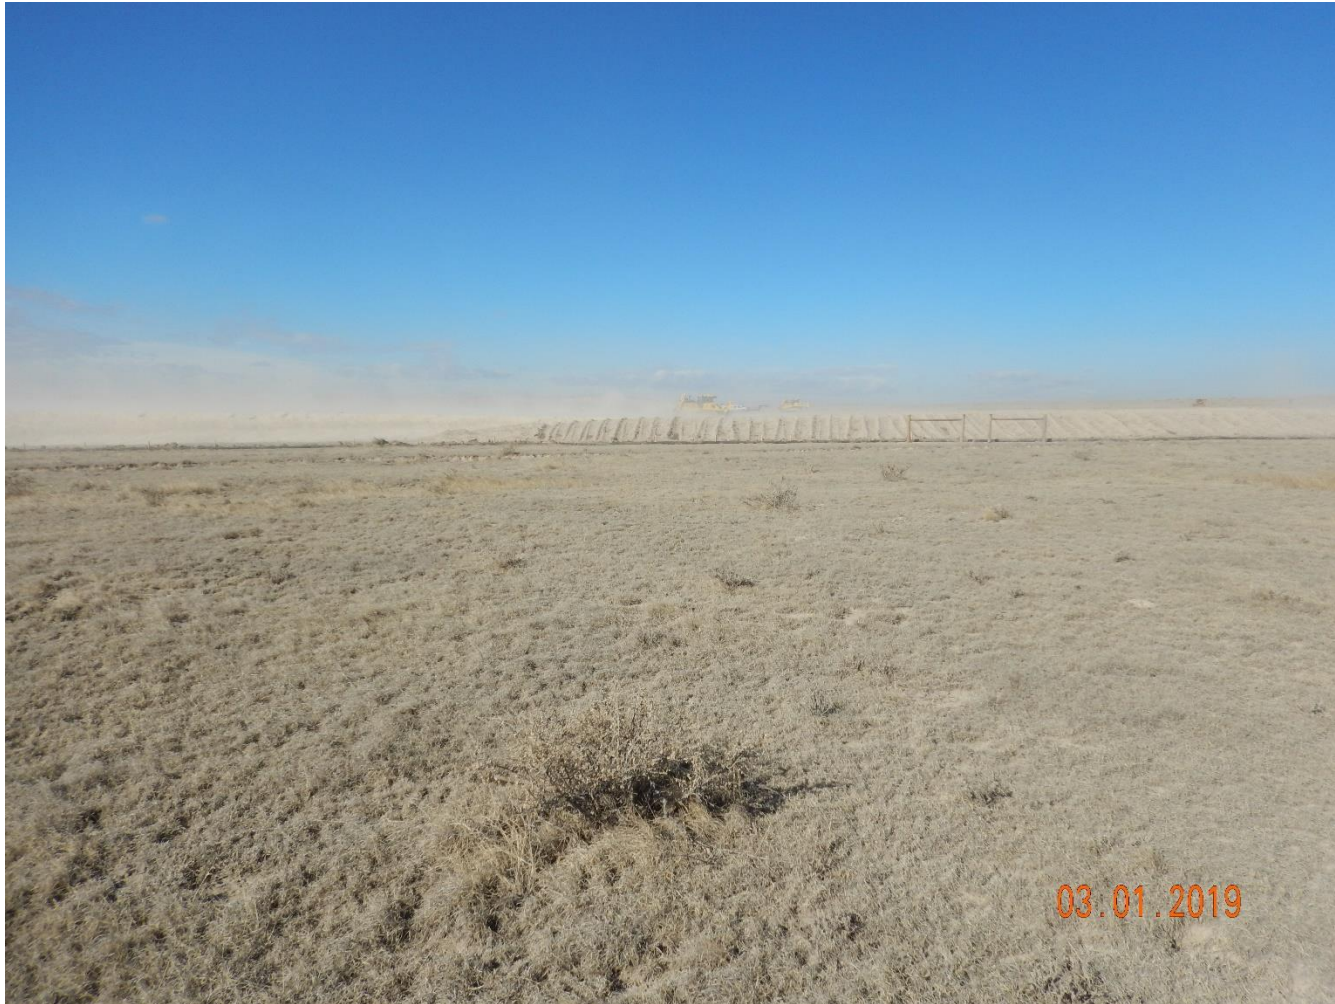
Photo 10: Photo taken from east of the location, facing west. Photo shows ongoing wind erosion degradation transporting sediment off of the location and soil stockpiles.

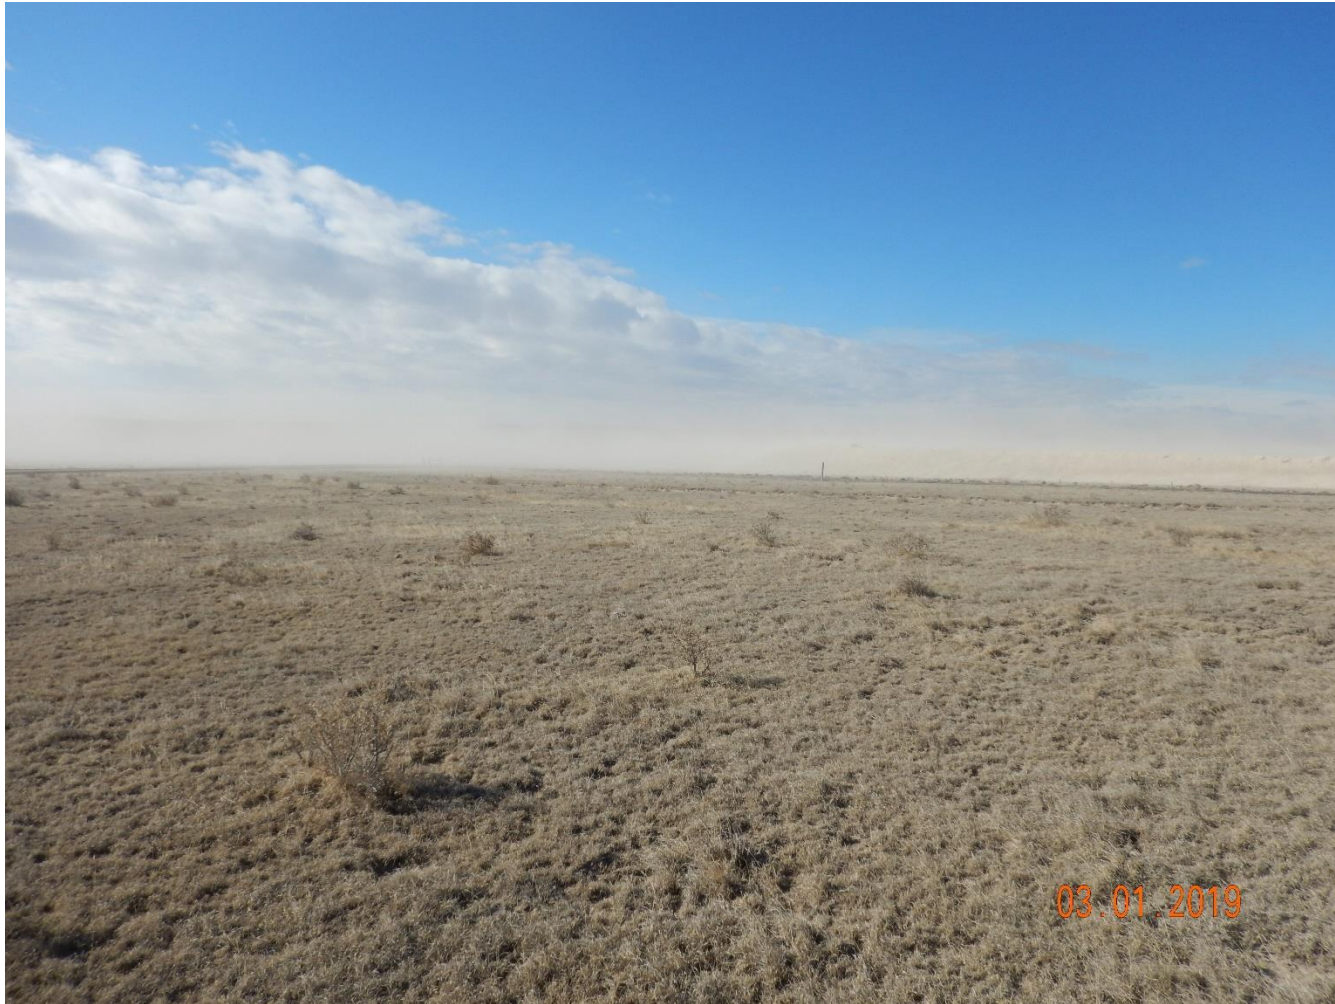
Photo 11: Photo taken from east of the location, facing southwest. Photo shows ongoing wind erosion degradation transporting sediment off of the location and soil stockpiles.

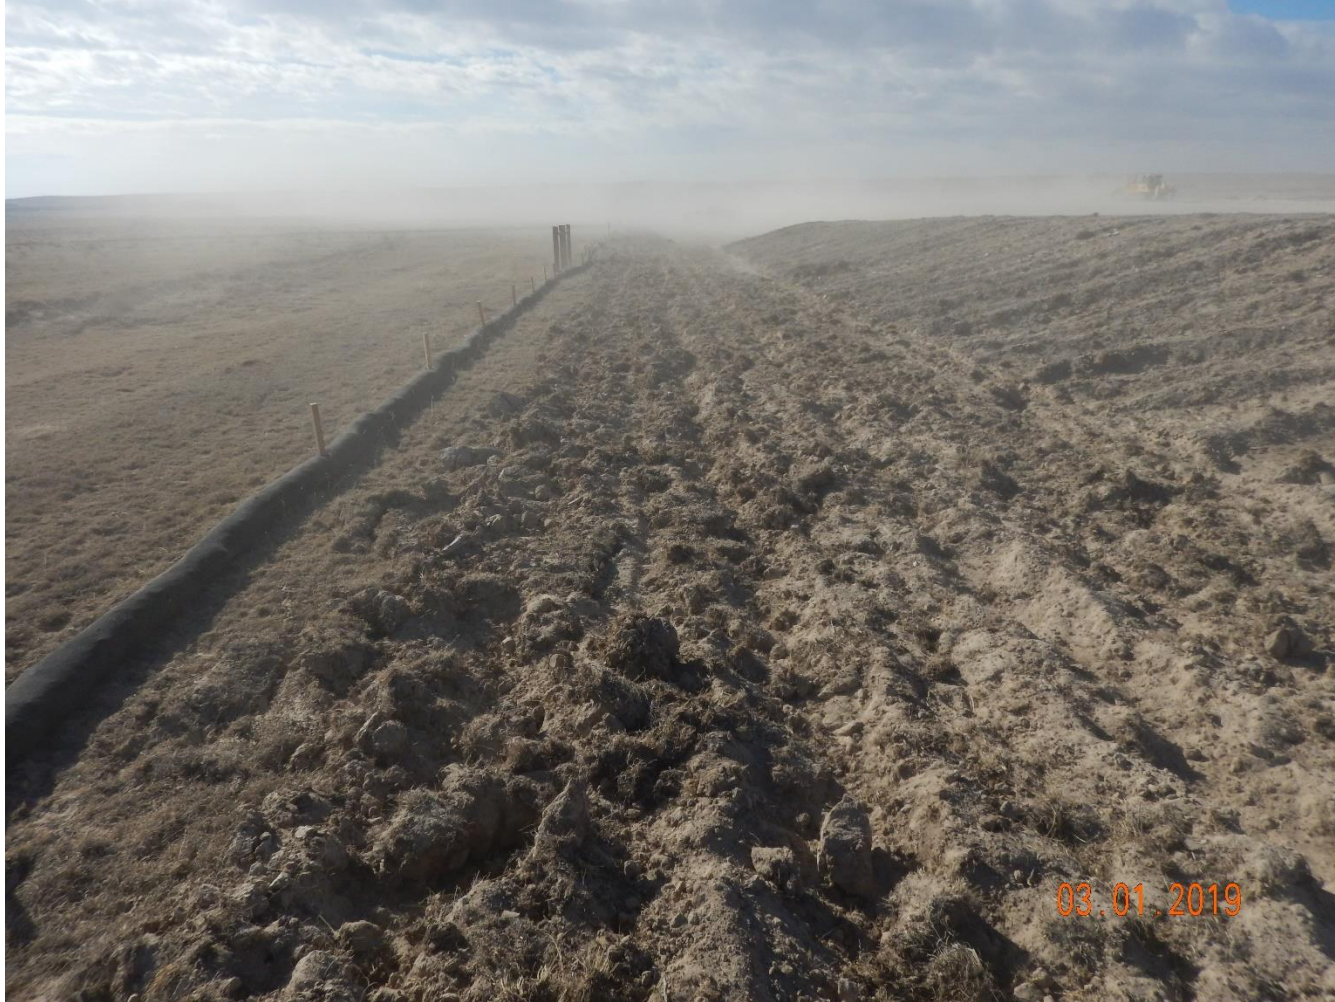
Photo 12: Photo taken from the east end of the location. Photo shows operator appears to have conducted maintenance on the surface roughening BMP per corrective actions. Photo also shows ongoing wind erosion degradation transporting sediment off of the location and soil stockpiles.

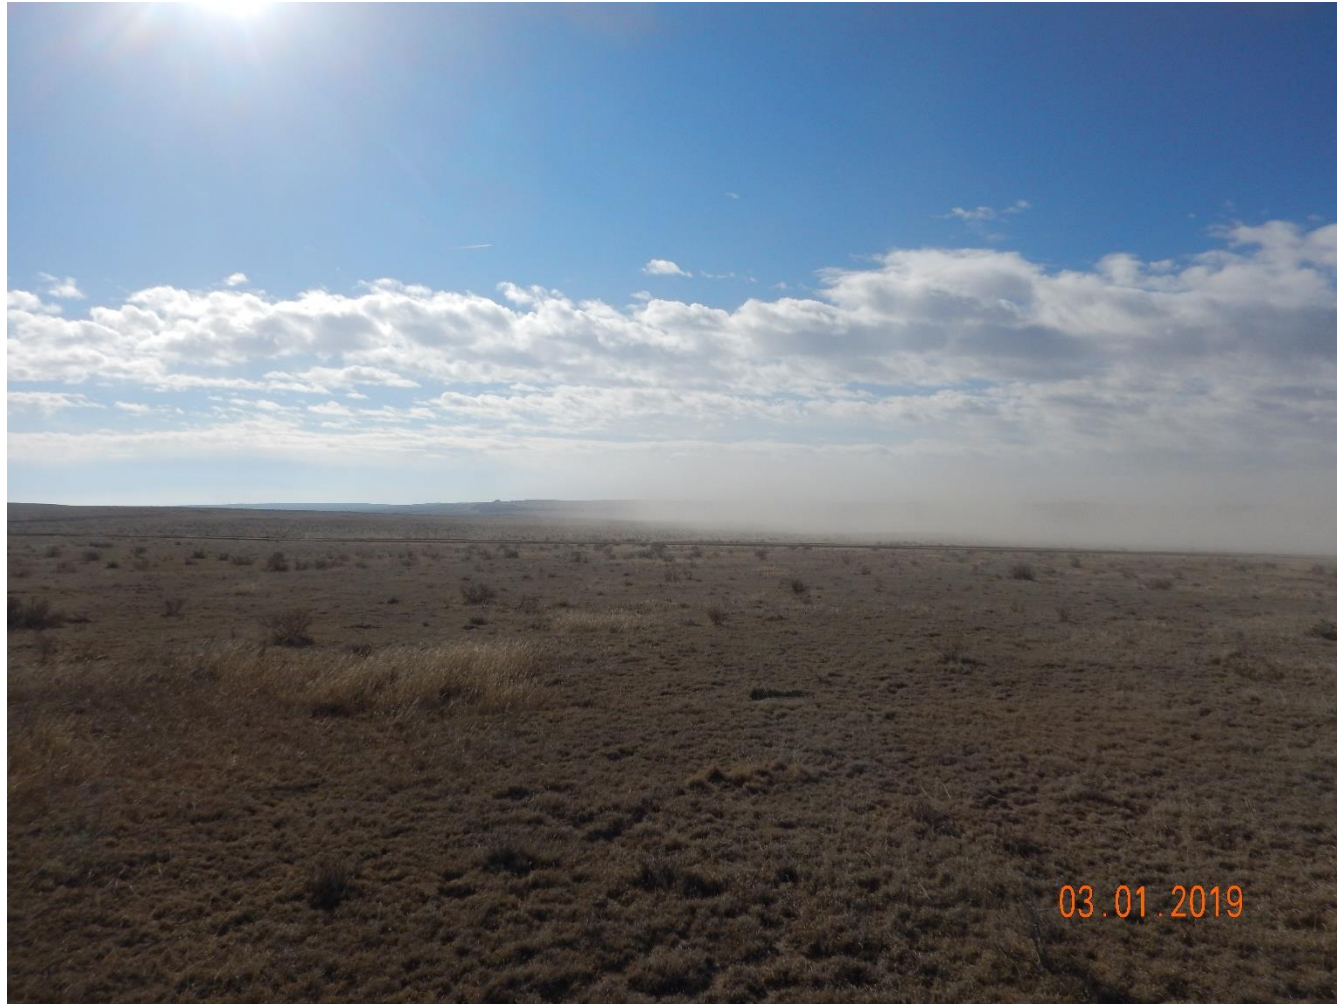
Photo 13: Photo taken from the east of the location, facing southeast. Photo shows ongoing wind erosion degradation transporting sediment off of the location and soil stockpiles.

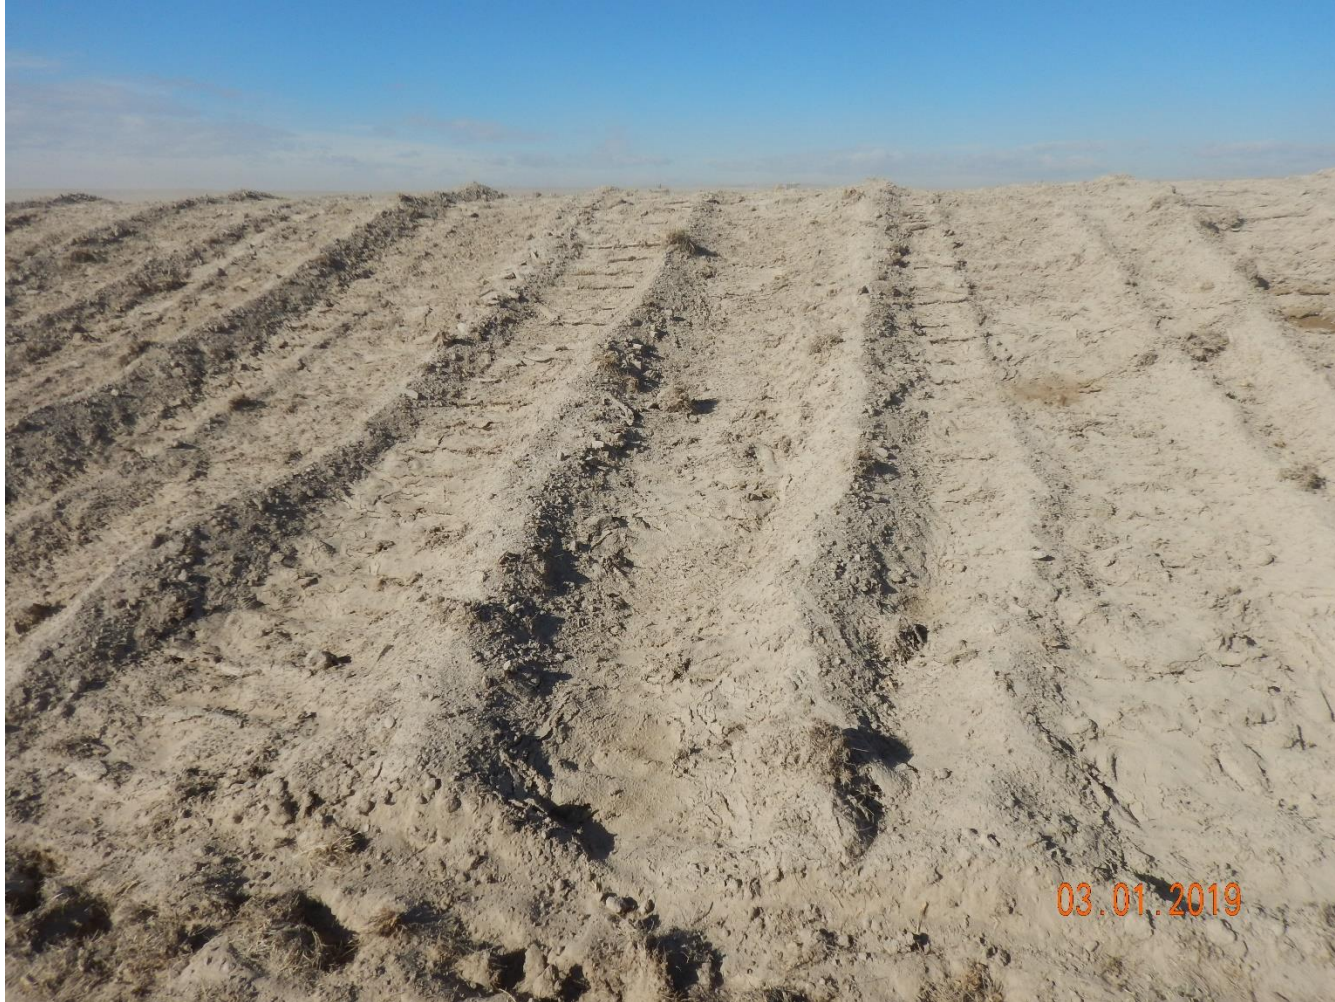
Photo 14: Photo taken from the soil stockpile on the east end of the location. See comments under photo 6.

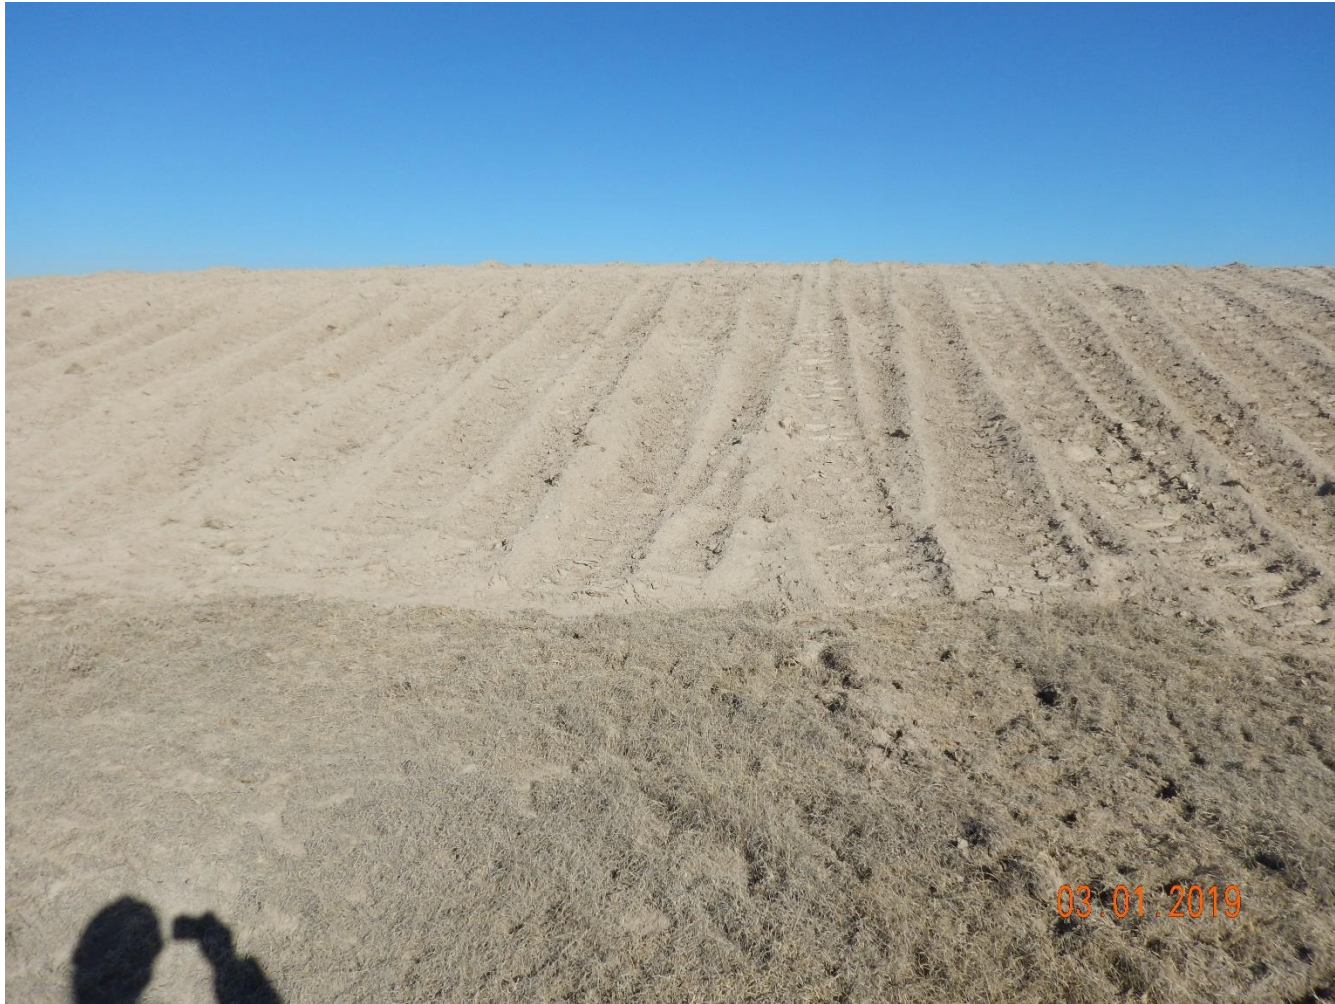
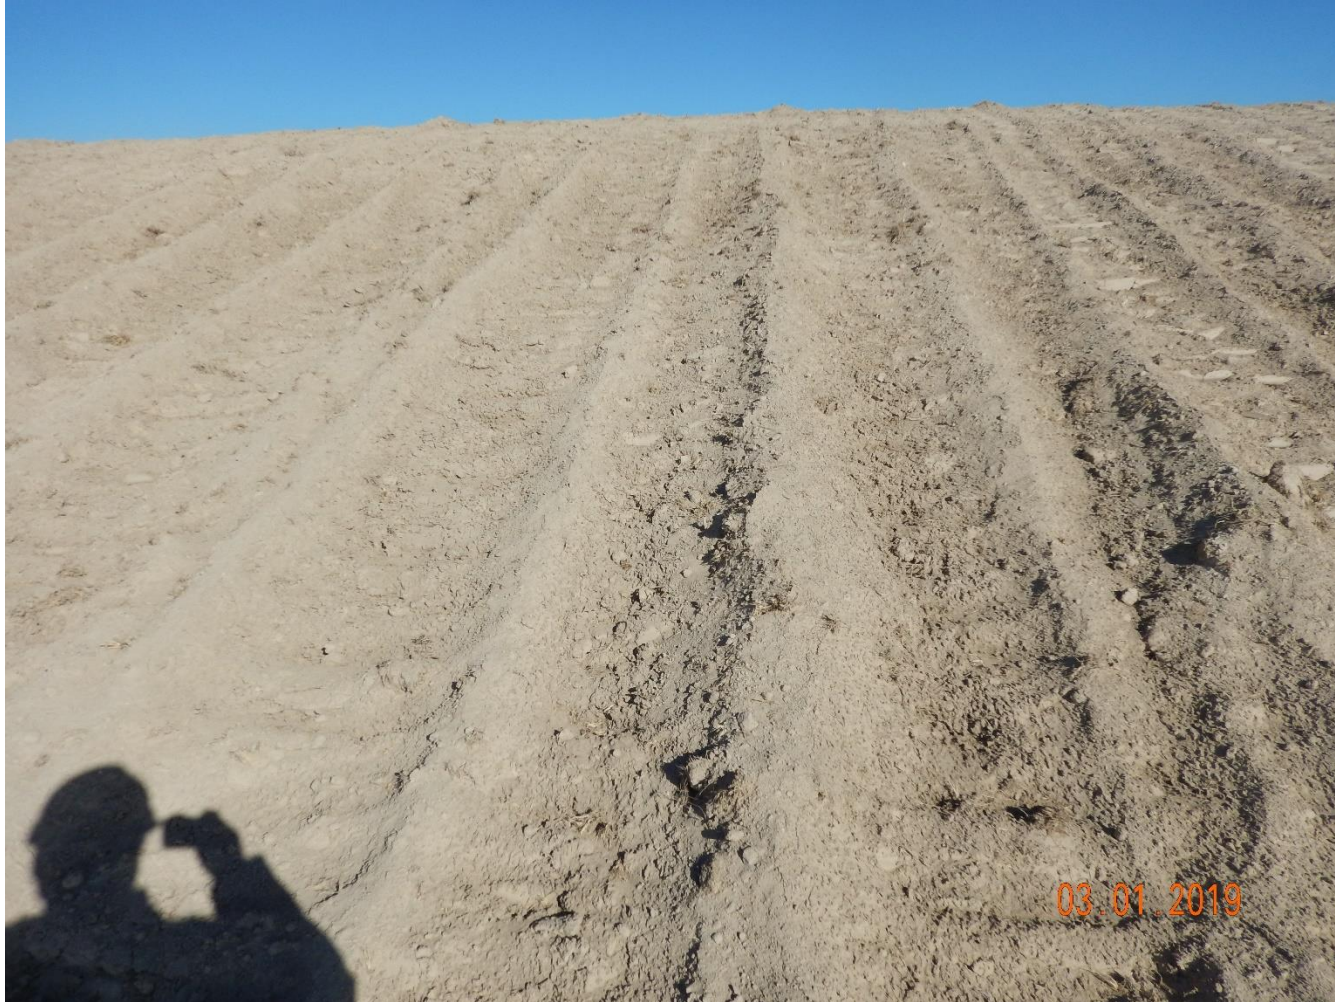
Photo 15: Photo taken from the soil stockpile on the north end of the location. See comments under photo 6.

Photo 16: Continued from photo 15.
