Inspection Photos

Operator: NOBLE ENERGY INC - 100322

Location ID: 460414

Weld County, CO

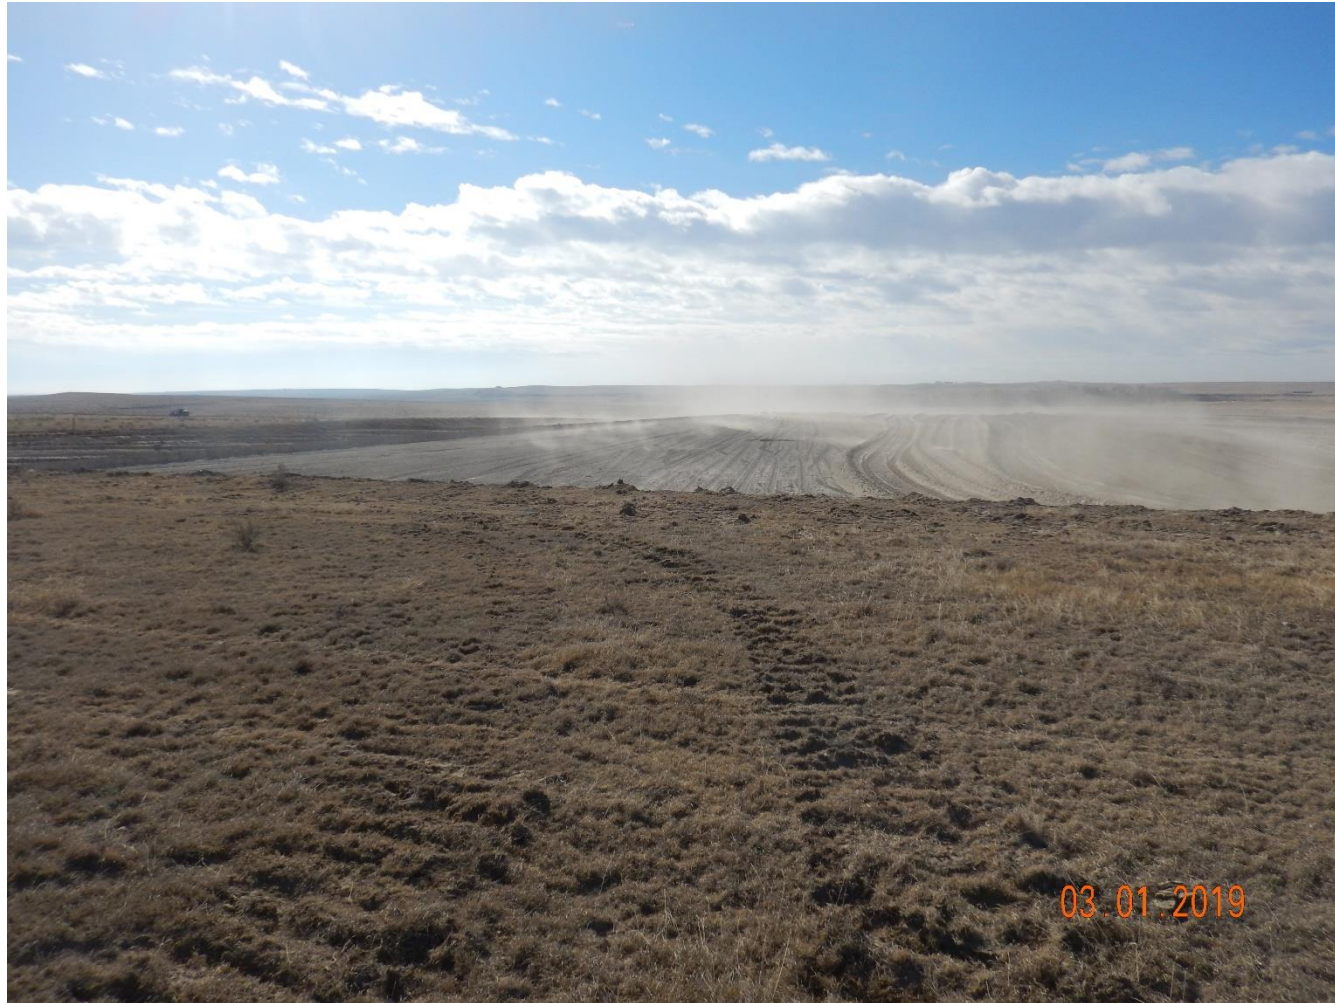
Photo 17: Photo taken from north of the location, facing southeast. Photo shows ongoing wind erosion degradation transporting sediment off of the location and soil stockpiles.

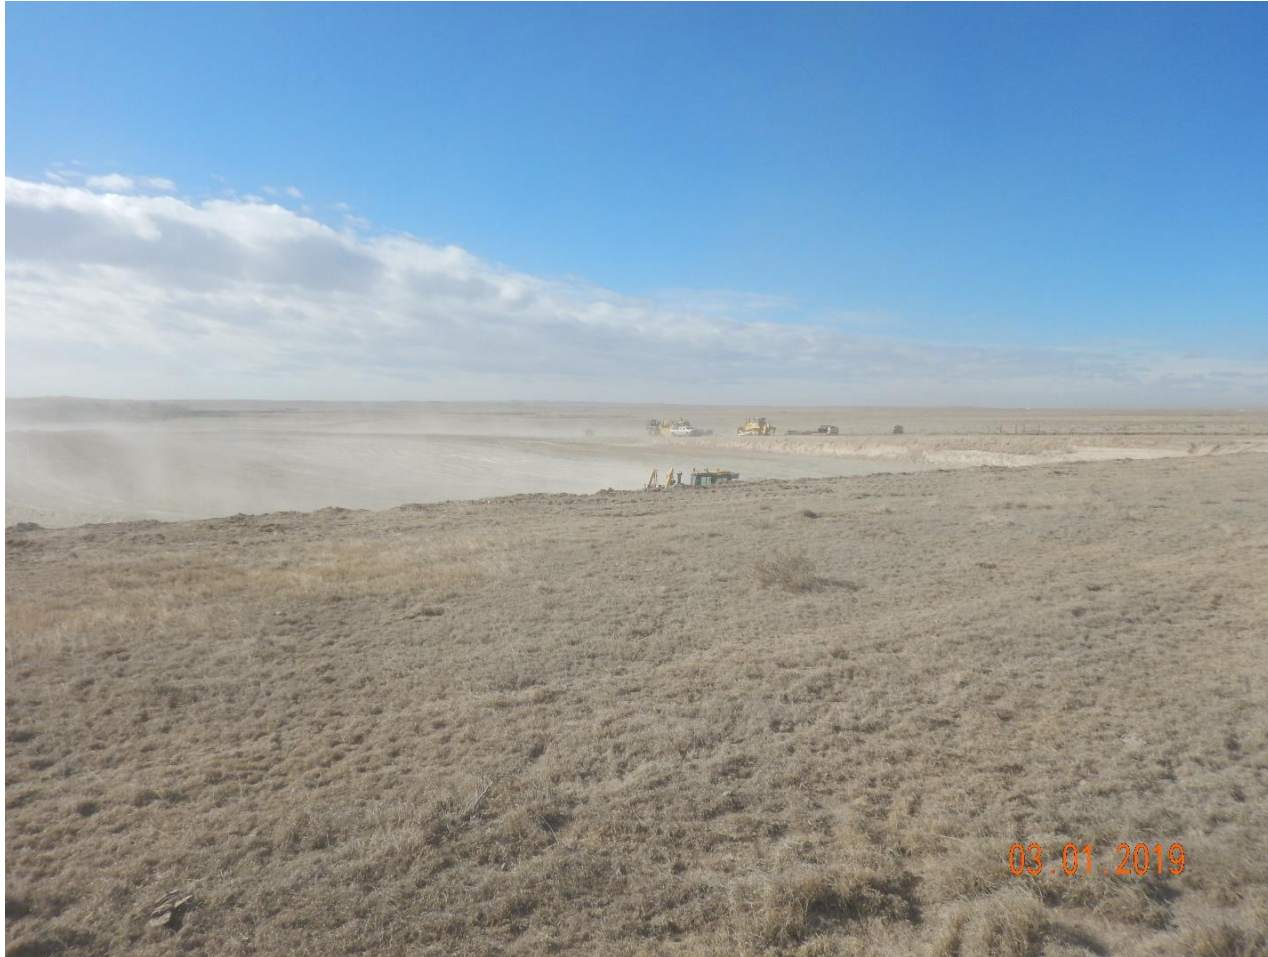
Photo 18: Photo taken from north of the location, facing southwest. Photo shows ongoing wind erosion degradation transporting sediment off of the location and soil stockpiles.

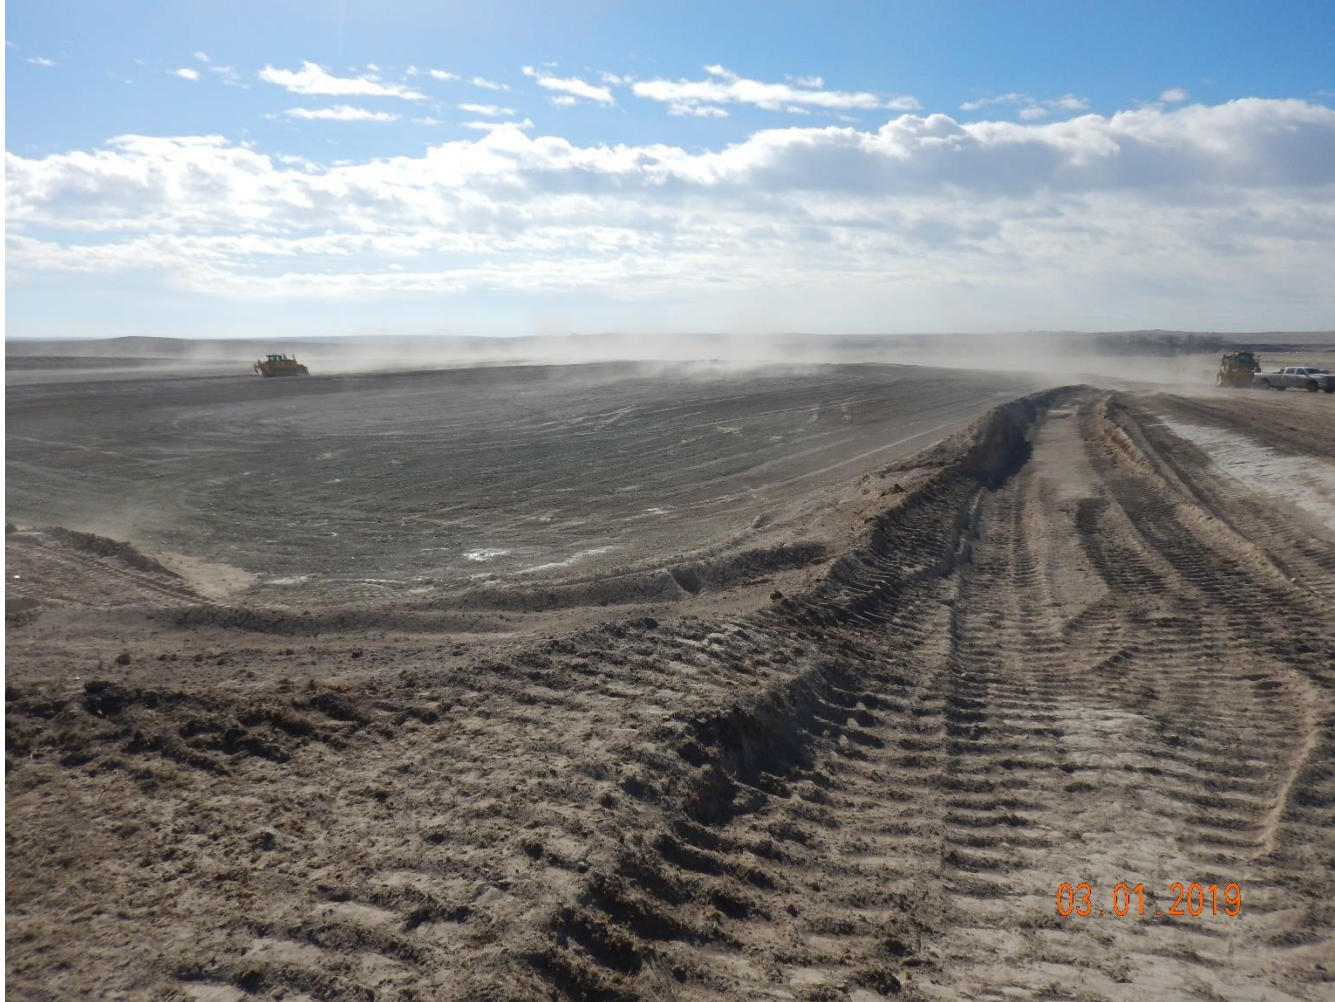
Photo 20: Photo taken from northwest corner of the location, facing southeast. Photo shows ongoing wind erosion degradation transporting sediment off of the location and soil stockpiles.

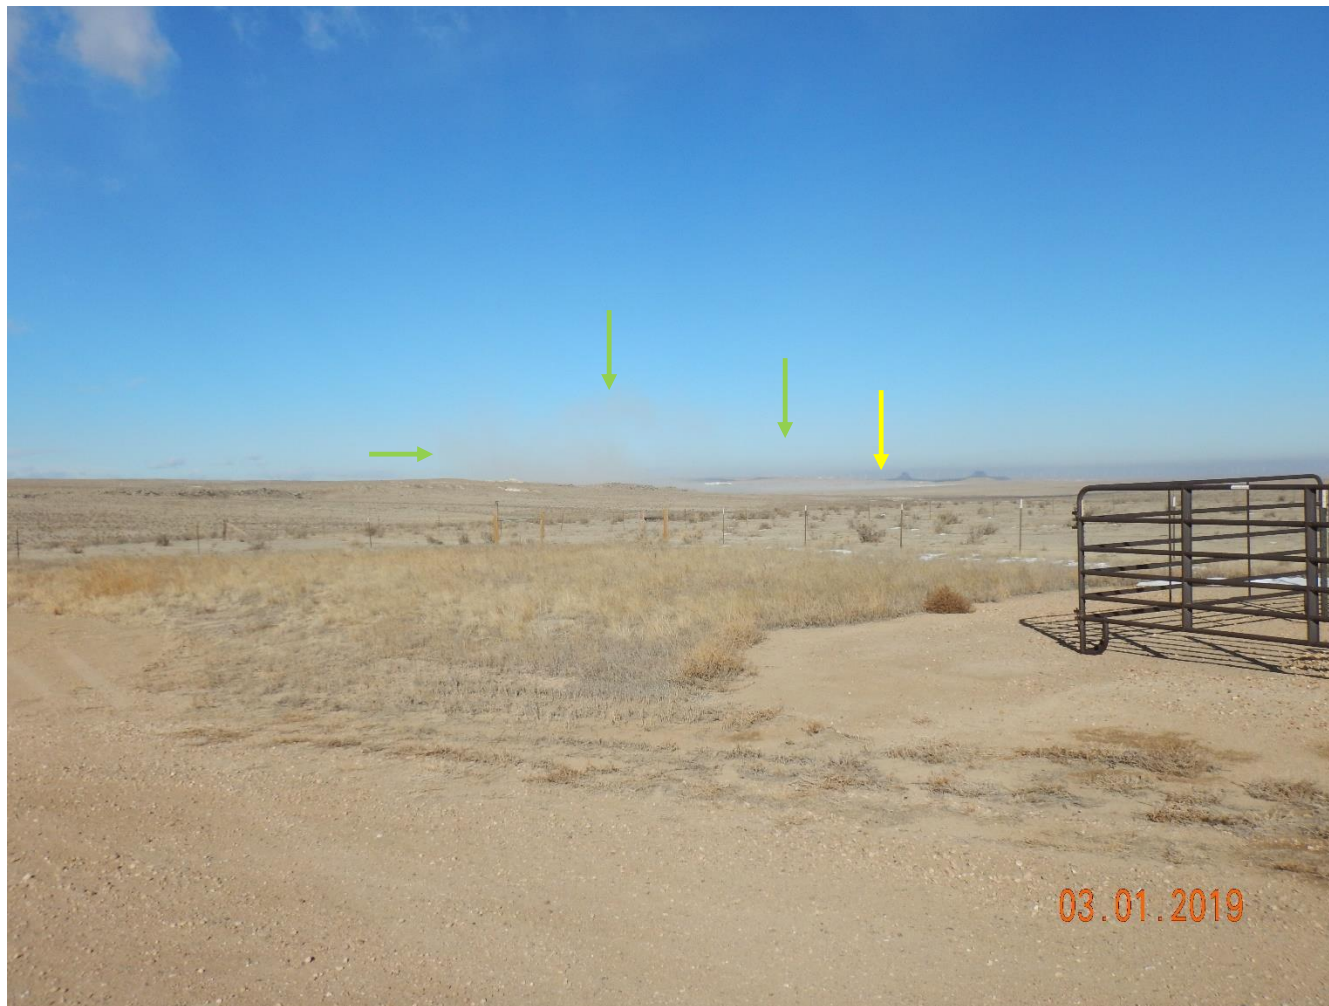
Photo 21: Photo taken from the north end of the [Shable LD #21-68HN](#) tank battery (123-36951), facing northwest towards the LD07-01 MULTI construction pad (yellow arrow). The Shable location is ~3 miles from the LD07 pad. Photo shows the dust cloud (green) due to wind erosion transporting sediment from the LD07 pad. Dust cloud appears to be several hundred feet in the area and is visible several miles from the location.

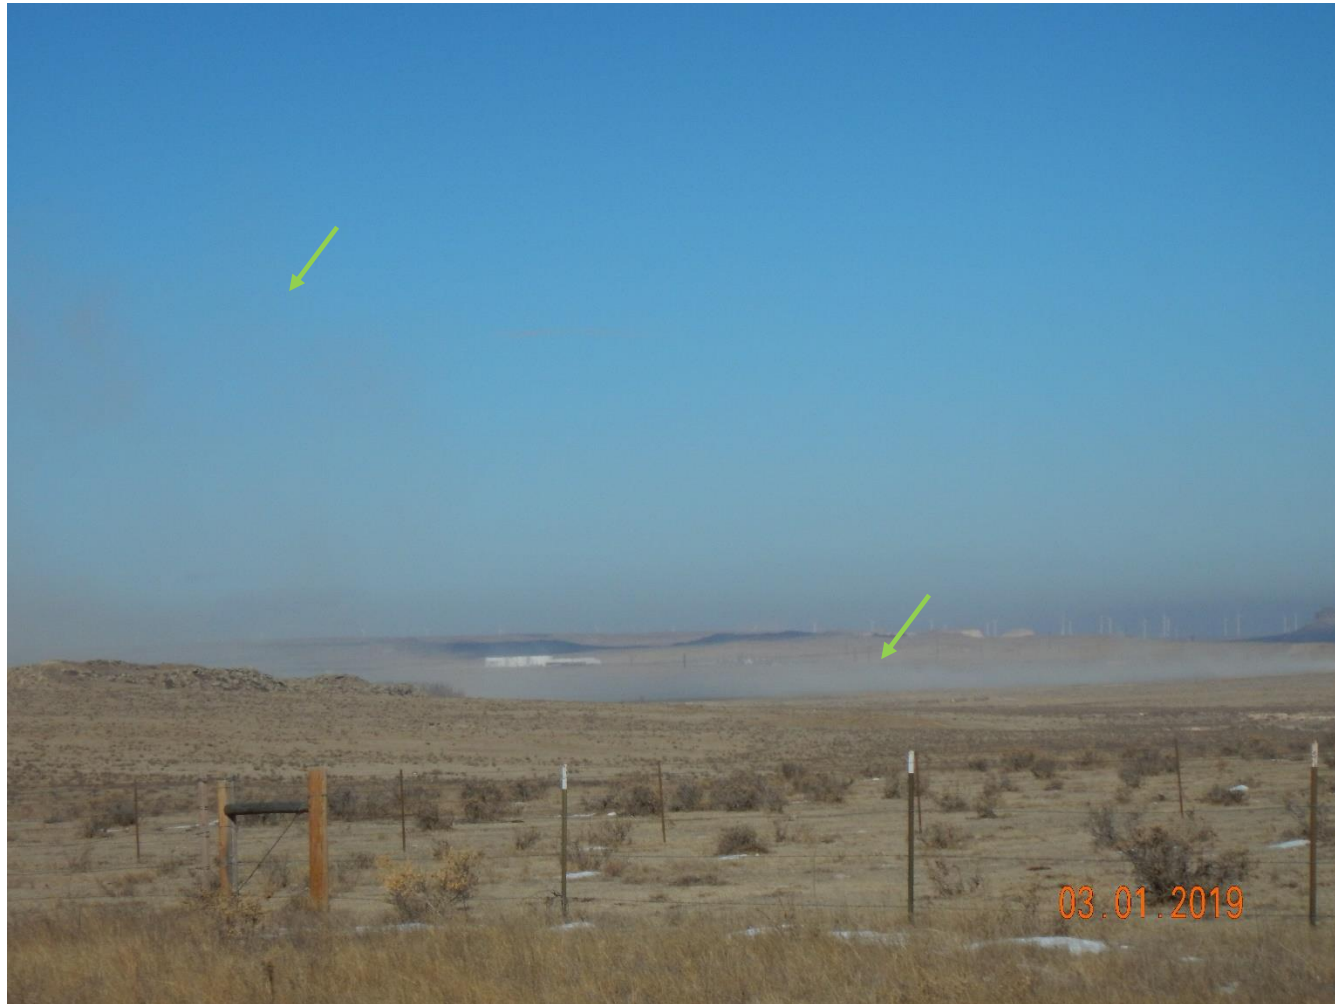
Photo 22: Continued from photo 21. Photo shows dust cloud (green arrow) and sediment transport from the LD07 pad.

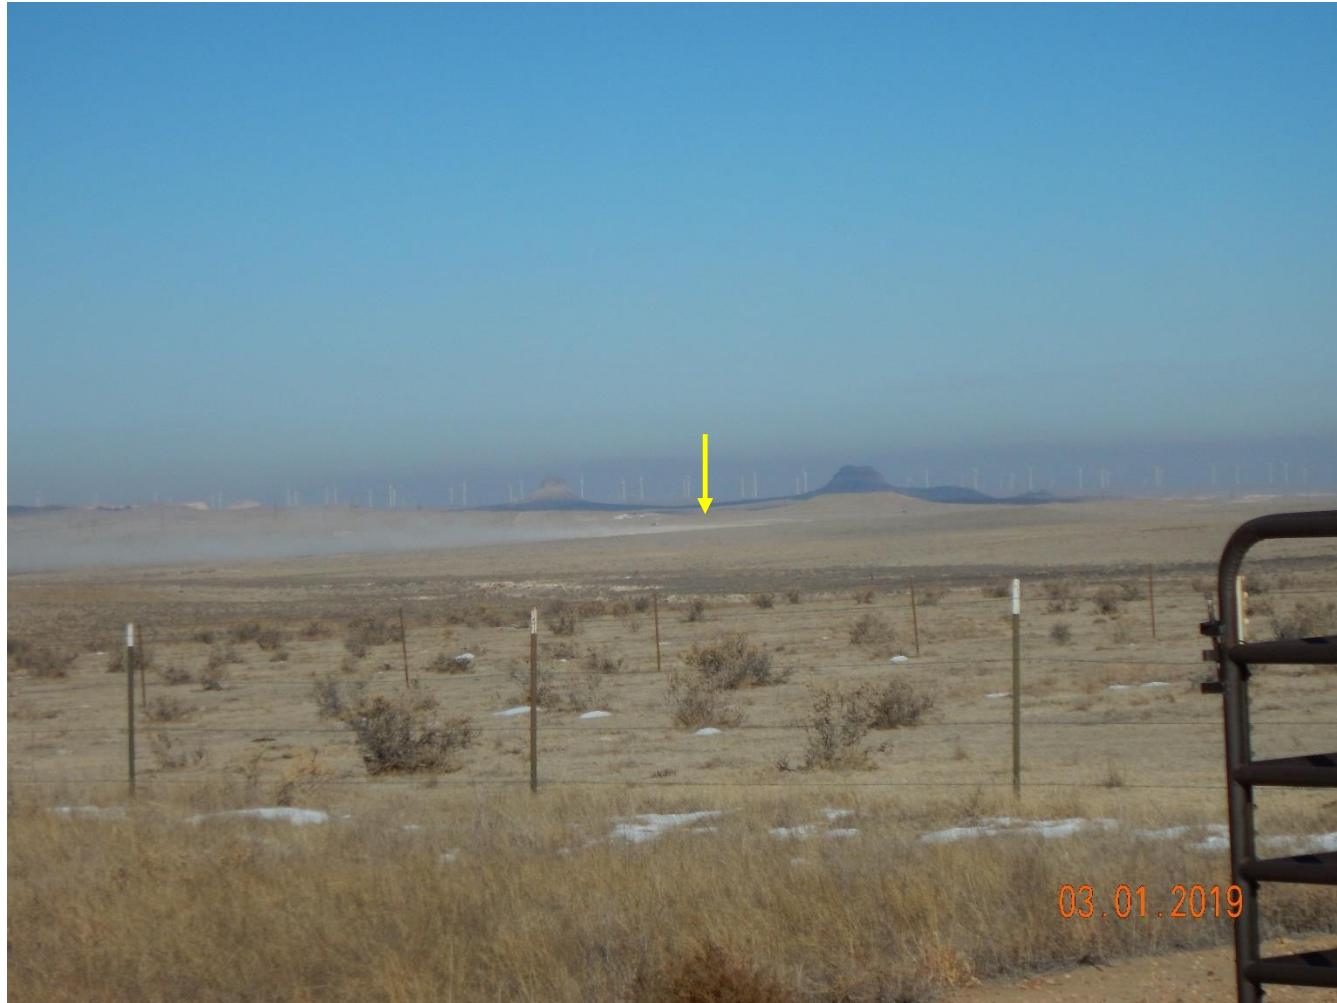
Photo 23: Continued from photo 21. Photo shows dust cloud and sediment transport from the LD07 pad (yellow arrow).
