# Construction and Stormwater Inspection

February 21, 2019

Operator: ENERPLUS RESOURCES (USA) CORPORATION - #10177

Inspection Photos  
Location Name: Alberta Cities East Pad  
Location ID: 455319

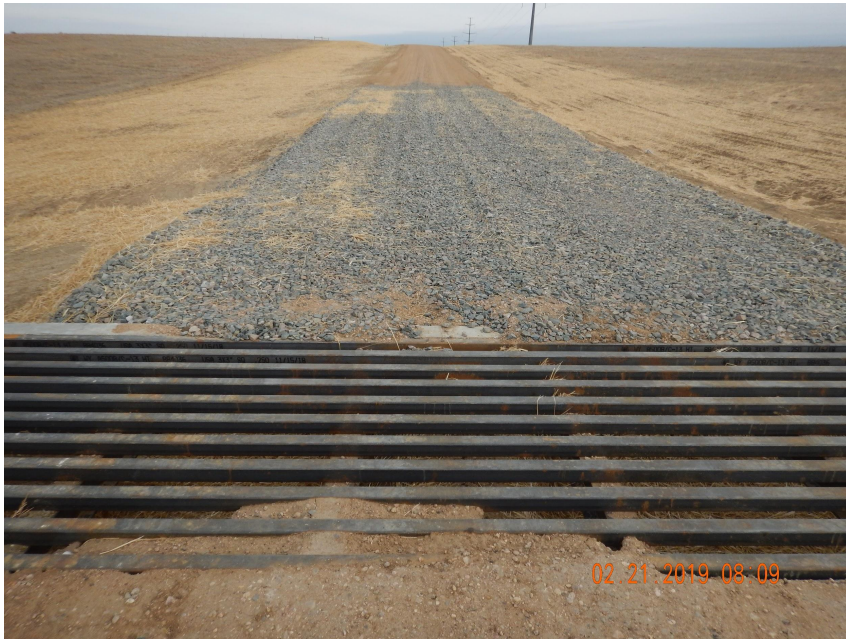
**Photo 1.** Photo taken from the entrance of location, facing North. Photo illustrates a tracking device BMP that appears to be in proper function condition and the outer perimeter of the access road has seeded and straw crimped with mulch.

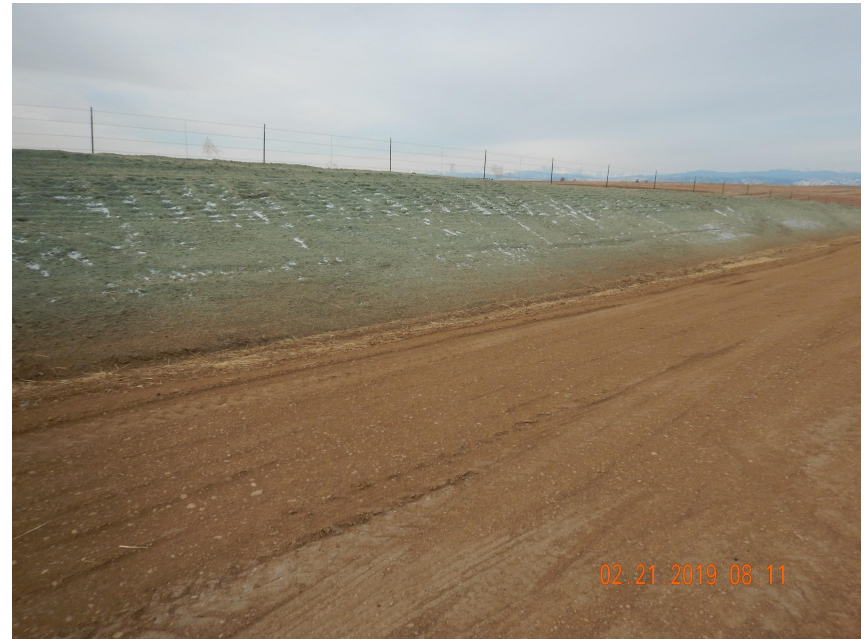
**Photo 2.** Photo taken from the southern location, facing West. Photo illustrates the cut slope has been temporarily stabilized with equipment tracking and hydromulch.

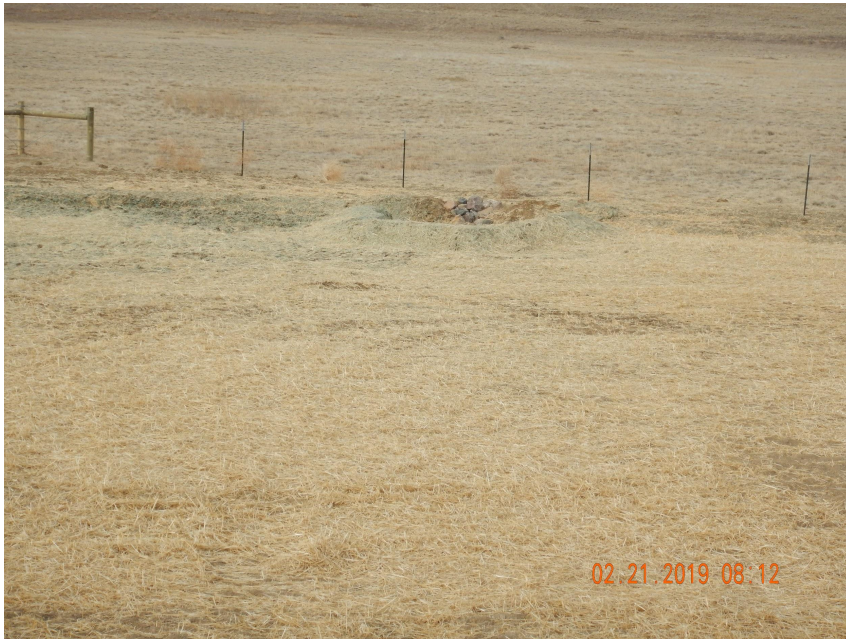
**Photo 3.** Photo taken from the southwestern perimeter of the location, facing West. Photo illustrates the western fill slope area has been seeded and straw crimped with mulch. The sediment trap is only for any runoff from the western fill slope area which includes the topsoil stockpile.

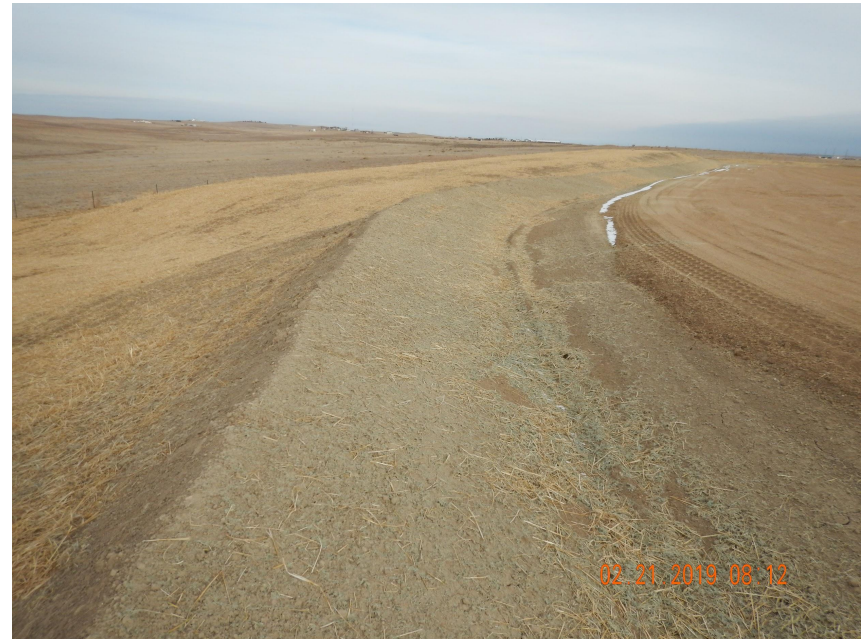
**Photo 4.** Photo taken from the southwestern well pad, facing North. Photo illustrates the ditch and berm has been temporarily stabilized with hydromulch. Also, photo illustrates the topsoil stockpile has been temporarily stabilized with equipment tracking, seeded and straw crimped with mulch.

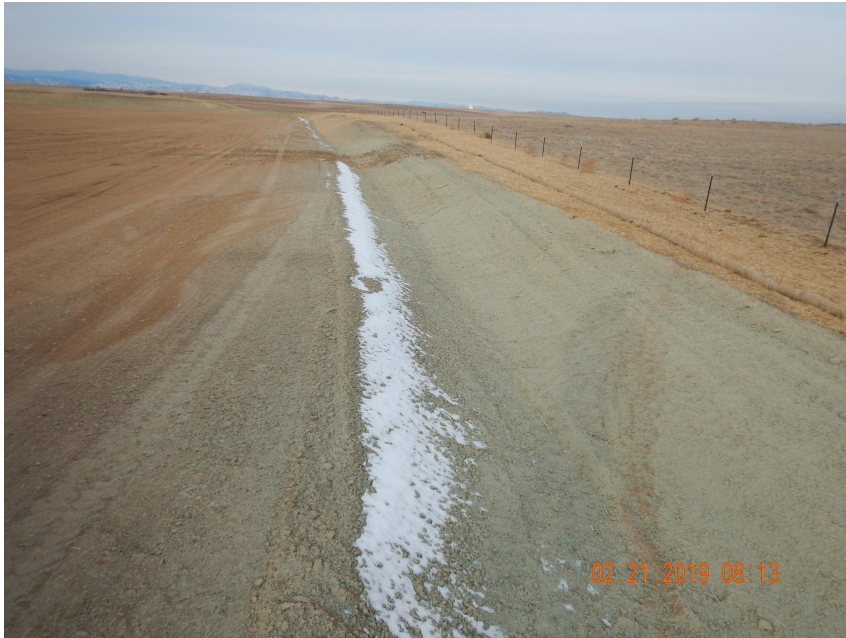
**Photo 5.** Photo taken from the northern well pad, facing West. See comments under Photo 4.

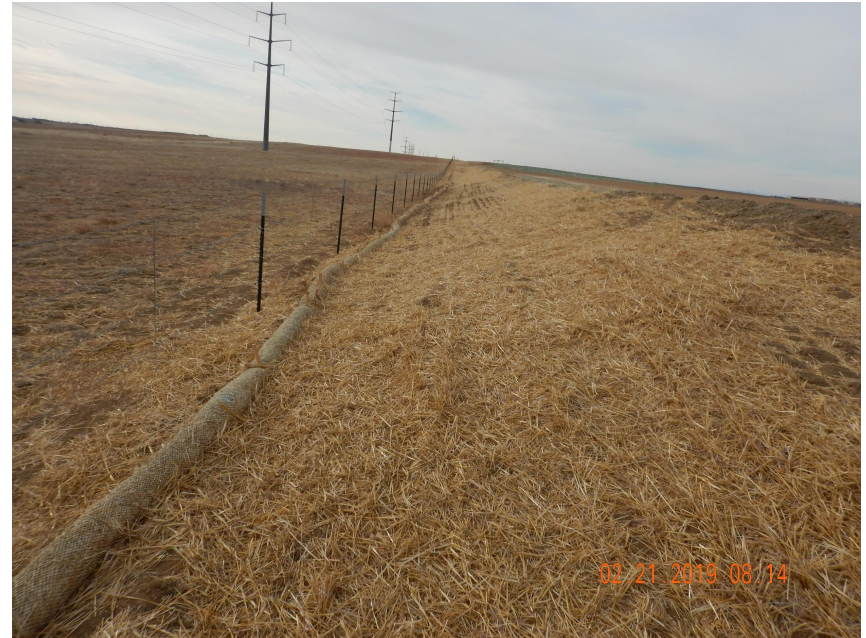
**Photo 6.** Photo taken from the northeastern perimeter of location, facing South. Photo illustrates the Operator performed the previous corrective action to properly install the straw wattle BMP.

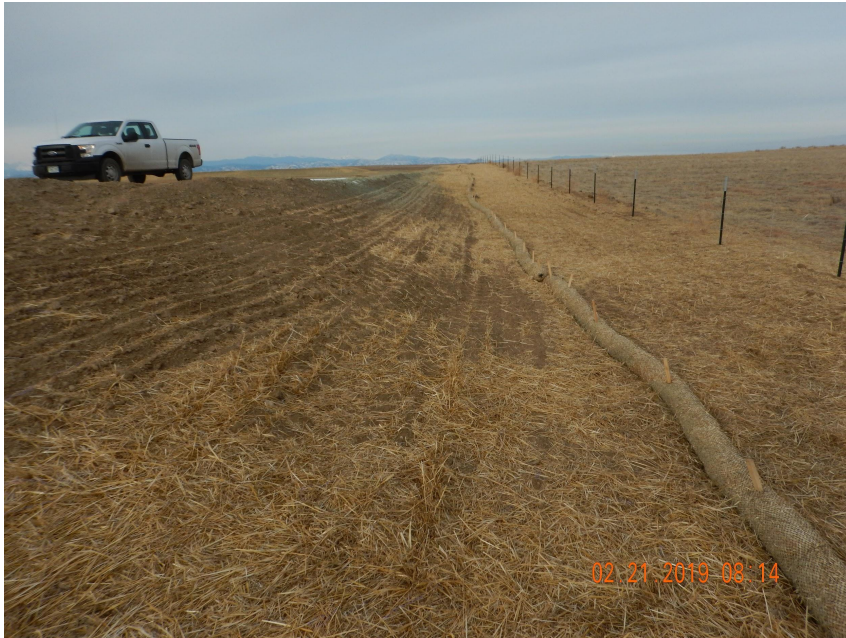
**Photo 7.** Photo taken from the northeastern perimeter of location, facing West. See comments under Photo 6.

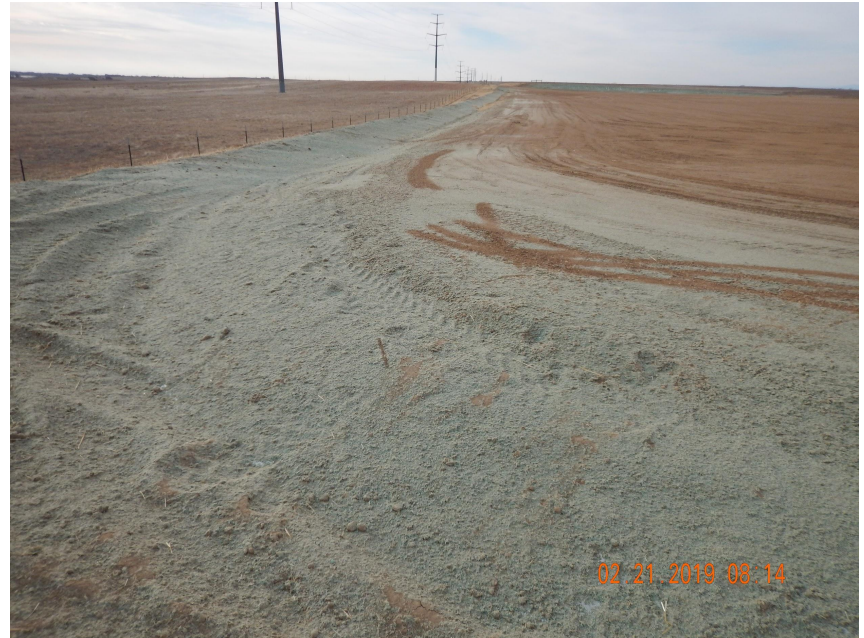
**Photo 8.** Photo taken from the northeastern well pad, facing South. See comments under Photo 4.
