**Response to February 27, 2019 Inspection
Document Number: 682504527**

COGCC conducted an inspection of the LD07-01 pad (Location ID 460414) on February 27, 2019 (Document 682504527) and submitted the inspection on February 28, 2019. During that inspection, COGCC made the following observations:

Name: LD07-01 Pad
Location ID: 460414

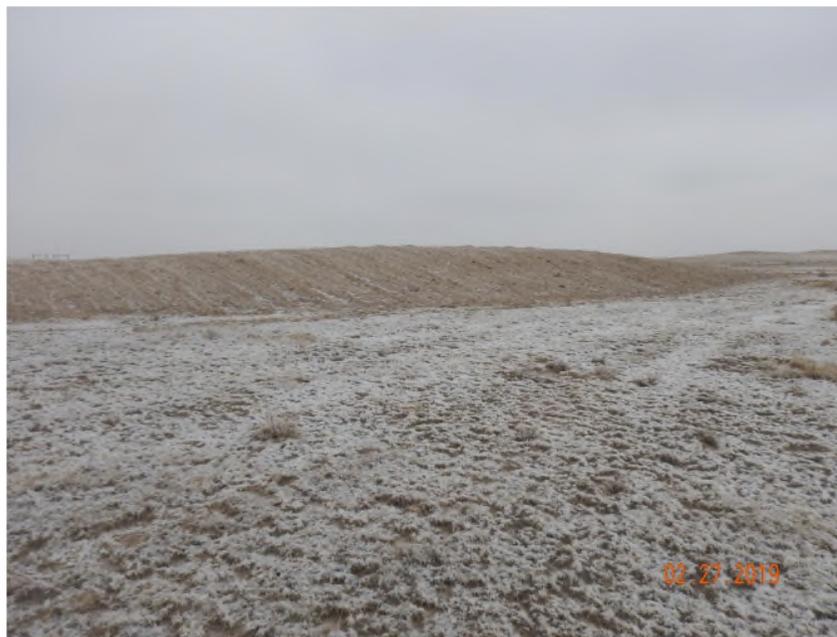
COGCC Photo 9. Photo taken from the north end of the disturbance area, facing northeast. Photo shows soil stockpile.

This photo was called out in the corrective action as one that documents that tracking was insufficient. From this distance, marks from tracking efforts are visible and the stockpile appears to be well-maintained.

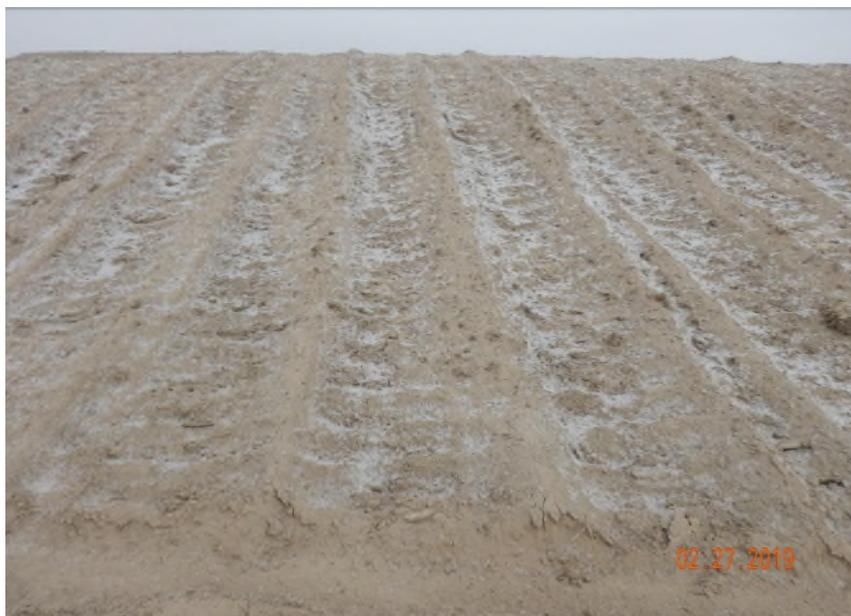
COGCC Photo 10. Continued from photo 9. Photo shows operator appears to have attempted to track the soil stockpile. Photo shows tracking does not appear to have been adequate as soils have not been sufficiently stabilized and remain loose material at risk to erosion degradation.

The inspector has indicated that tracking does not appear to be sufficient. This photo shows the individual rows and treadmarks from the vehicle tracks, indicating the tracking was properly done and that the tracking is sufficient to mitigate erosion. Noble will continue to evaluate and maintain tracking, as needed.

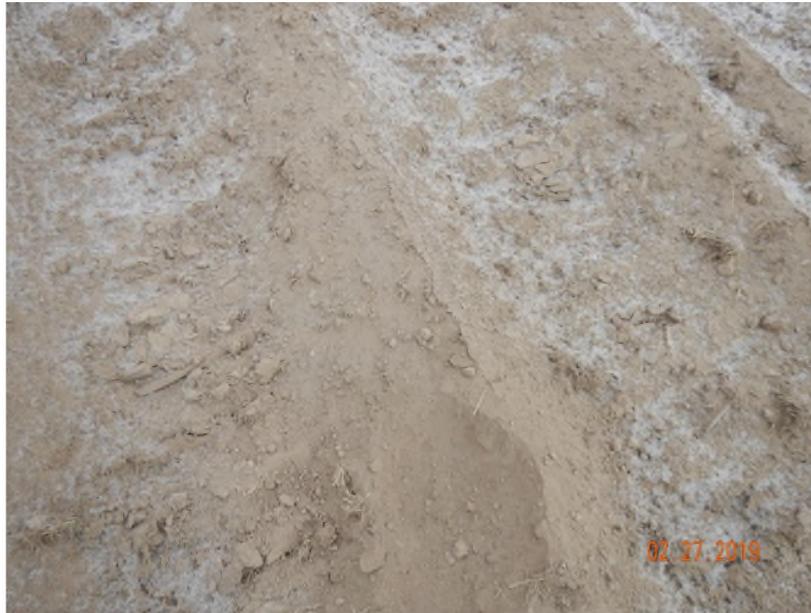
COGCC Photo 11. Continued from Photo 11. Photo shows tracking does not appear to have been adequate as soils have not been sufficiently stabilized and remain loose material at risk to erosion degradation.

This photo appears to show a boot mark in the tracked stockpile. Noble strives to achieve sufficient, compliant, and effective stormwater BMPs. In the context of COGCC photos 9, 10, and 12, the tracking appears to be effective and well maintained. The tracking, along with other site BMPs, appear to be mitigating erosion.

Noble attempts to maintain effective and compliant BMPs regardless of the level of activity on location. The loose soil noted in this photo (COGCC photo 11) caused by an apparent boot print appears to be an isolated incident. The additional photos represent an otherwise well-maintained BMP (COGCC photos 10 and 12).

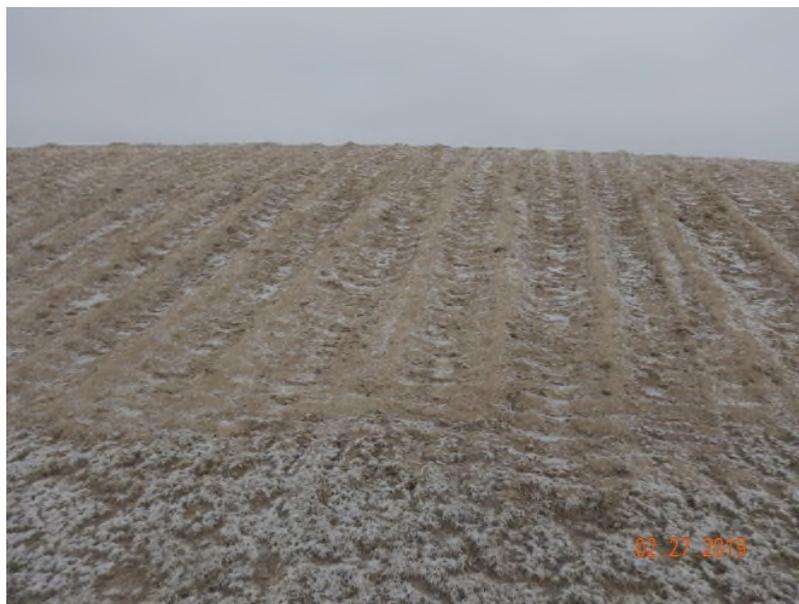
The inspector has indicated that tracking does not appear to be sufficient. This photo shows the individual rows and treadmarks from the vehicle tracks, indicating the tracking was properly done and that the tracking was sufficient to mitigate wind erosion. Noble will continue to evaluate and maintain tracking, as needed.

COGCC Photo 12. Continued from photo 10, see comments under photo 11.

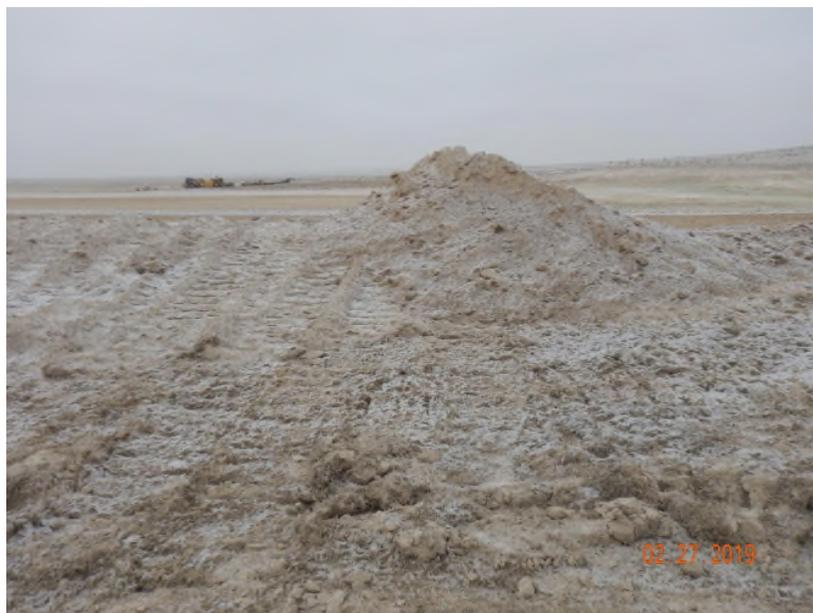
COGCC Photo 15. Photo taken from the soil stockpiles on the east end of the location. See comments under photo 10.

Noble has removed this soil stockpile and re-tracked this area.

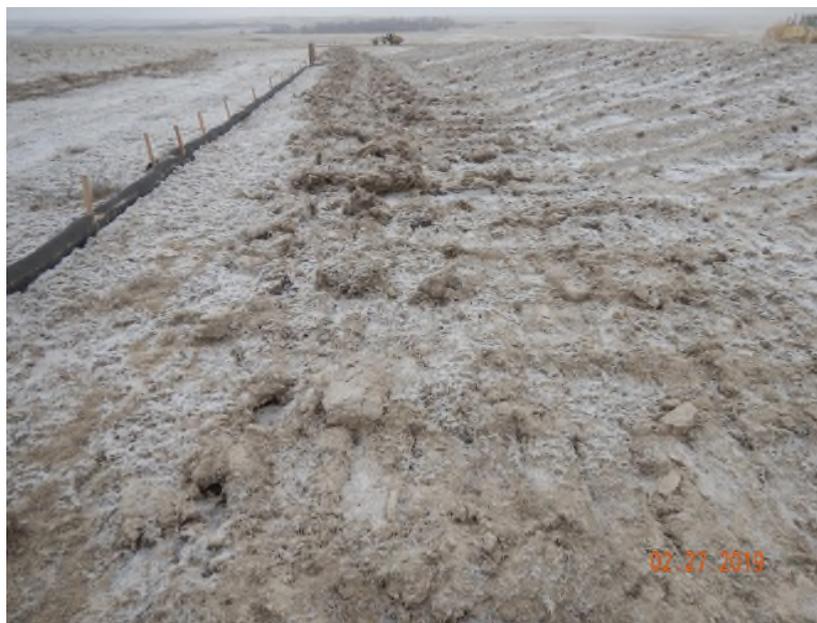
Stormwater Comment (3): Operator appears to have traveled over the surface roughening (ripping) on the east end of the location. BMP is no longer in proper functioning condition and requires maintenance.

COGCC Photo 16. Photo taken from the east end of the location. Photo shows operator appears to have driven over the surface roughening BMP along the perimeter of the location. BMP is no longer in proper functioning condition and requires maintenance.

It is unclear from this photo where the ripping is in disrepair. This photo appears to show indentations where the tines have dug into the soil and small blocks of turned over soil that are commonly generated by ripping activities, indicating the ripping is in good repair. However, Noble has re-ripped this location at the request of COGCC.

This photo also shows how several BMPs are used together at the perimeter to mitigate erosion and sediment migration. Filtrexx can be observed on the left side of the photo at the disturbance area fenceline. To the right of the Filtrexx you can see vegetation, which provides additional stormwater treatment and wind erosion mitigation. Farther right, ripping has been installed to slow water and increase infiltration, prior to reaching the vegetation and the Filtrexx. Finally, the slopes at the far right have been tracked to further minimize erosion and sediment loss. The pad construction area in this photo is located outside of the frame, to the right.

Response (3): It is unclear from the photo provided by COGCC (photo 16) that the ripping requires maintenance; however, Noble has re-ripped this location to ensure the ripping is properly maintained. Please see additional comments in the photo log below.

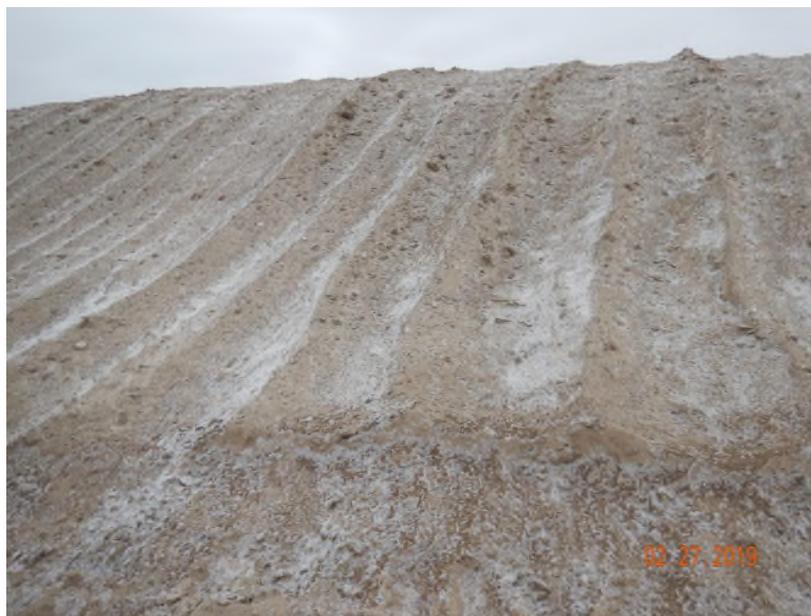
COGCC Photo 17. Photo taken from the soil stockpiles on the south end of the location. See comments under photo 10.

Noble began removing this soil on 3/1/2019 and placed it on pad side slopes to enable revegetation of those slopes. Any remaining stockpiled soil was re-tracked at the end of the day.

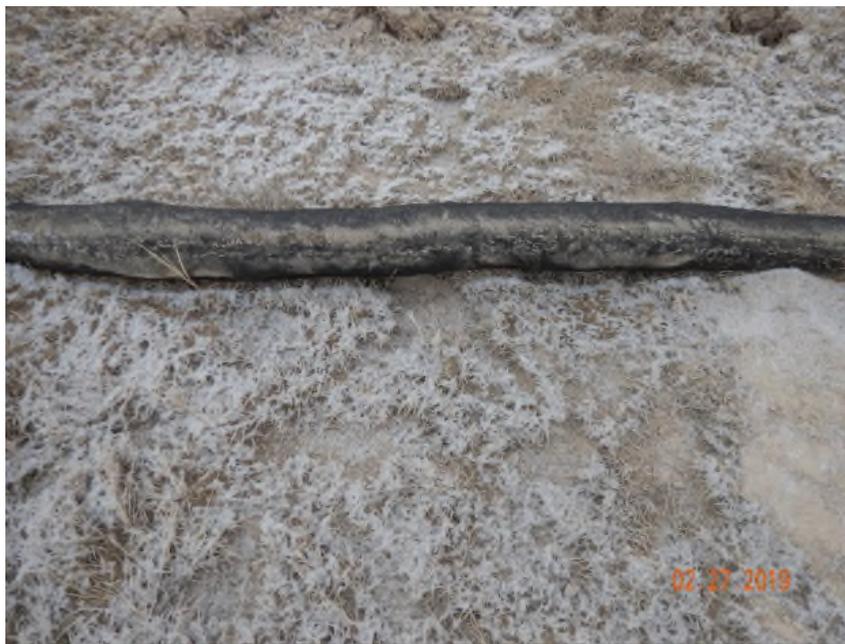
COGCC Photo 18. Photo shows Operator has installed an 8 inch diam. "Filtrexx SiltSoxx" wattle as a perimeter control. Operator has installed BMP by placing wattle upon the surface of the soil and staking in place. The following photos are examples that show that due to site conditions found commonly within rangeland (bumpy, rocky, changes in elevation affecting ground surface contact), this "lay on surface" installation practice is not appropriate or sufficient to allow this perimeter control to mitigate stormwater runoff on rangeland; BMP does not achieve a 100% ground surface contact to interrupt and mitigate stormwater runoff.

Based on manufacturer's specifications, Noble believes that Filtrexx can properly be used in rangeland without trenching. Noble has deployed approximately 4,000 feet of Filtrexx at this location, and believes the imperfections noted in the inspector's photos are not indicative of inadequate BMP installation. Proper surface contact has been achieved on over 99% of the installation and will effectively minimize sediment migration. This, taken into consideration with the other BMPs used at this location, suggests that BMPs are properly selected and installed.

Noble does not believe that an all or nothing approach is in line with good engineering practice. When a BMP is effective at minimizing soil erosion and sediment migration, it is beneficial to use that BMP, particularly when used as part of a BMP treatment train. Please also refer to COGCC Photo 16 in this photo log.

Trenching also requires the removal of vegetation, which itself provides stormwater treatment. Trenching would also create disturbed soils at the perimeter of our location, where sediment would be more likely to migrate off-site.

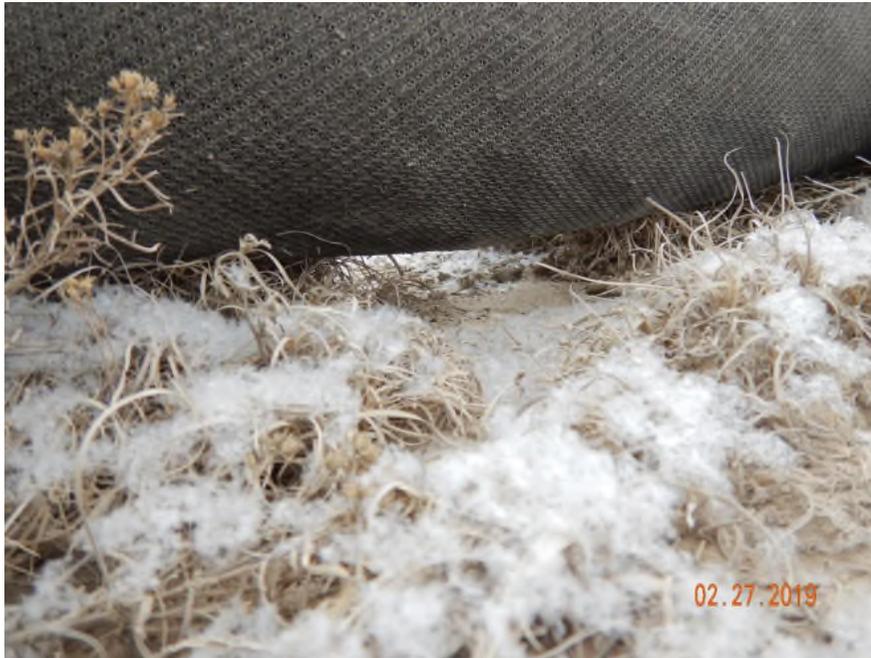
COGCC Photo 19. See comments under photo 18.

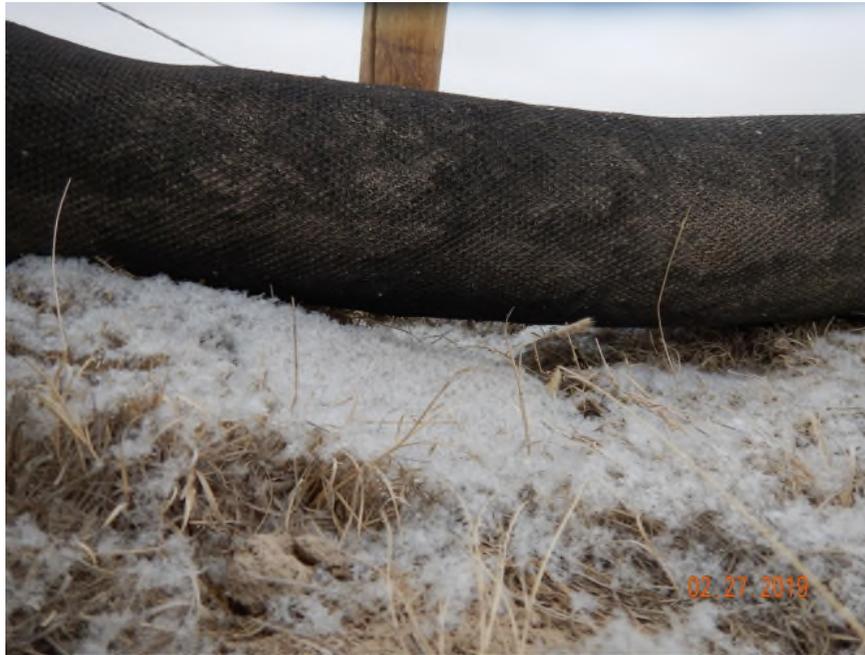
COGCC Photo 20. See comments under photo 18.

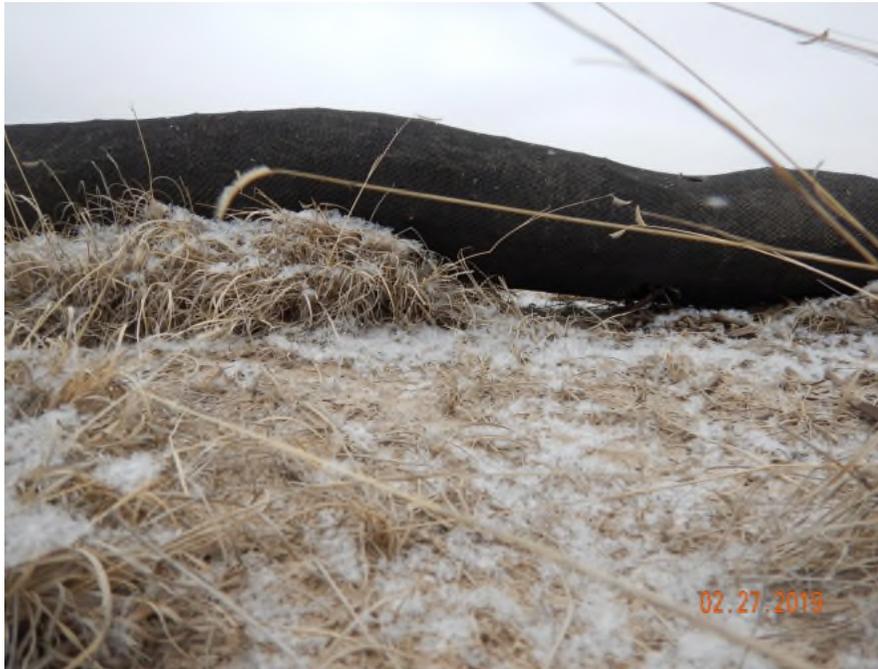
COGCC Photo 21. See comments under photo 18.
