Inspection Photos

3/04/2019

Operator: SWN PRODUCTION COMPANY LLC -
10396

Location ID: 427955

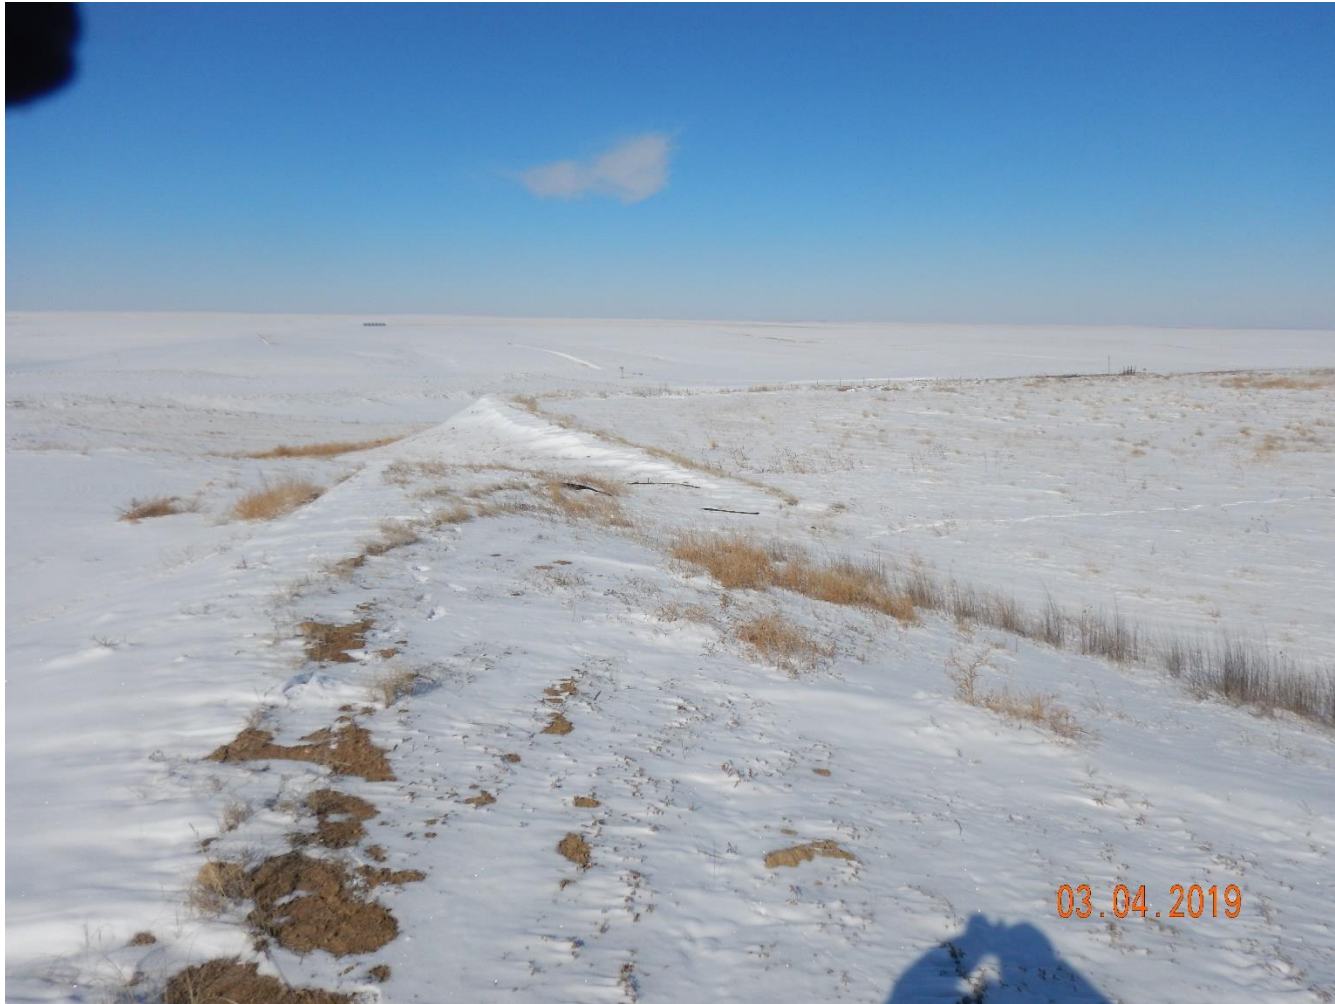
Photo 1: Photo taken from the south end of the location, facing west. Photos 1-4 provide an overview of the location from west, northwest, northeast to east. Corrective actions and COAs required operator to conduct reclamation and reduce the location's disturbance area to 0.92 acres. Photos show reclamation has not been conducted; disturbance area has not been reduced.

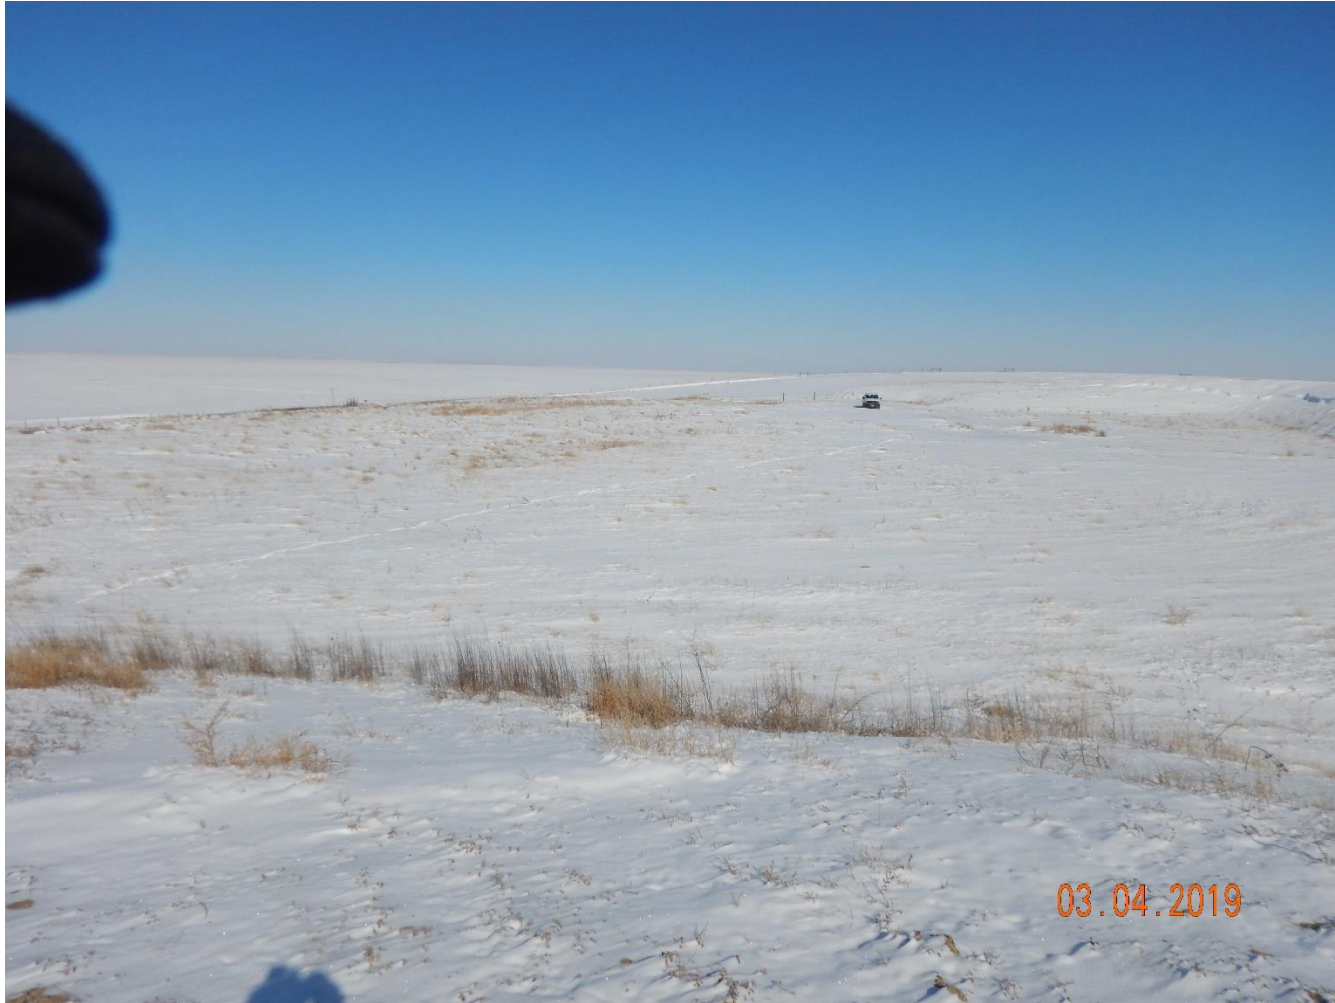
Photo 2: See comments under photo 1.

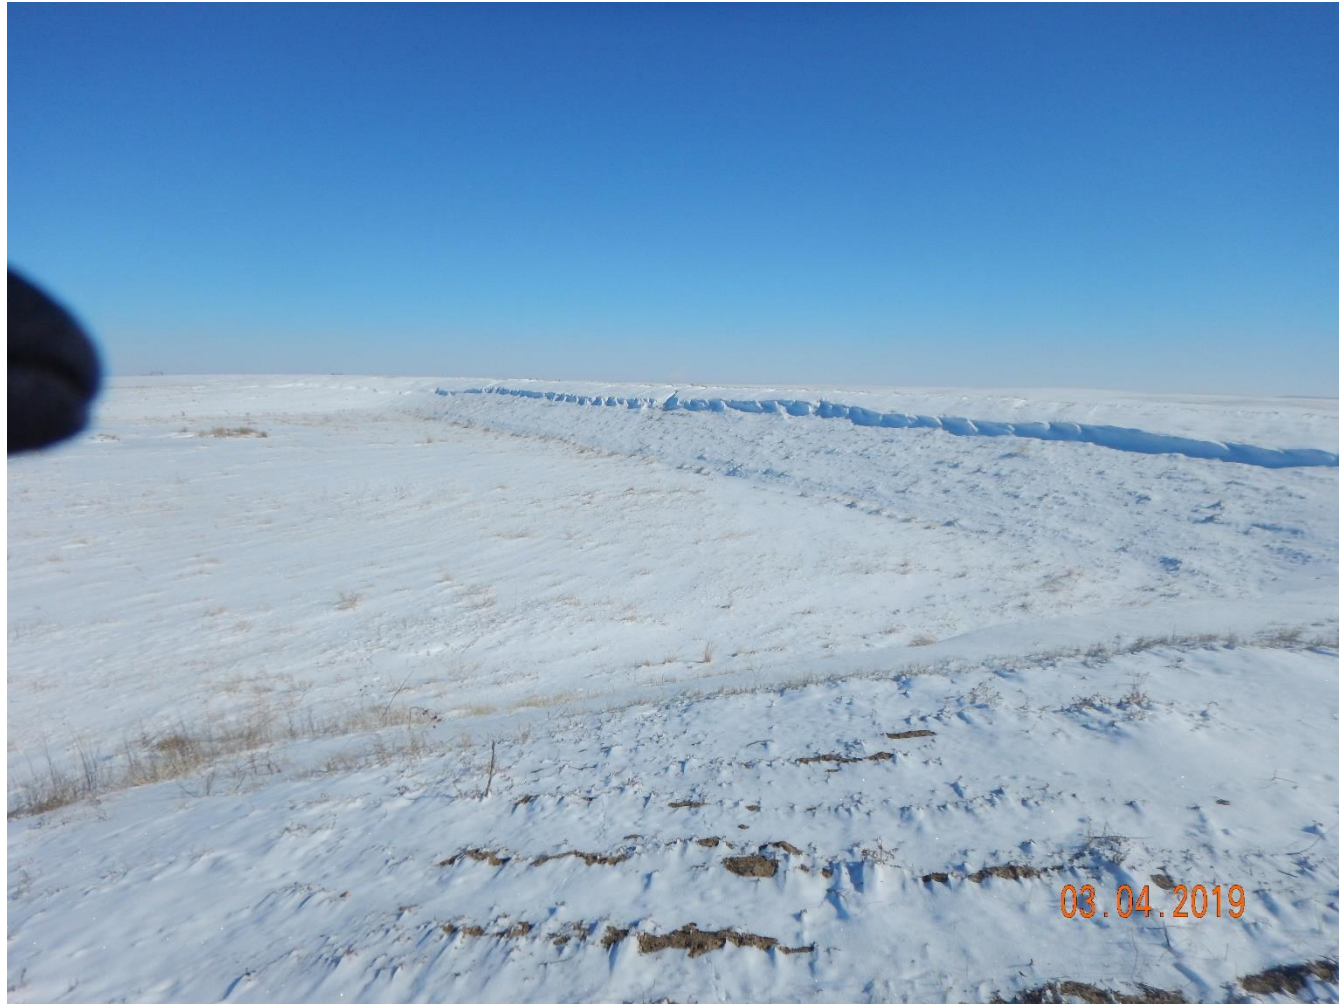
Photo 3: See comments under photo 1.

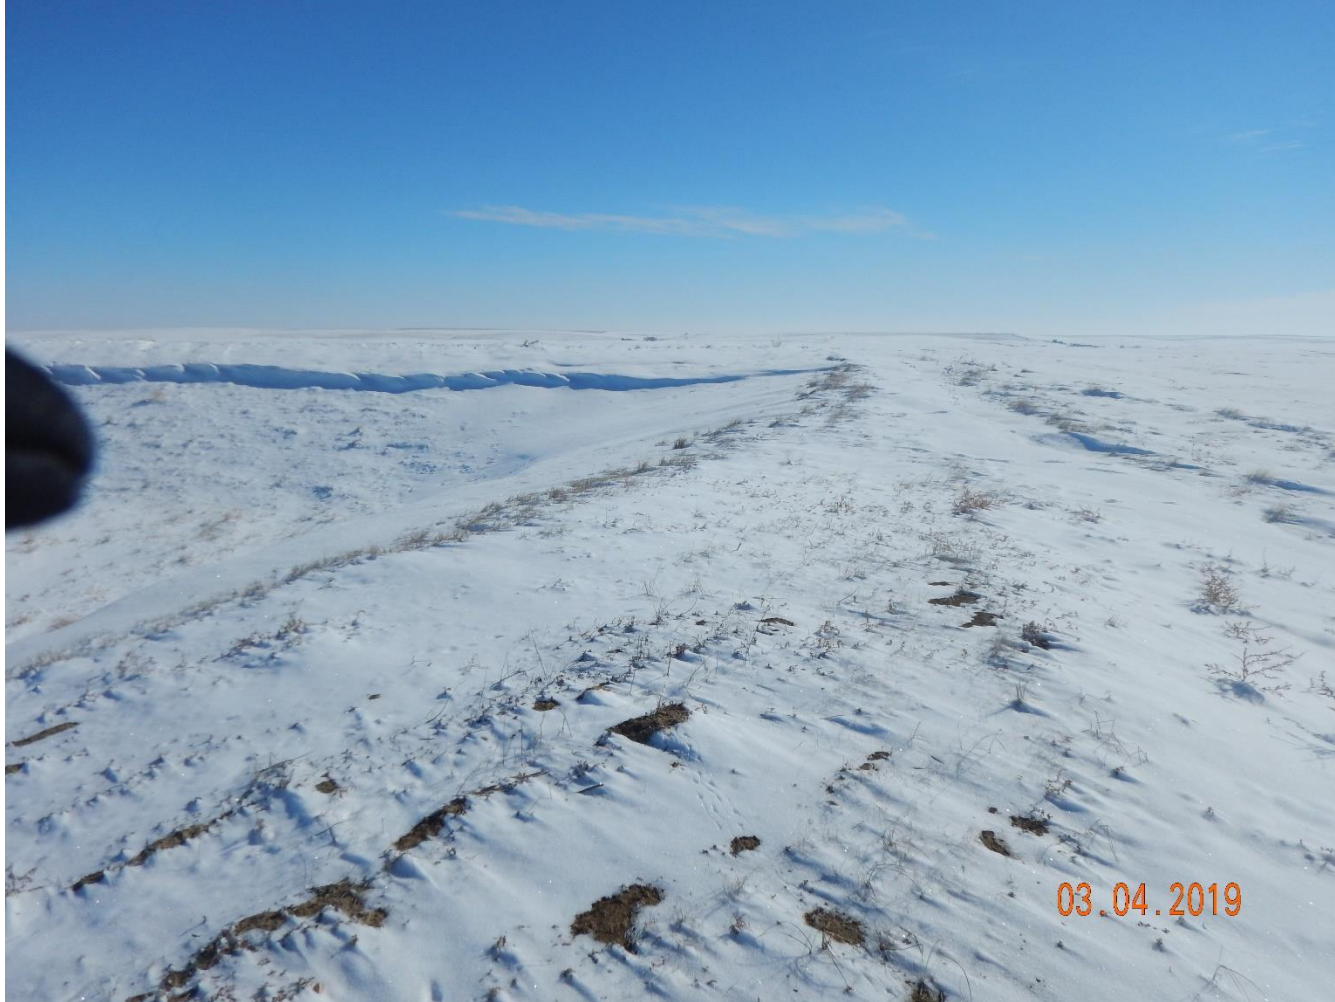
Photo 4: See comments under photo 1.

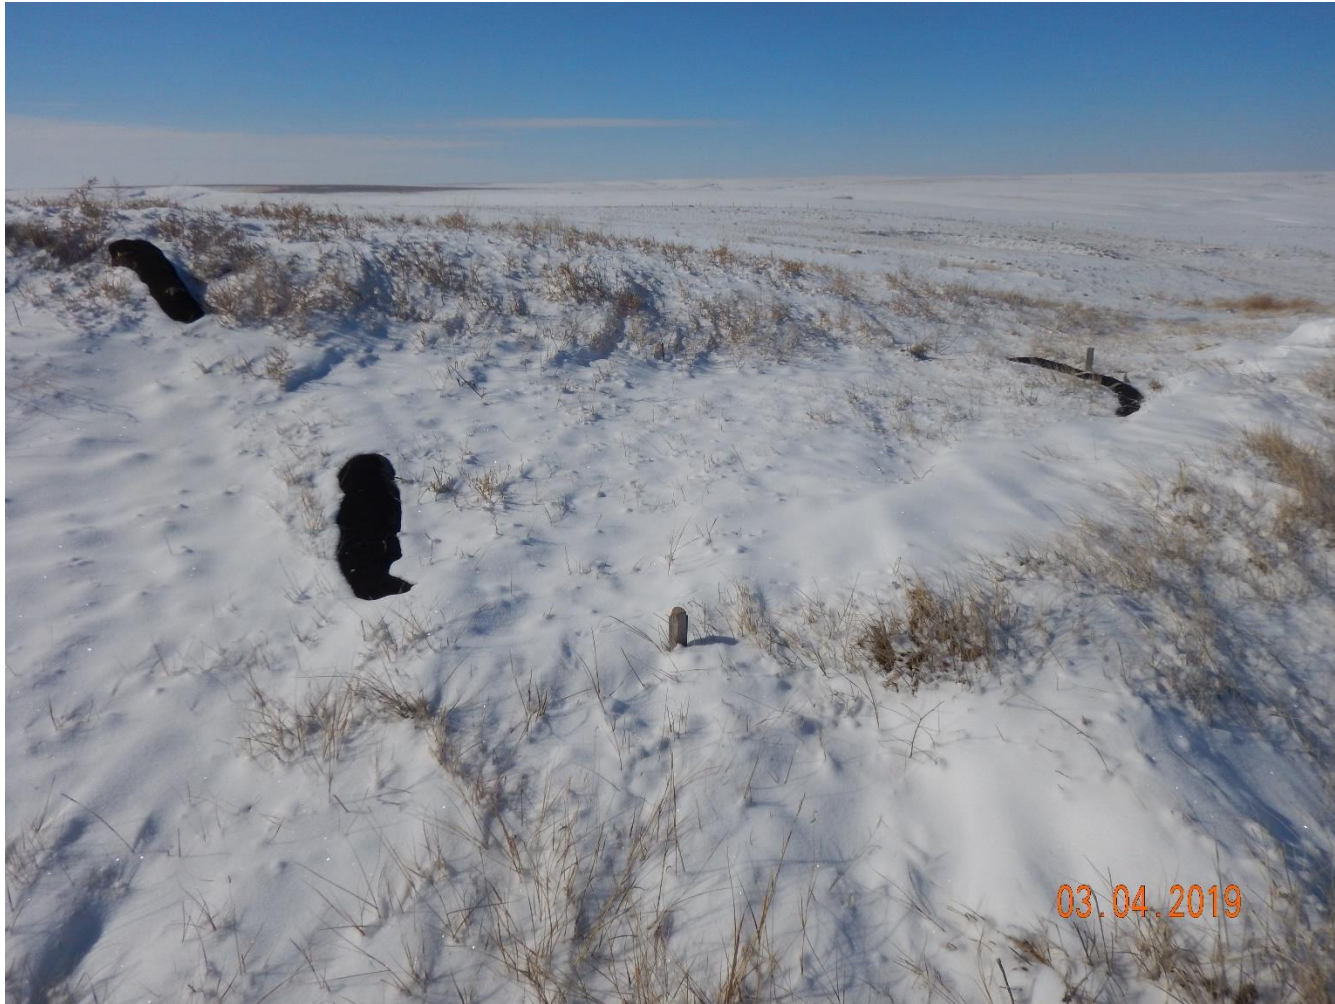
Photo 5: Photo taken from the south end of the location, facing southwest. Photo shows wood-mulch wattle (stormwater ponding BMP). Previous inspections documented that BMP was degrading. Photo shows BMP remains on location.

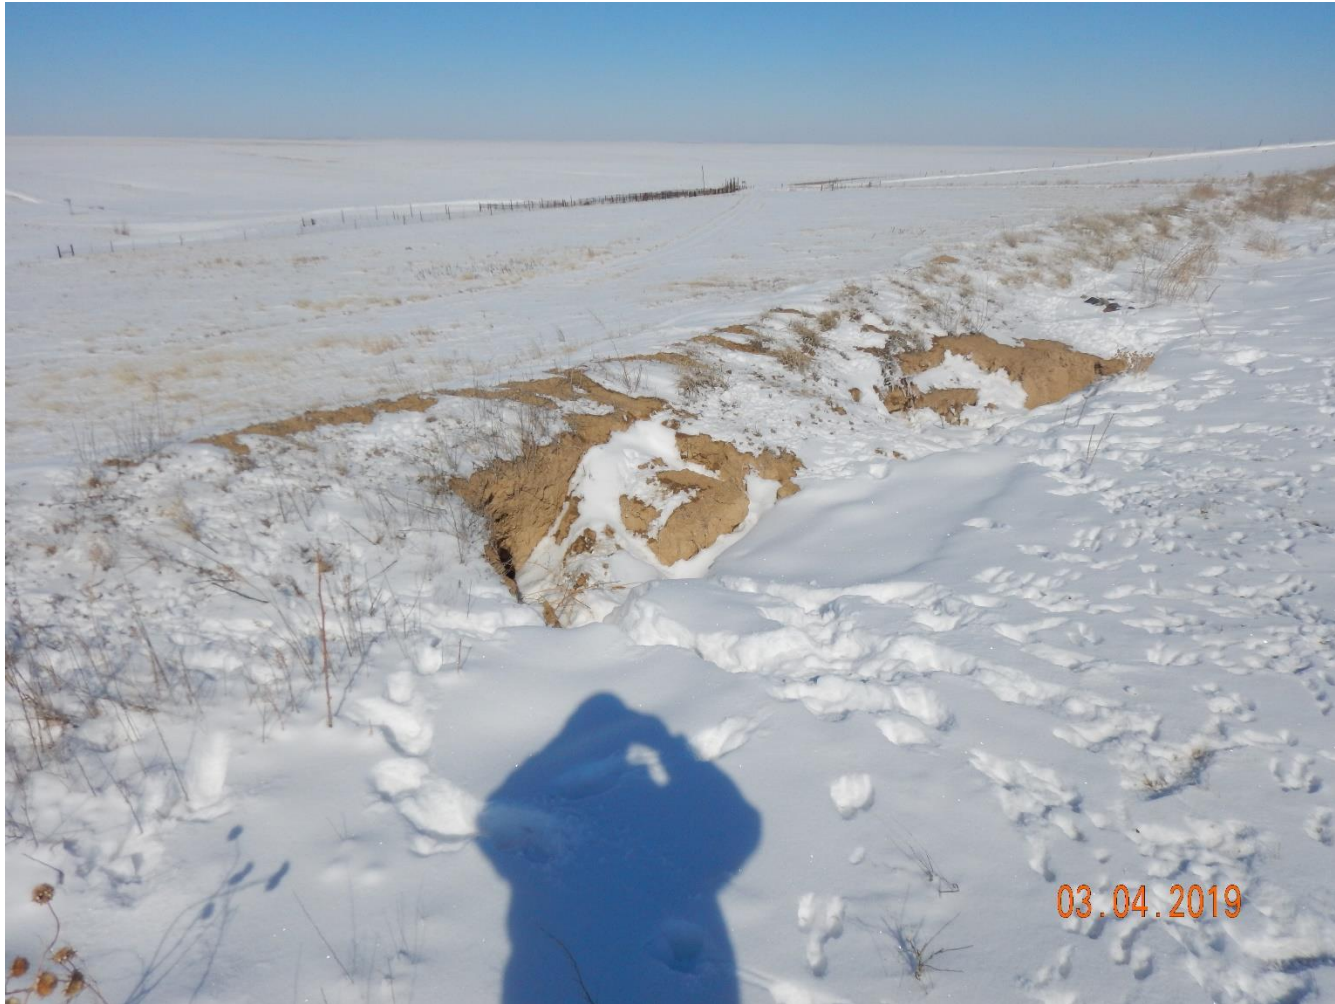
Photo 6: Photo taken from the ditch on the west end of the location, facing northwest. Previous inspections documented that stormwater runoff has incised the ditch along the west end of the pad and created sinkholes within the ditch. Photo shows stormwater degradation within the ditch has not been repaired and stabilized.

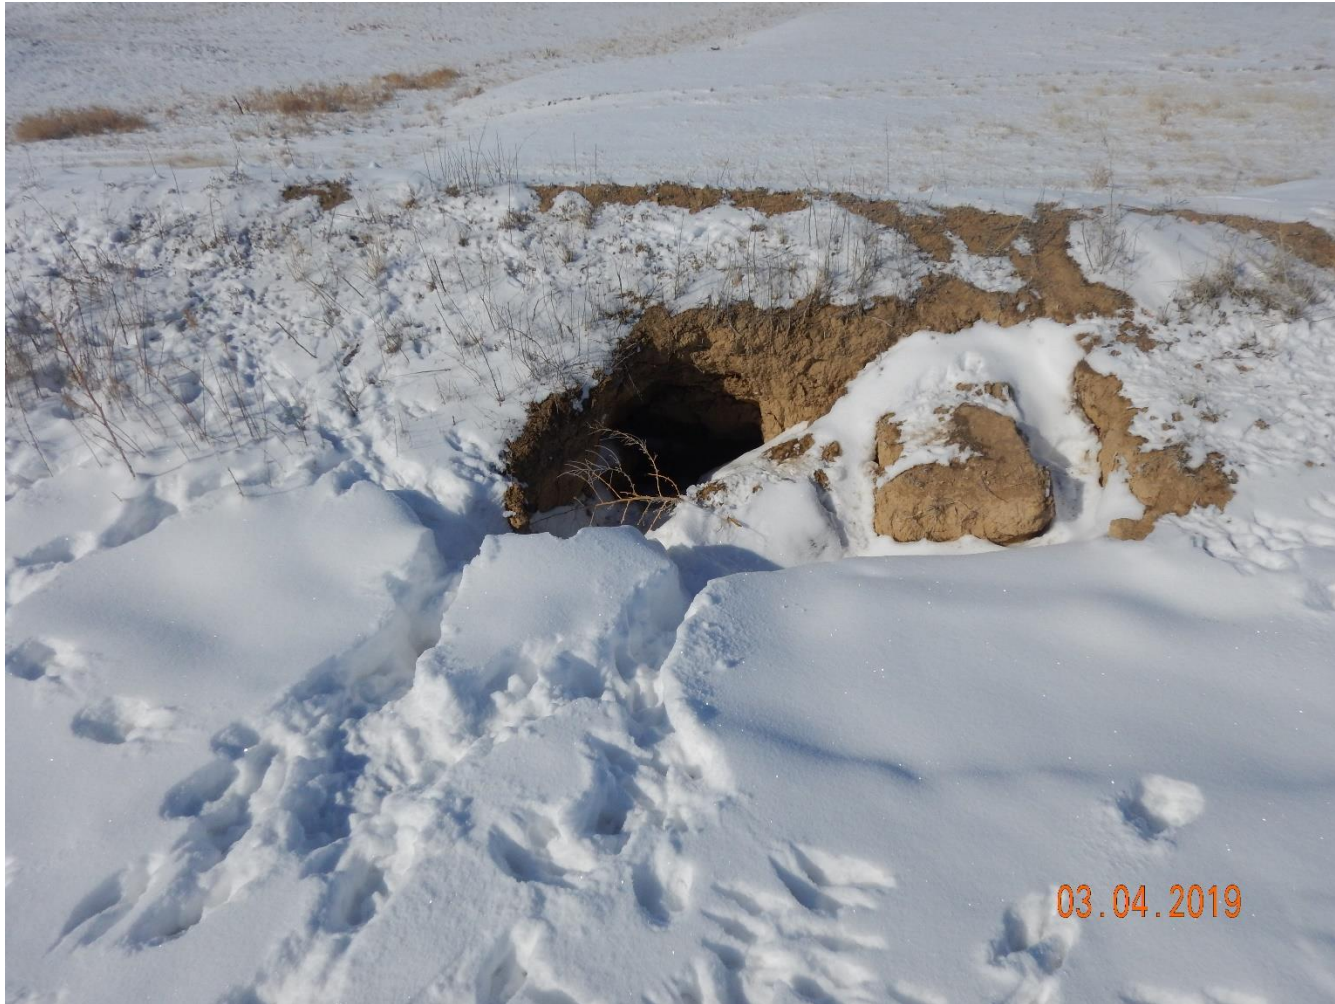
Photo 7: Photo taken from the ditch on the west end of the location, facing west. See comments under photo 6.

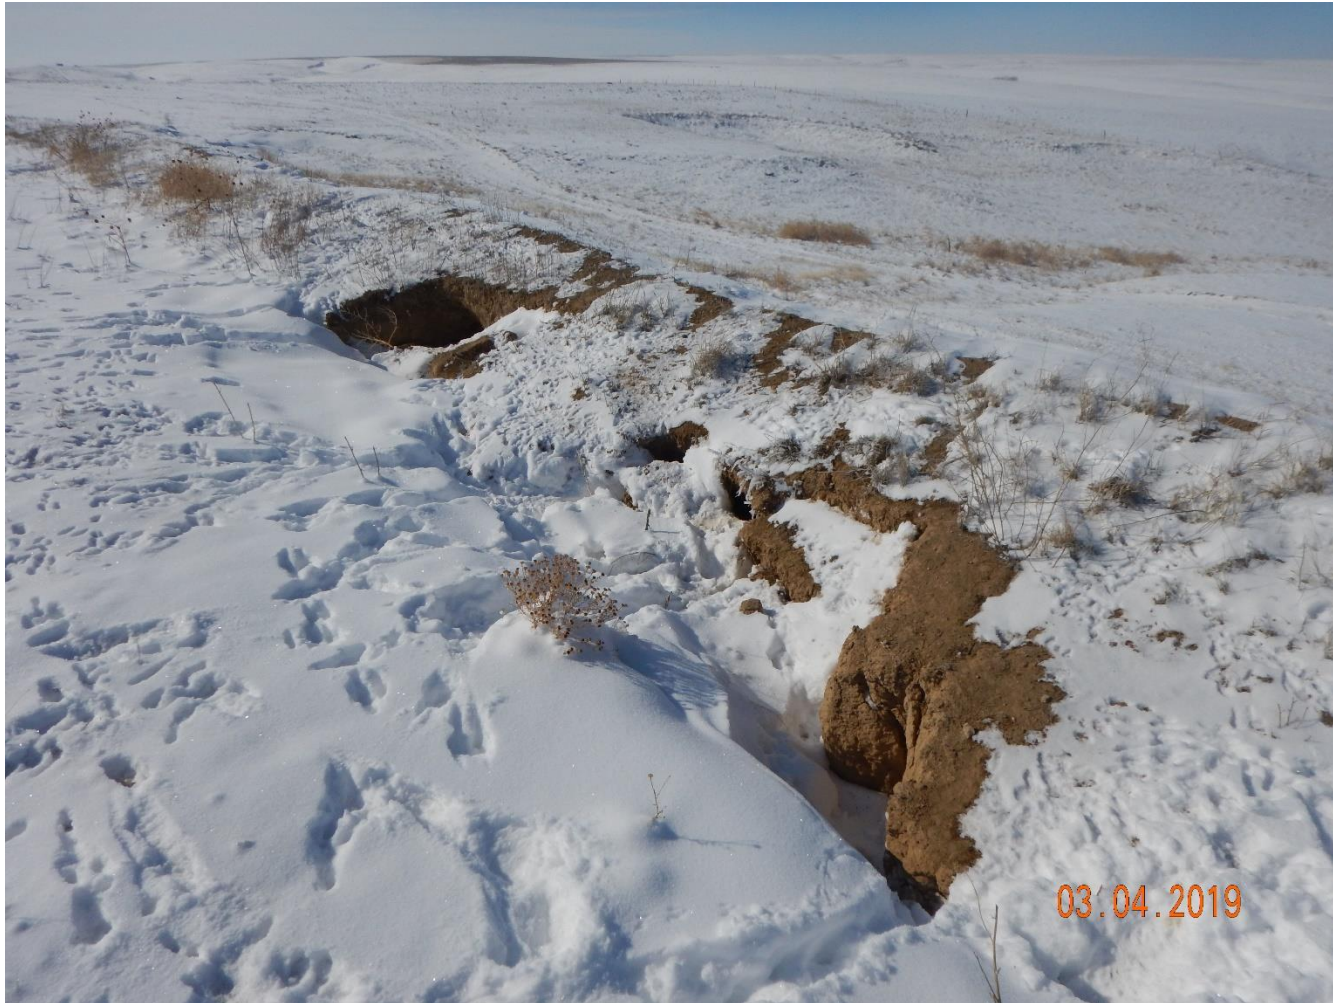
Photo 8: Photo taken from the ditch on the west end of the location, facing southwest. See comments under photo 6.

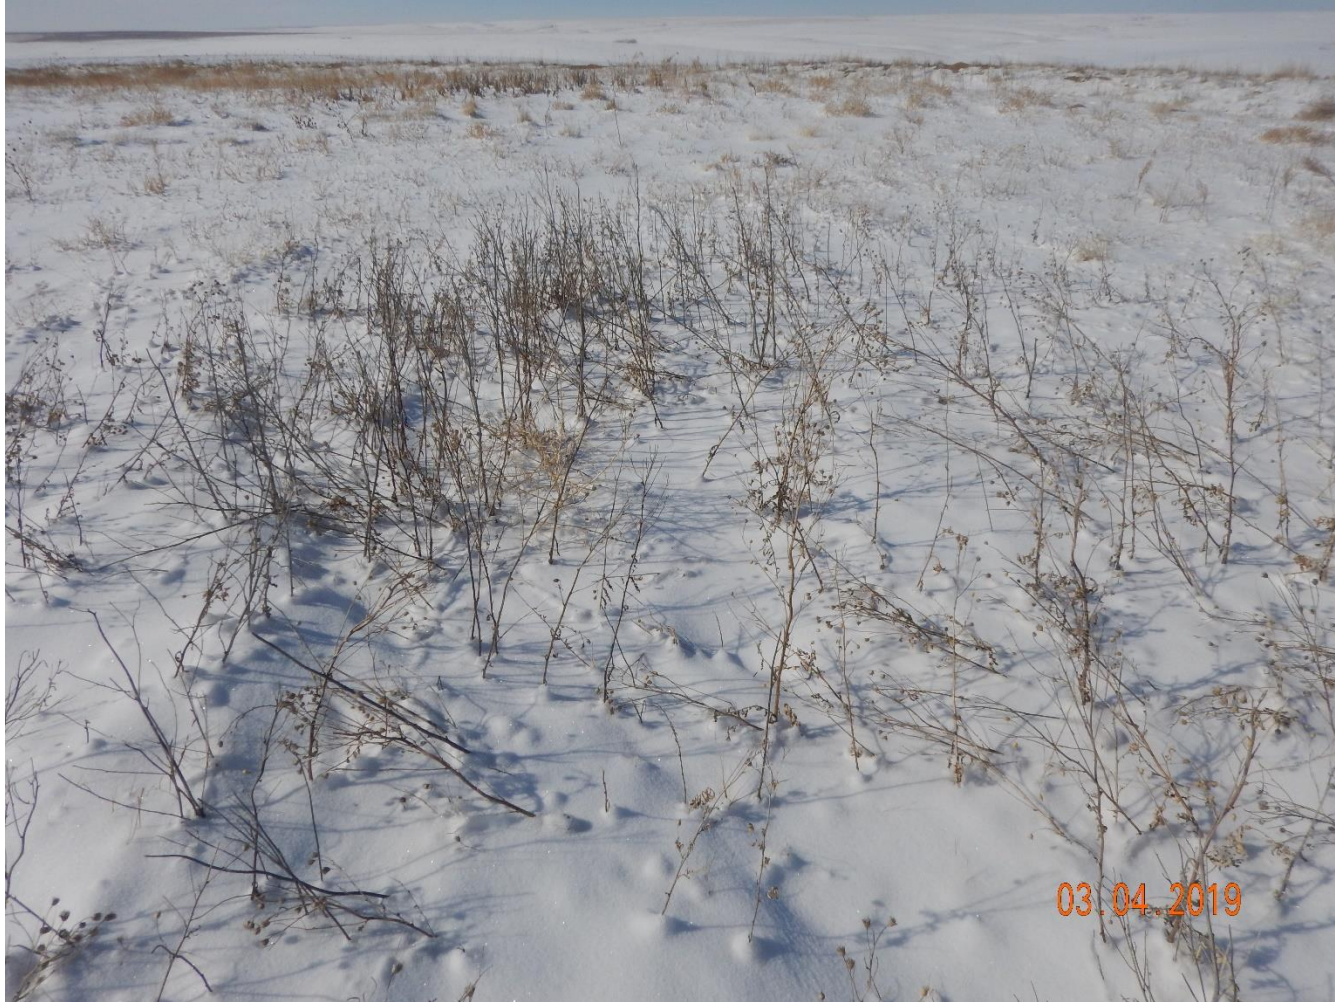
Photo 9: Photo taken from the north end of the location. Photo shows a patch of Canada thistle on location. Canada thistle (*Cirsium arvense*) is a Colorado state listed noxious weeds and requires management.

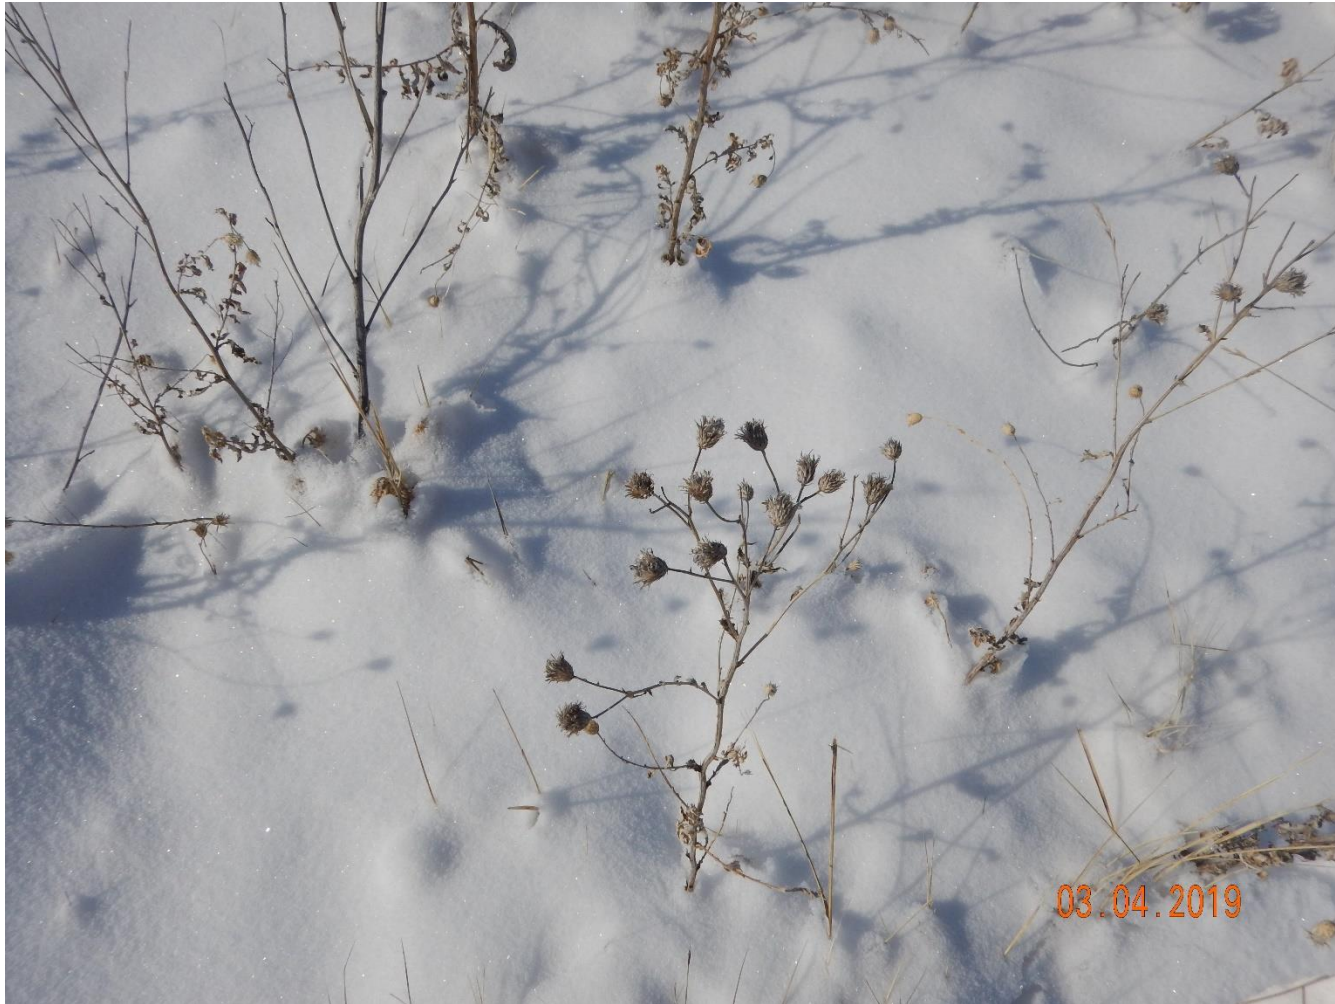
Photo 10: Photo taken from the north end of the location. Photo shows Canada thistle.

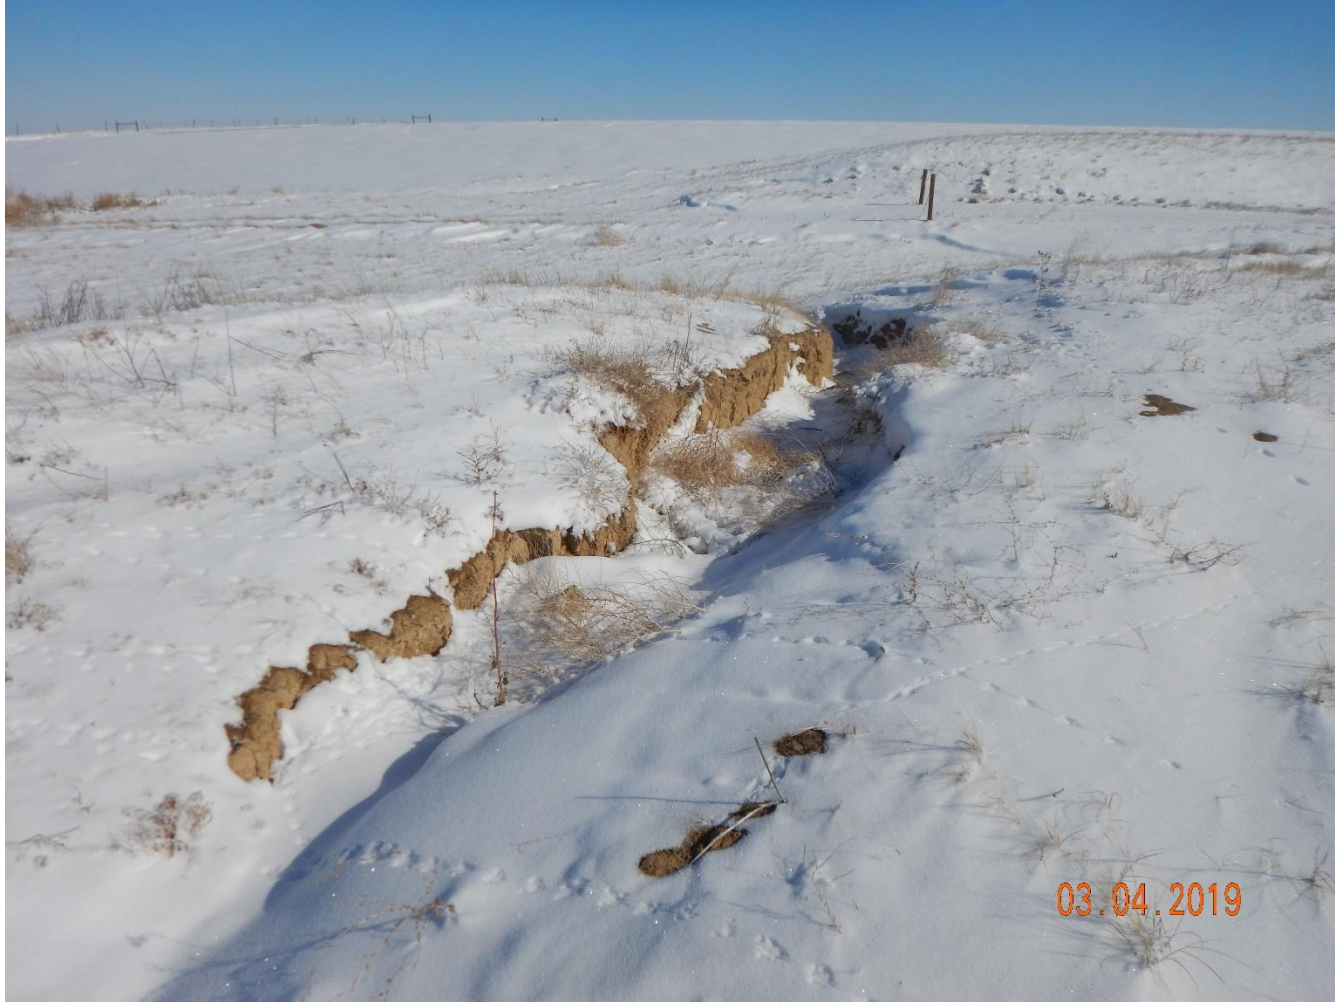
Photo 11: Photo taken from the north end of the location, facing northeast. Photo shows gully erosion has not been repaired and or stabilized.

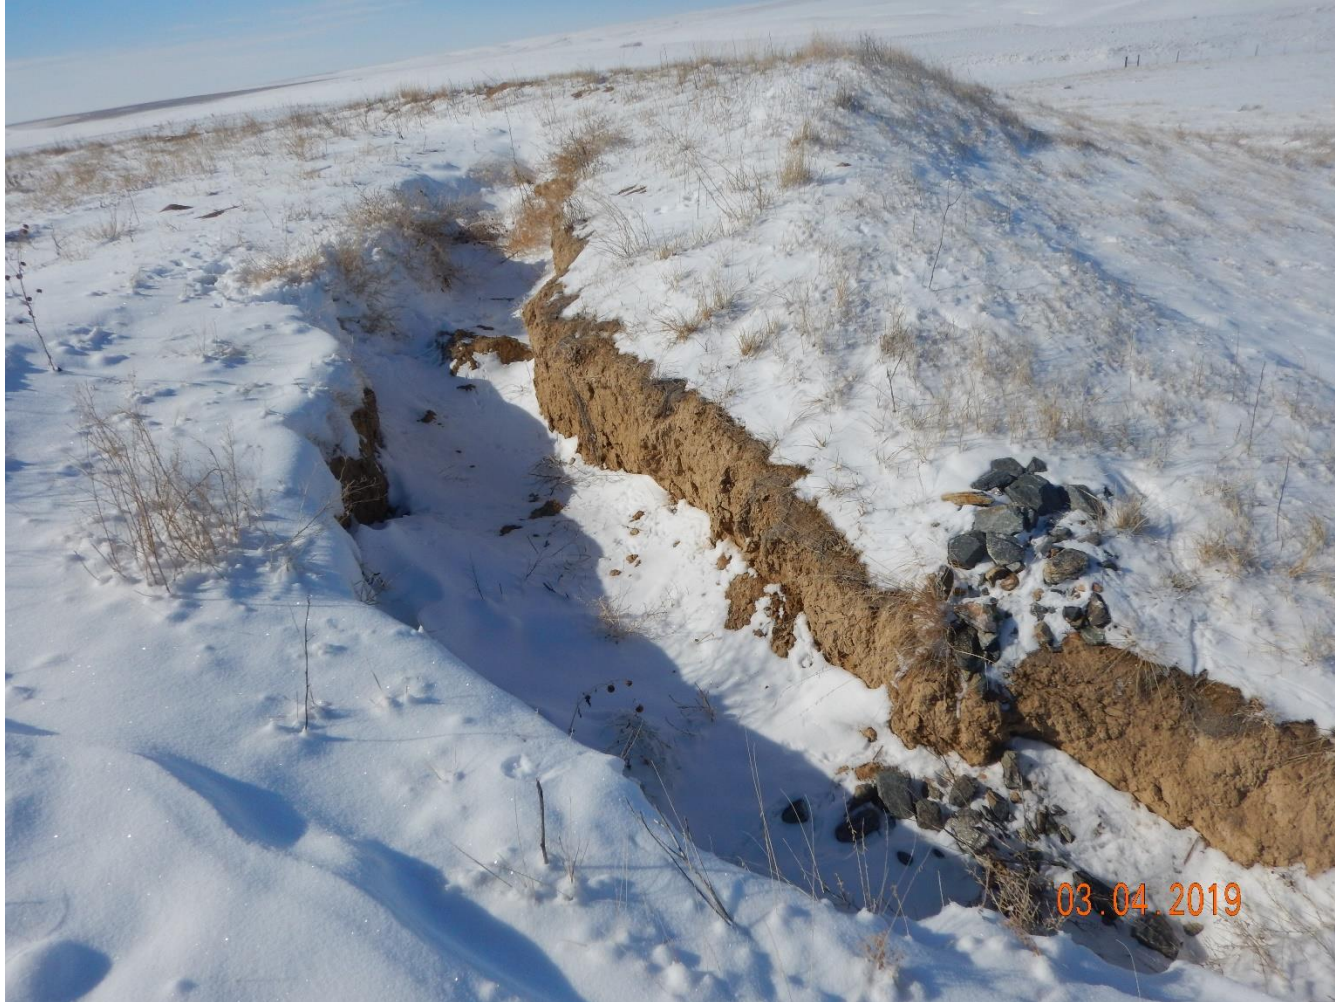
Photo 12: Photo taken from the north end of the location, facing southwest. Photo shows gully erosion has not been repaired and or stabilized.

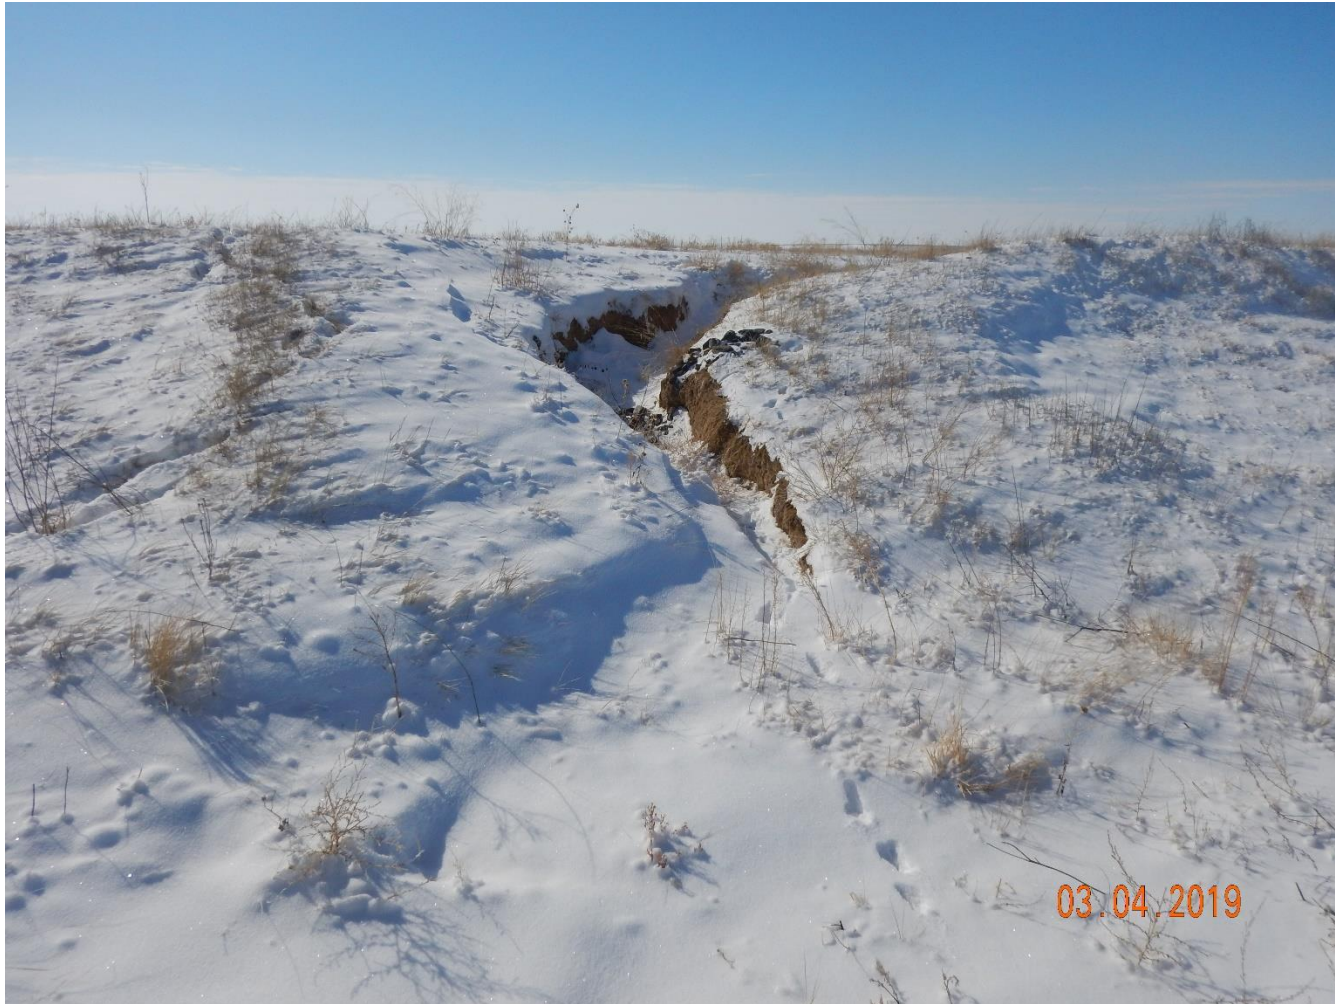
Photo 13: Photo taken from the north end of the location, facing south. Photo shows gully erosion has not been repaired and or stabilized.

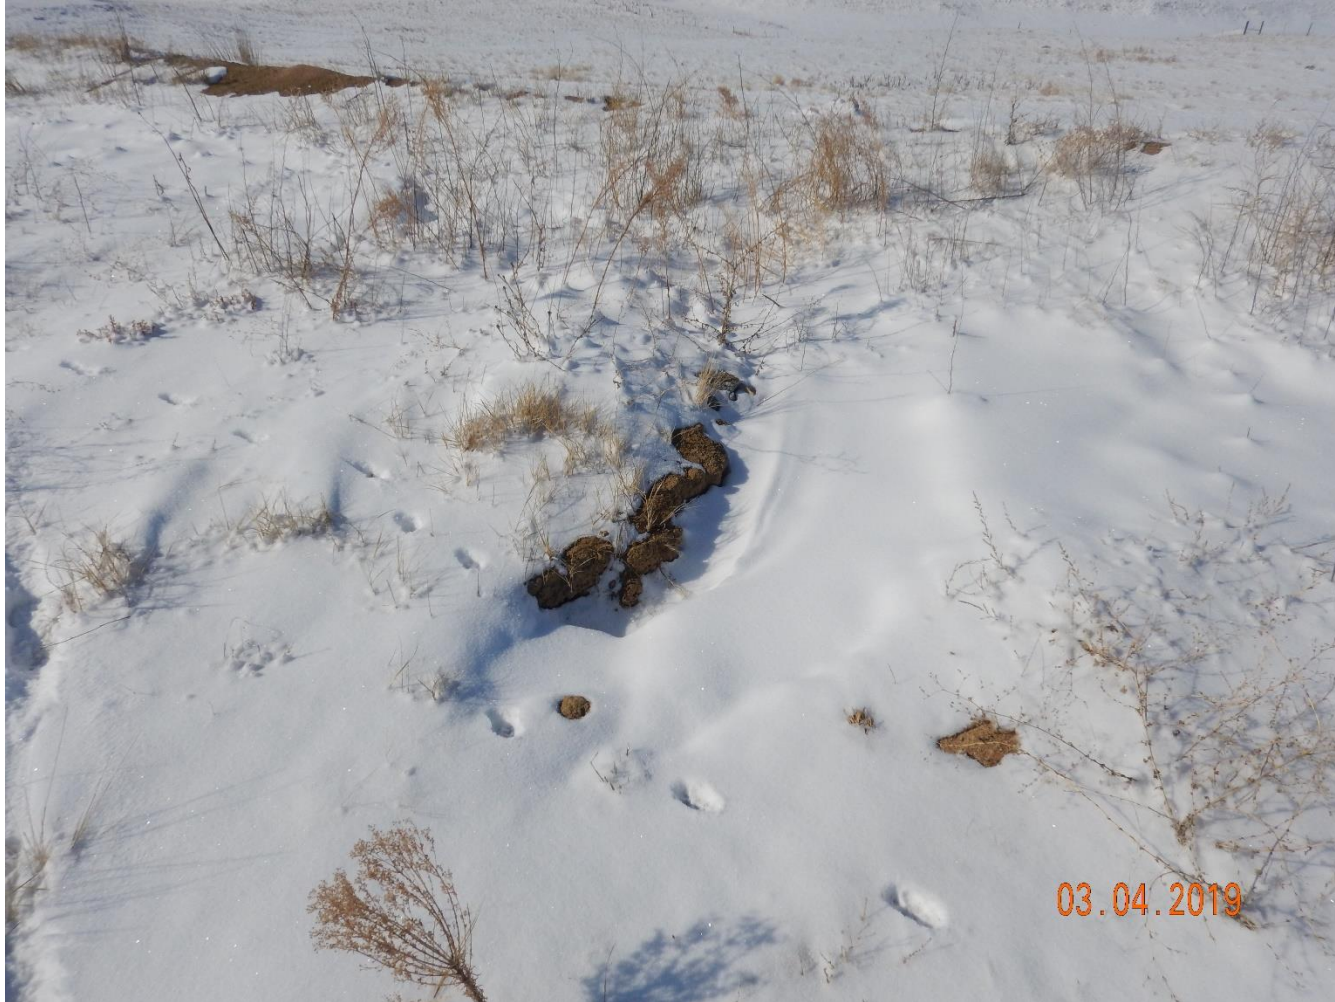
Photo 14: Photo taken from the ditch on the west end of the location. Photo shows area previously documented where erosion degradation has been cutting eastward into the pad. Photo shows erosion degradation has not been repaired or stabilized.

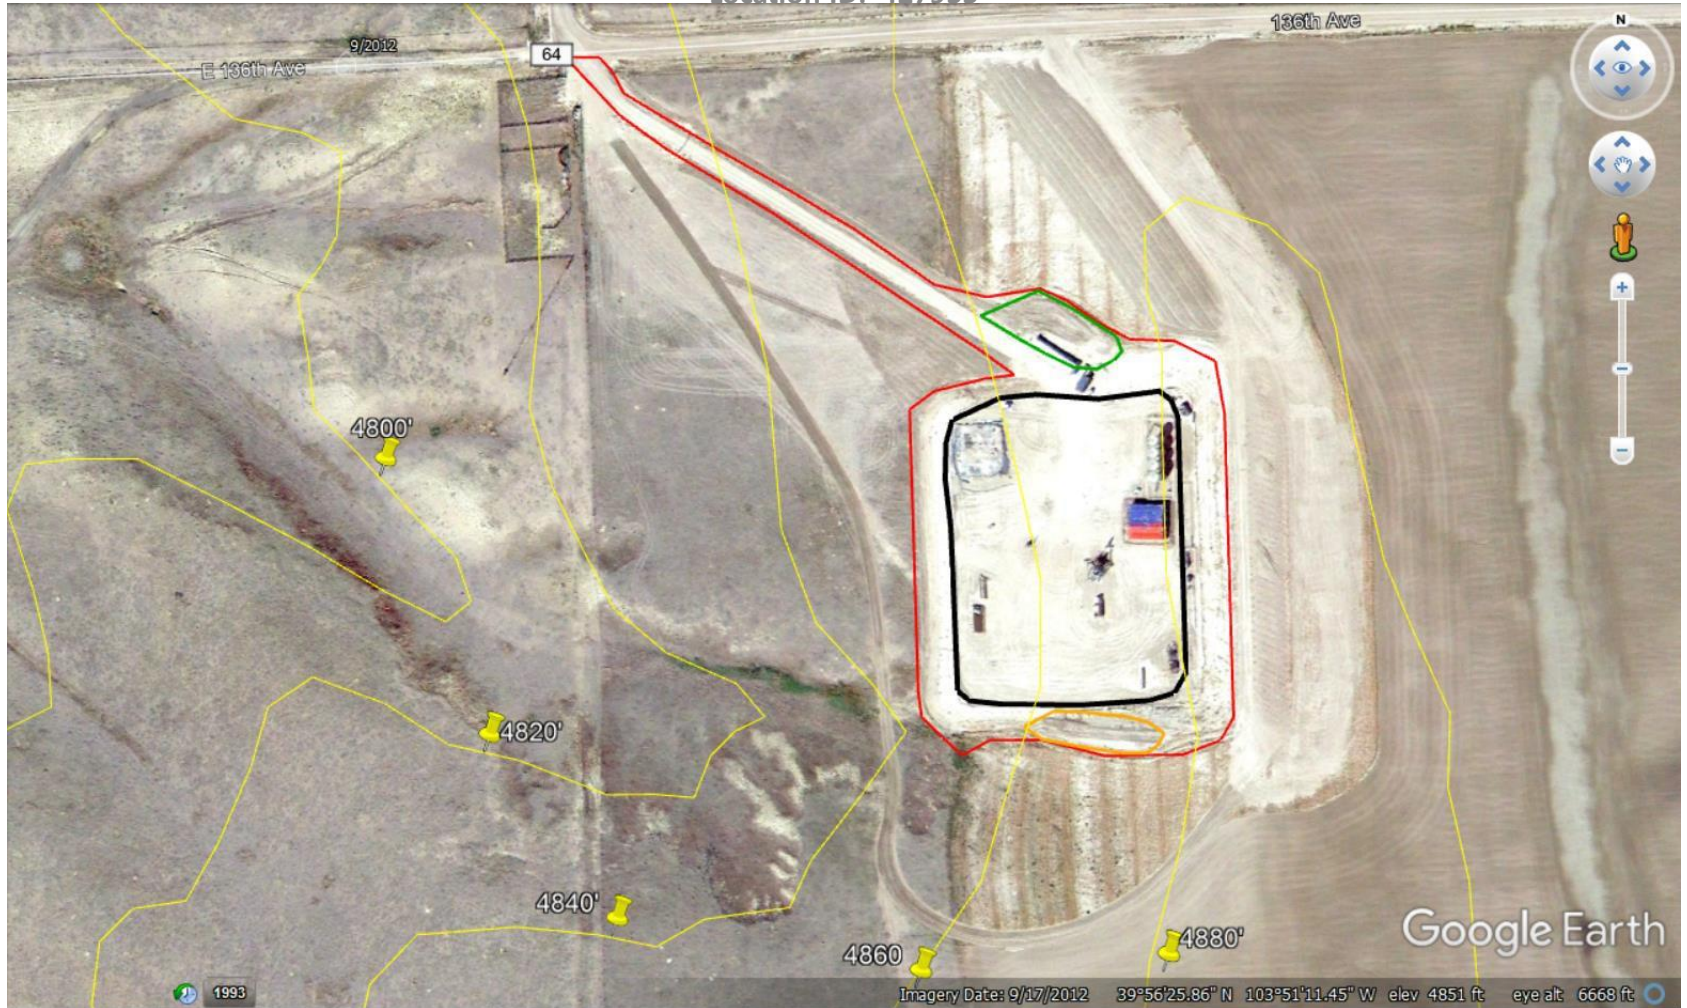
Photo 16: 9/17/2012 Aerial imagery. Well was SPUD 4/11/2012. COGCC records show first production date on 07/2012. COGCC 1003 reclamation rules require operator to perform interim reclamation (IR) on areas no longer reasonably needed for production to occur no later than three (3) months on cropland after drilling operations. Date IR would need to have been conducted is 10/2012. Photo shows location prior to when IR would need to have been conducted. 2A doc. # 400252948 states disturbance size during construction is 3.67 acres. Total disturbance size is ~4.5 acres (4.92 with access road).

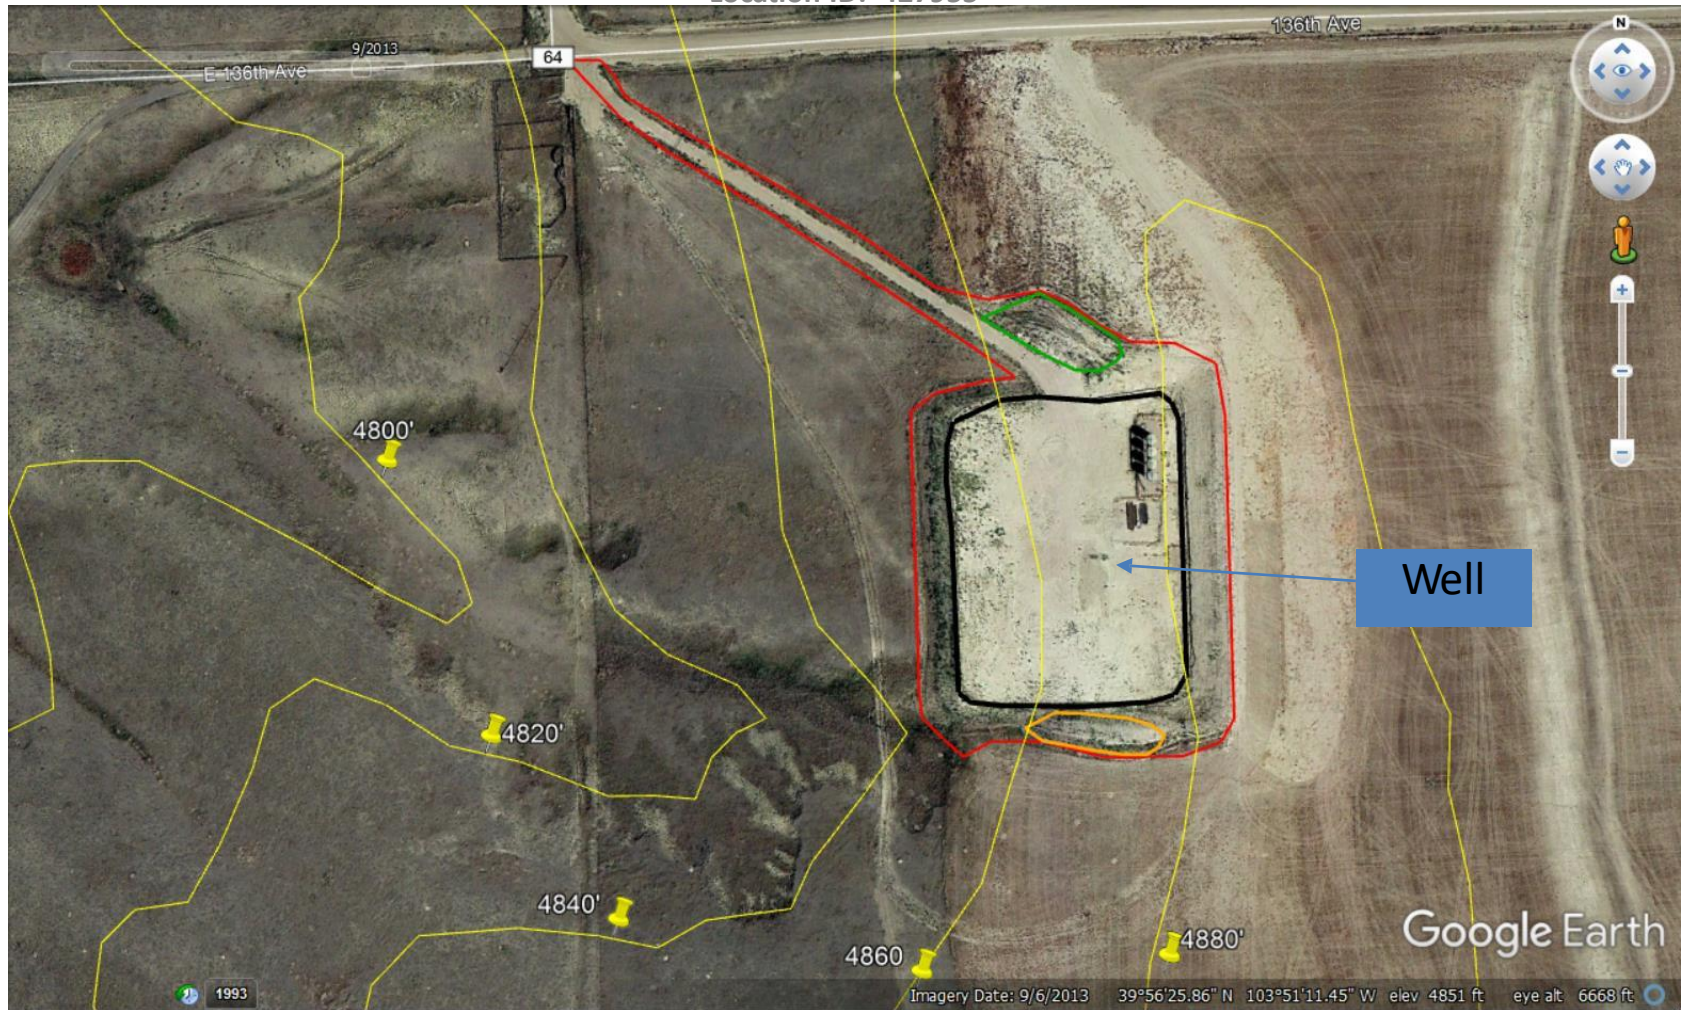
Photo 17: 9/06/2013 aerial imagery. 2A doc. #400252948 states size of location after IR is 0.92 acres, with IR estimated to begin on 9/1/2012. Based on production records, interim reclamation (IR) on areas no longer reasonably needed for production should have occurred no later than 10/2012. Photo image date is 11 months after when IR should have occurred. Photo shows location does not appear to have been reduced in size; IR does not appear to have been conducted. Total disturbance remains ~4.9 acres with pad/production area ~2.43 acres.
