Inspection Photos

3/04/2019

Operator: SWN PRODUCTION COMPANY LLC -
10396

Location ID: 427955

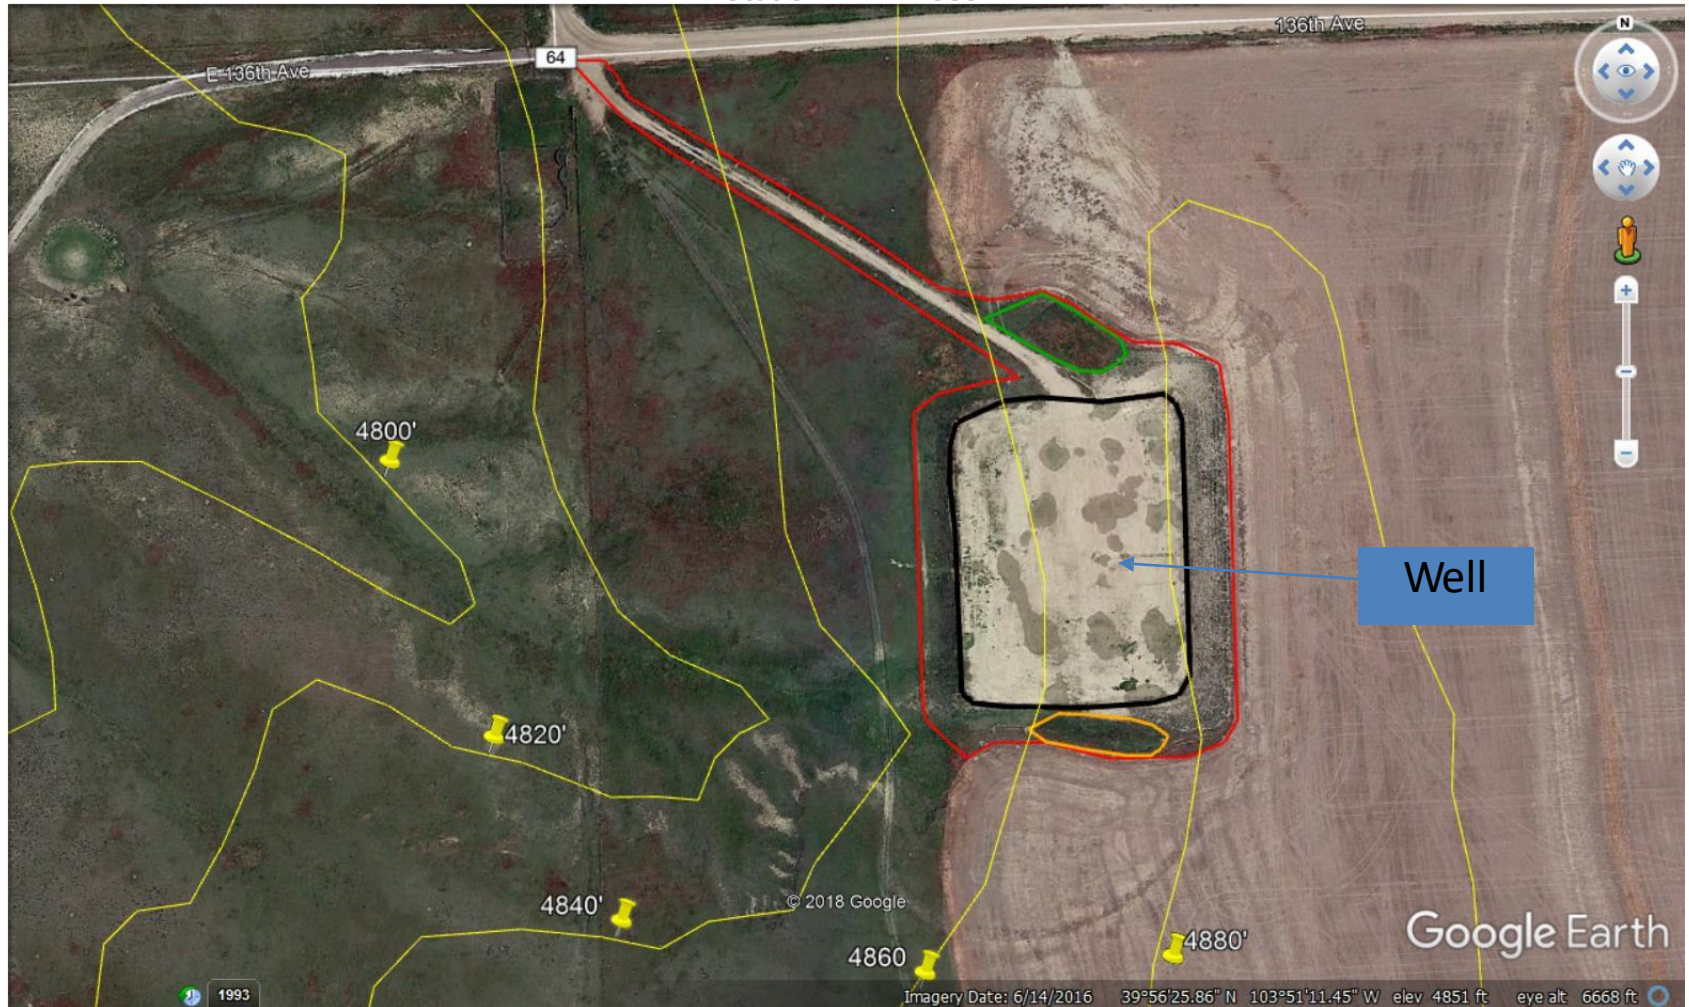
Photo 18: Current available aerial imagery dated 06/14/2016. 6(s) doc. #400900611 states well was PA'd on 8/28/2015. Photo shows well and equipment appear to have been removed. Location would now have been subject to 1004 reclamation rules which require final reclamation to be completed within 3 months on crop land after plugging a well. Final reclamation should have been completed by 11/28/2015. Photo shows location/disturbance size
