Interim Reclamation and Stormwater Inspection

February 28, 2019

Operator: HIGHPOINT OPERATING CORPORATION- 10071

Location ID: 444078

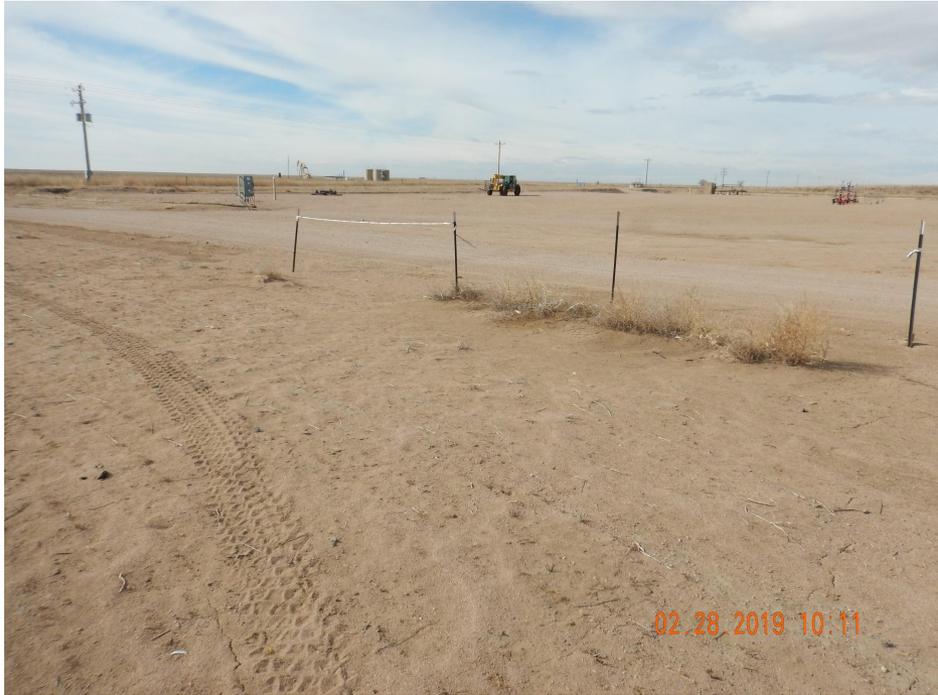
Photo 1. Photo taken east of the Location, facing Southwest. Photo illustrates soil particle deposition off Location as a result from wind erosion which is impacting the adjacent cropland. Soil particle deposition was observed ~100' east off Location. Well pad area has not been adequately stabilized to control dust and prevent wind erosion. Also, Operator has failed to perform Interim Reclamation to reduce disturbance areas only needed for production operations.

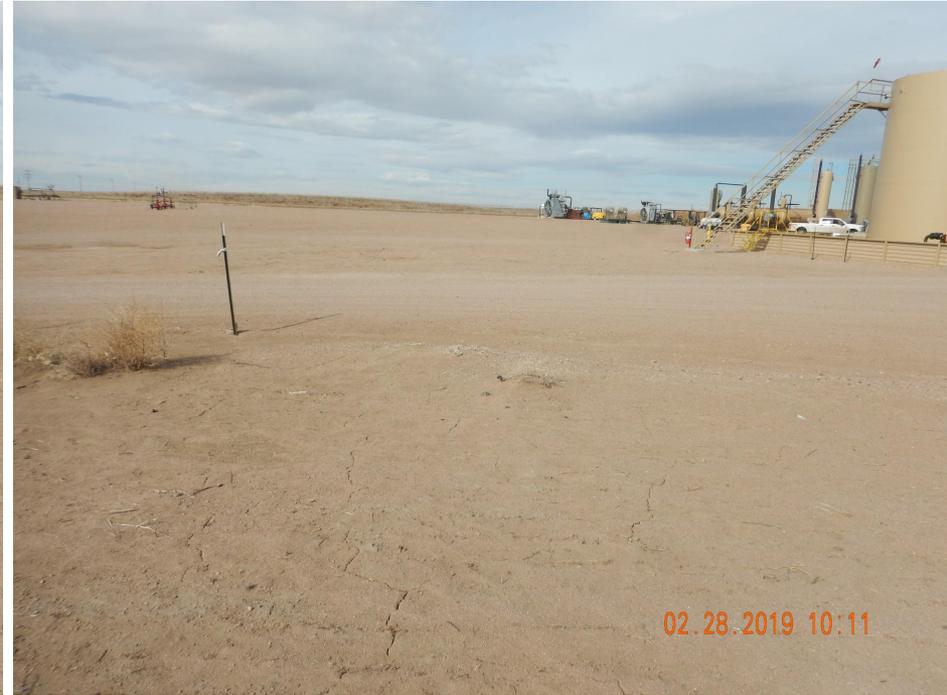
Photo 2. Photo taken east of the Location, facing West. See comments under Photo 1.

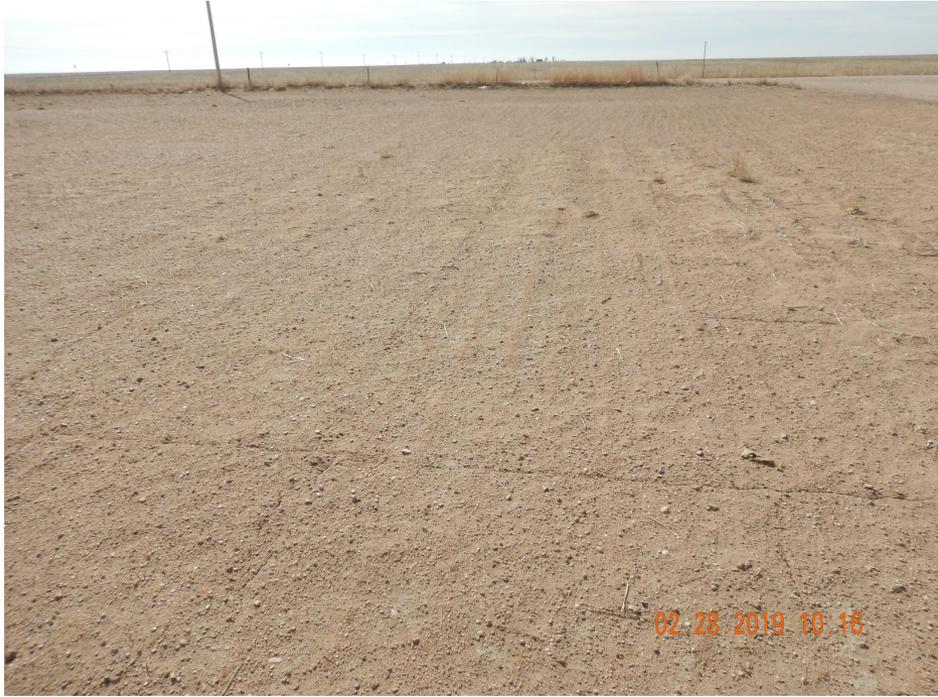
Photo 3. Photo taken east of the Location, facing South. See comments under Photo 1.

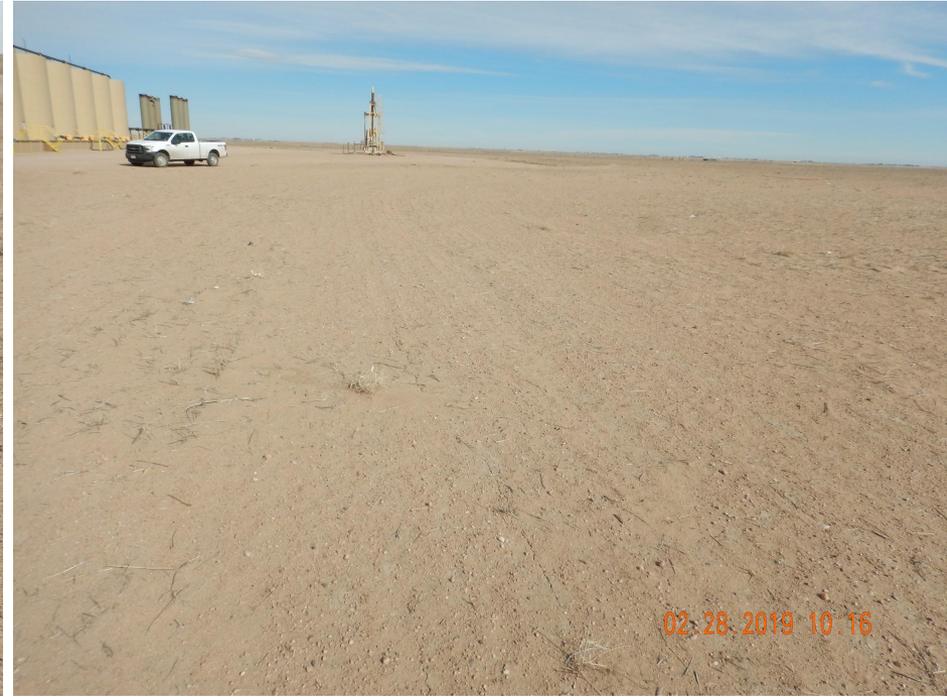
Photo 4. Photo taken east of the Location, facing North. See comments under Photo 1.

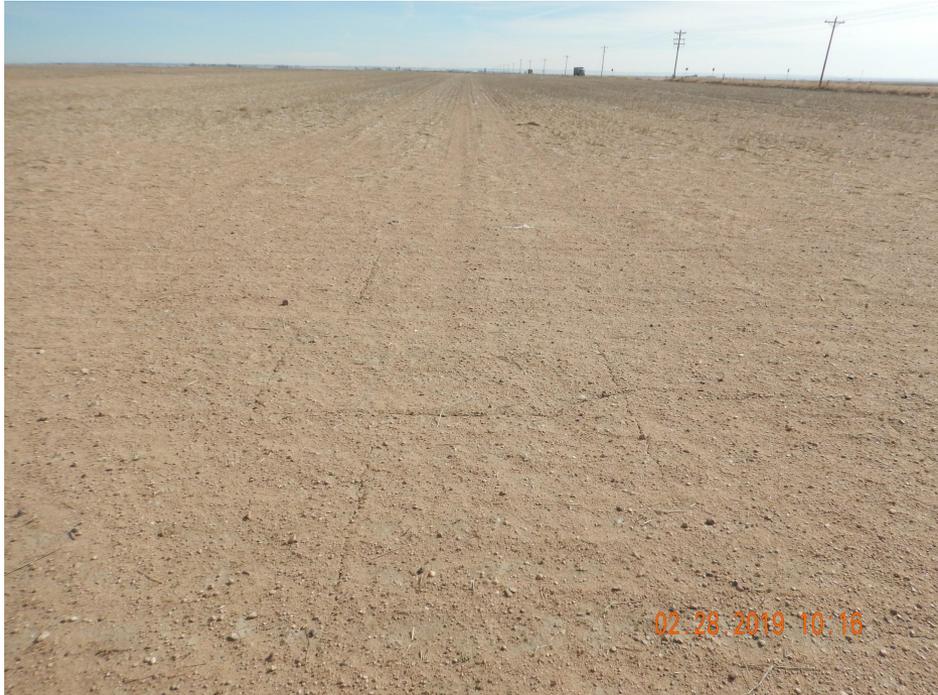
Photo 5. Photo taken east of the Location, facing East. See comments under Photo 1.

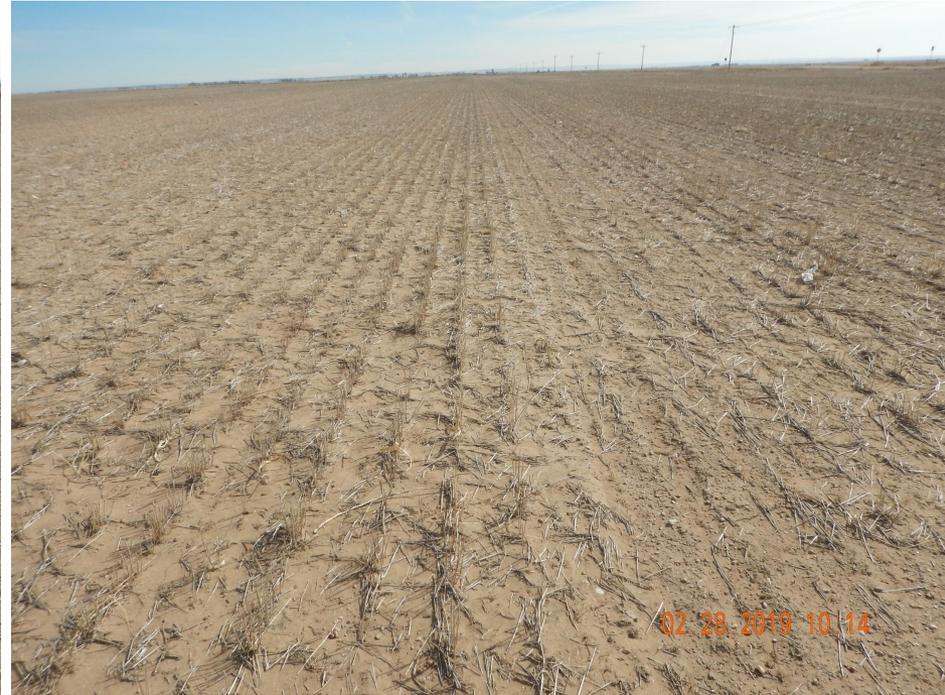
Photo 6. Reference photo taken east of the Location, facing East. Photo illustrates an area that does not appear to be impacted by soil particle deposition.

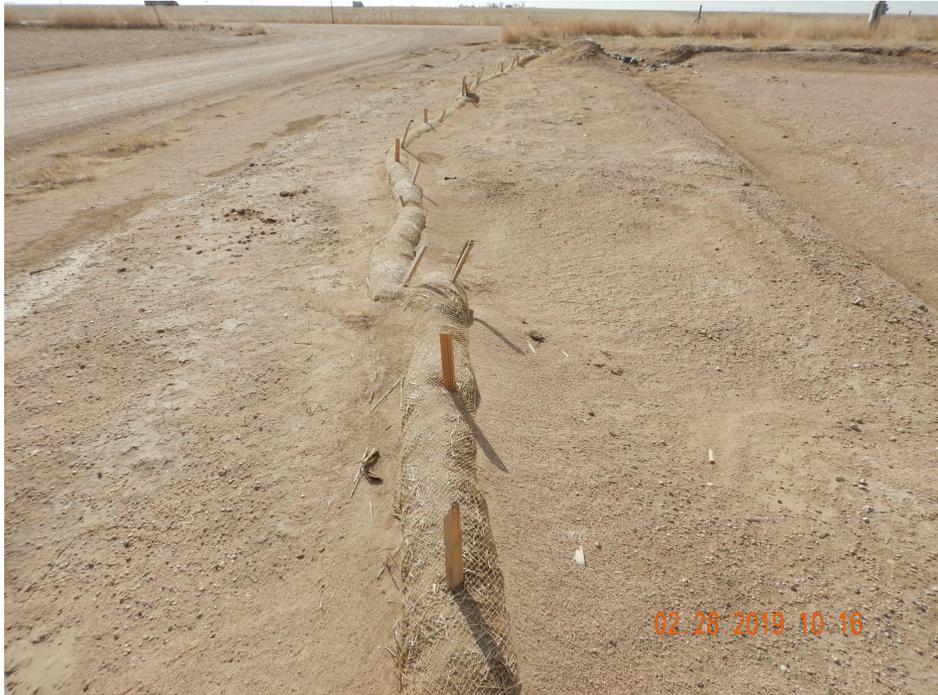
Photo 7. Photo taken east of the southeastern perimeter of the Location, facing South. Photo illustrates soil particle deposition accumulation along the straw wattle BMP that is originating on Location and blowing east off Location.

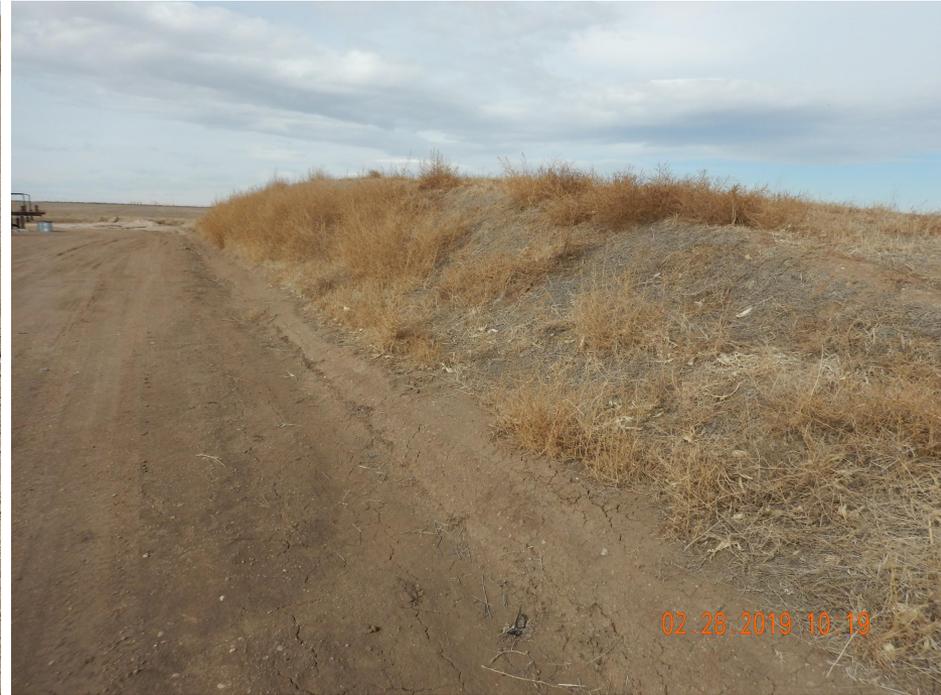
Photo 8. Photo taken from the northern topsoil stockpile, facing West. Photo illustrates weed (Russian thistle) establishment on the topsoil stockpile. Operator has failed to prevent weed establishment on the topsoil stockpile per Rule 1002.c.

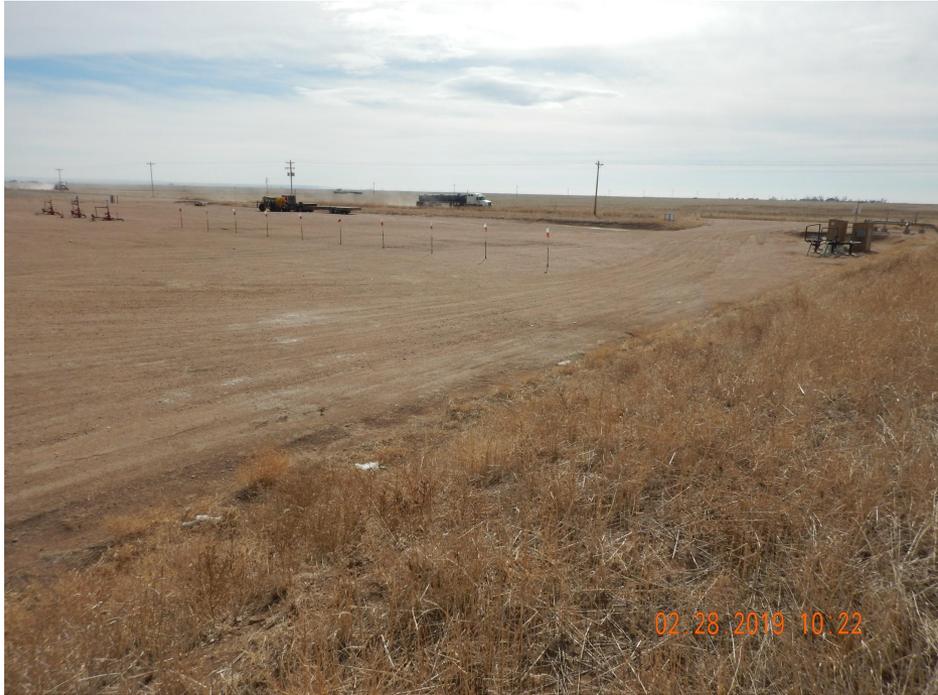
Photo 9. Photo taken from the eastern topsoil stockpile, facing Southeast. Photo illustrates the Operator has failed to perform Interim Reclamation.

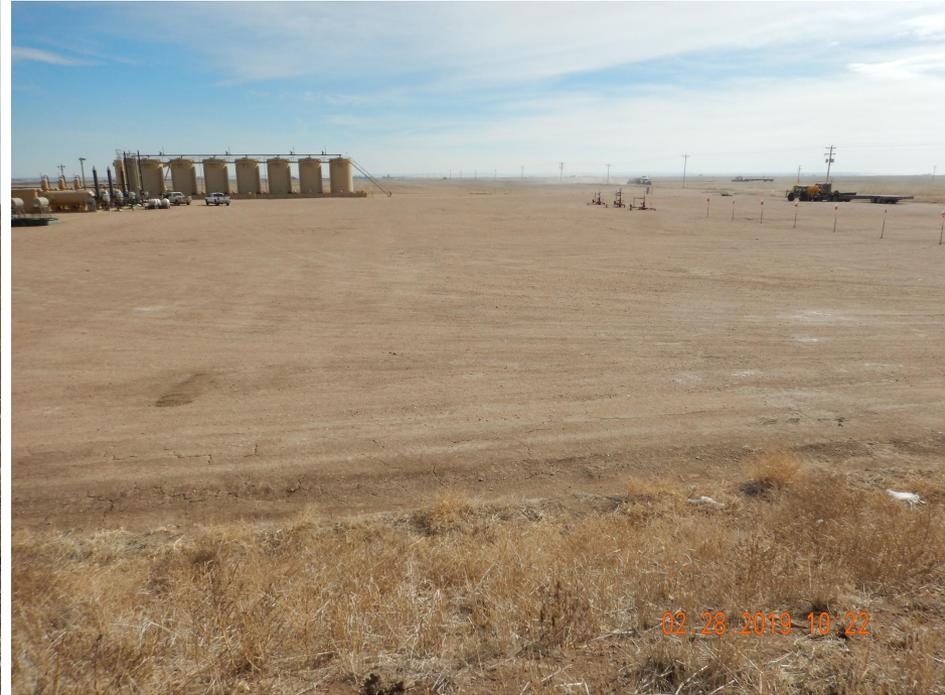
Photo 10. Photo taken from the eastern topsoil stockpile, facing East. See comments under Photo 9.
