Inspection Photos
Location Name: SUNSET 24-3
API #: 05-071-08158
Insp. Doc. # 695100269

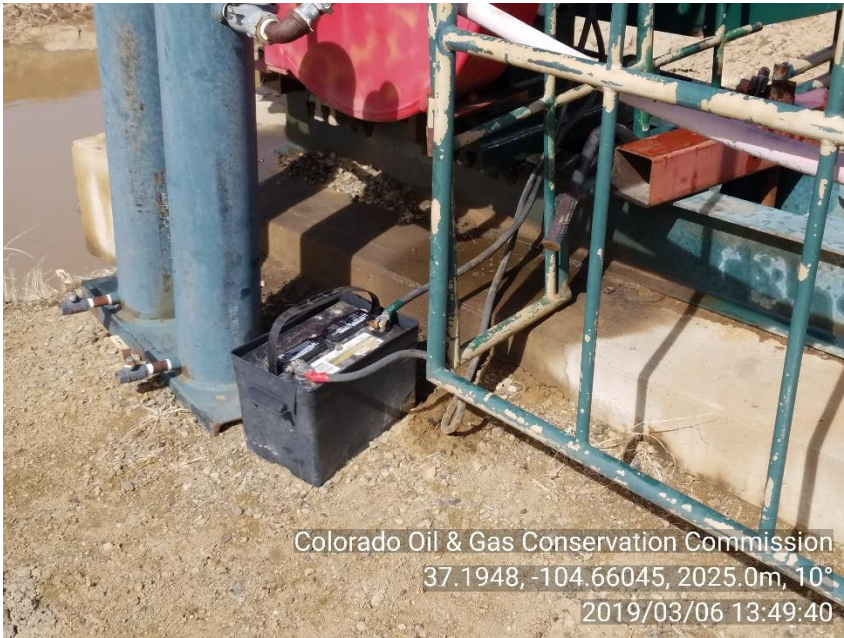
**PHOTO 3: MECHANICAL CONDITION/ APPEARS PUMPJACK
MOTOR IS LEAKING OIL**

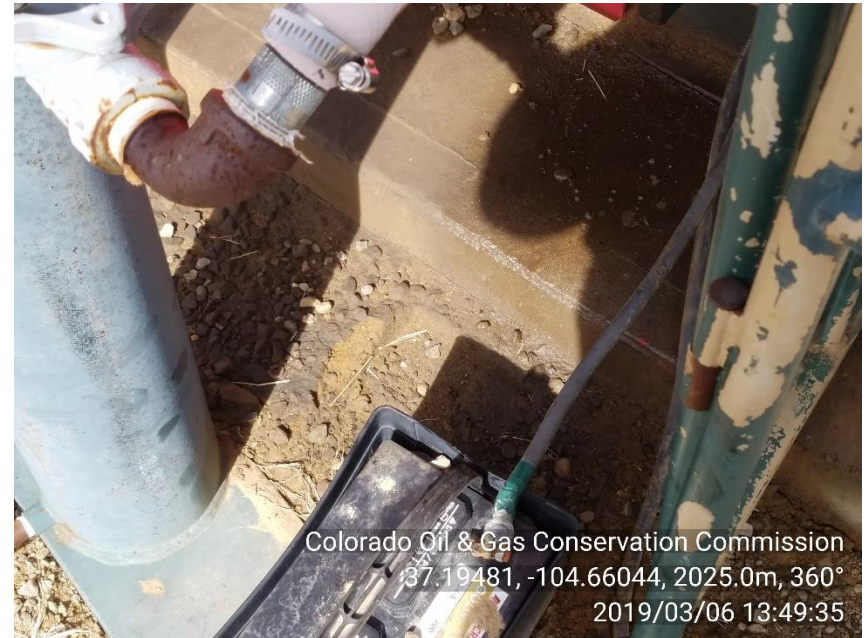
**PHOTO 4: IMPACTED SOIL/ OIL APPEARS TO BE LEAKING FROM
PUMPJACK MOTOR AND RUNNING ONTO THE GROUND ON
SOUTHWEST SIDE OF PUMPJACK**
