Inspection Photos

API: 05-071-06636

Operator: PIONEER NATURAL RESOURCES

Inspection Date: 3/1/2019

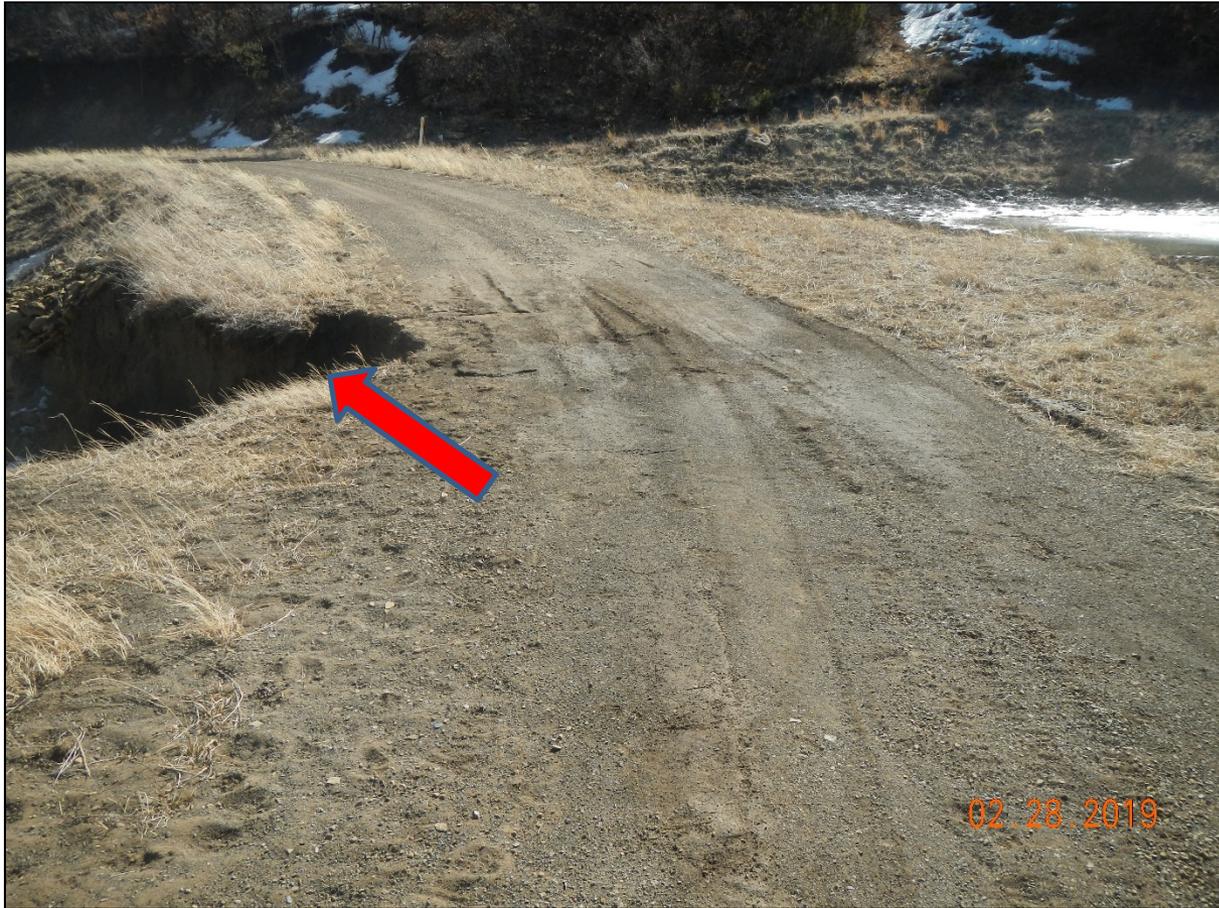
Photo 1. Erosion is occurring along the access road at Lat/Long:37.08649,-104.75026.

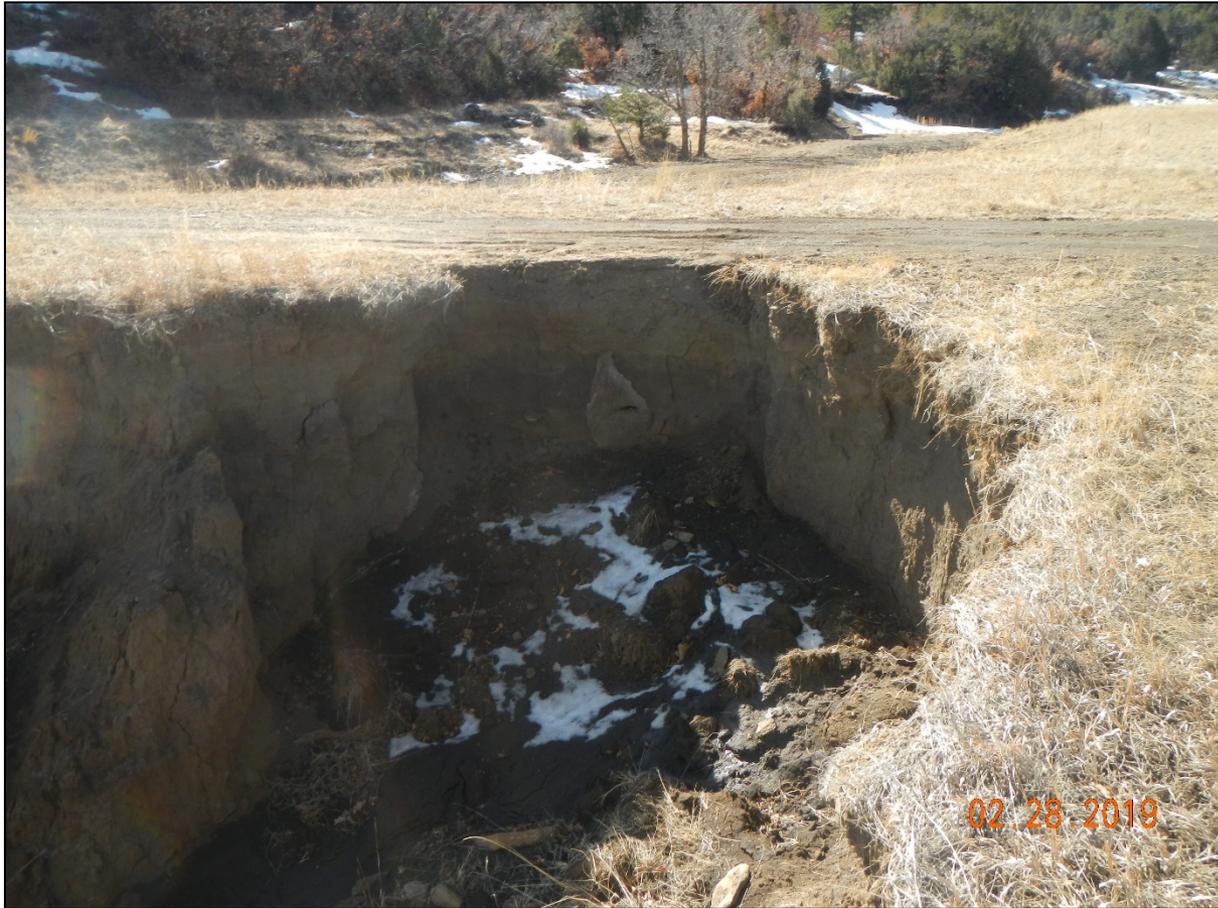
Photo 2. Stormwater appears to flow across the road causing significant erosion.

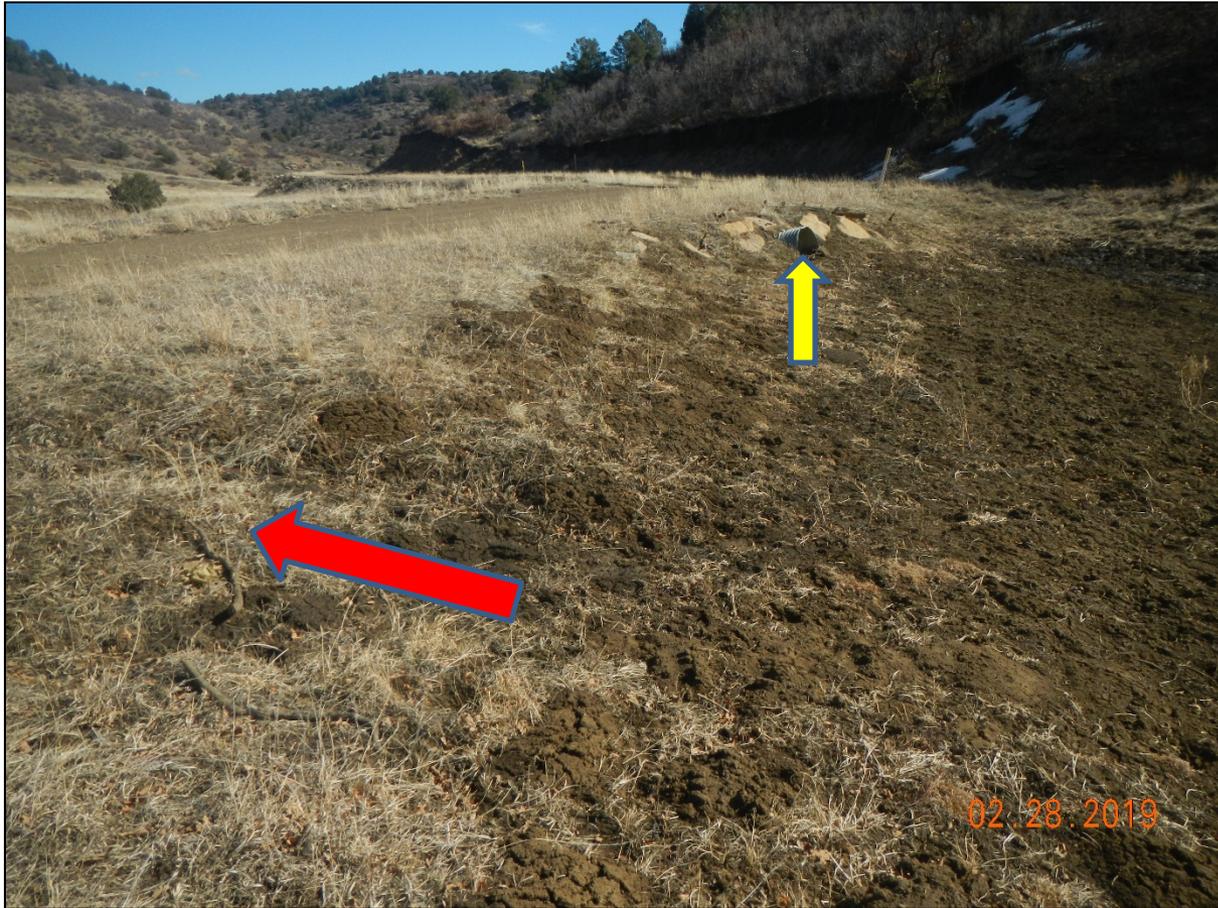
Photo 3. Stormwater is flowing toward the access road (red arrow) and not toward the culvert (yellow arrow). Culvert may be plugged up with debris.

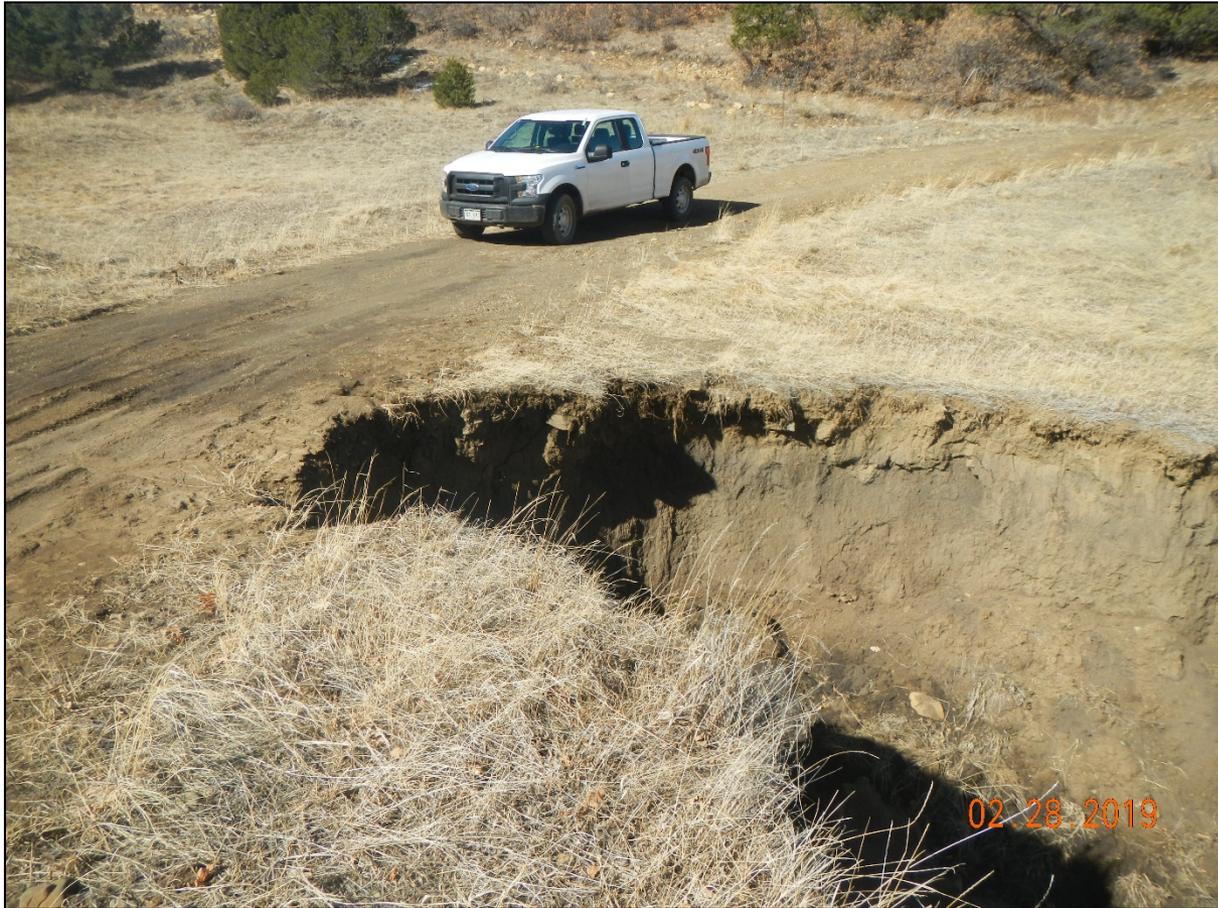
Photo 4. Erosion is cutting into the road, approximately 8-10 ft. deep.

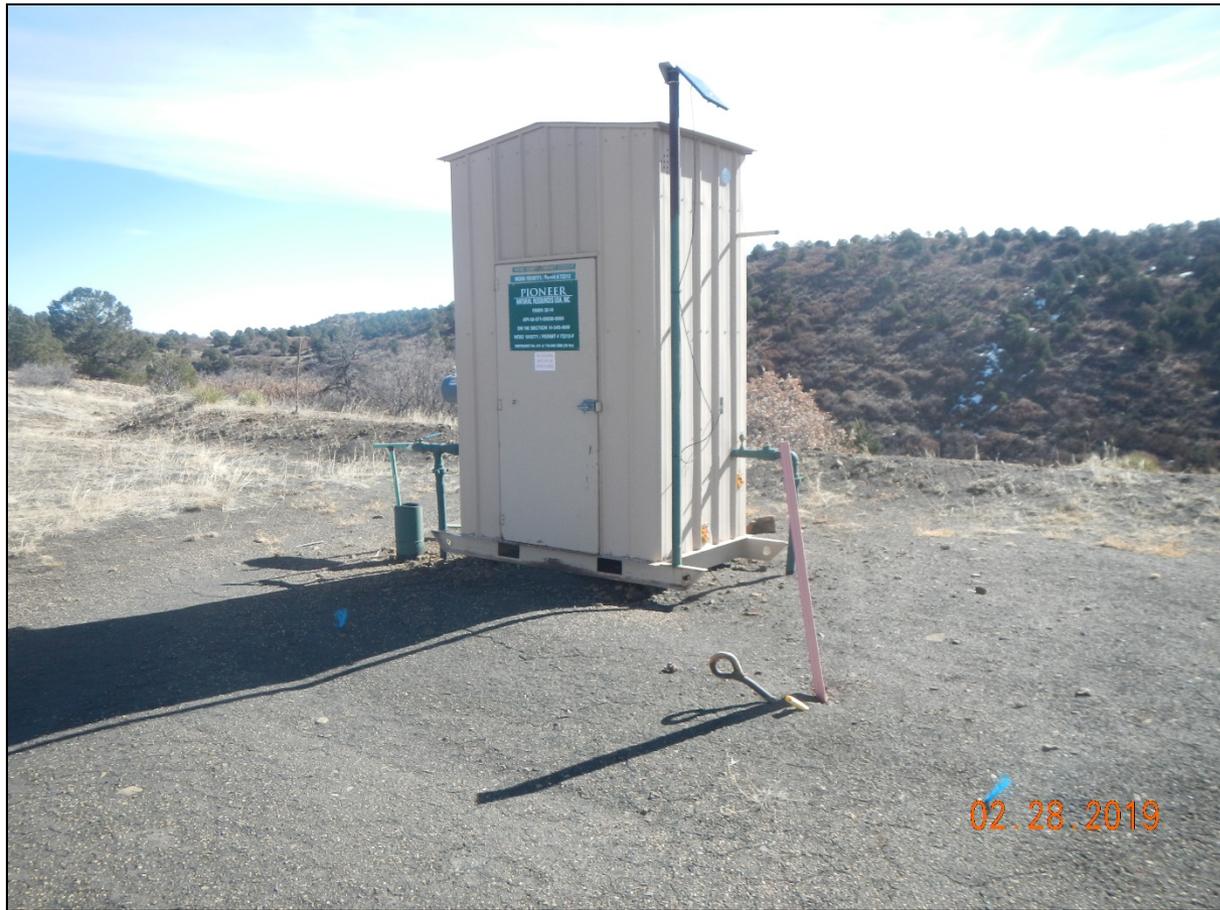
Photo 5. Well sign present at the location.

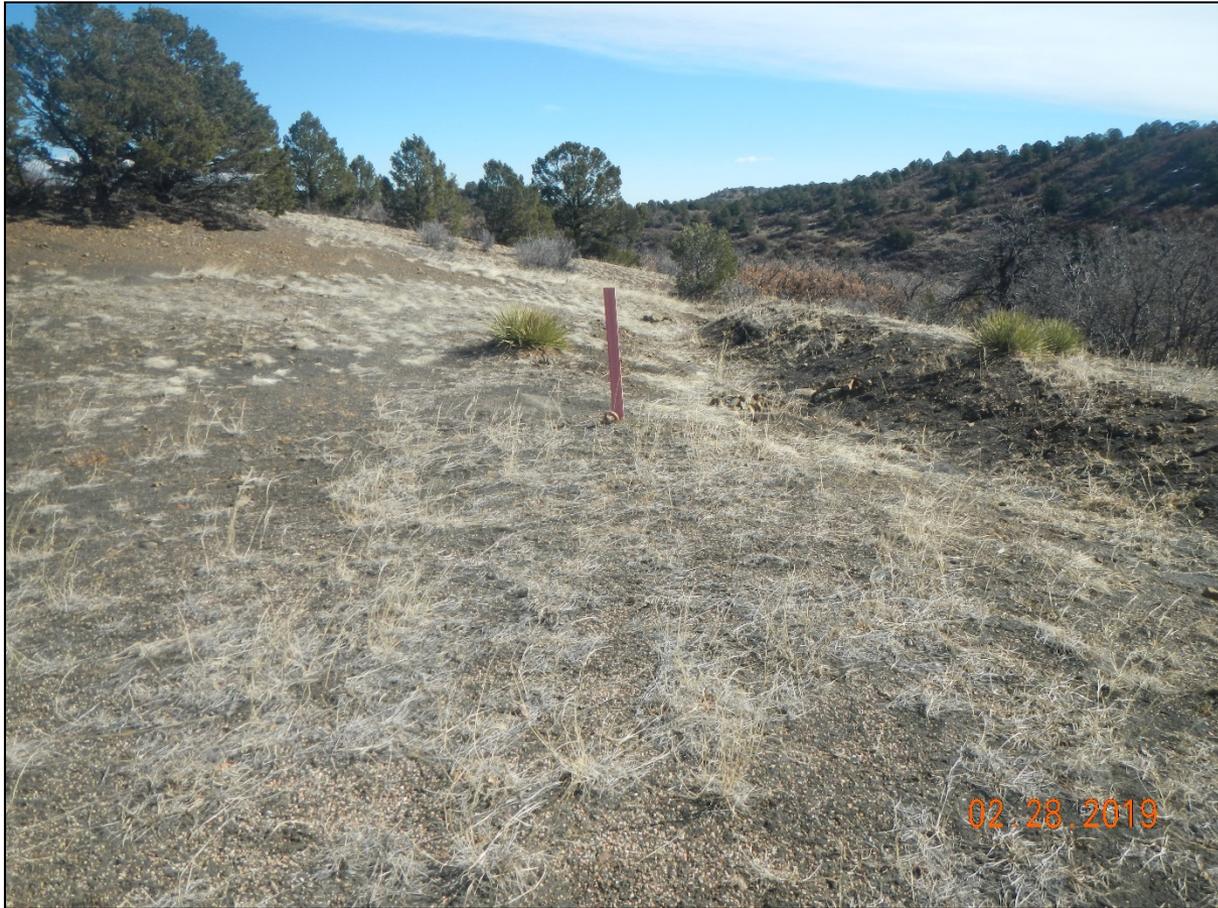
Photo 6. Facing toward the north side of the location. Vegetation is established and guy line marker is present.

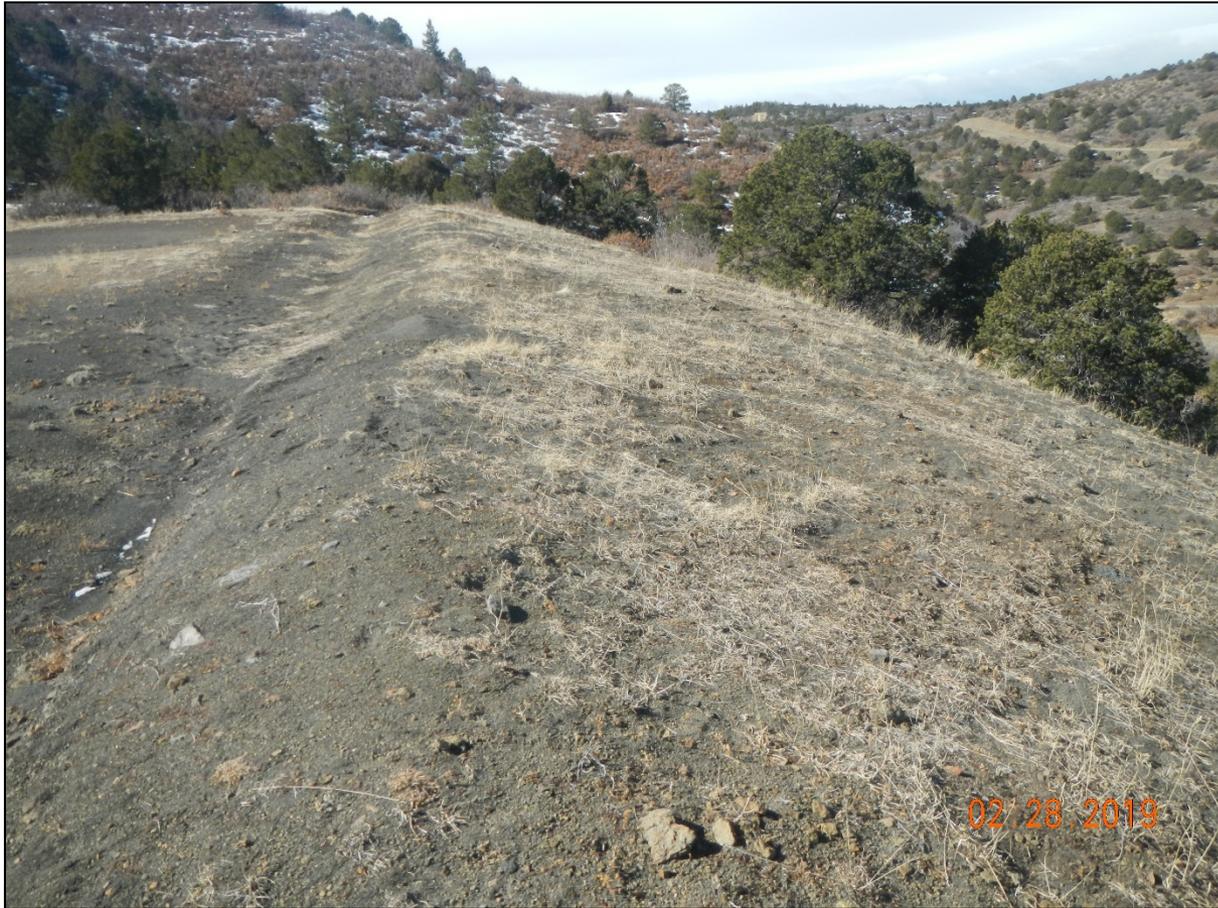
Photo 7. Facing toward the south side of the location. Vegetation is established along the fill slope.

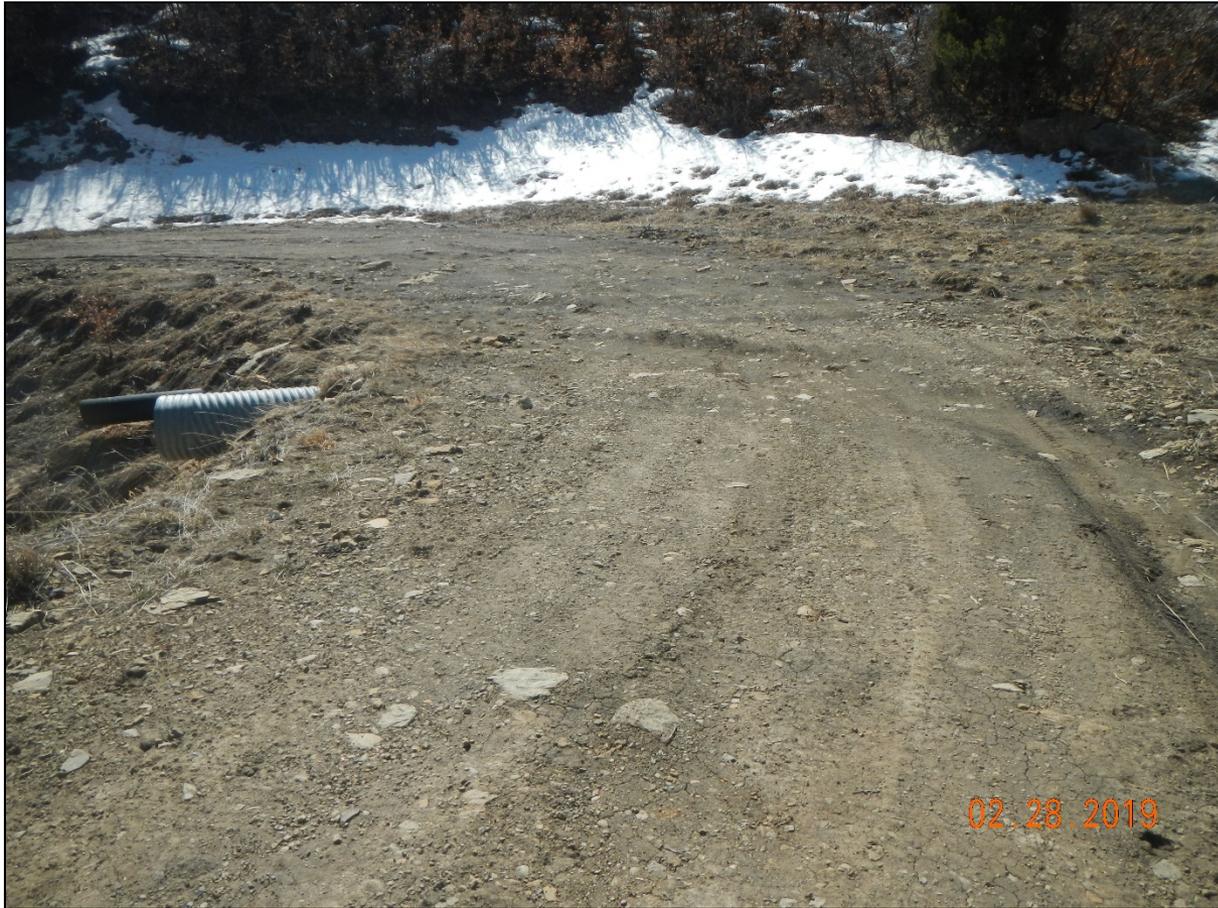
Photo 8. Culvert is filled in with sediment and stormwater is flowing across the road.
Lat/Long:37.09338,-104.74751
